STATE OF VERMONT  
AGENCY OF TRANSPORTATION

Scoping Report

FOR  
STATEWIDE NORTHWEST STP CULV(90):  
ESSEX VT15 BR #2

VT ROUTE 15, BRIDGE 2 OVER INDIAN BROOK

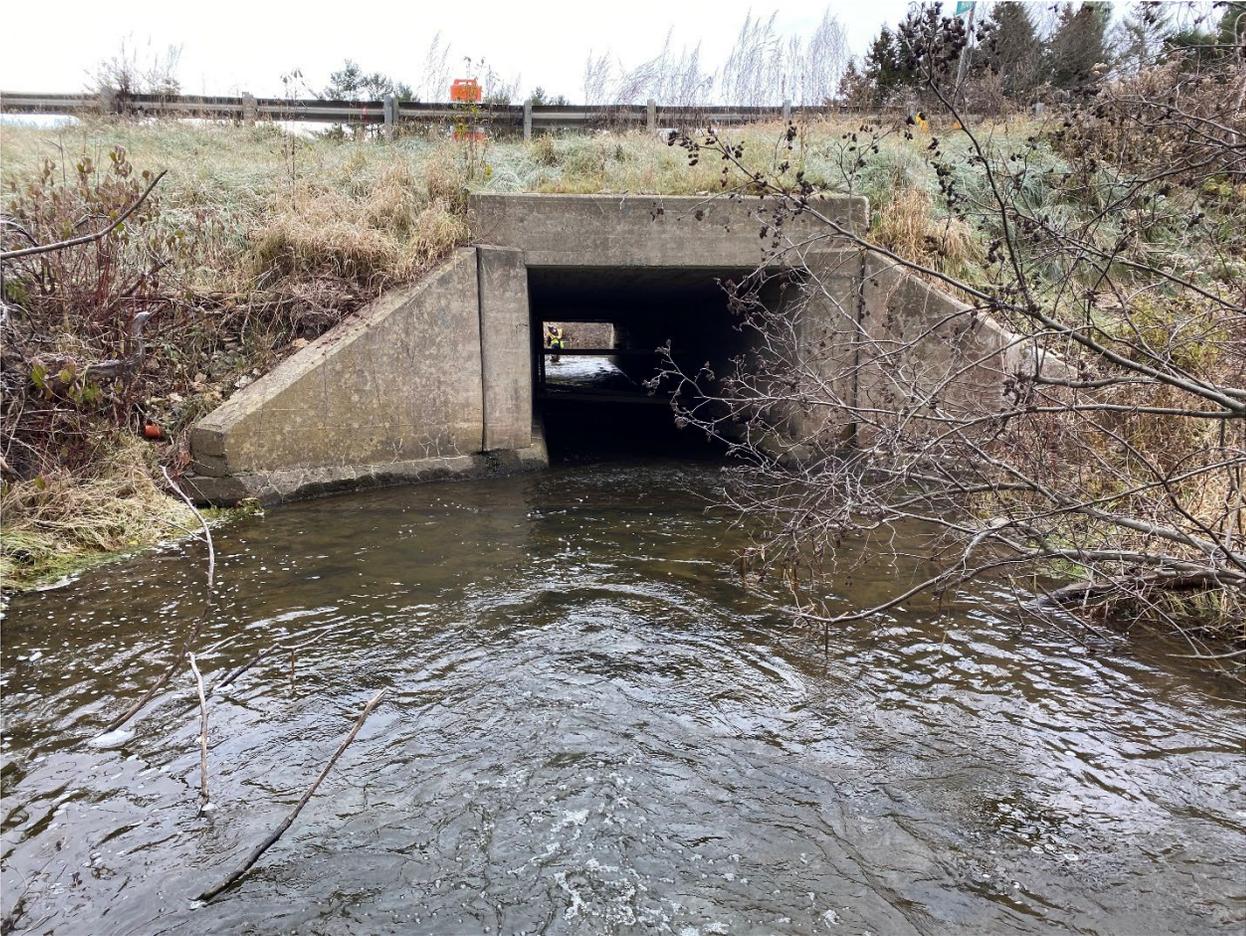
Upstream Elevation (Inspection photo 2021)

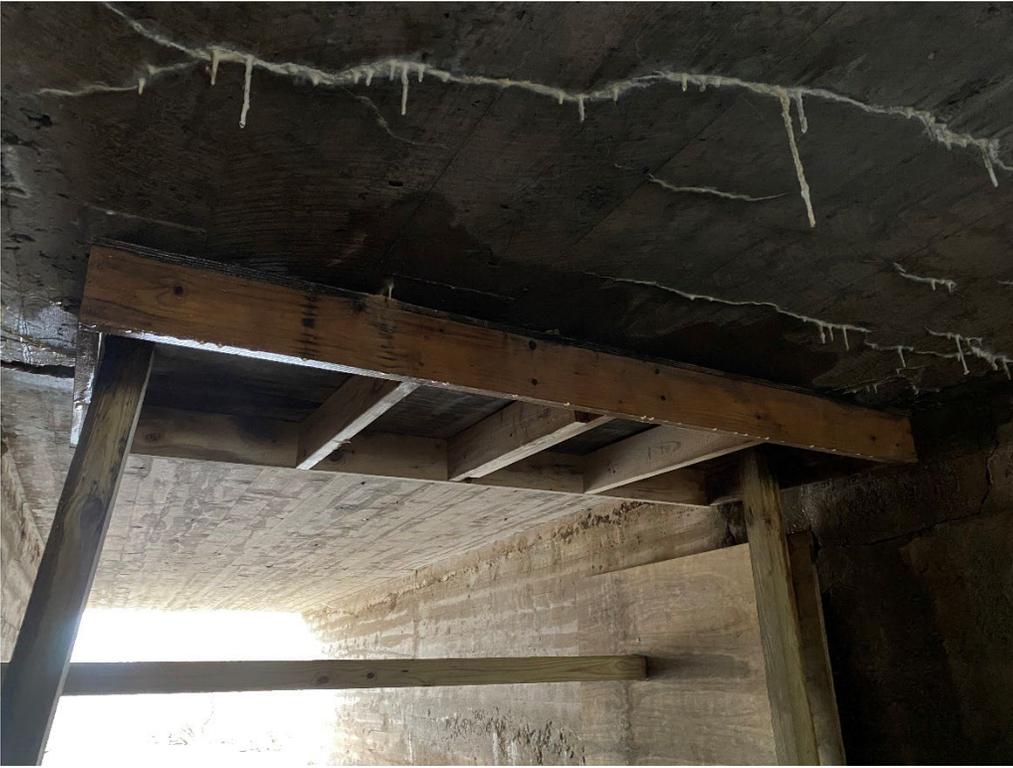
Timber bunker below Upstream Spall (Inspection photo 2021)

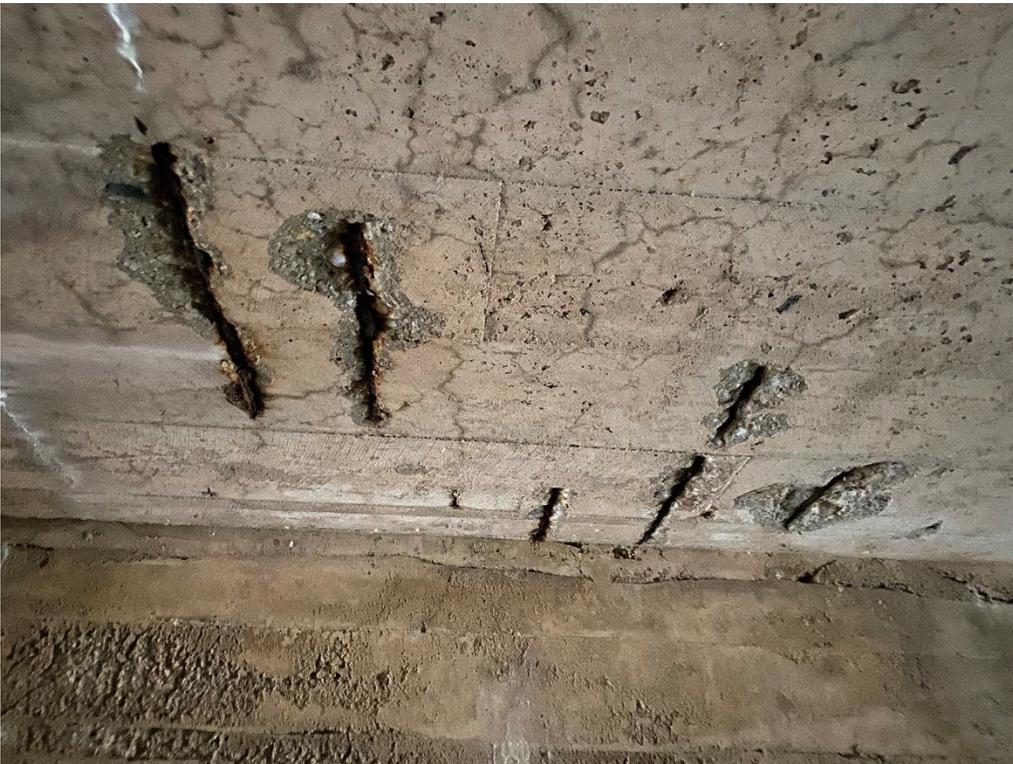
Box Soffit Shallow Rebar below Roadway (Inspection photo 2021)

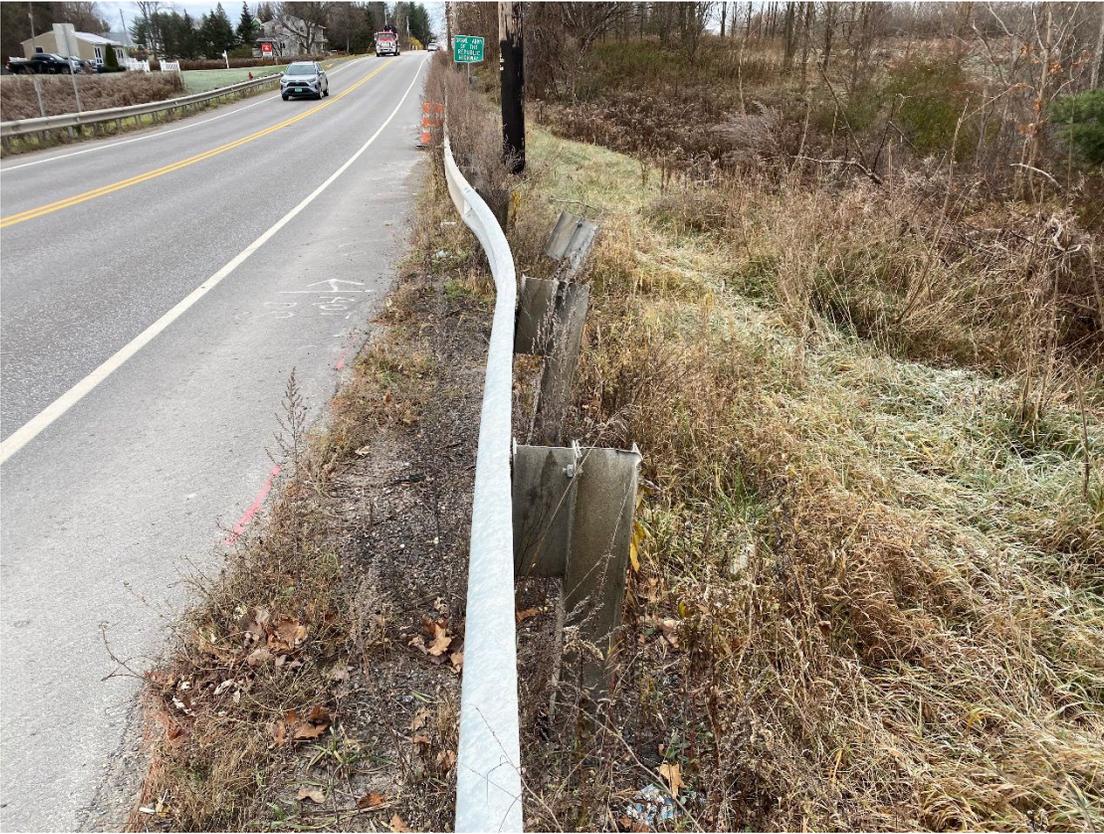
Impact Damage Northern Side Rail (Inspection photo 2021)

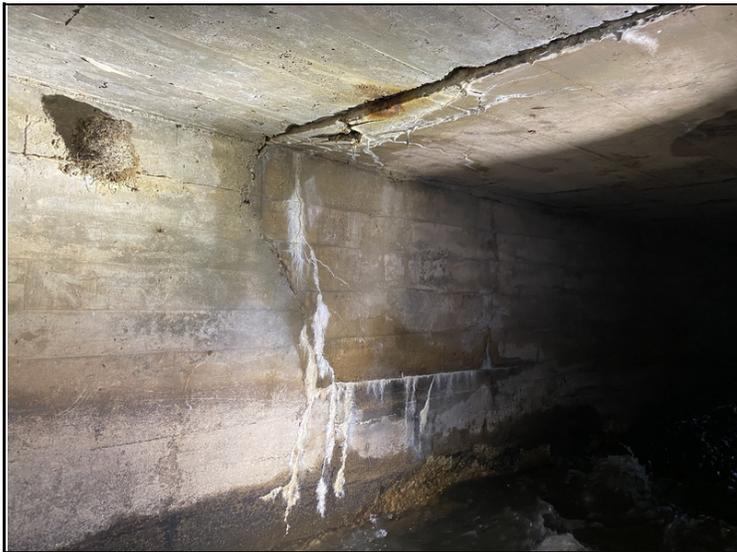
Displacement in Box with Heavy Saturation, Rust

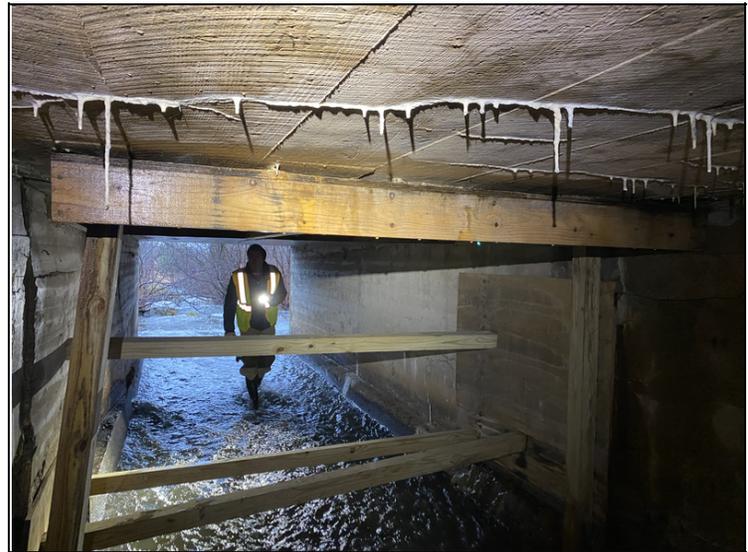
Timber Blocking to prevent further Spalling / Settlement in Roadway Near Upstream End / Below Approach Rail

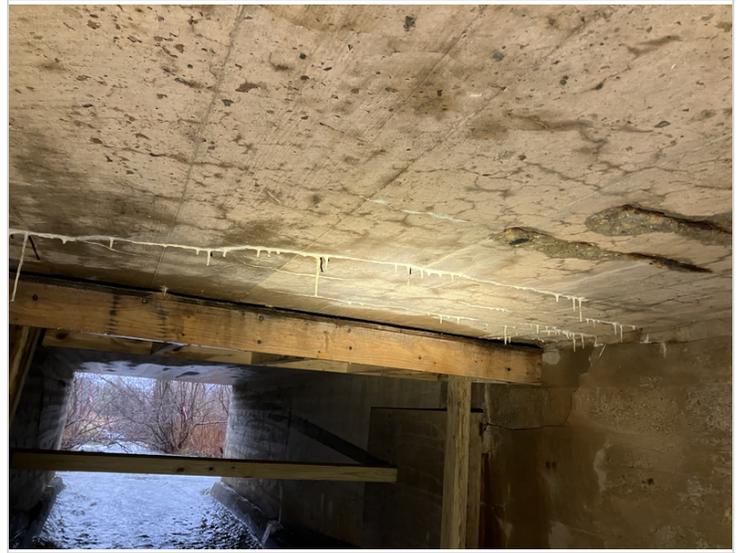
Cracking and Efflorescence on downstream Side of Timber supports

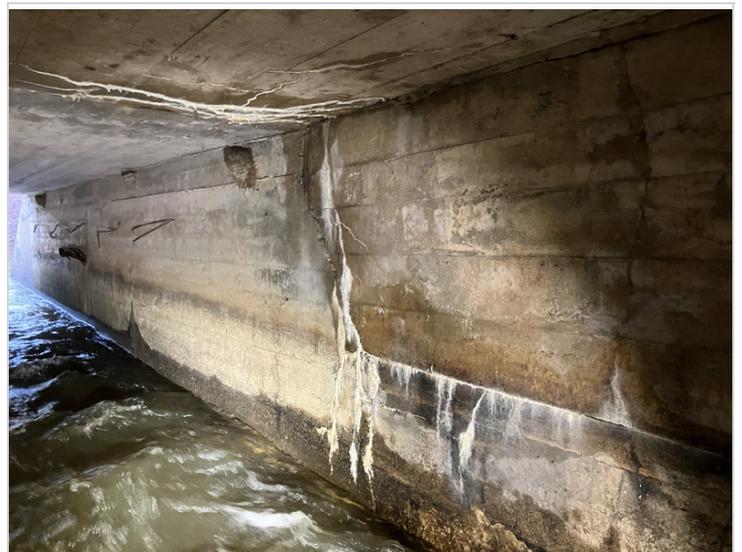
Cracking and Efflorescence on Western Side of Culvert near Midspan

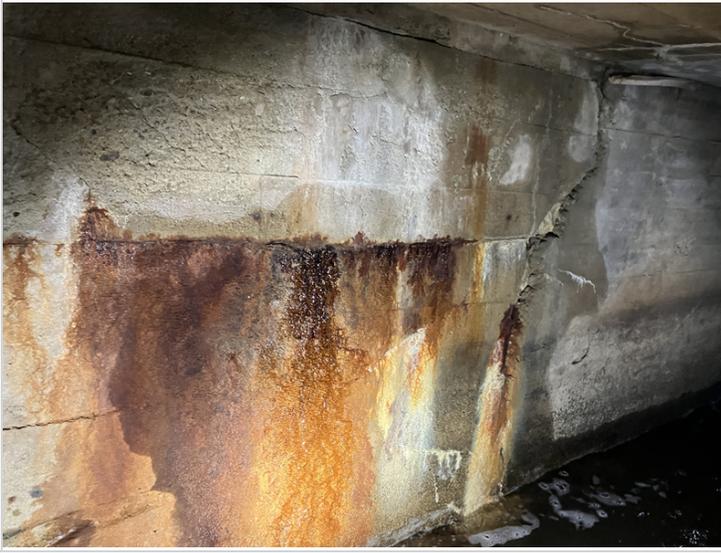
Cracking, Efflorescence and Rust staining on Eastern Side of Culvert near Midspan

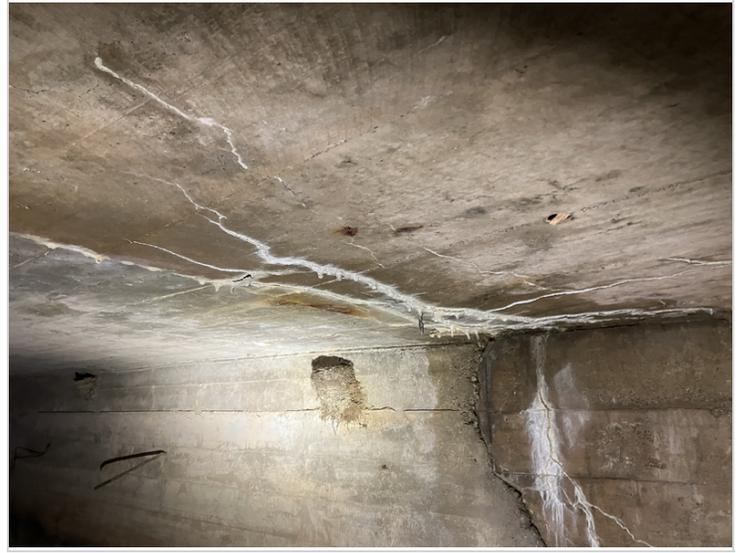
Cracking and Efflorescence and sagging along western side and top of culvert near downstream end

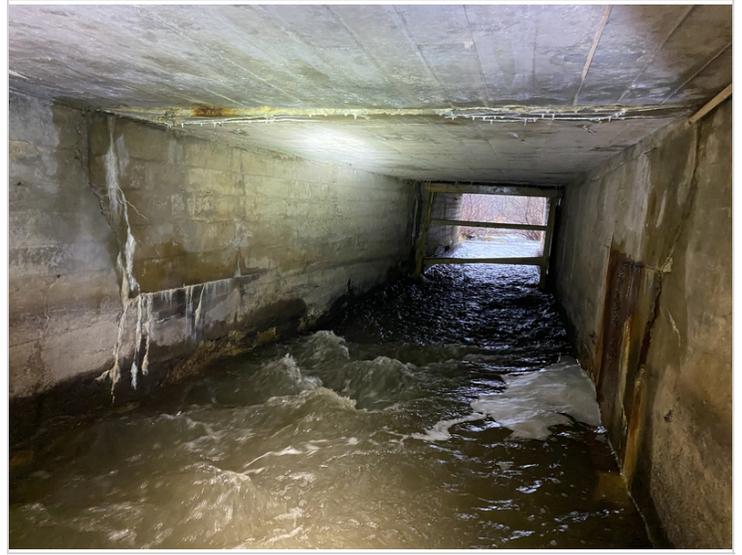
Displacement in Box with Heavy Saturation, Rust Staining and Efflorescence at Widening/Lengthening Joint Downstream

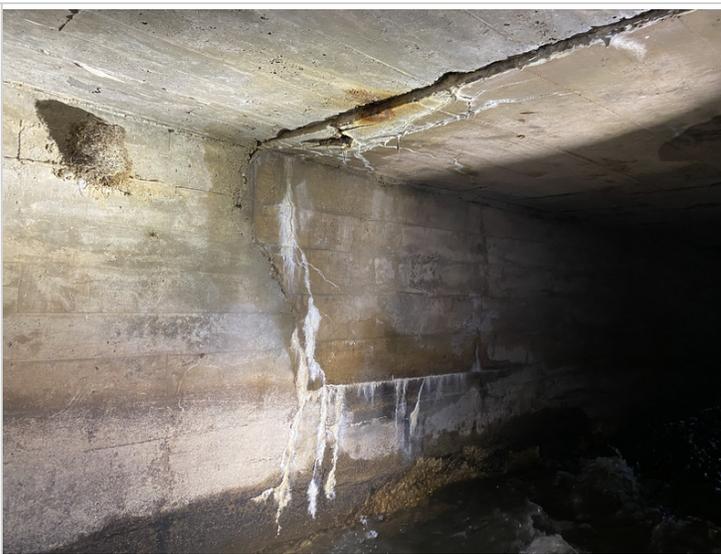
Displacement in Box with Heavy Saturation, Rust Staining and Efflorescence at Widening/Lengthening Joint Downstream

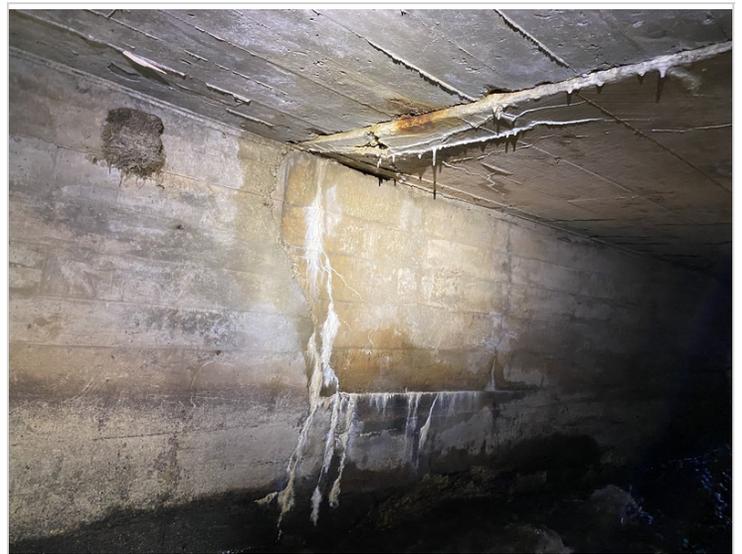
Displacement in Box with Heavy Saturation, Rust Staining and Efflorescence at Widening/Lengthening Joint Downstream

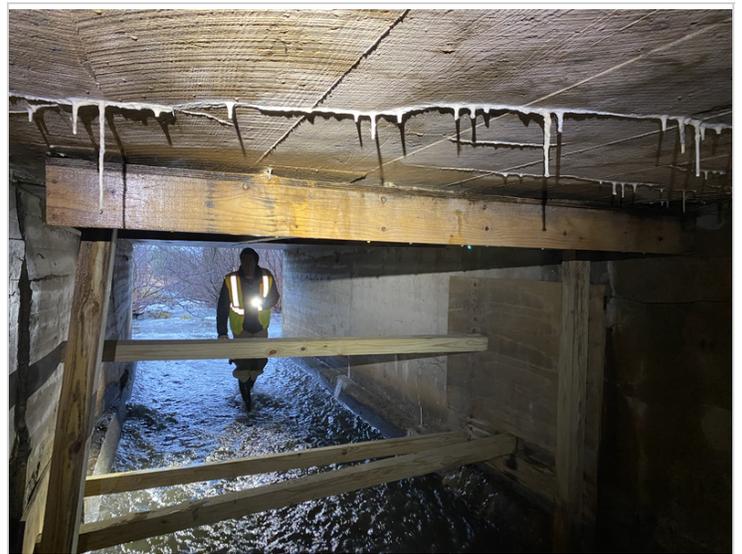
Timber Blocking to prevent further Spalling /  
Settlement in Roadway Near Upstream End /  
Below Approach Rail

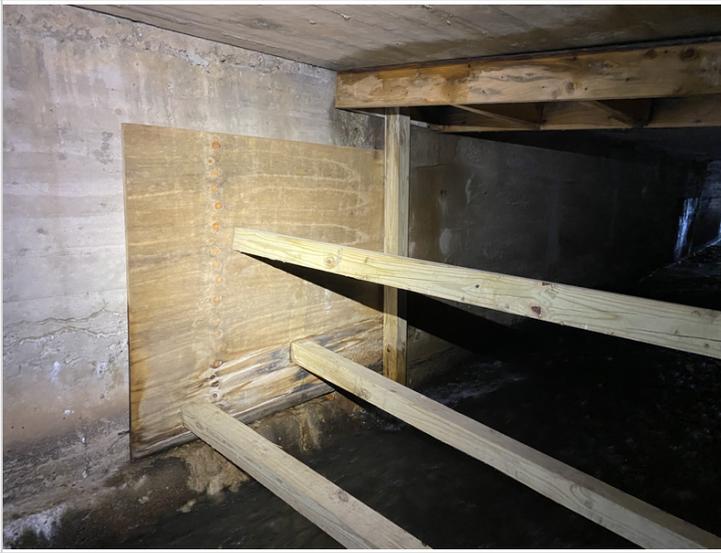
Timber Blocking to prevent further Spalling /  
Settlement in Roadway Near Upstream End /  
Below Approach Rail

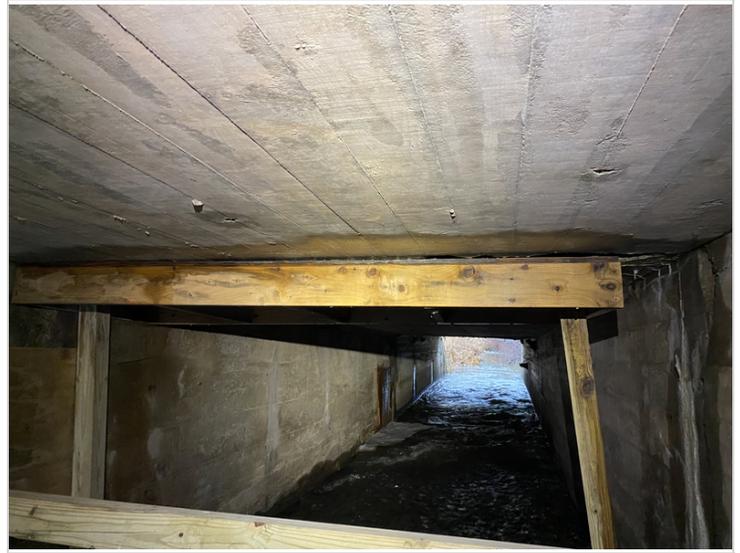
Timber Blocking to prevent further Spalling /  
Settlement in Roadway Near Upstream End /  
Below Approach Rail

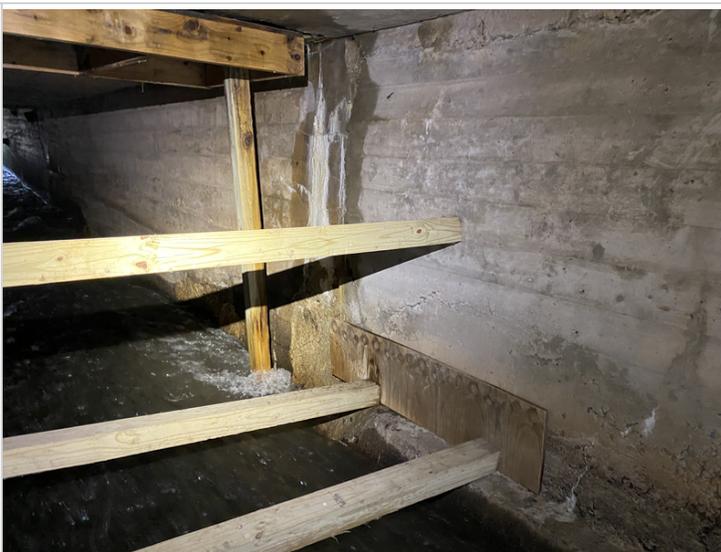
Timber Blocking to prevent further Spalling /  
Settlement in Roadway Near Upstream End /  
Below Approach Rail

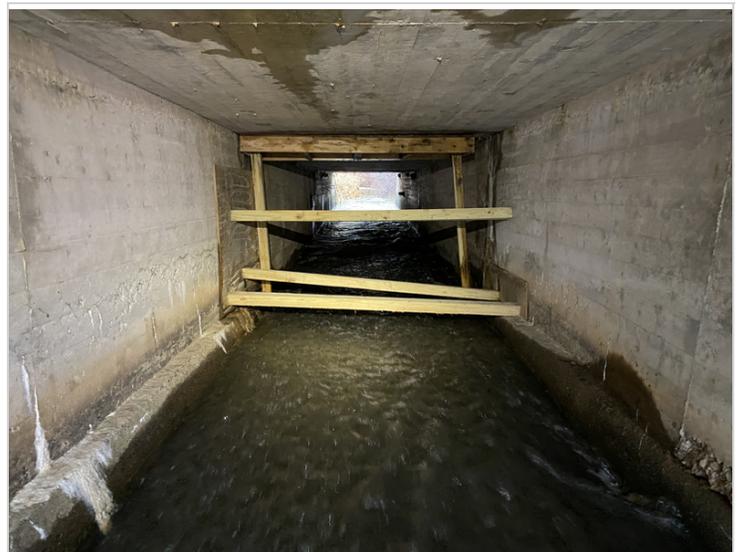
Timber Blocking to prevent further Spalling /  
Settlement in Roadway Near Upstream End /  
Below Approach Rail
