STATE OF VERMONT  
AGENCY OF TRANSPORTATION

Scoping Report

FOR  
STATEWIDE NORTHWEST STP CULV(90):  
JERICHO VT15 BR #6A

VT ROUTE 15, BRIDGE 6A OVER UNNAMED BROOK

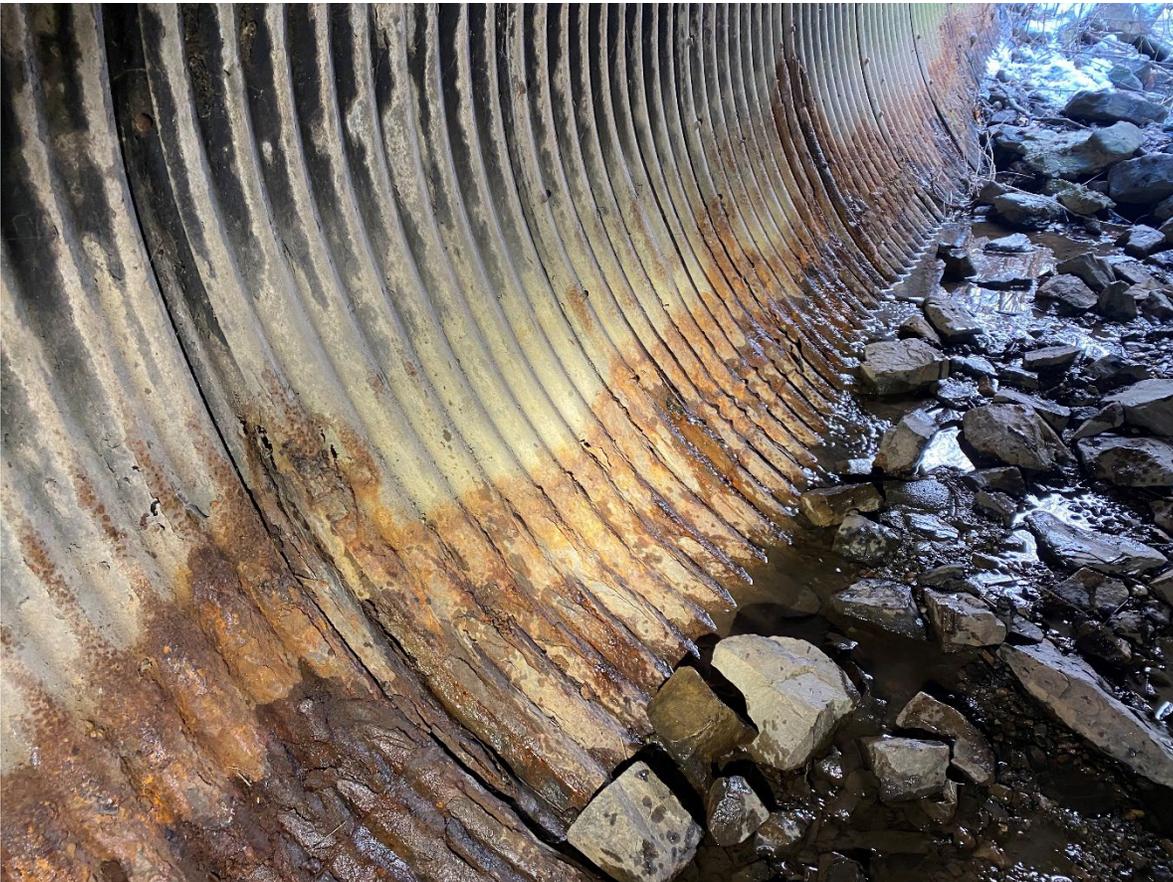
Western Upstream Invert Corrosion (Inspection photo 2021)

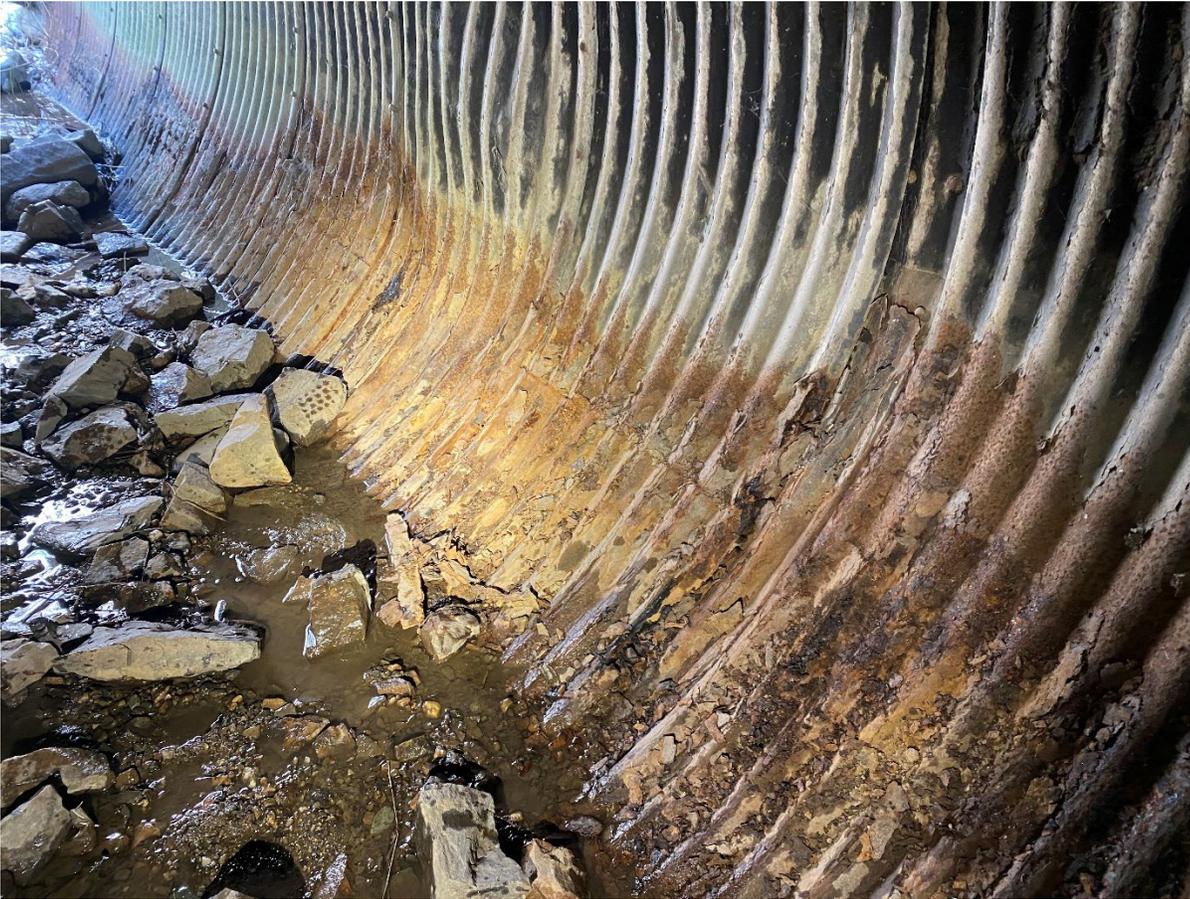
Eastern Upstream Invert Corrosion (Inspection photo 2021)

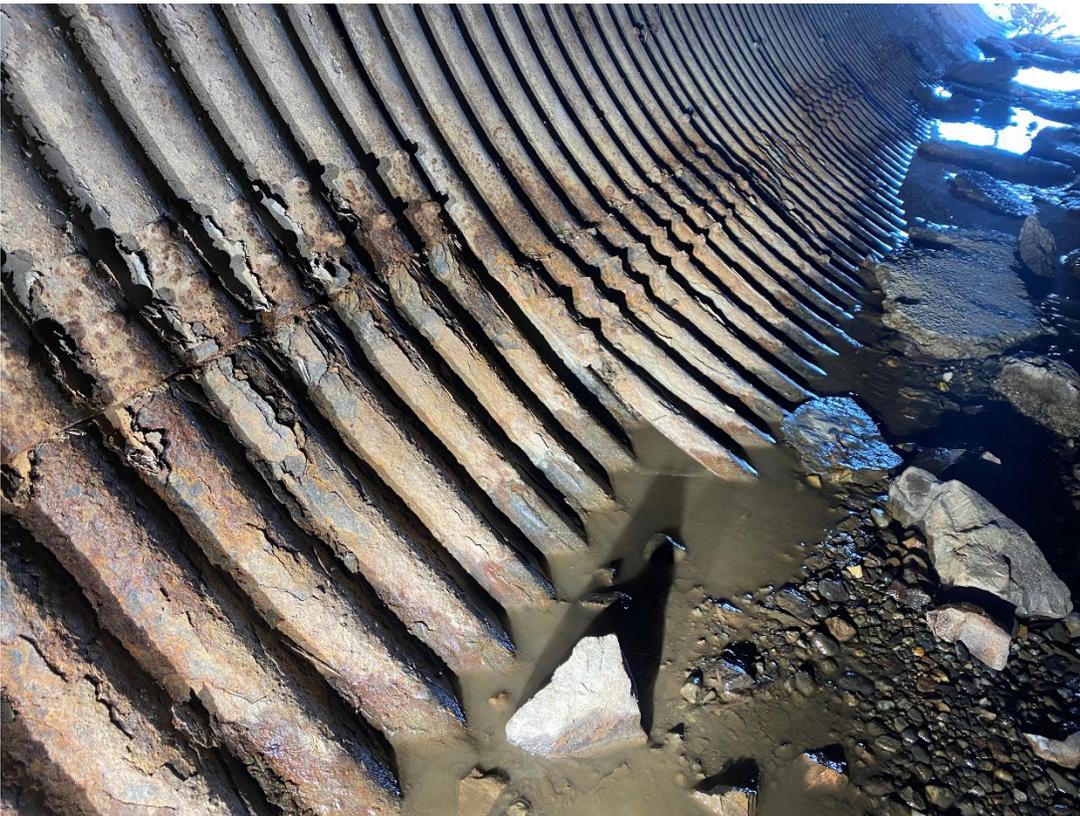
Eastern Invert Distortion/Corrosion (Inspection photo 2021)

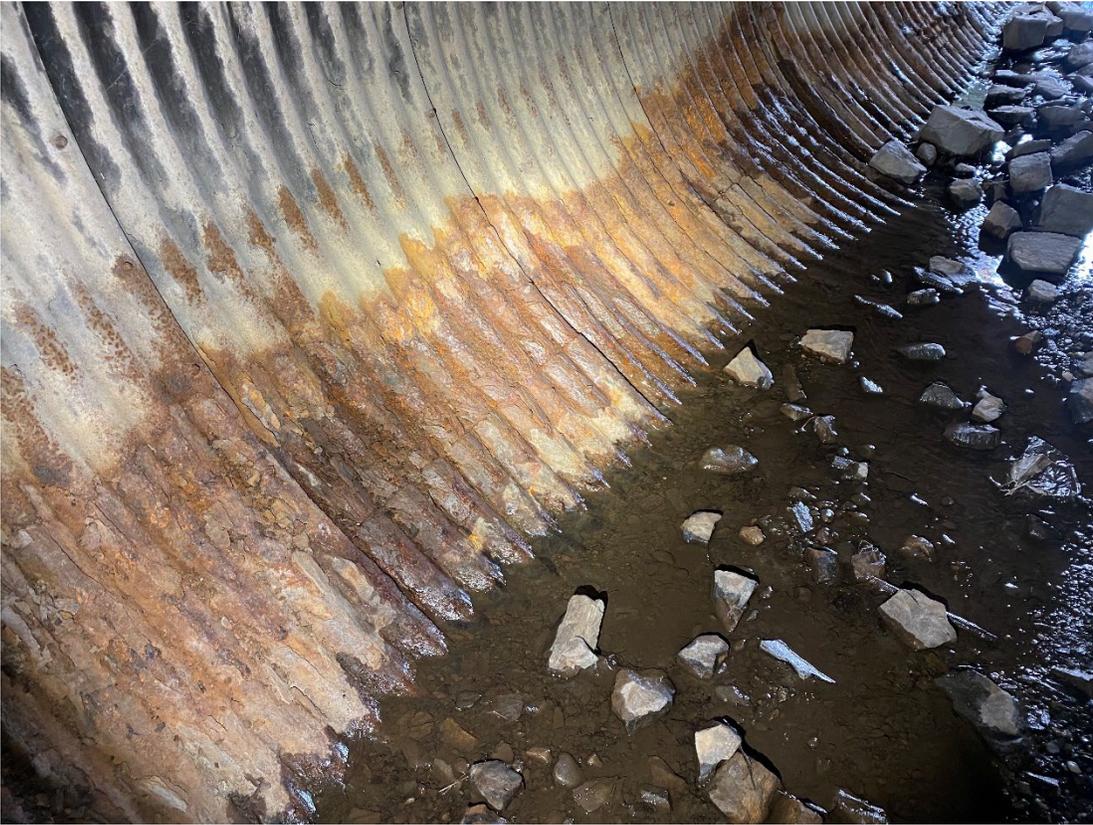
Western Upstream Invert Corrosion (Inspection photo 2021)

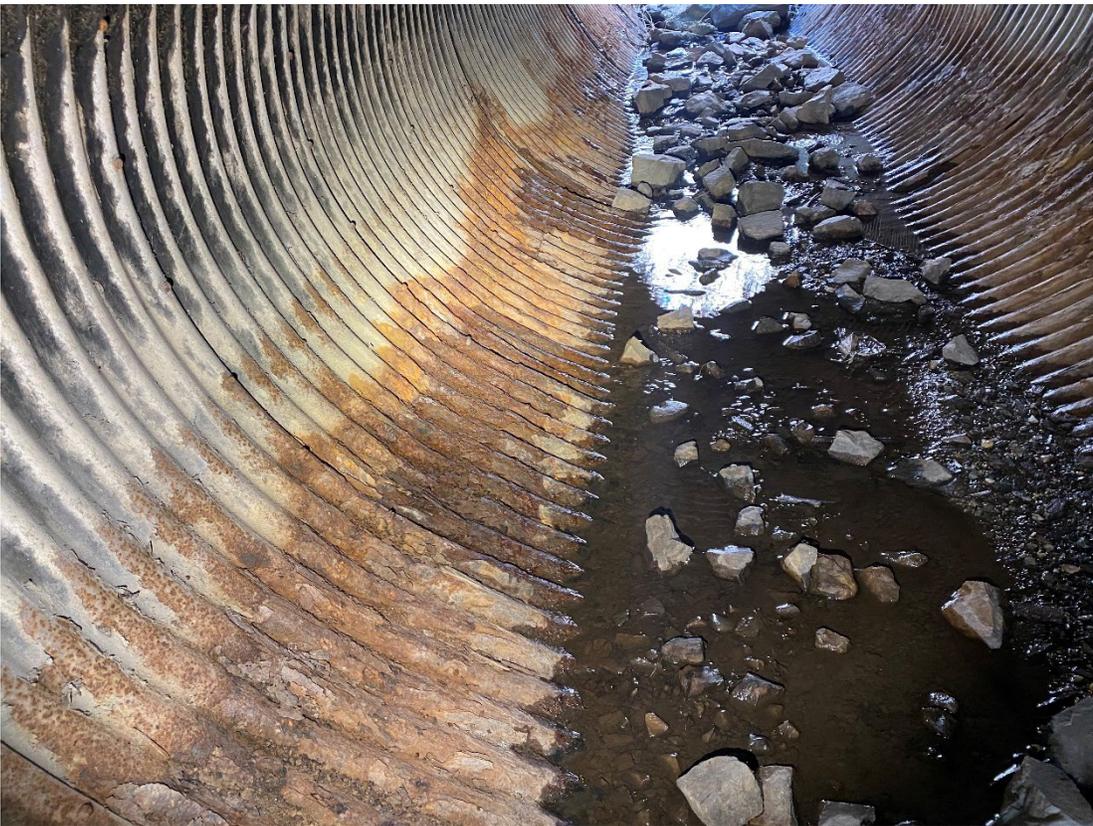
Western Invert Corrosion (Inspection photo 2021)

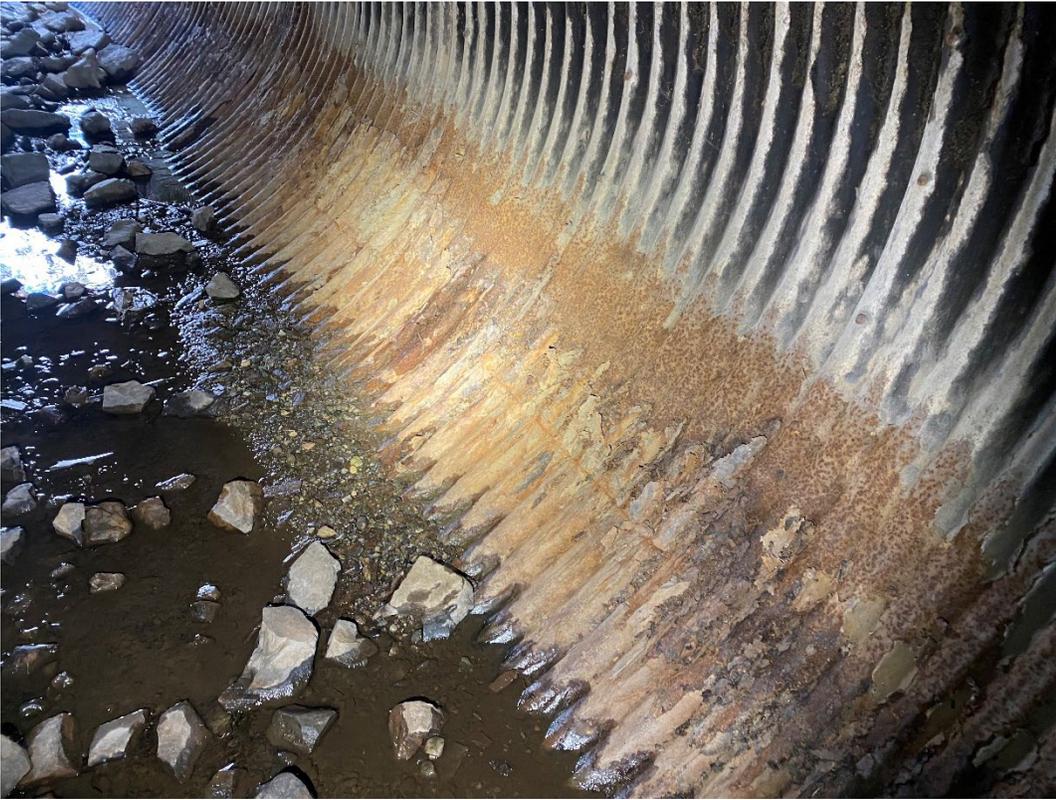
Eastern Invert Corrosion (Inspection photo 2021)

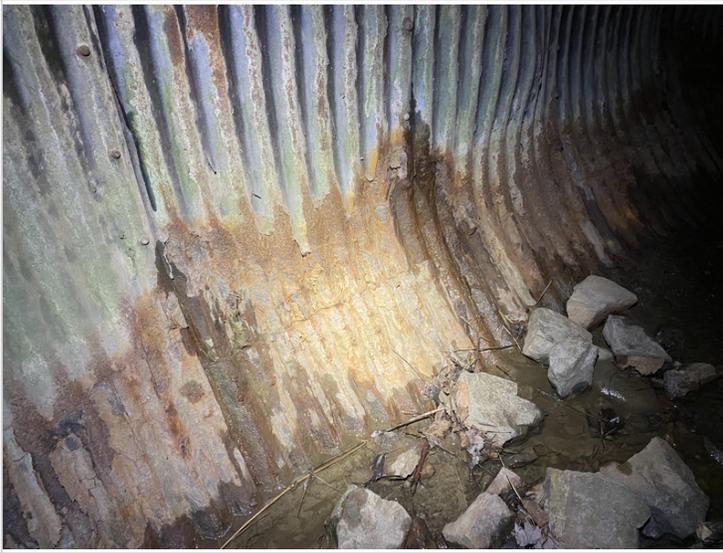
Heavy Corrosion along Eastern Wall near Upstream

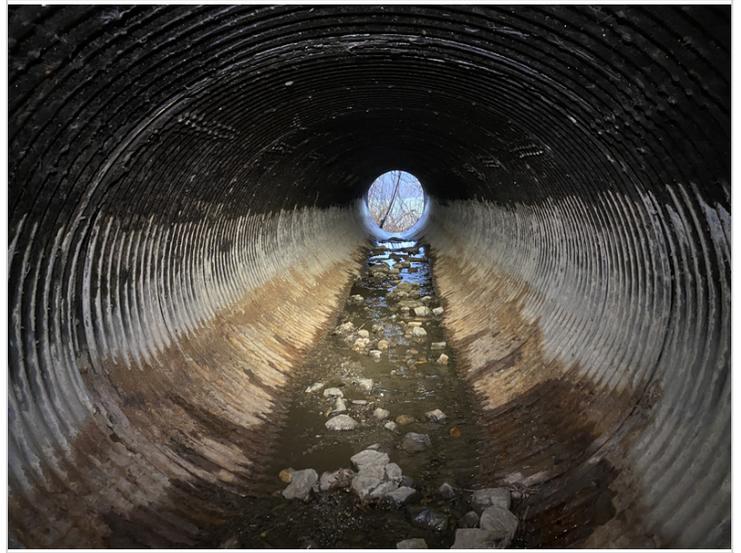
Pipe Squashing from Upstream

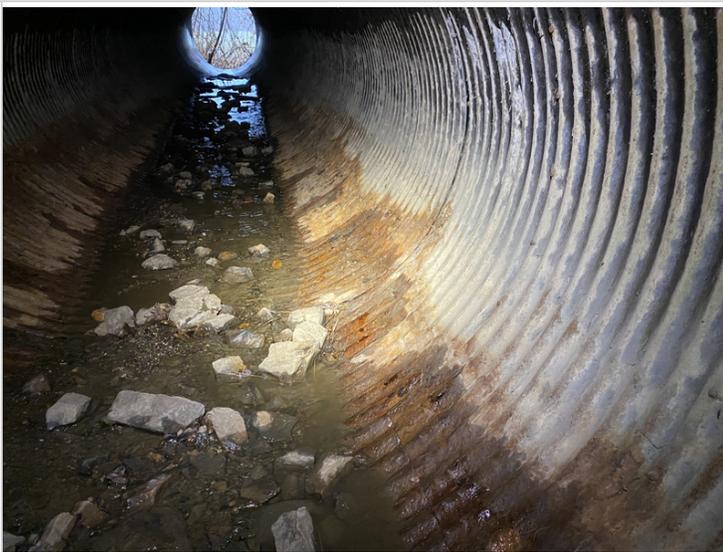
Western Wall Corrosion from Upstream

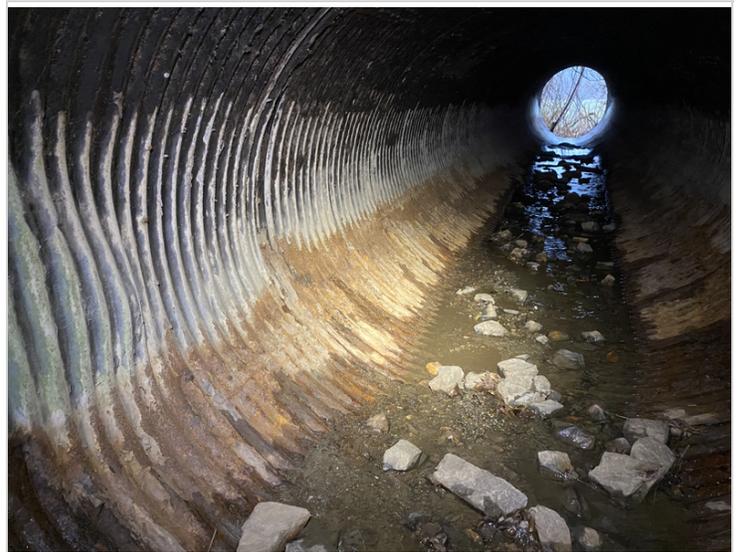
Eastern Wall Corrosion from Upstream

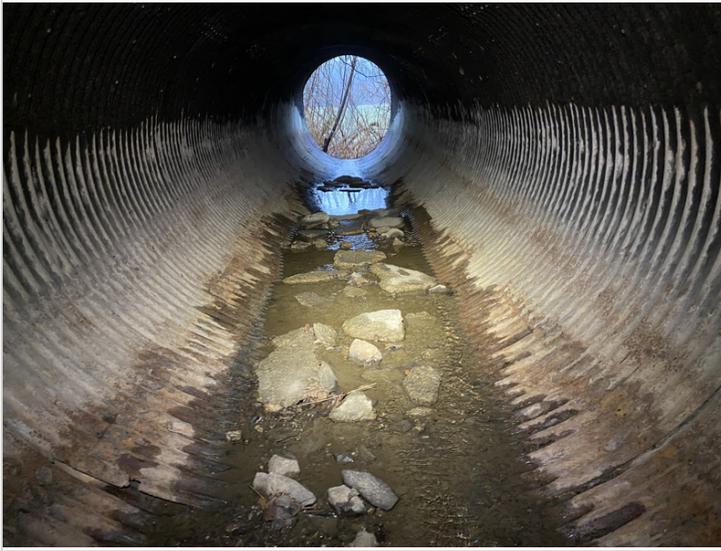
Invert Corrosion from Upstream
