**STATE OF VERMONT
AGENCY OF TRANSPORTATION**

**Scoping Report
FOR
NORTON BF 0321(21)**

VT ROUTE 114, BRIDGE 41 OVER NUMBER FIVE BROOK

December 21, 2023

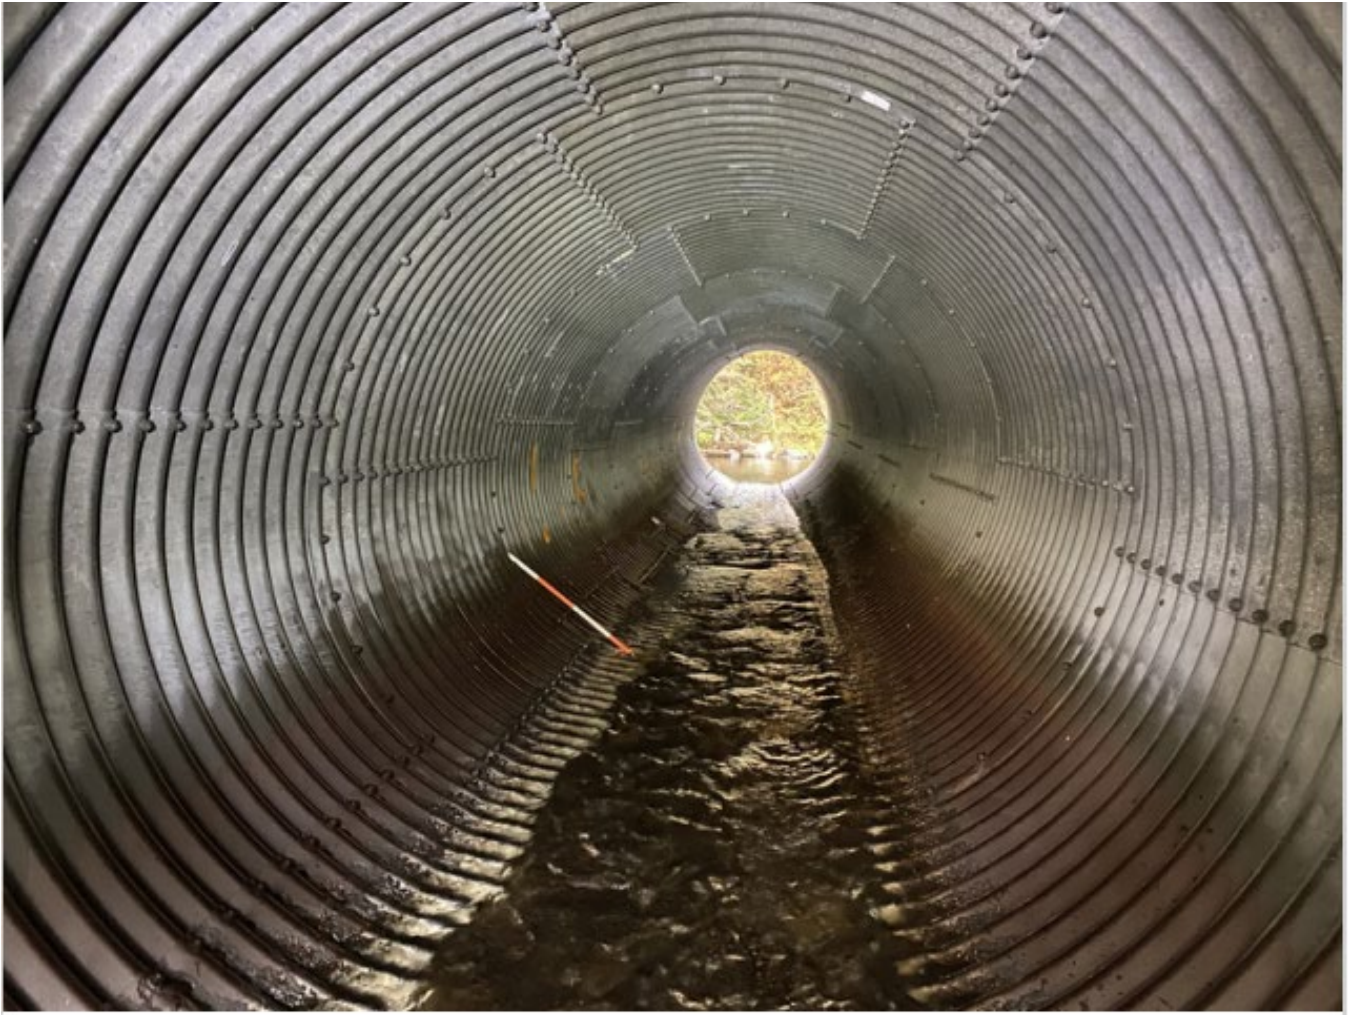
Barrel from upstream (Inspection photo 2022)

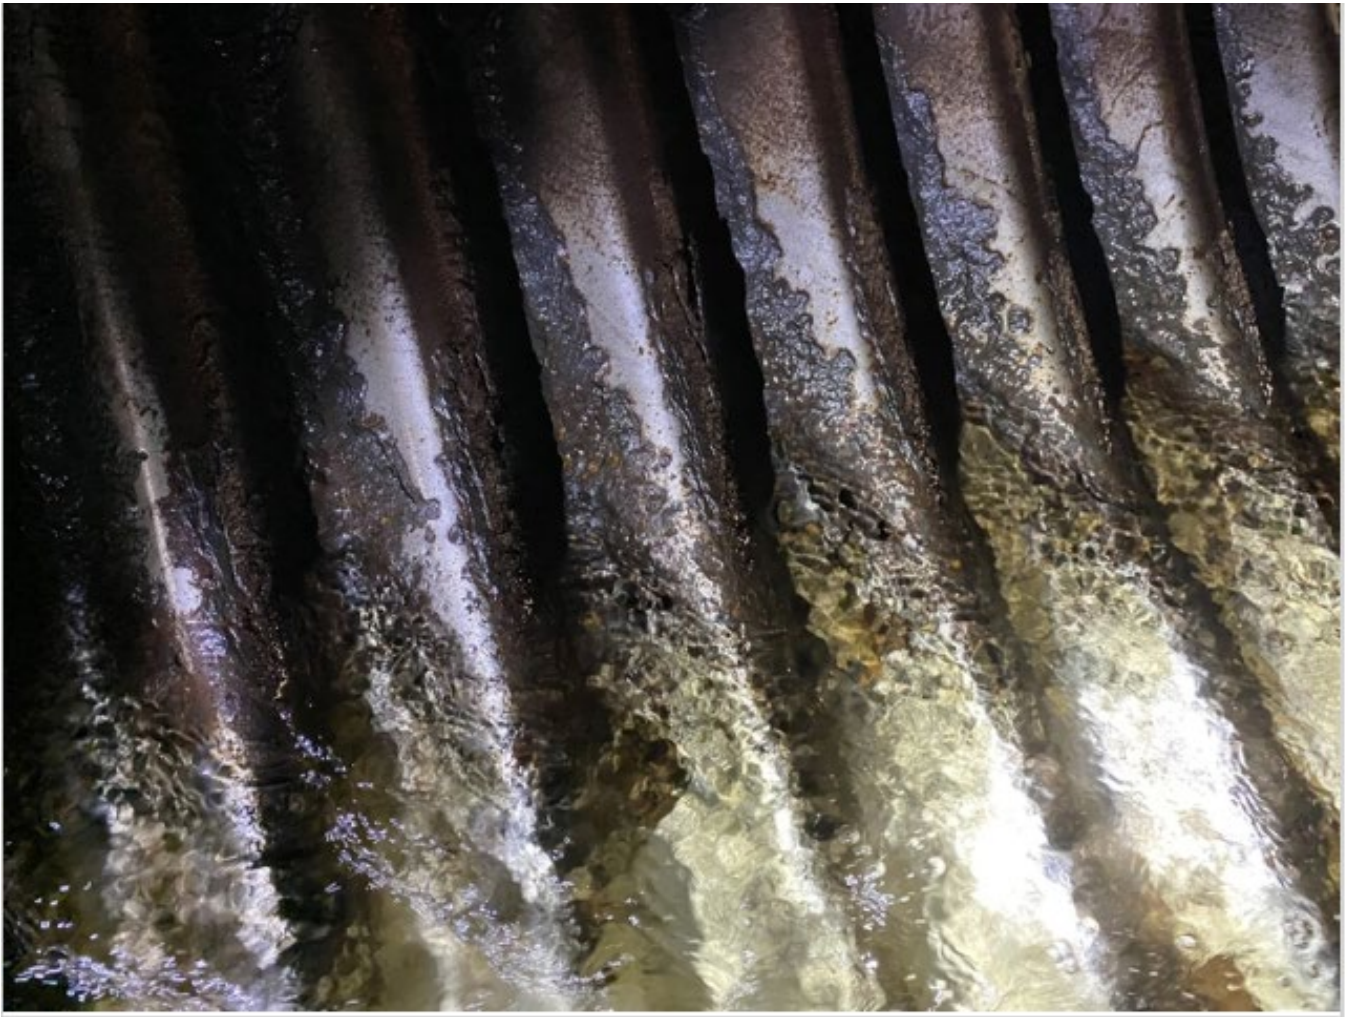
Inspection Finding Photo (2022)

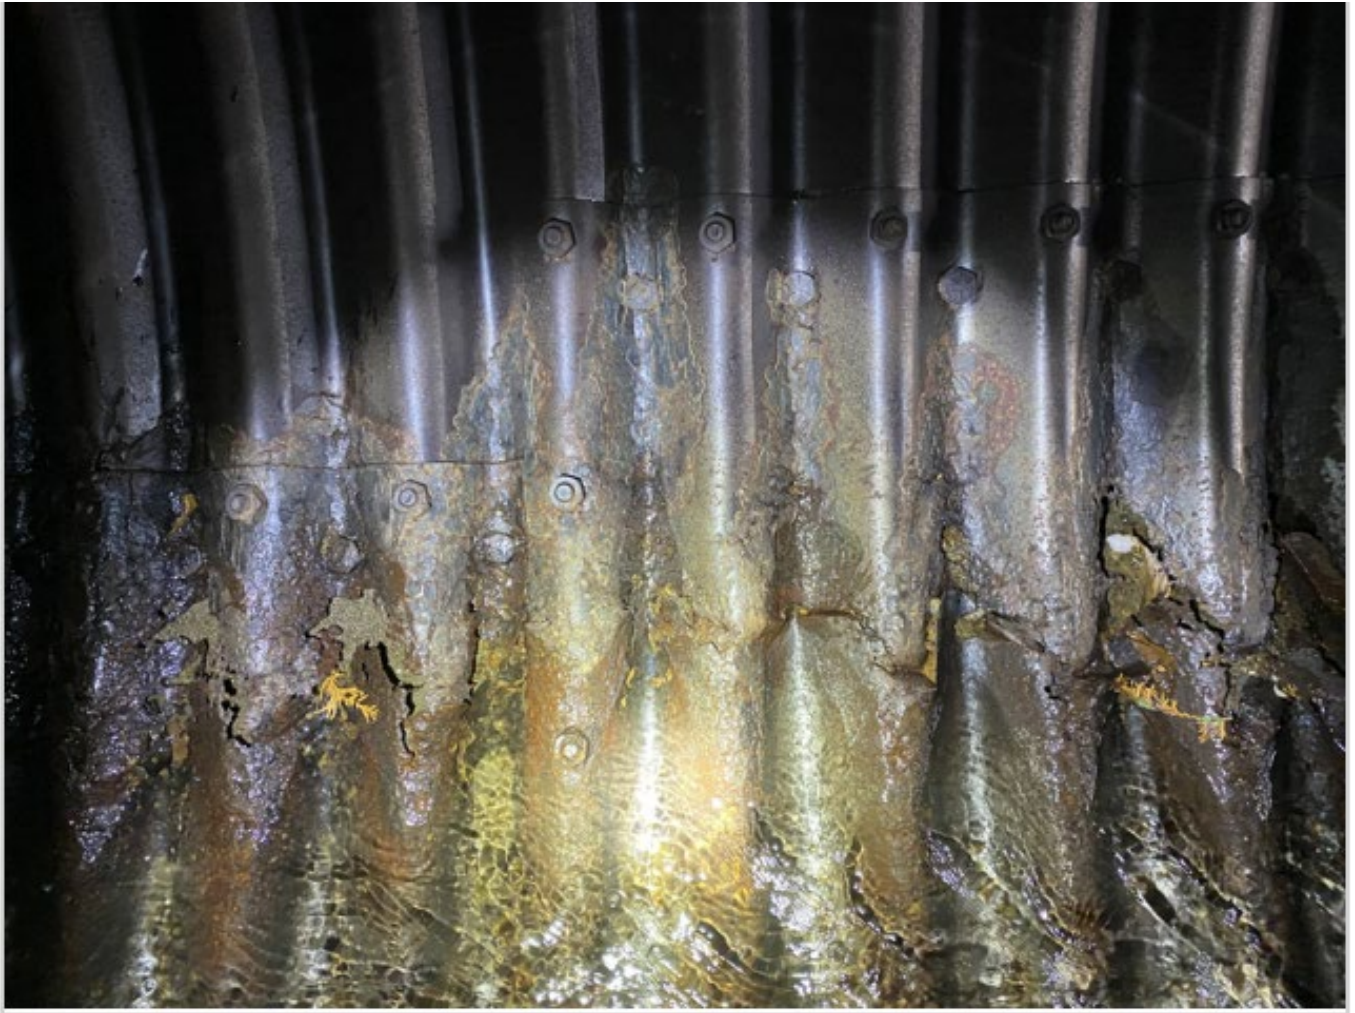
Inspection finding photo (2022)

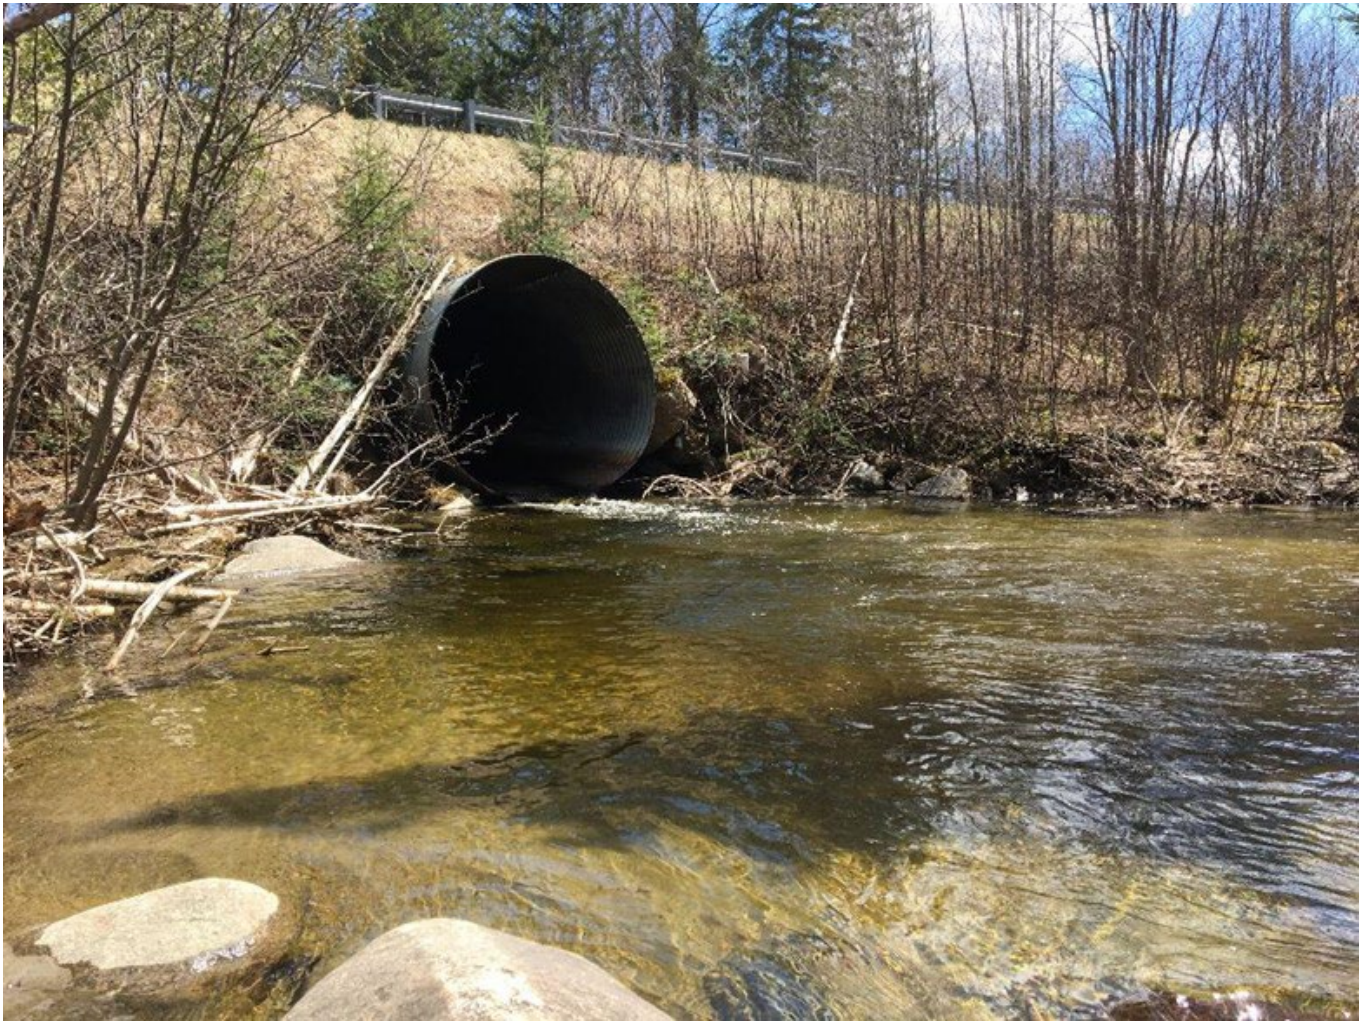
- d. The channel on the downstream end of the pipe has a large scour pool with some slight erosion along the embankments.
2. The existing culvert does not meet the measured bank full width of Number Five Brook.

Outlet and scour pool (Inspection photo 2020)

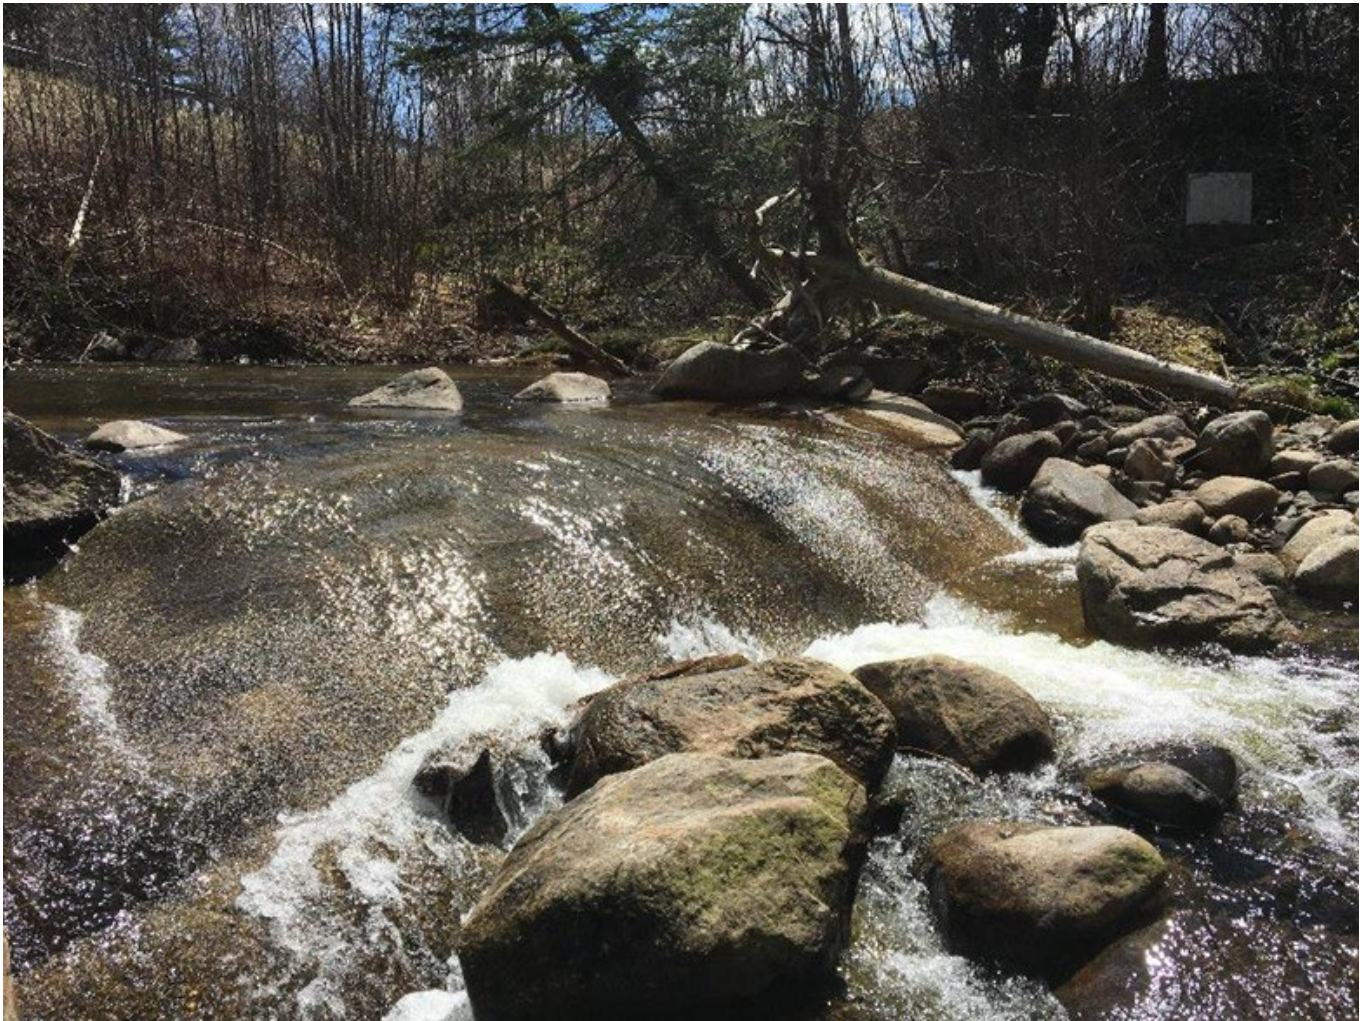
Scour hole “sill” is visible ledge at outlet (Inspection photo 2020)

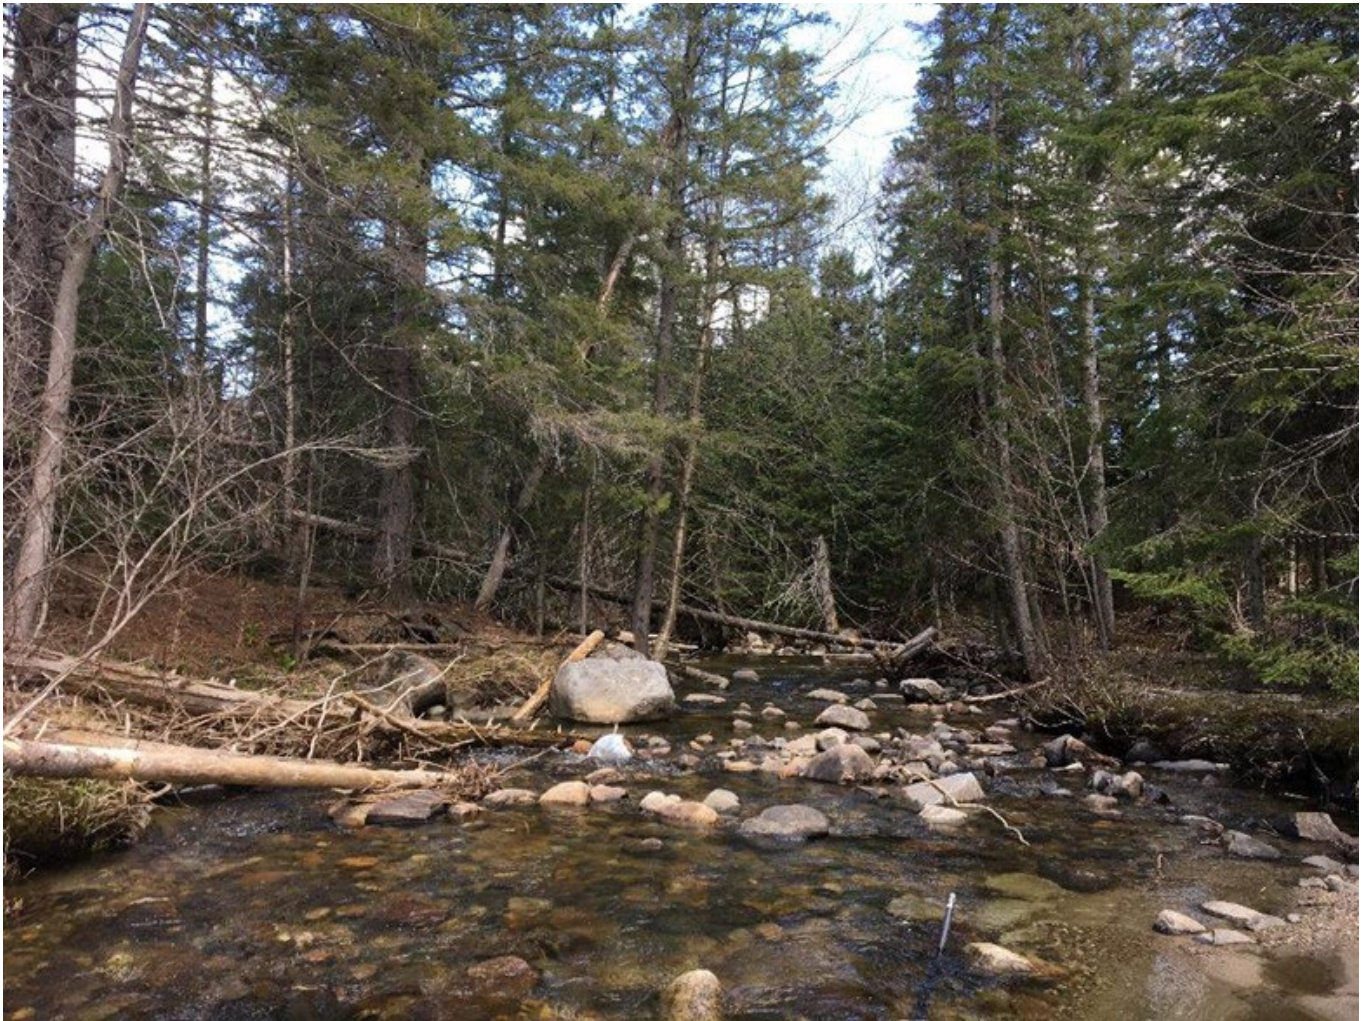
View of downstream below outlet scour hole (Inspection photo 2020)

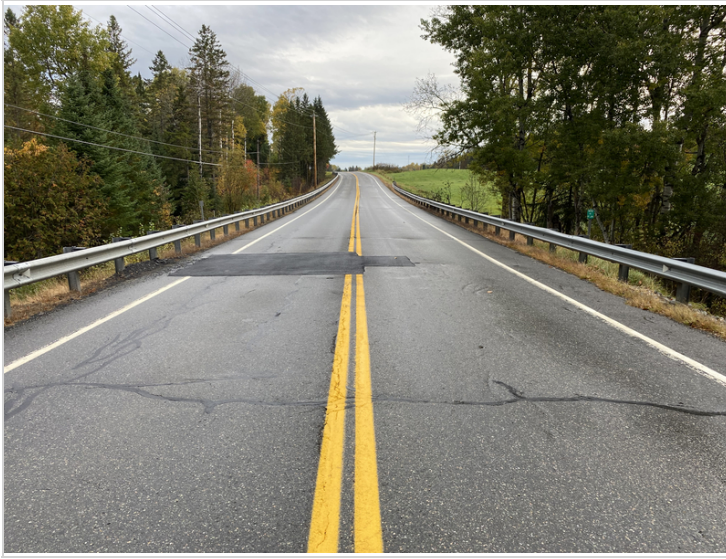
- c. Large perforations have formed along lower portions of the southern side of the culvert wall causing the pipe to deform/crush with piping occurring. The piping has caused settlement in the roadway with asphalt patching present over the structure mainly in the southern travel lane.

Asphalt Patch over Downstream End of Structure

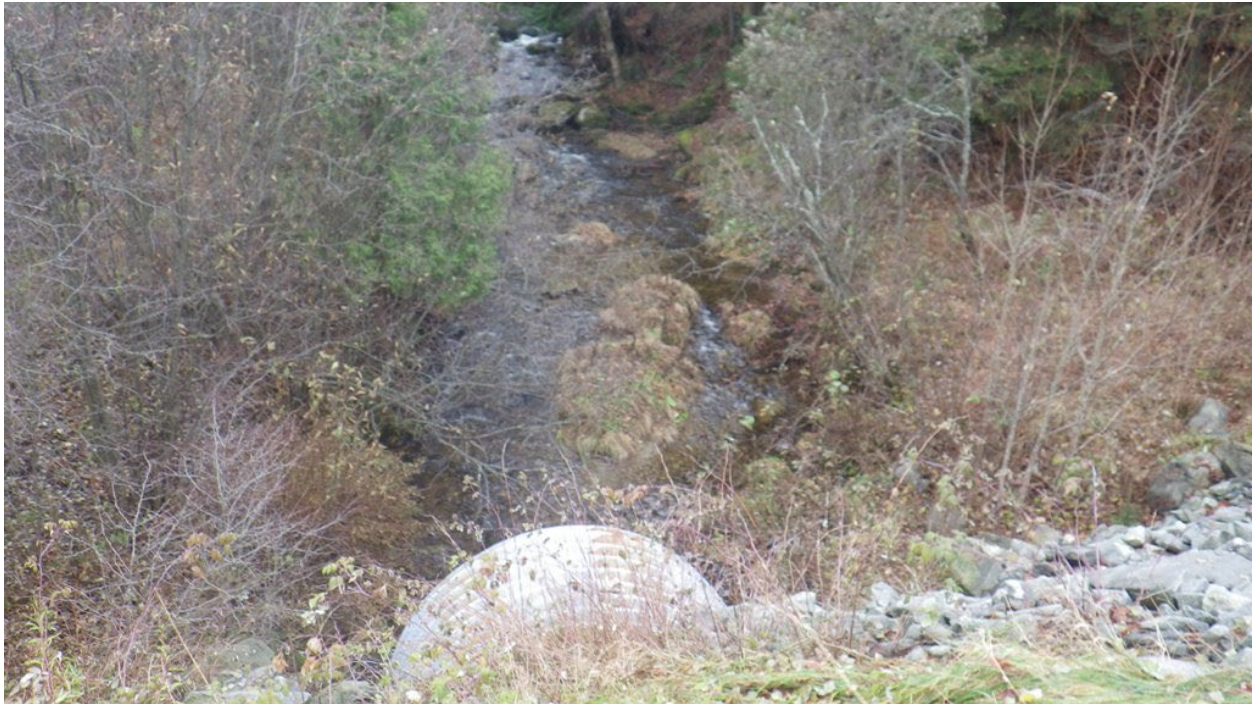
Figure 3.2: *Facing upstream; note boulders and cobbles in riverbed, and the possibility of bedrock outcroppings. [Inspection photo dated 2018]*
