STATE OF VERMONT AGENCY OF TRANSPORTATION

Scoping Report

FOR FERRISBURGH BF 019-4(35)

US ROUTE 7, BRIDGE 139 OVER LEWIS CREEK

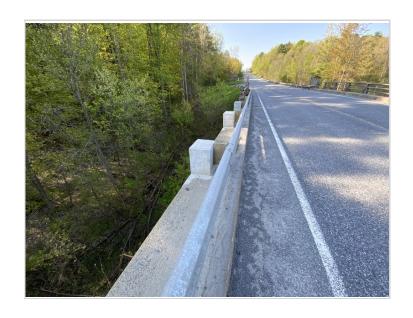
Aluminum tube steel rail is in good condition. The concrete pedestals have large delamed areas with rust staining and spalls with exposed reinforcing throughout. Sections of the upstream rail has had repairs with new pedestals installed at the abutment ends and near mid span with W beam rail added

Upstream repaired rail

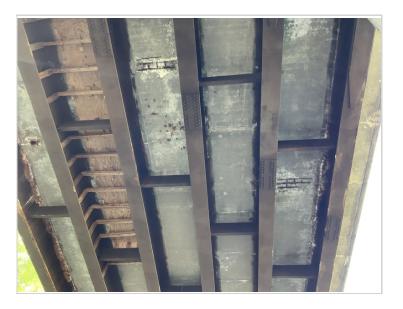
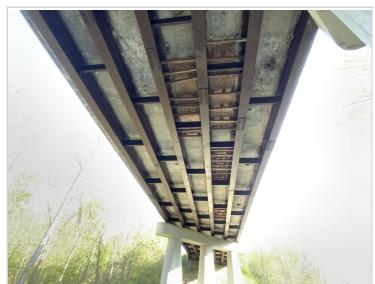
Moderate to heavy saturation throughout with efflorescence, varying sized delams, and small areas of rust staining. There are a few areas of spalling that extend the full width of the bays and penetrate up to and beyond the first layer of reinforcing. Bays 3 and 4 have large areas of timber form work in place along spans 1 and 2.

Spalls Span 1 bays 1 and 3

A deck replacement project should be considered.

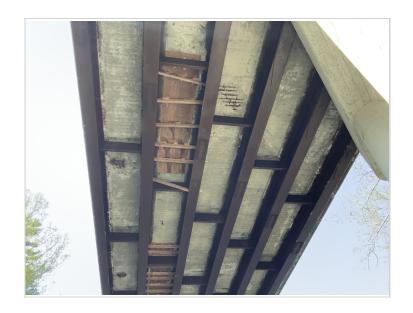
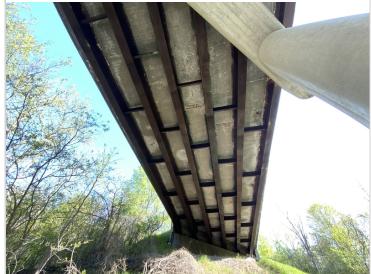
Spall span 2 bay 3

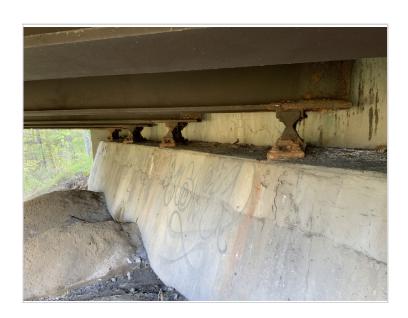
Abutment 1 bearings

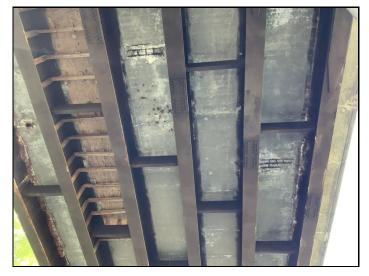
Spalls Span 1 bays 1 and 3

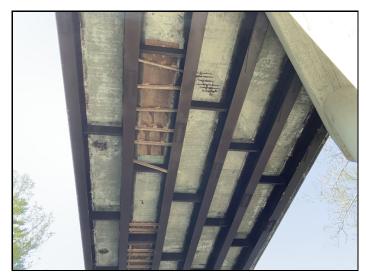
Spall span 2 bay 3

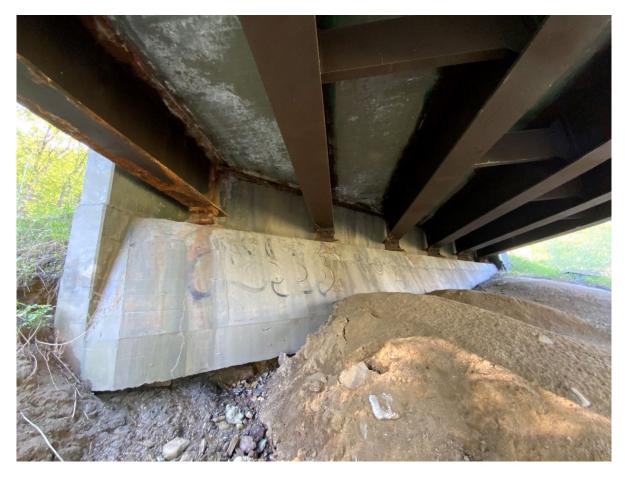
Appendix A 2: Abutment 1. Note some undermining of the left side of the abutment.

Bank armoring should also be included as part of this project in order to mitigate the observed erosion at the abutment banks.
