Local Concerns Meeting

WILLARD COVERED BRIDGE

HARTLAND BO CVBR(2)

Mill Street (TH 15), Bridge 22 over Ottauquechee River

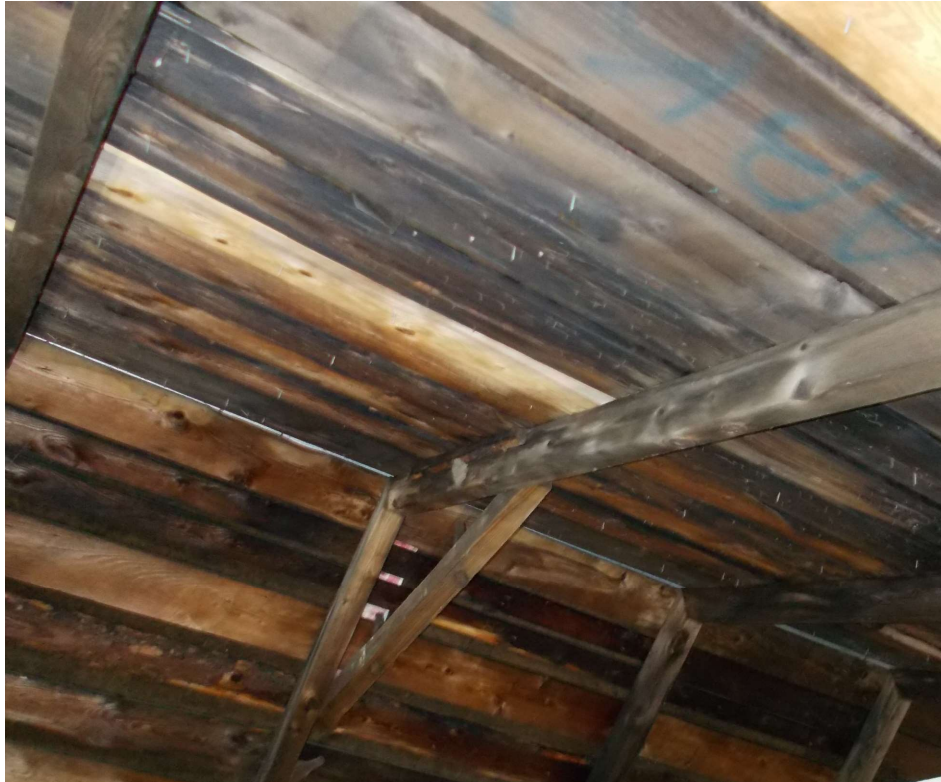
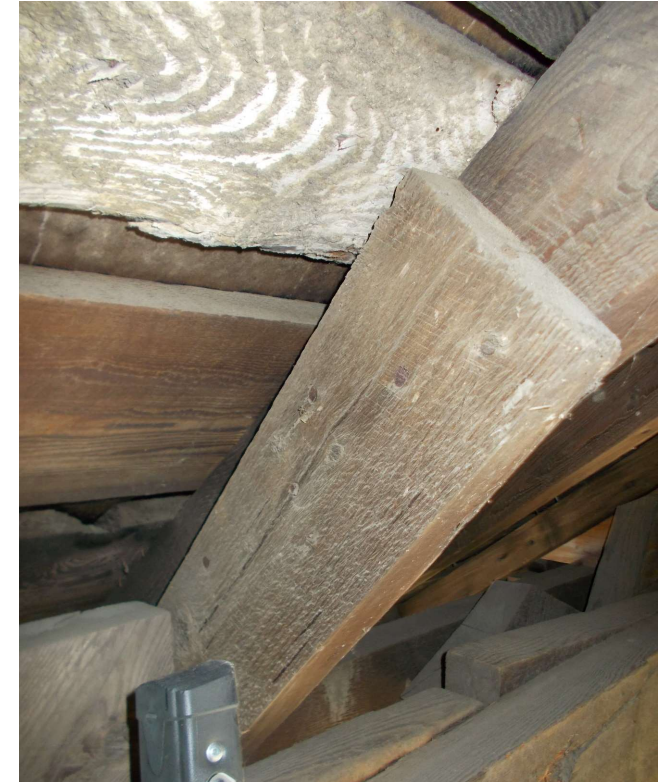
Roofboards and Rafters

- Splits
- Rot
- Roof leaks ^{TSO}

There were definitely splits and rot. Not sure about broken rafters or if the rot was caused by old or current roof leaking.

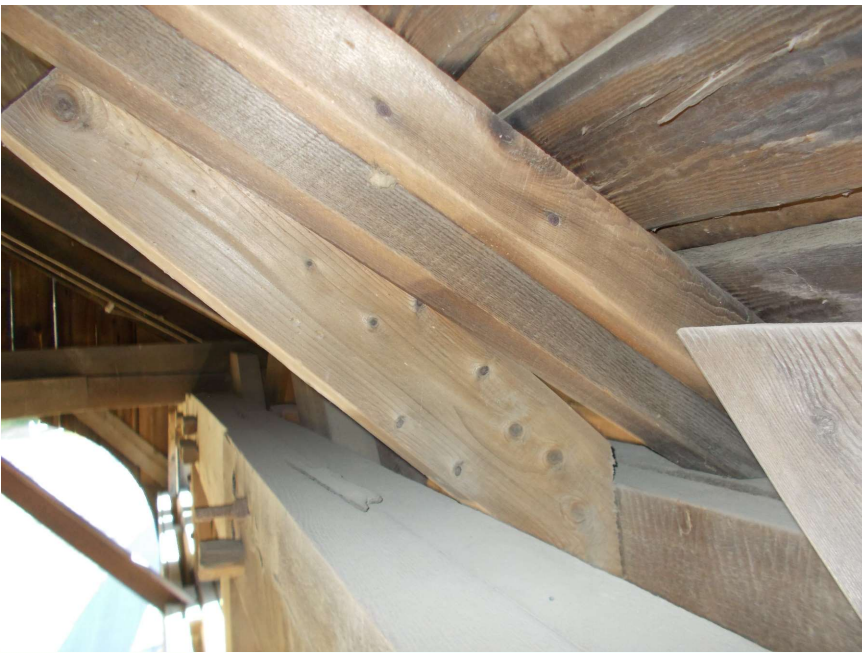
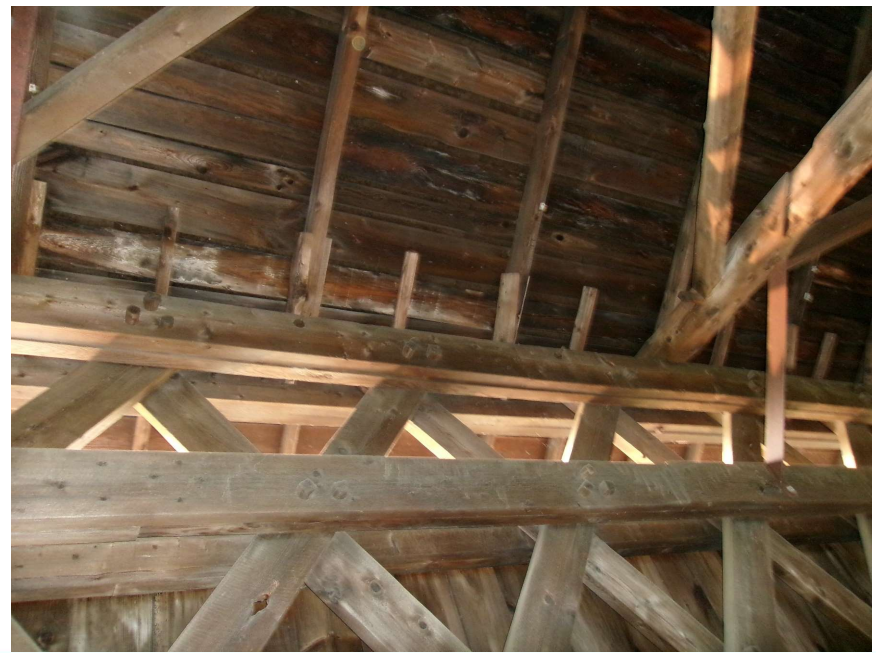
Rafters Extensions

- Extension provides more overhang protection
- Increases snow loads

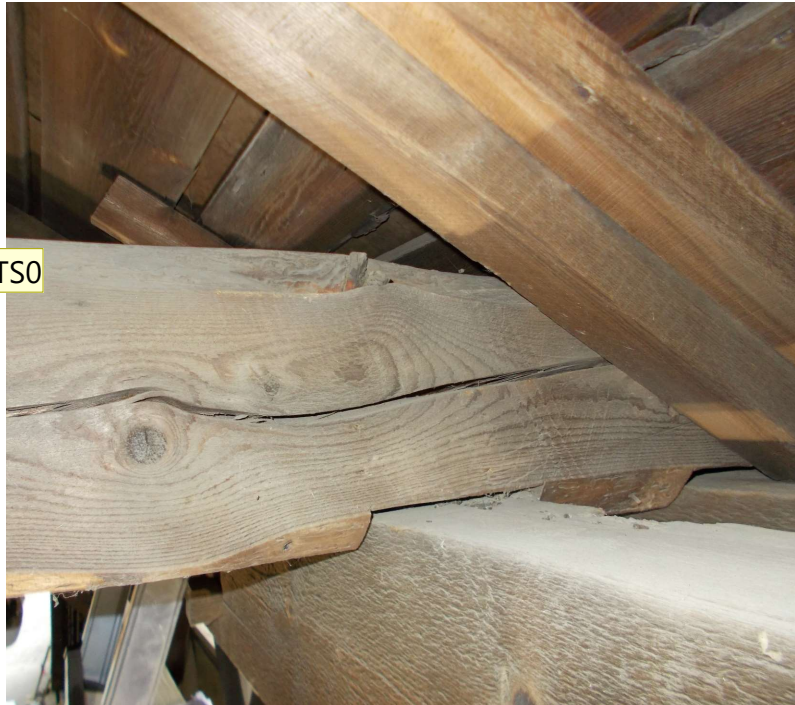
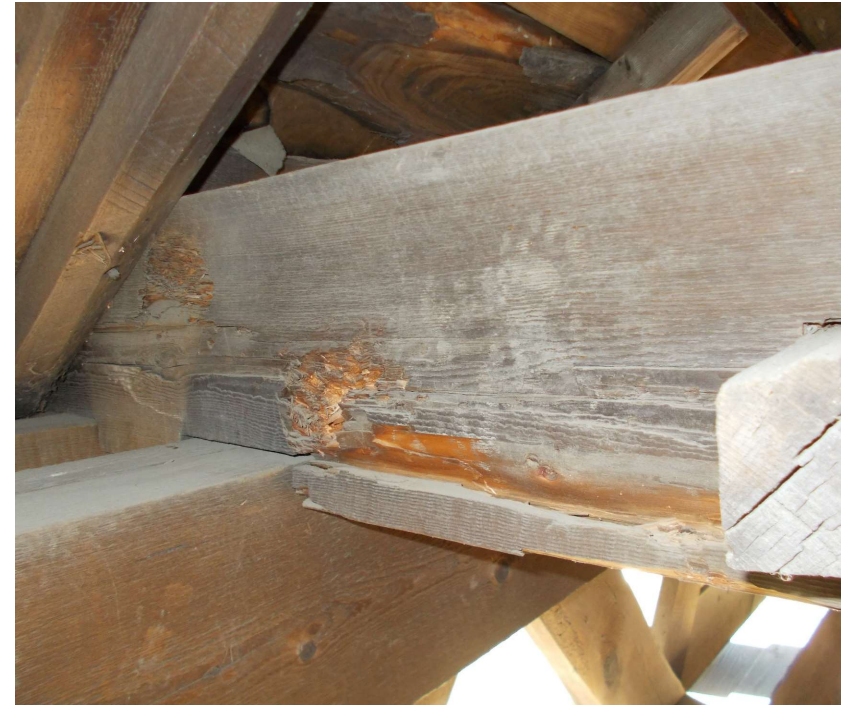
Tie Beam Members

- Splits
- Breaks
- Rot
- Impact Damage

I could not find a picture of impact damage.

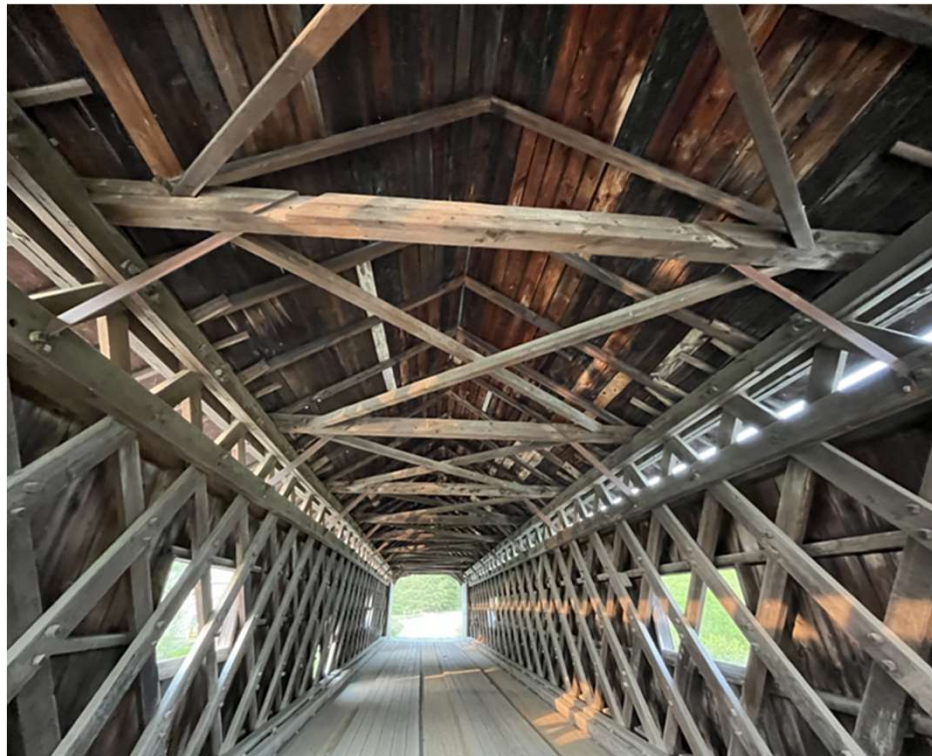
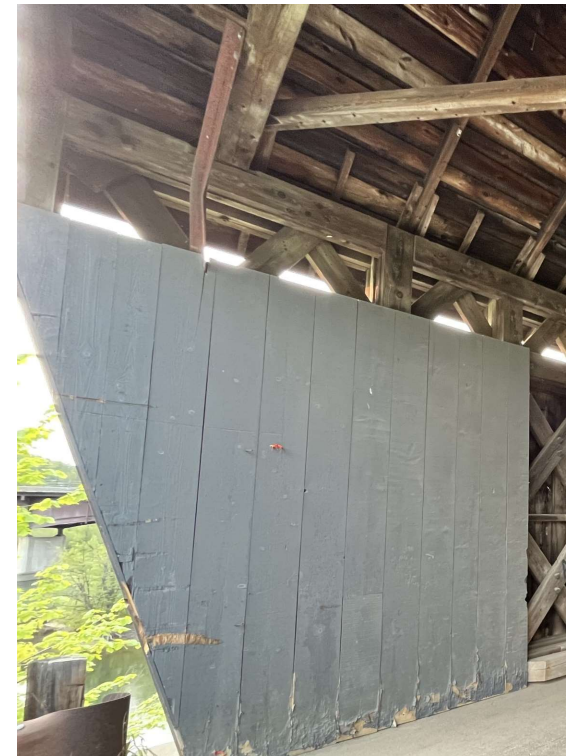
Cross Bracing and Knee Braces

- Splits
- Poor Connection

- Original replaced with steel angles
- Impact damage

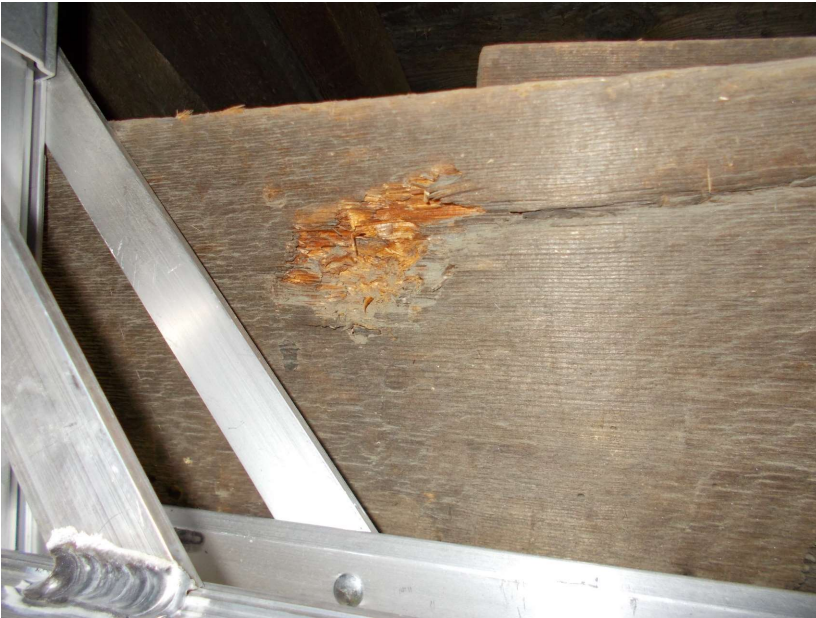
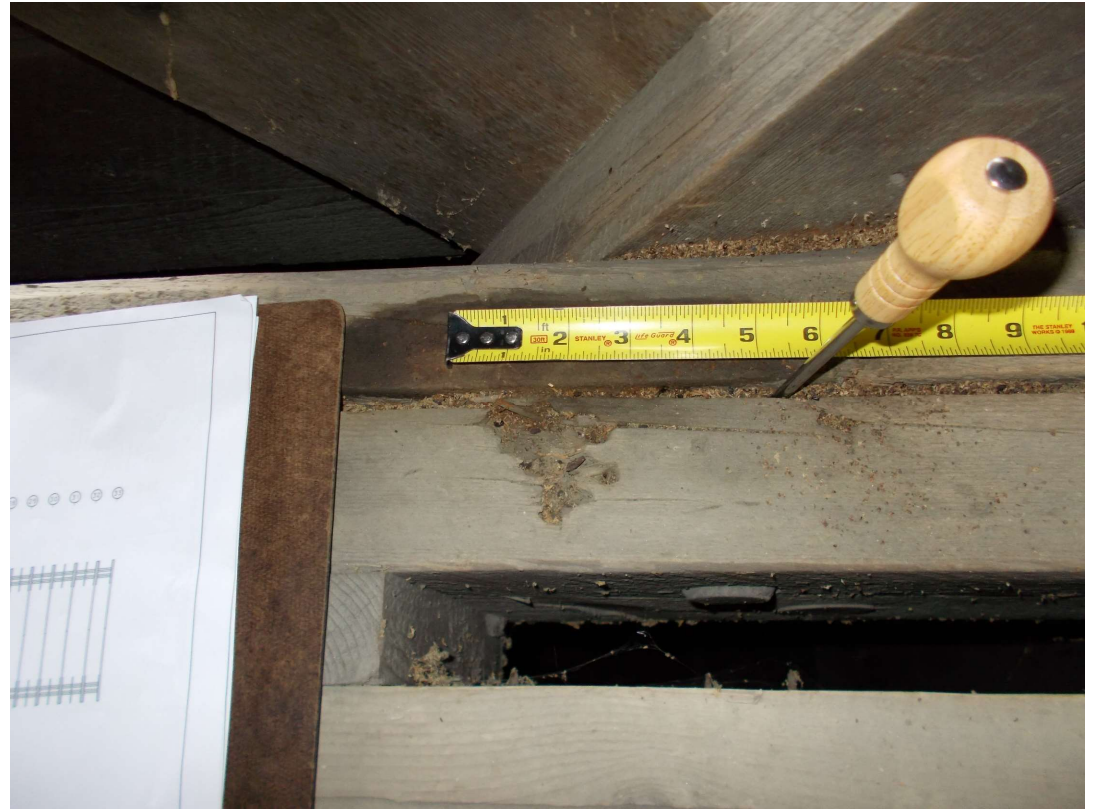
Top Chord Members

- Minor Rot
- Hidden Rot

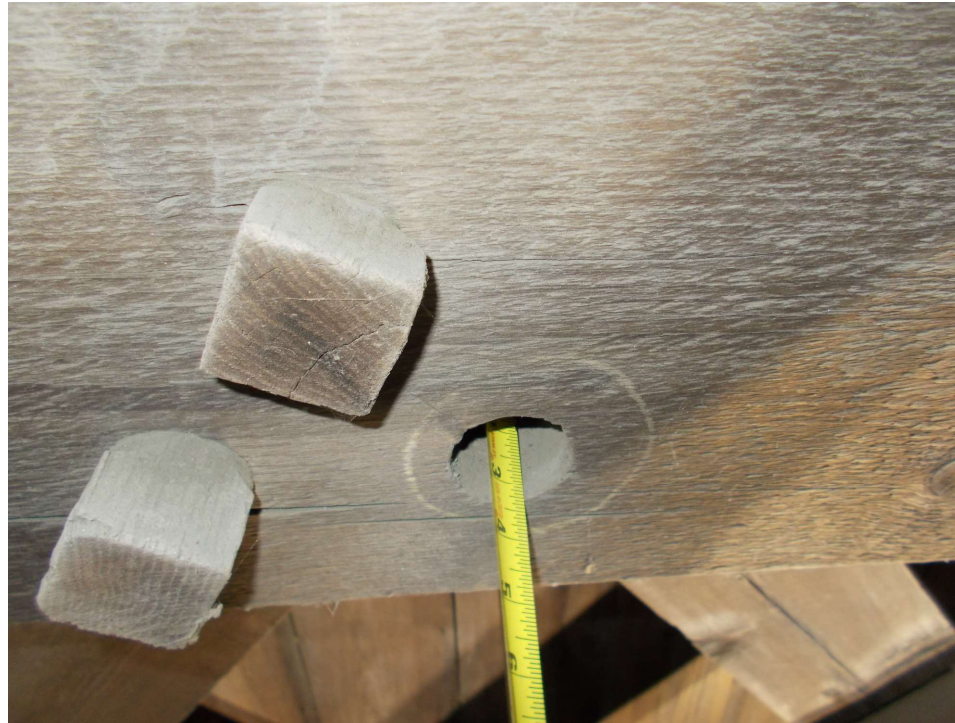
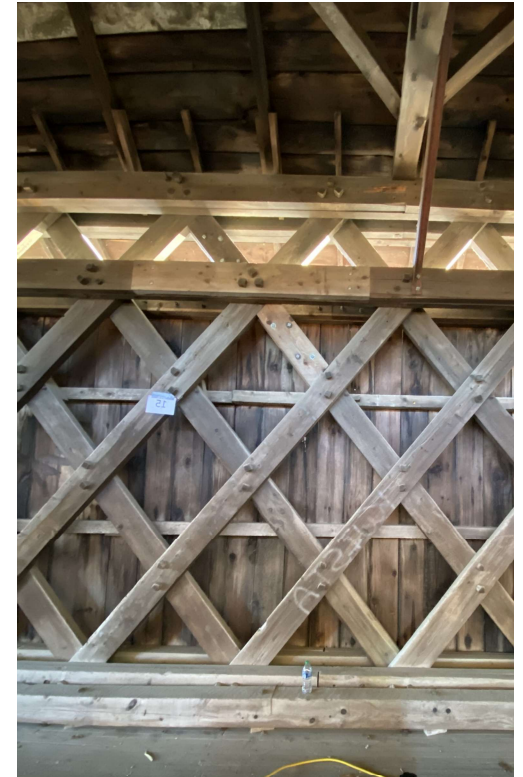
Top Chord Members (continued)

- Short Trunnels
- Short Chord Lengths

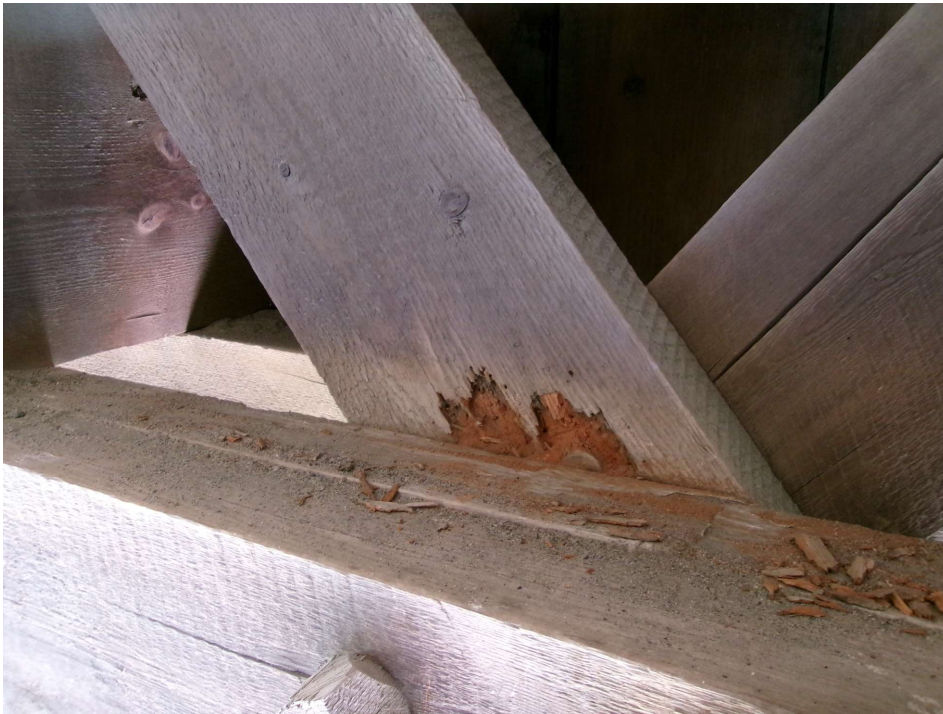
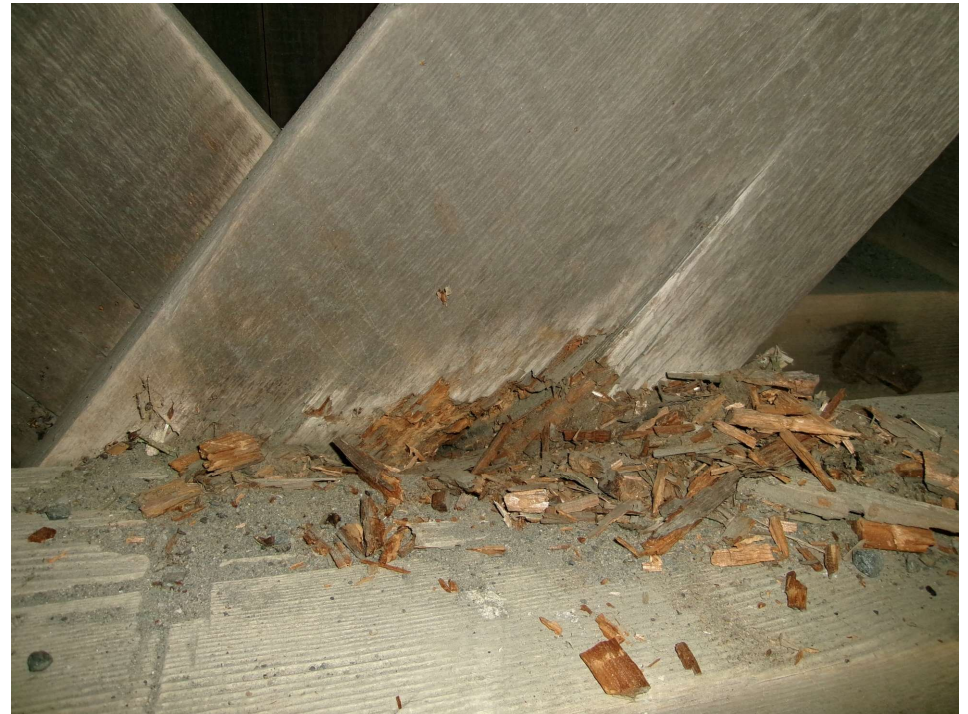
Lattice Members

- Rot

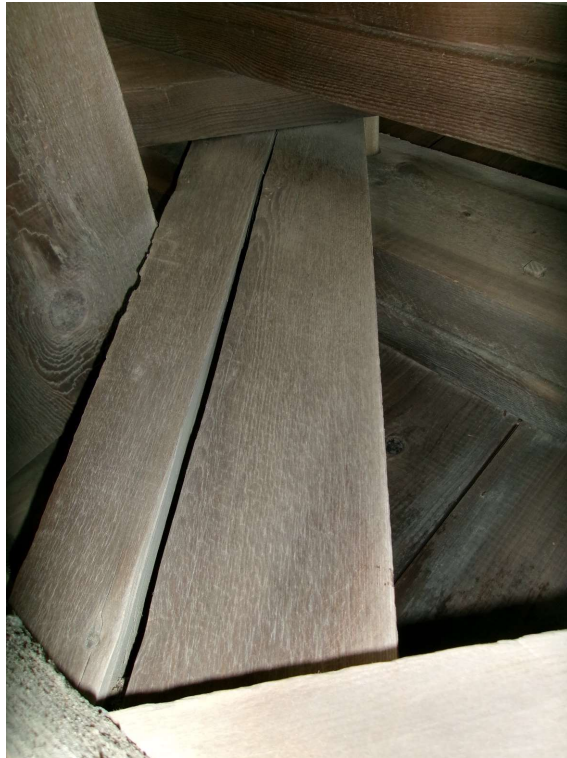
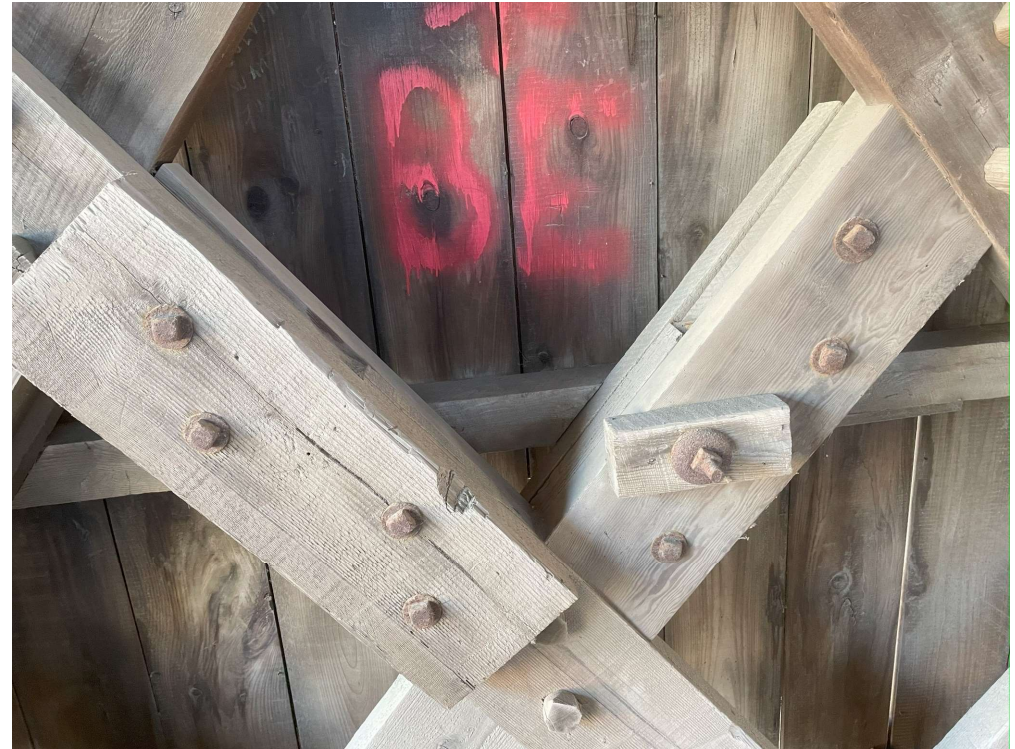
Lattice Members (continued)

- Splits
- Splices

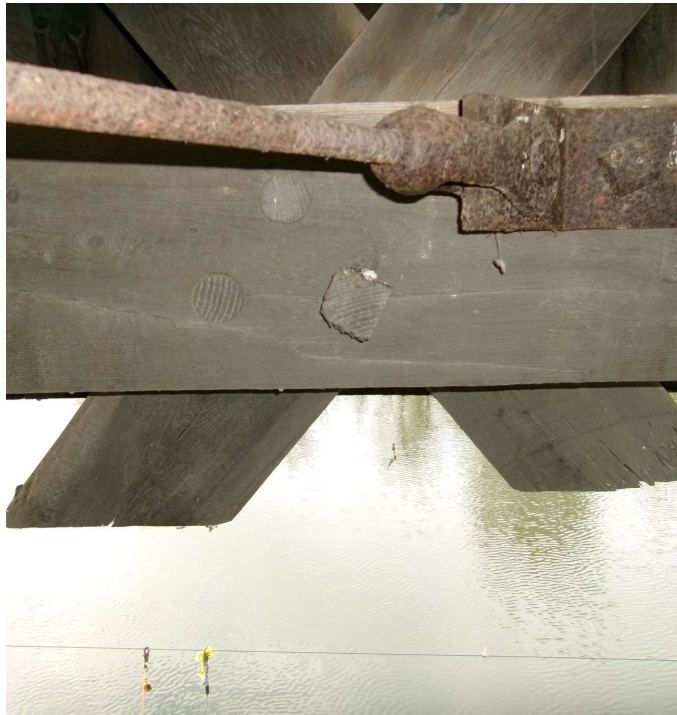
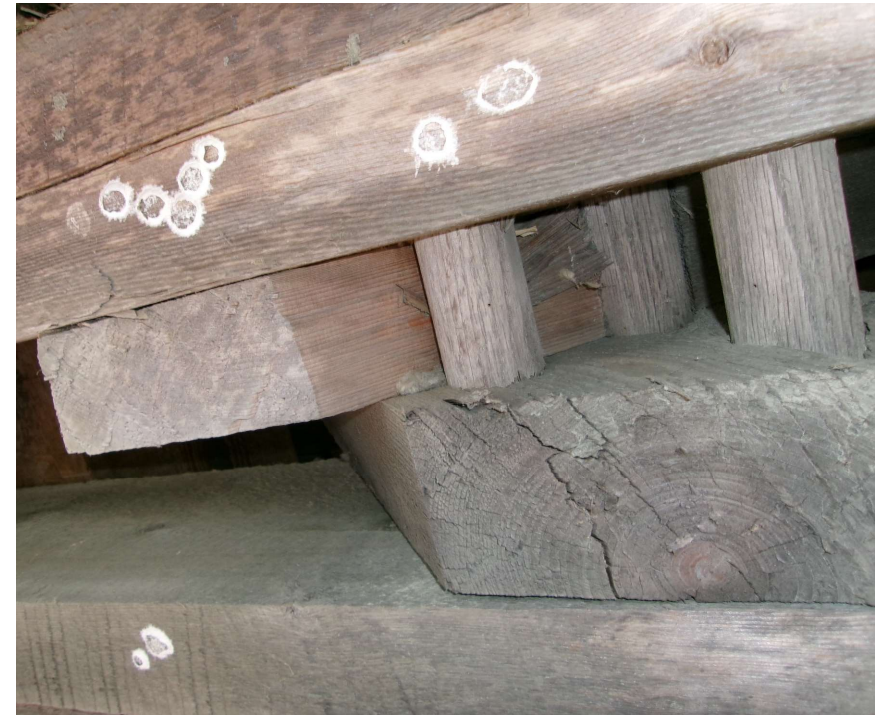
Lattice Members (continued)

- Misaligned trunnels

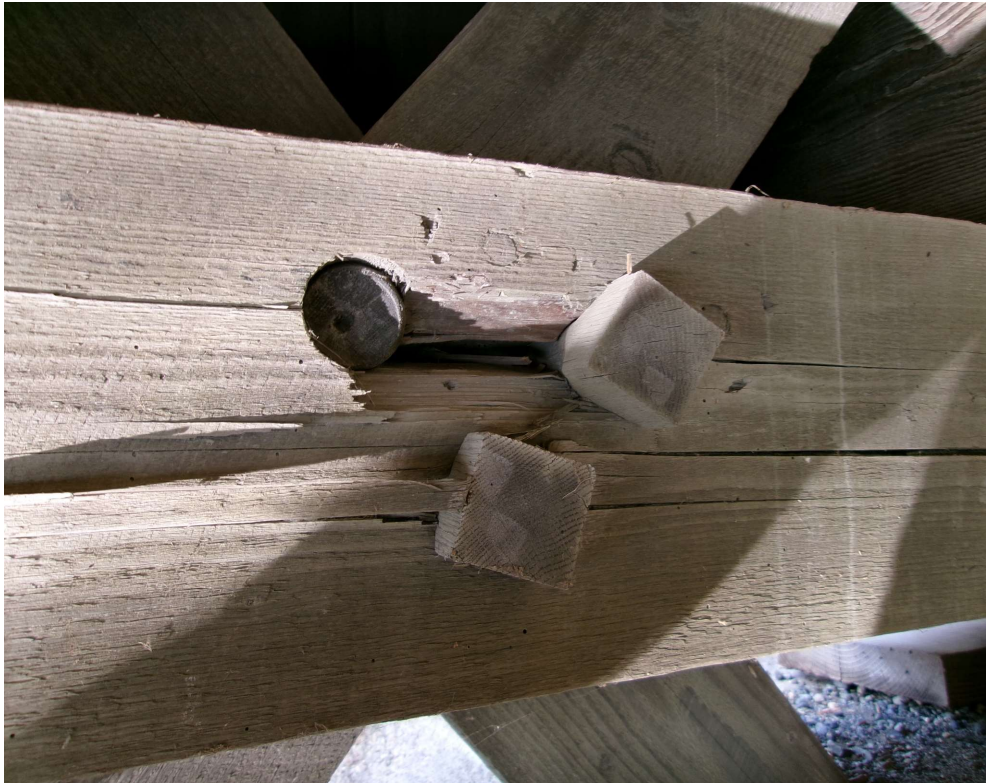
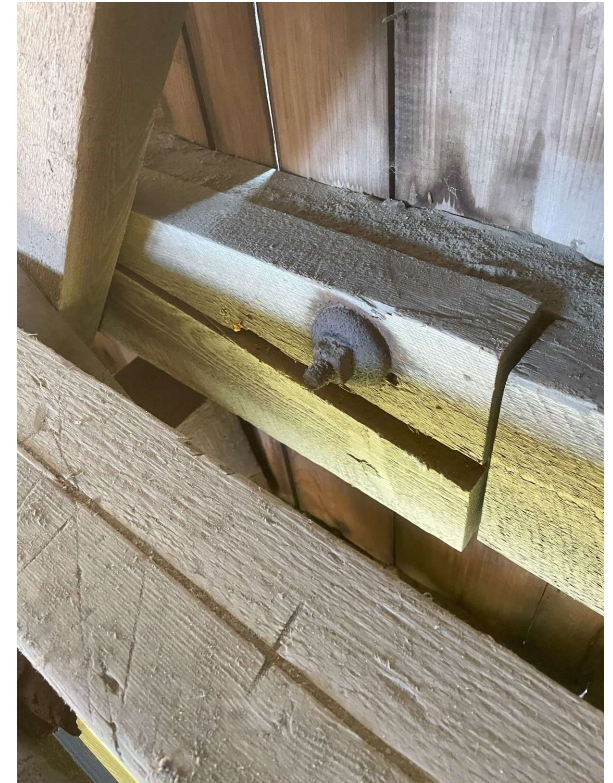
Bottom Chord Members

- Splits
- Breaks

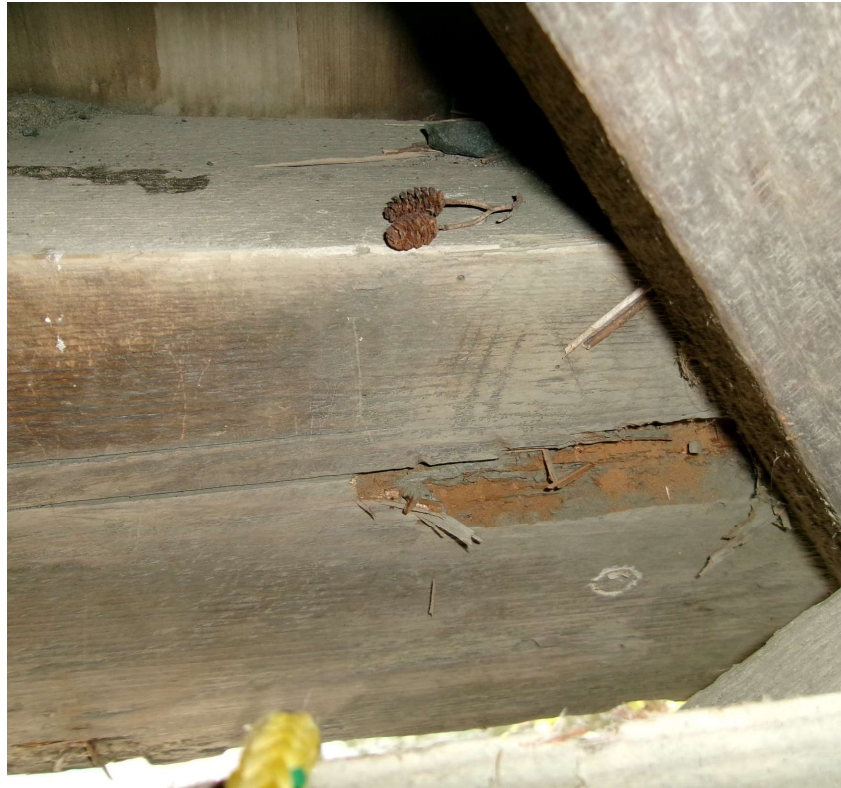
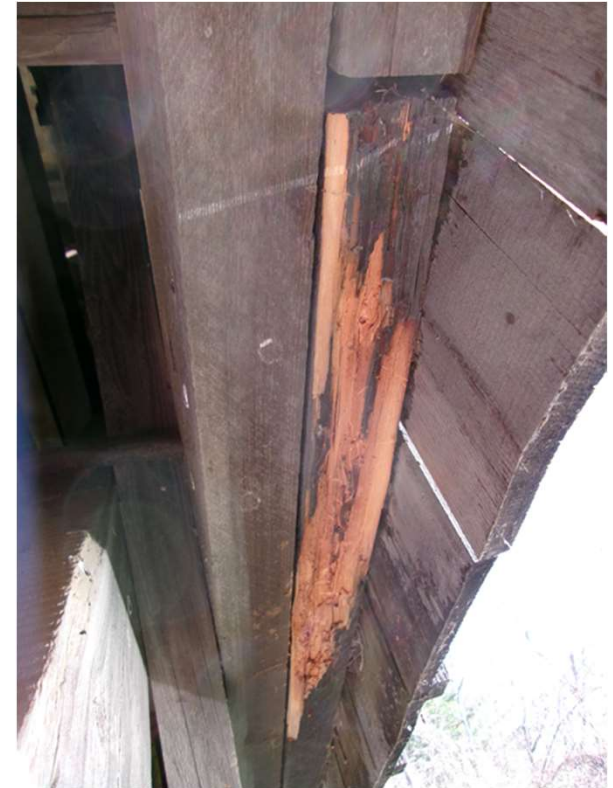
Bottom Chord Members (continued)

- Weathering
- Rot
- High moisture content

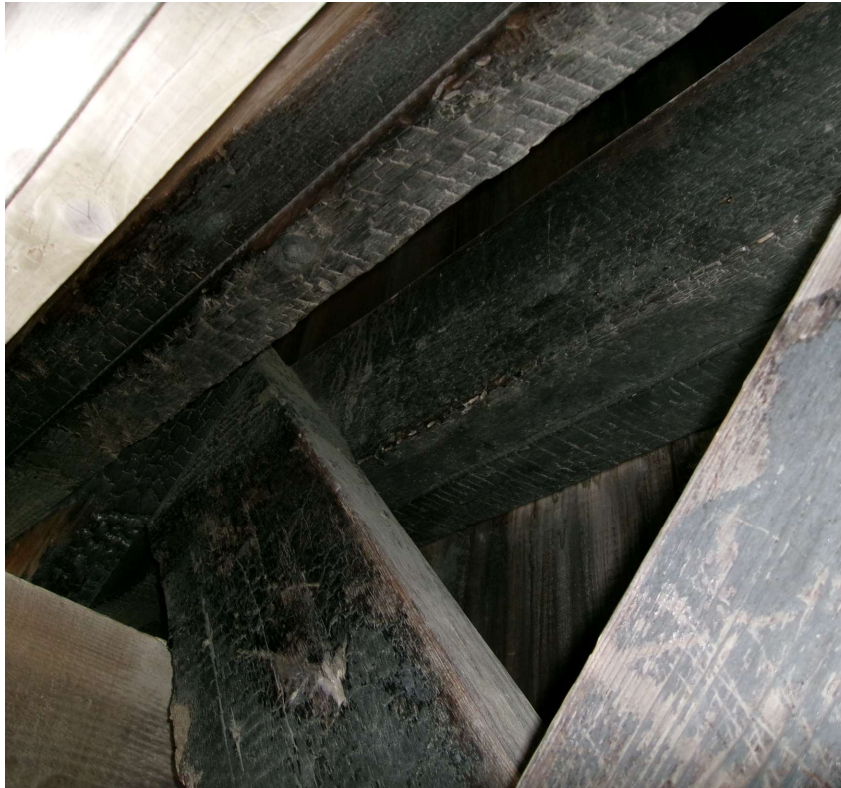
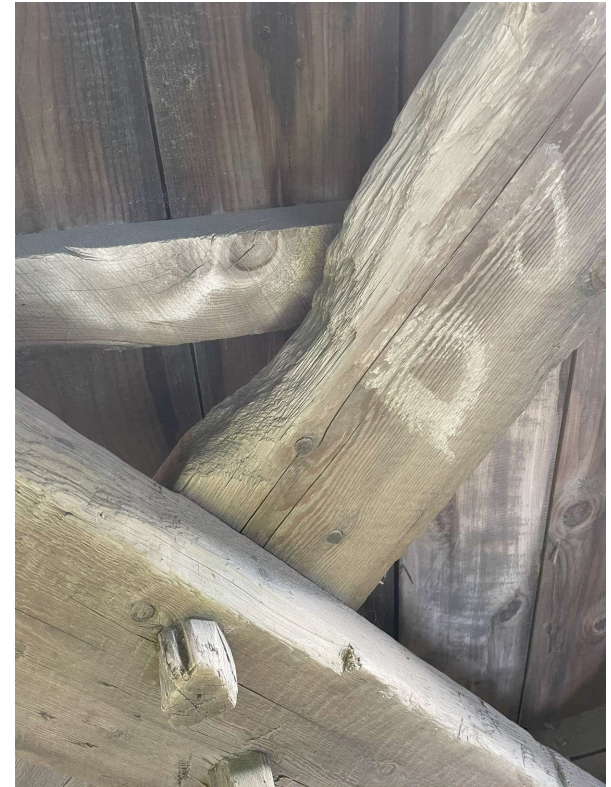
Bottom Chord Members (continued)

- Fire Damage
- Section Loss

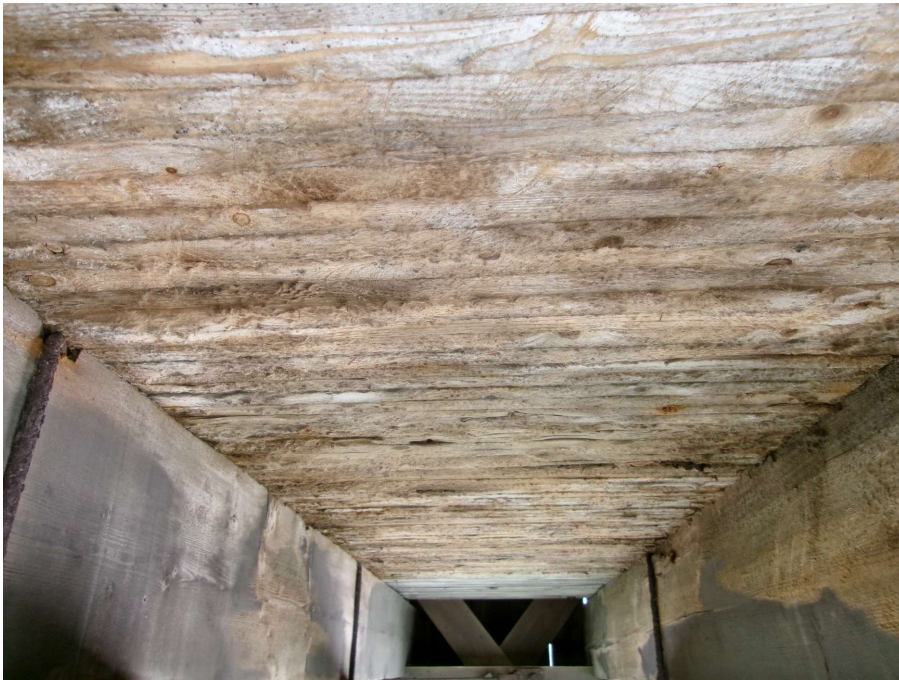
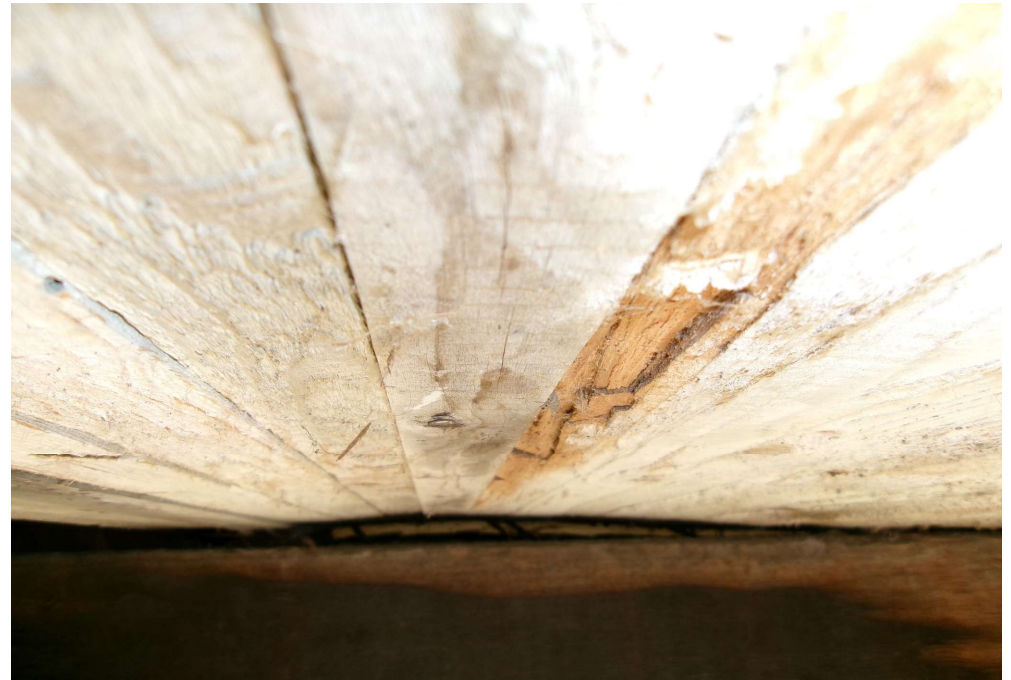
Deck

- Rot

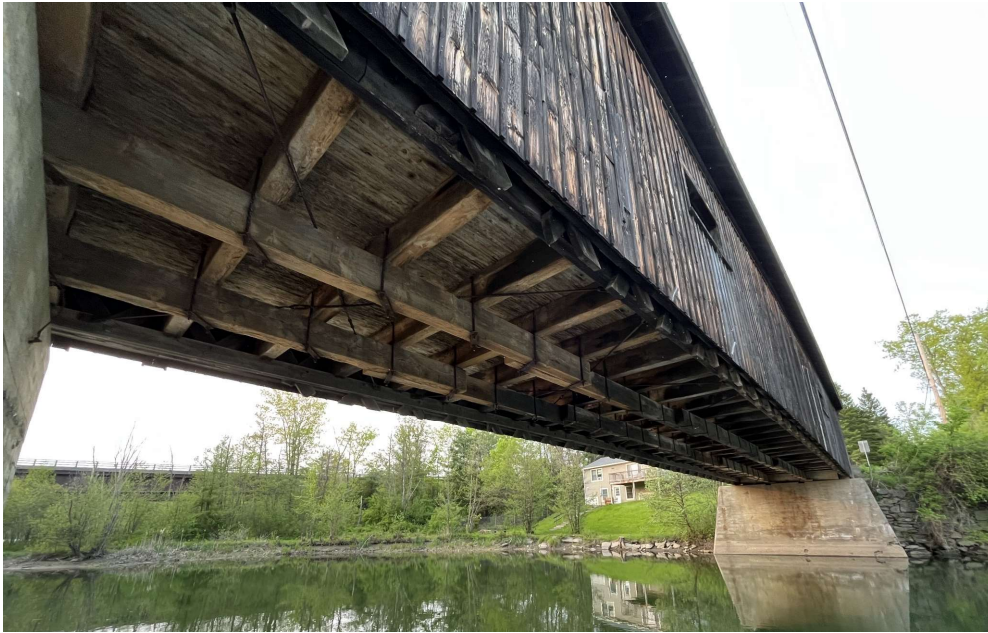
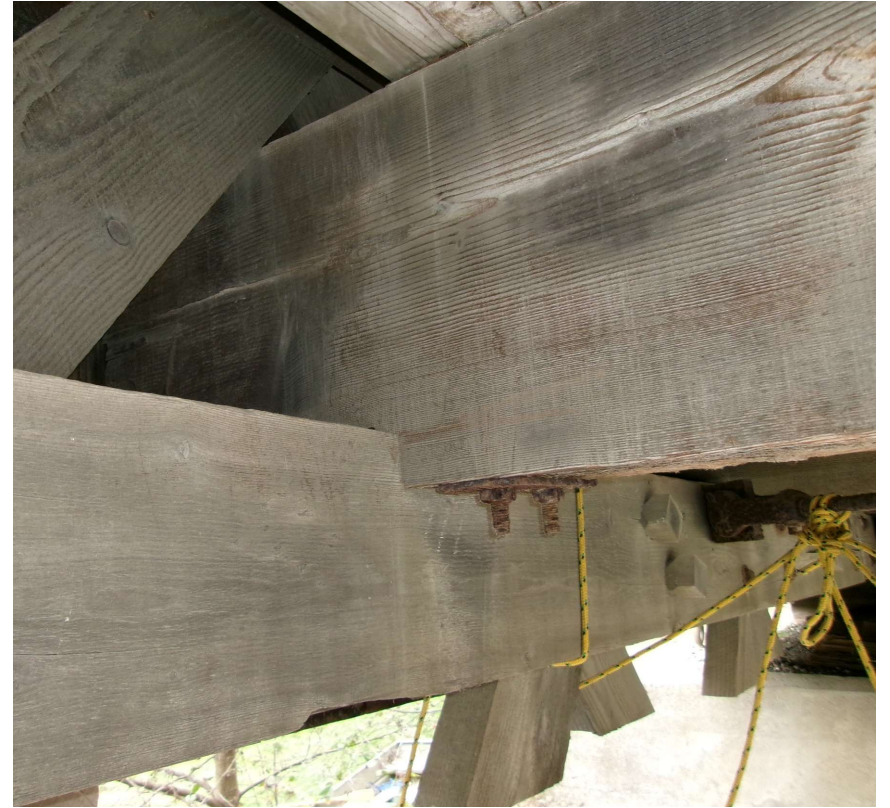
Floor Beams

- Satisfactory condition
- Possible hidden rot on top of floor beams

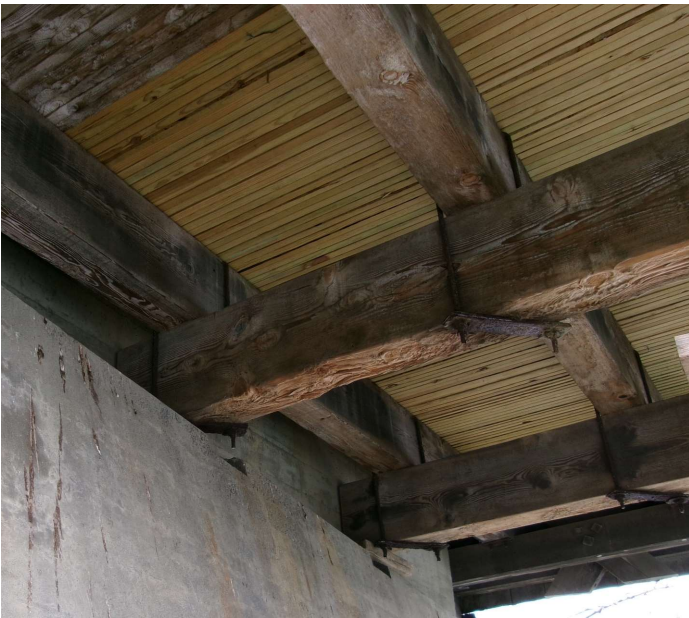
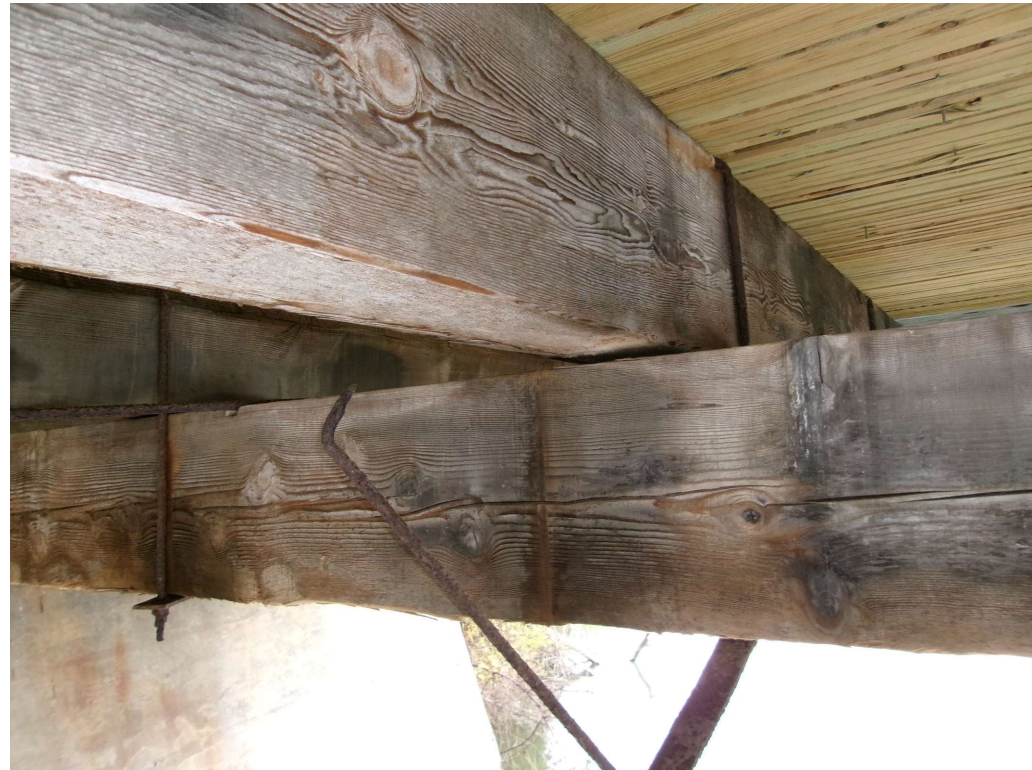
Distribution Beams

- Rot
- Rusted/failed hangers

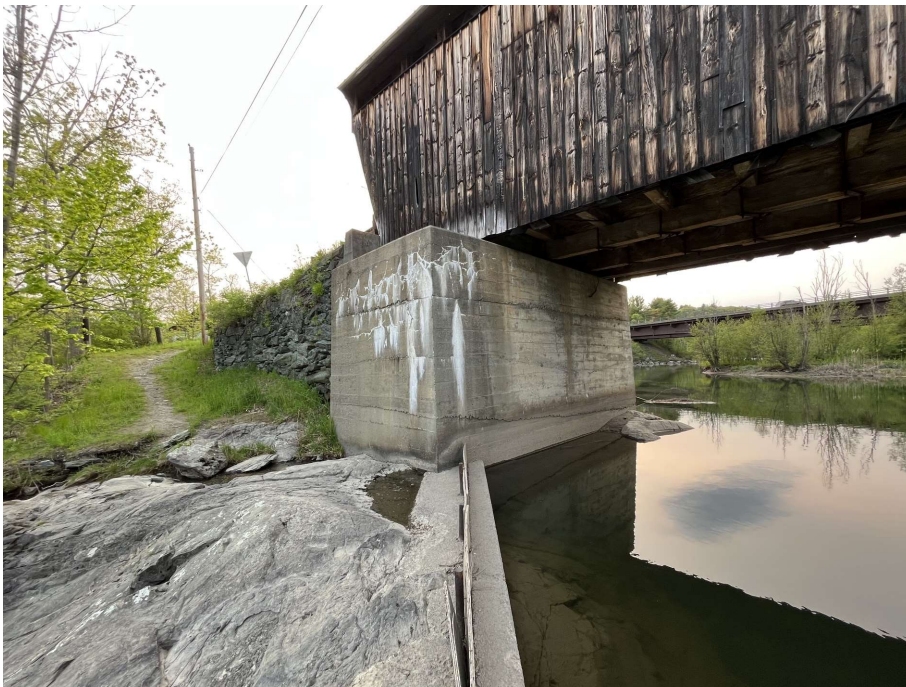
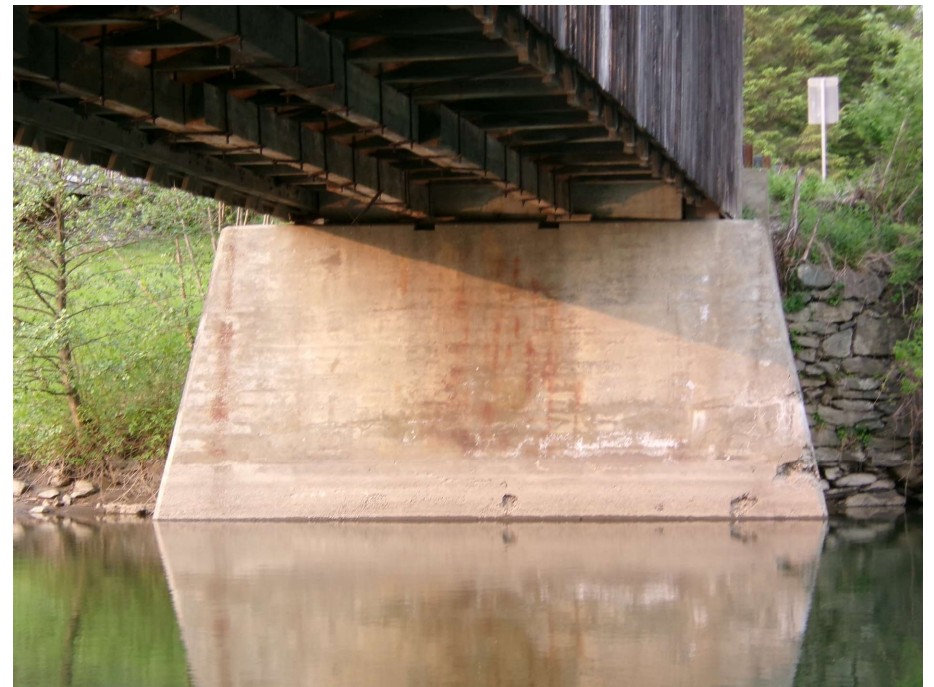
Abutments and Wingwalls

- Concrete faced stone abutments

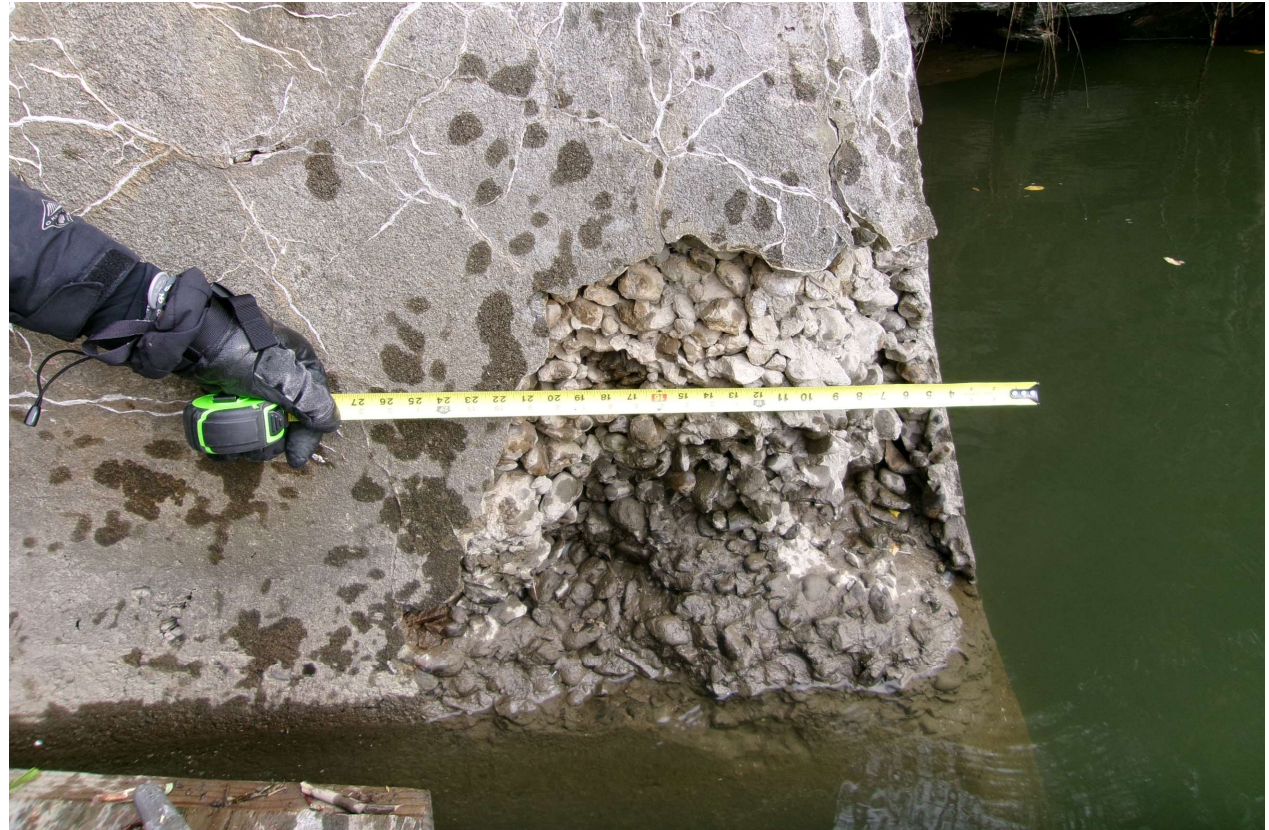
Abutments and Wingwalls (Continued)

- Spalling
- Poor Consolidation
- Round Aggregate

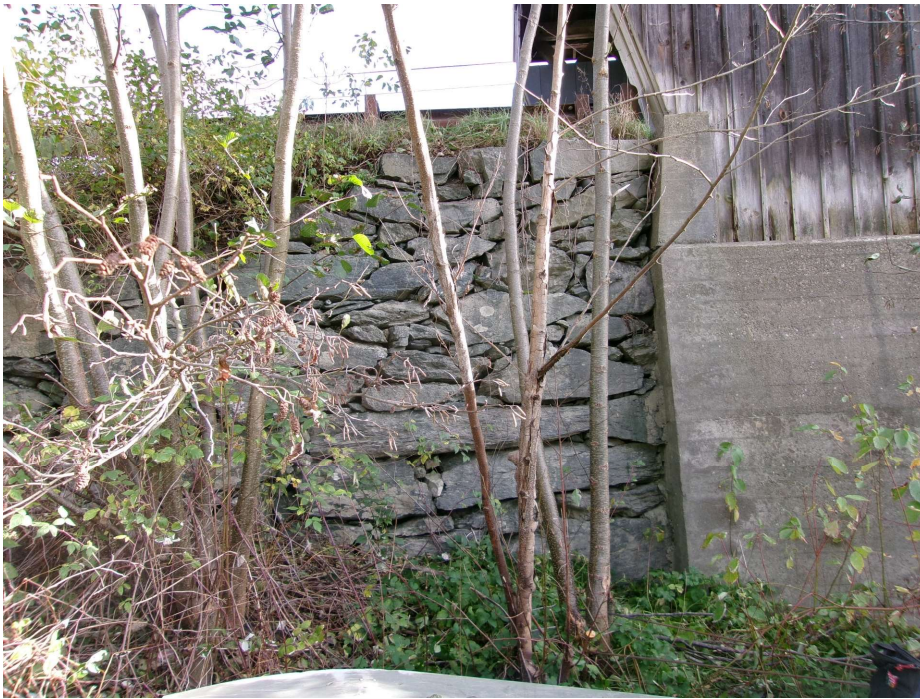
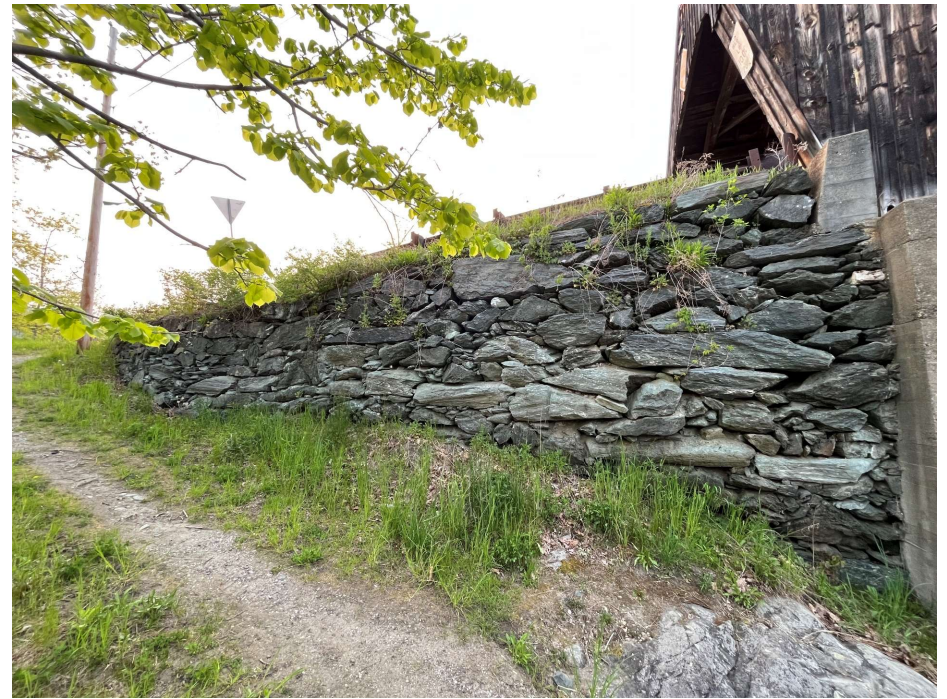
Abutments and Wingwalls (Continued)

- Stone wingwalls

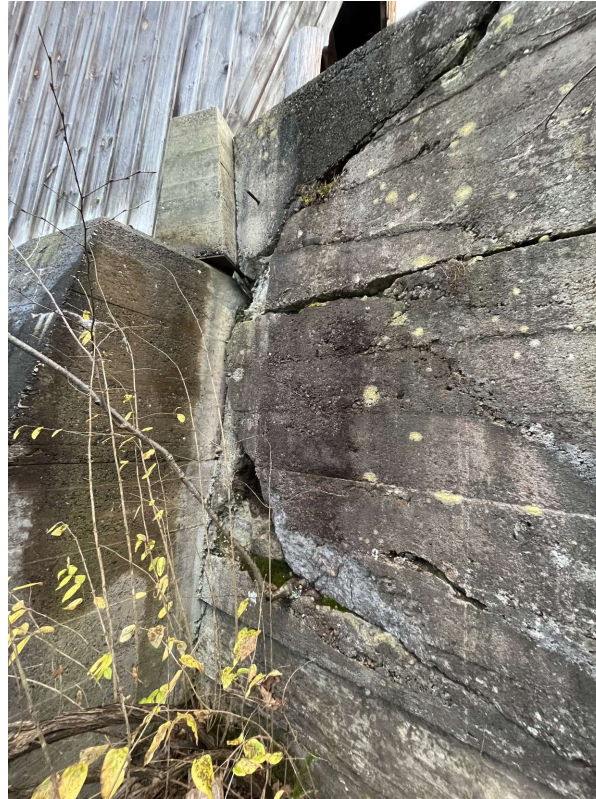
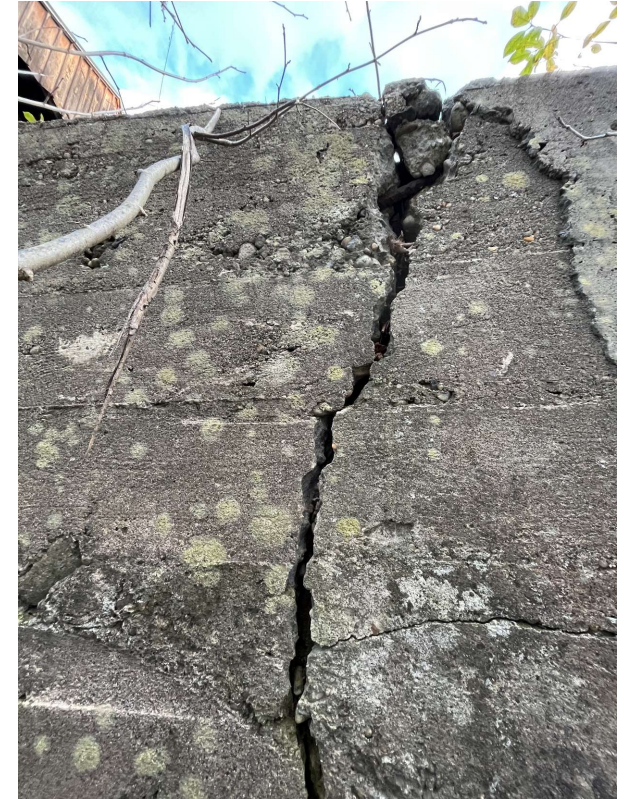
Abutments and Wingwalls (Continued)

- Southwest wingwall in poor condition
