Local Concerns Meeting

WILLARD COVERED BRIDGE

HARTLAND BO CVBR(2)

Mill Street (TH 15), Bridge 22 over Ottauquechee River

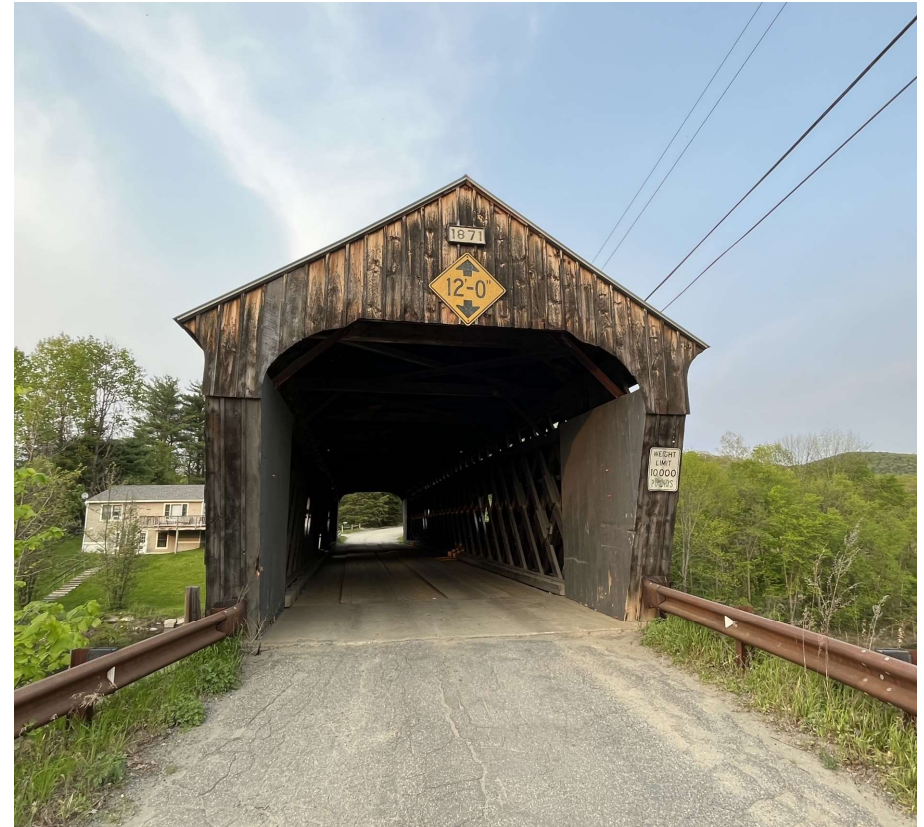
Portals

- Currently in satisfactory condition
- Past impact damage to portal support structure is evident

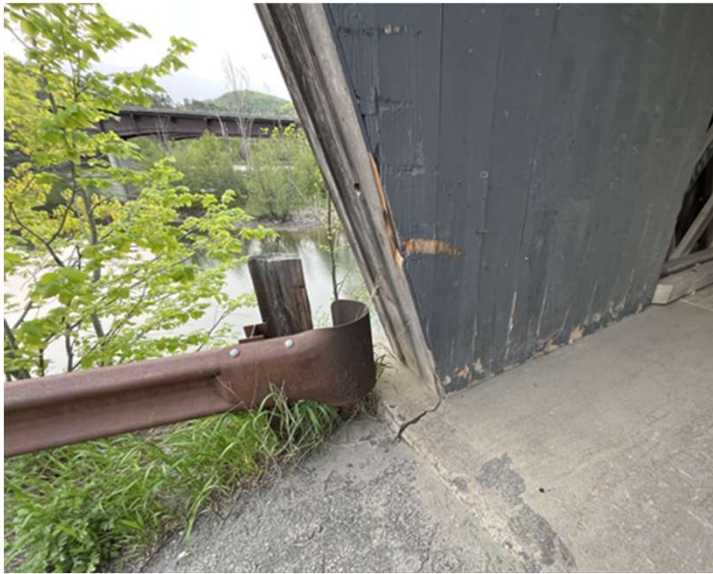
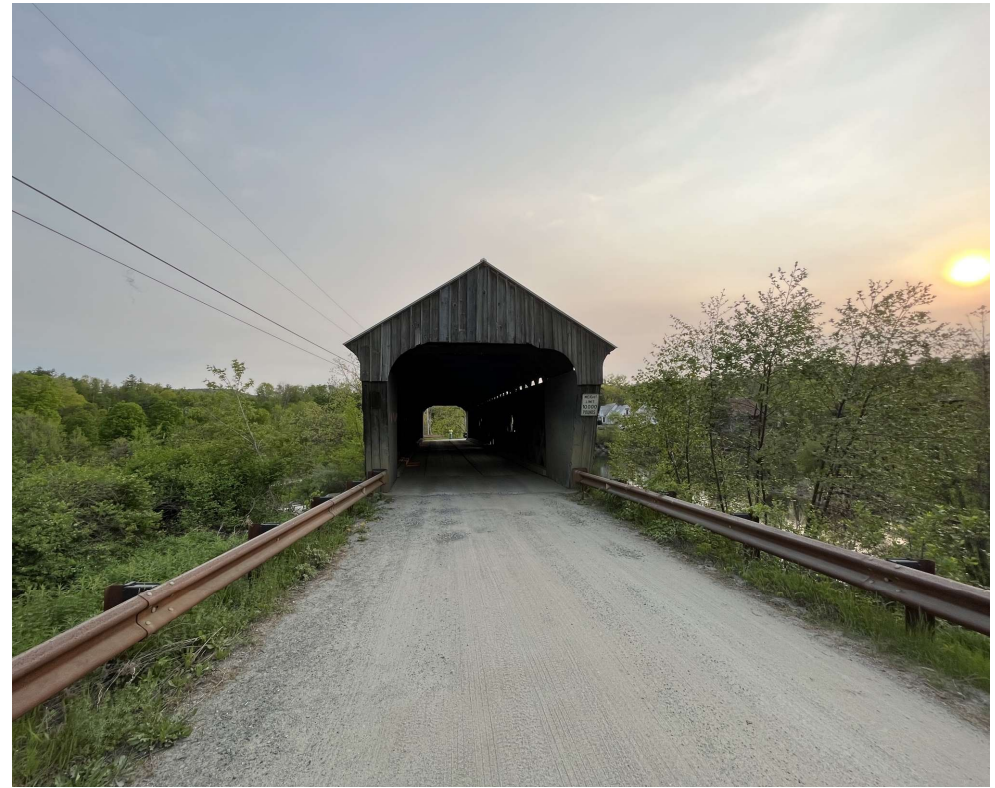
Roadway Approach and Railing

- Satisfactory condition
 - Guardrail repair southwest corner
 - Stormwater drains toward north end of bridge
