STATE OF VERMONT AGENCY OF TRANSPORTATION

Scoping Report

Morristown BF 0239(4)

Town Highway 2 - FAS Route 0239, Bridge 8 over The Lamoille River

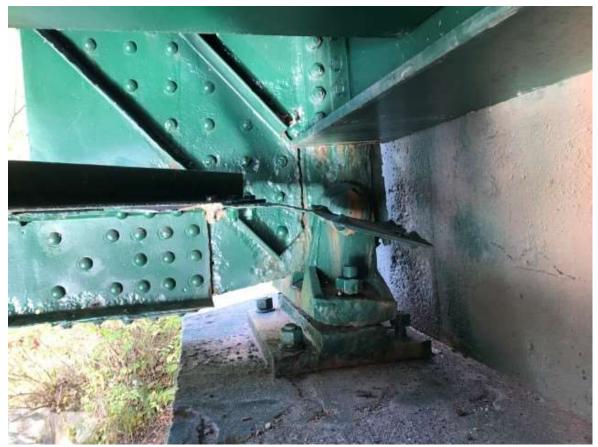
Rocker bearing

B.C.07 Bridge Bearings Condition Rating (SATISFACTORY - Widespread minor or isolated moderate defects.) Heavy pitting with some rust staining in bearing,

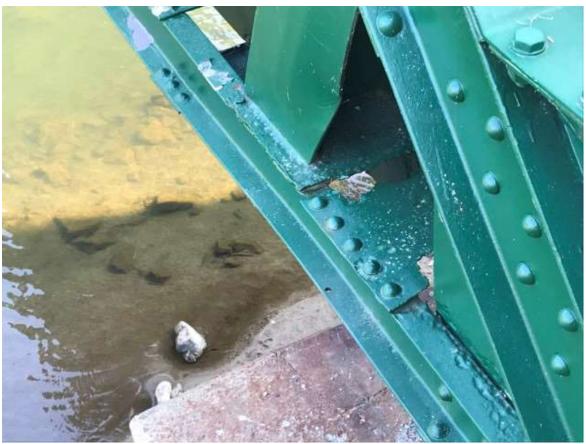
1. The structure has heavy section loss and pitting throughout the steel below the bridge deck.

Girder damage

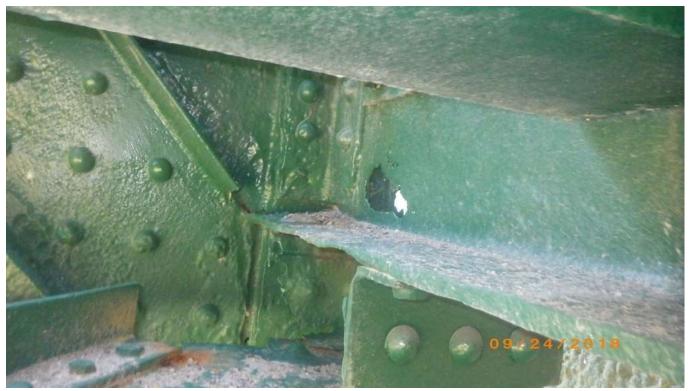
Stringer Rust

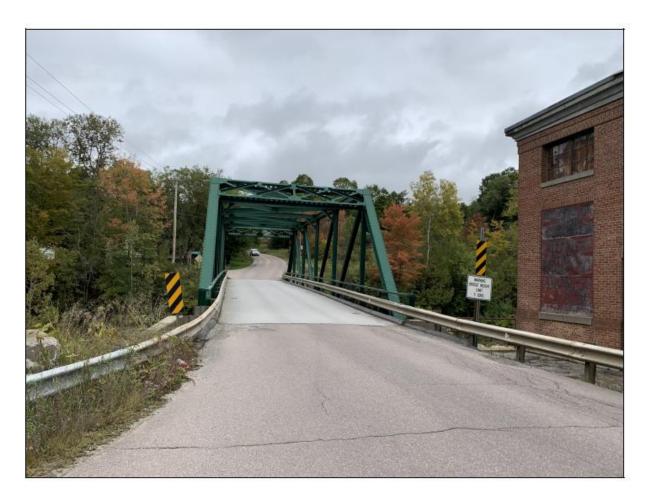
Figure 1: Note overhead utilities present west side of bridge

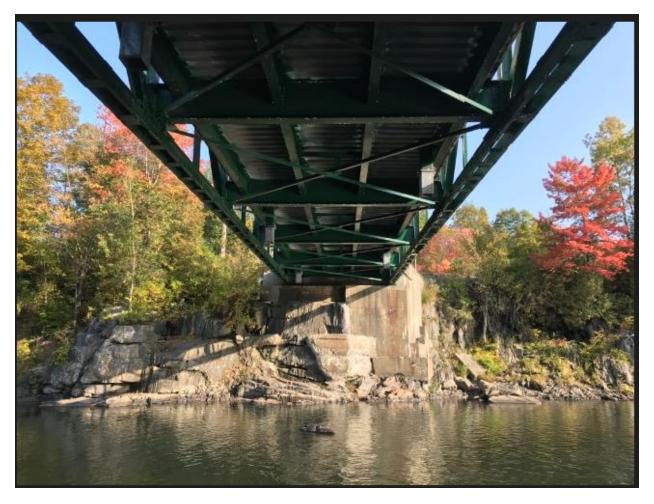
Figure 7 : Abutment 2 on bedrock

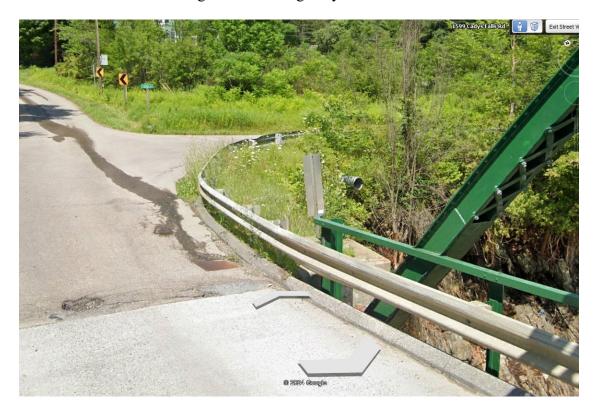
Street view from bridge of NE quadrant where D. Place and shoe shop structures were formerly located. *Note outfall pipe in corner and concrete retaining wall connected to bridge.

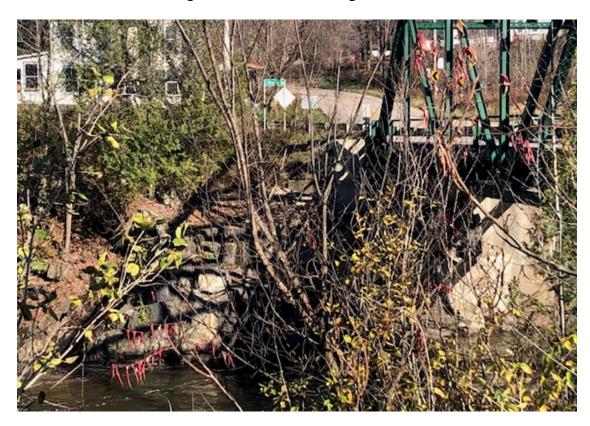
NW quadrant showing rip rap from bridge abutment and steep slope to river.
