STATE OF VERMONT  
AGENCY OF TRANSPORTATION

**Scoping Report**

**Swanton BF 036-1(16)**  
**VT ROUTE 78, BRIDGE 6 OVER MISSISQUOI RIVER**

March 10, 2025  
Revised May 30, 2025  
Final August 15, 2025

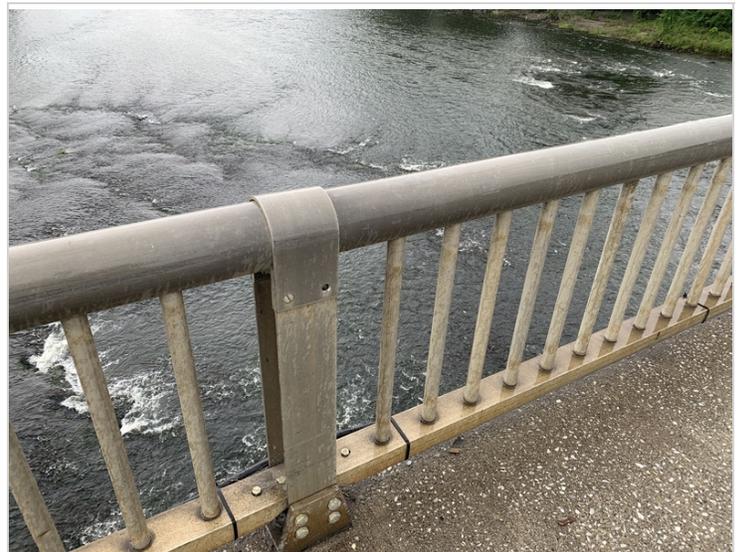
Missing bolt in the rail hoop

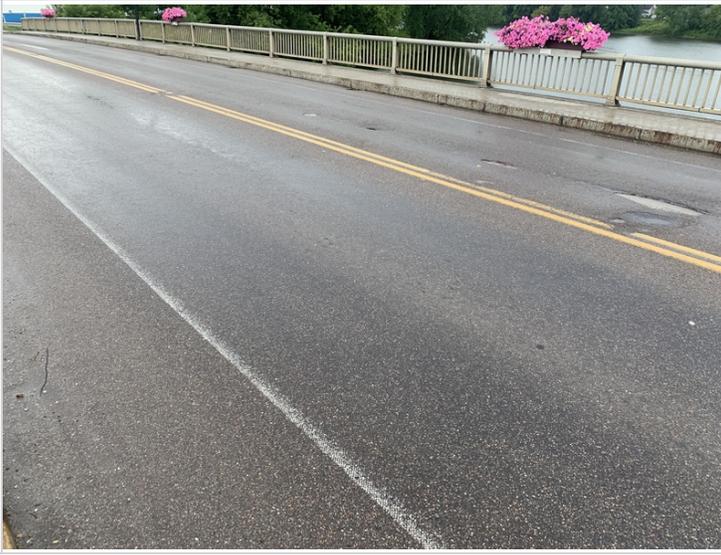
1. Both abutment joints have advanced deterioration, and the wearing surface has numerous potholes across the bridge. The latest inspection report states ‘the joints have failed and are ineffective’, and that the joint troughs have failed at multiple locations. The joints are scheduled to be repaired during the Summer of 2024 through a separate contract.

Potholes in wearing surface

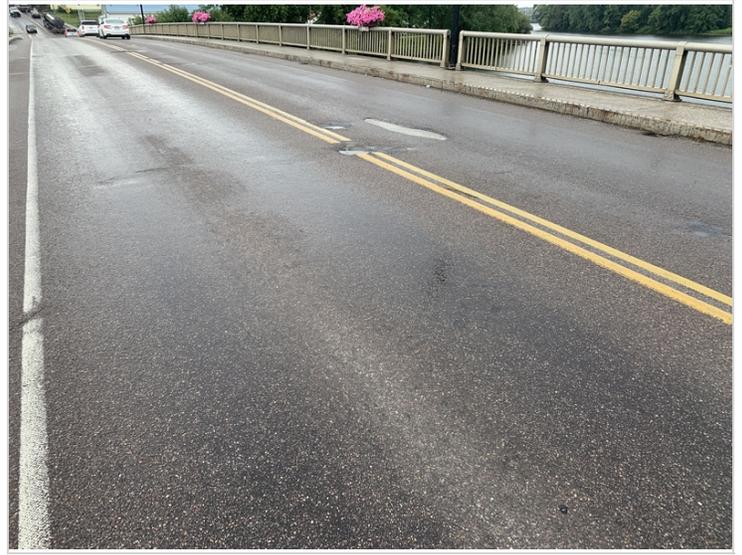
Exposed deck

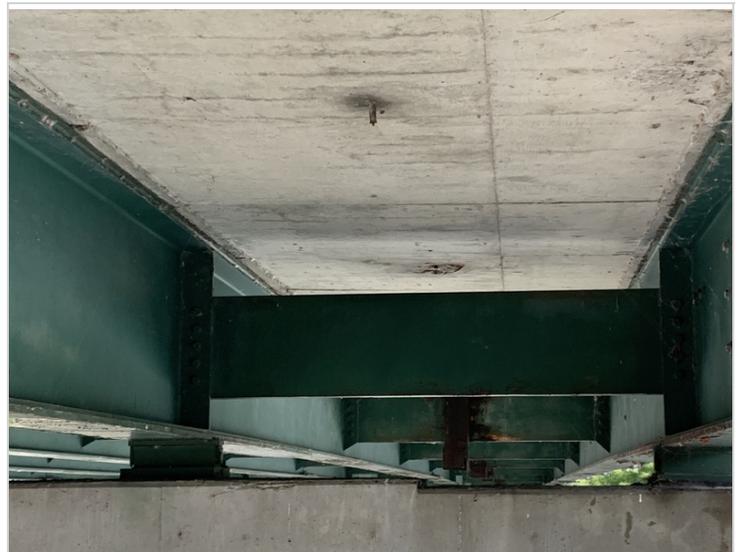
Saturation and minor spalling around deck weep tubes

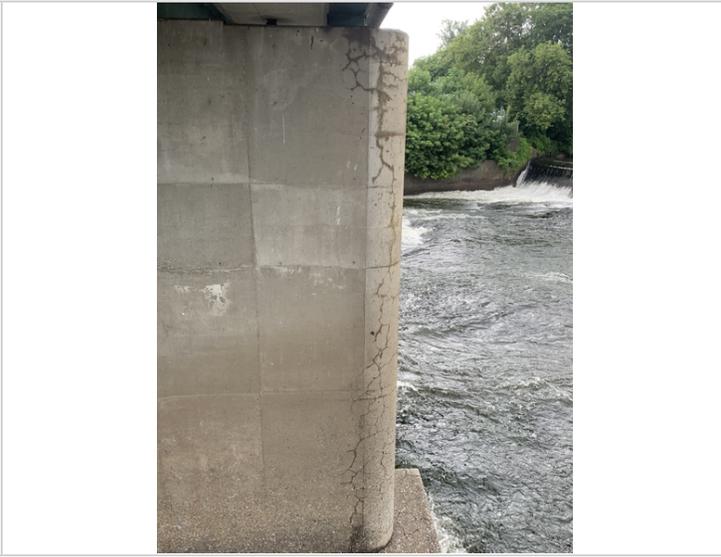
Upstream pier 2 nose cracking

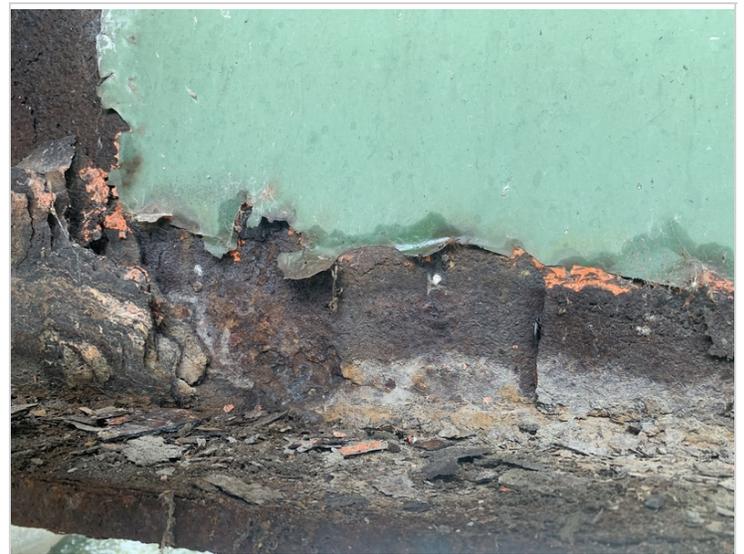
2. All beam ends at the abutments have significant rust. The downstream (north) fascia beam has significant rust on the bottom flange and lower web over the full length of the bridge.

Heavy rust scale beam 1

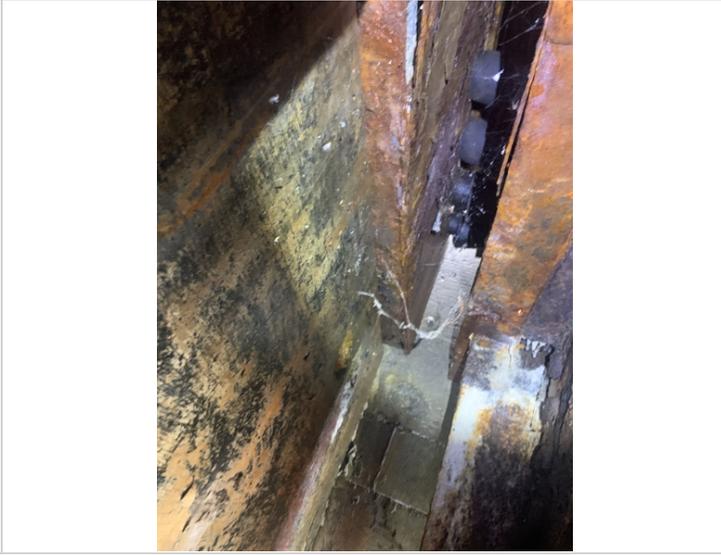
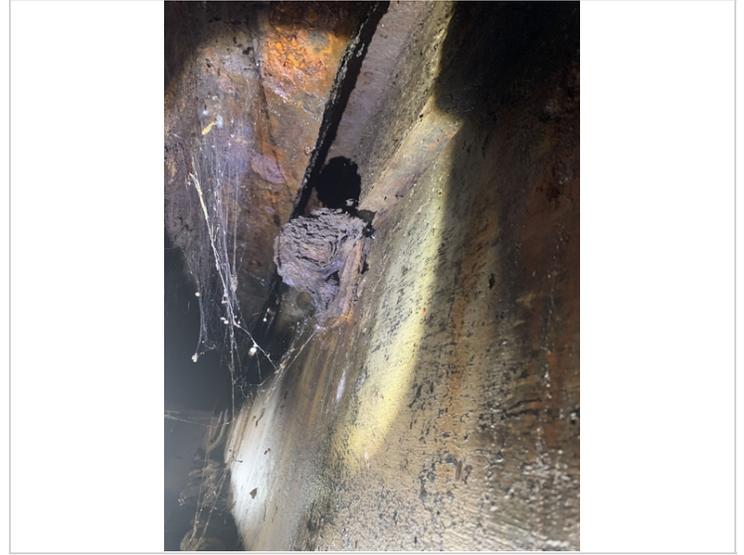
"8/8/2023 Both bridge joints have some wood temporary form work in place due to failing joint plates. The steel support brackets that hold the joint in place has advanced corrosion and most of them are detached. Joint replacement is needed.

corroded bracket abutment 1 joint

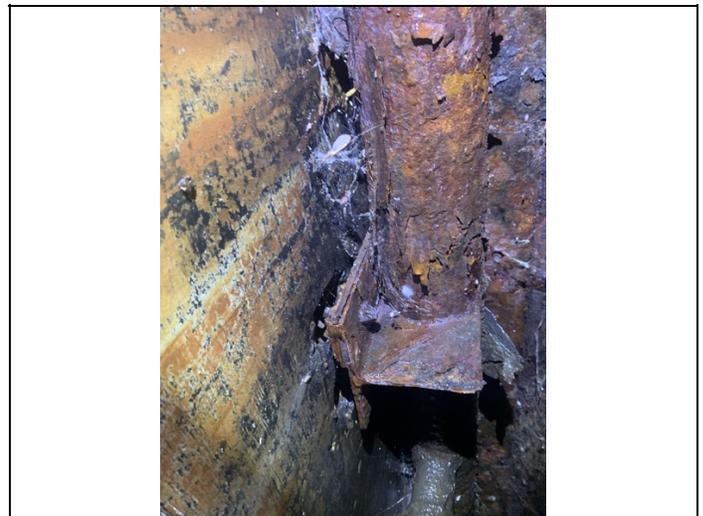
drain trough failed from corrosion

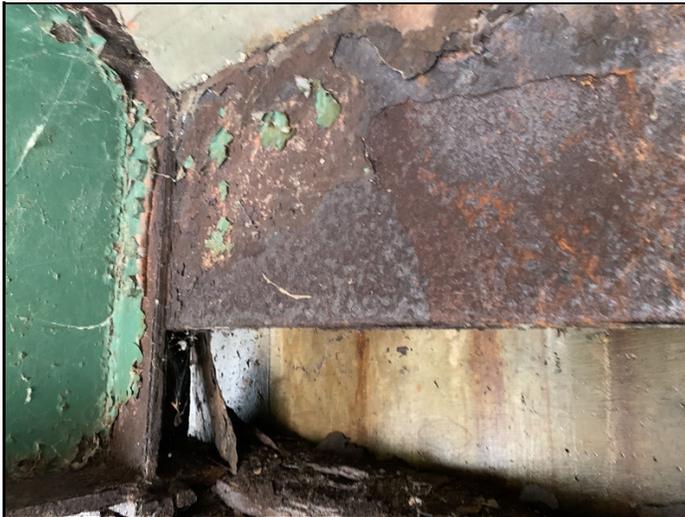
3. The end diaphragms at both abutments have significant rust. The outer bay intermediate diaphragms have rusted through at scupper locations.
4. The abutment bearings have significant rust, and the pier bearings only have two anchor bolts.

End diaphragm's abutment 1
