Local Concerns Meeting

Upper Cox Brook Covered Bridge

Lower Cox Brook Covered Bridge

Northfield Falls Covered Bridge

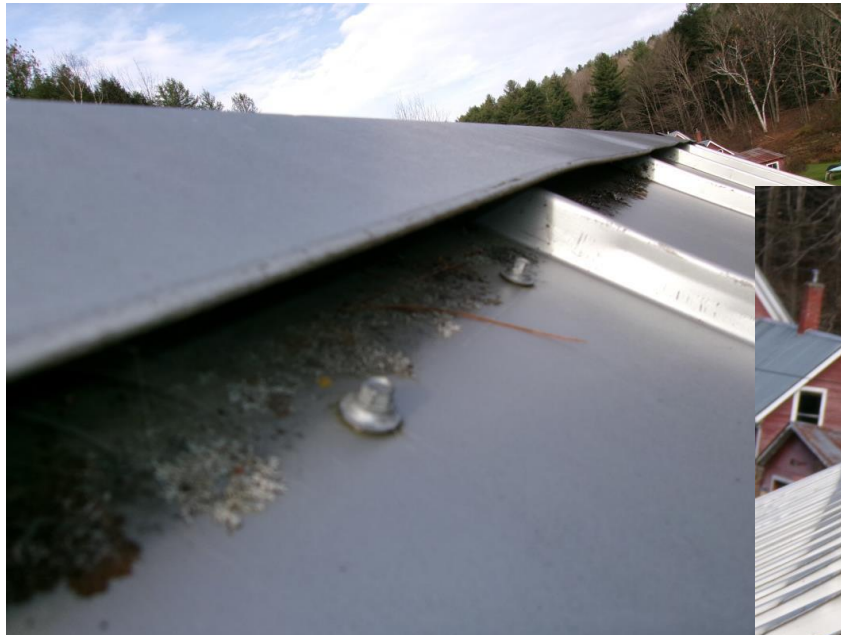
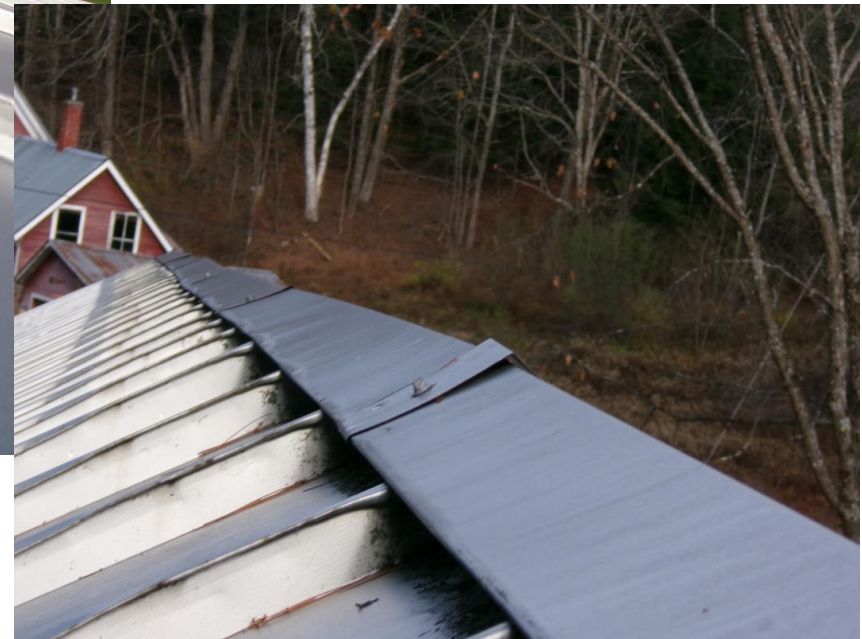
Metal Roof

- Leaks
- Screw Attachment

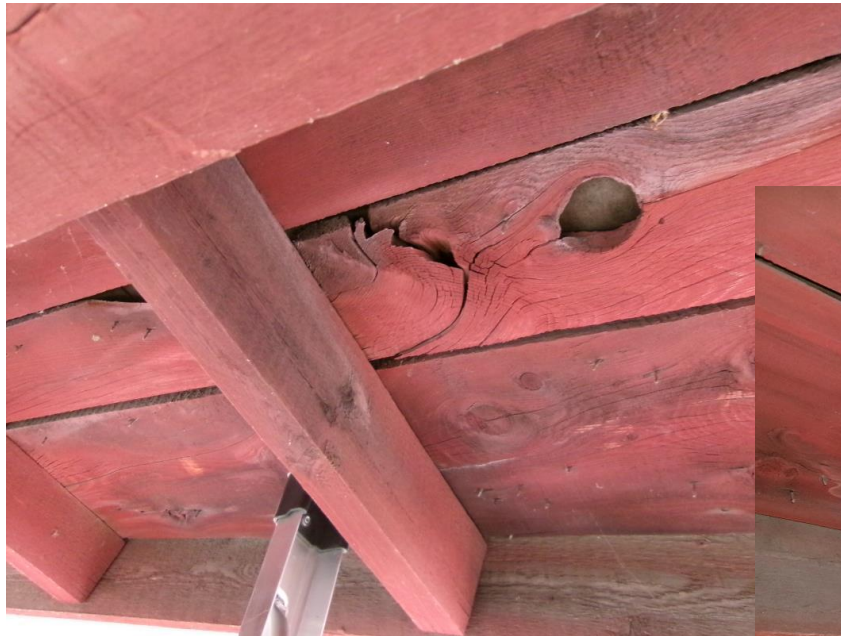
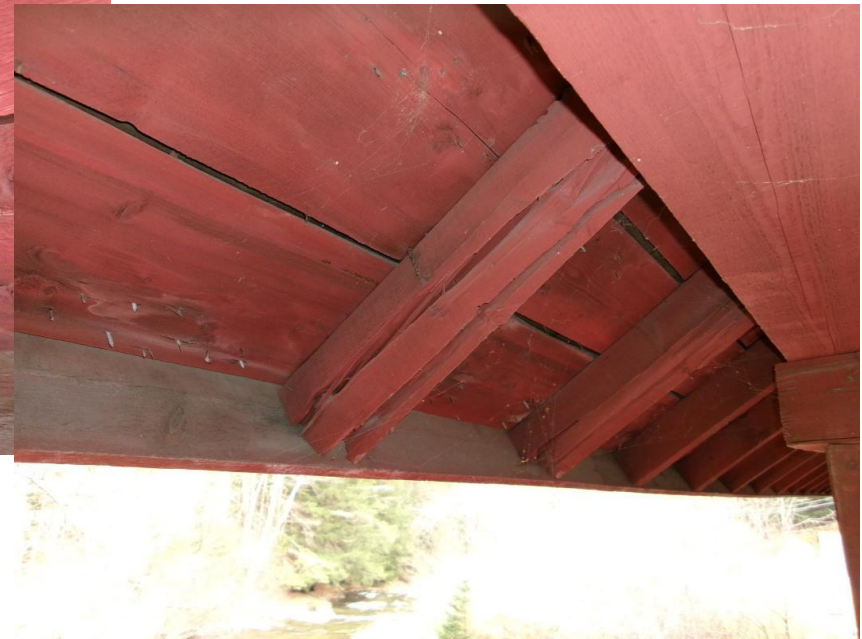
Roofboards and Rafters

- Splits,
- Breaks
- Rot

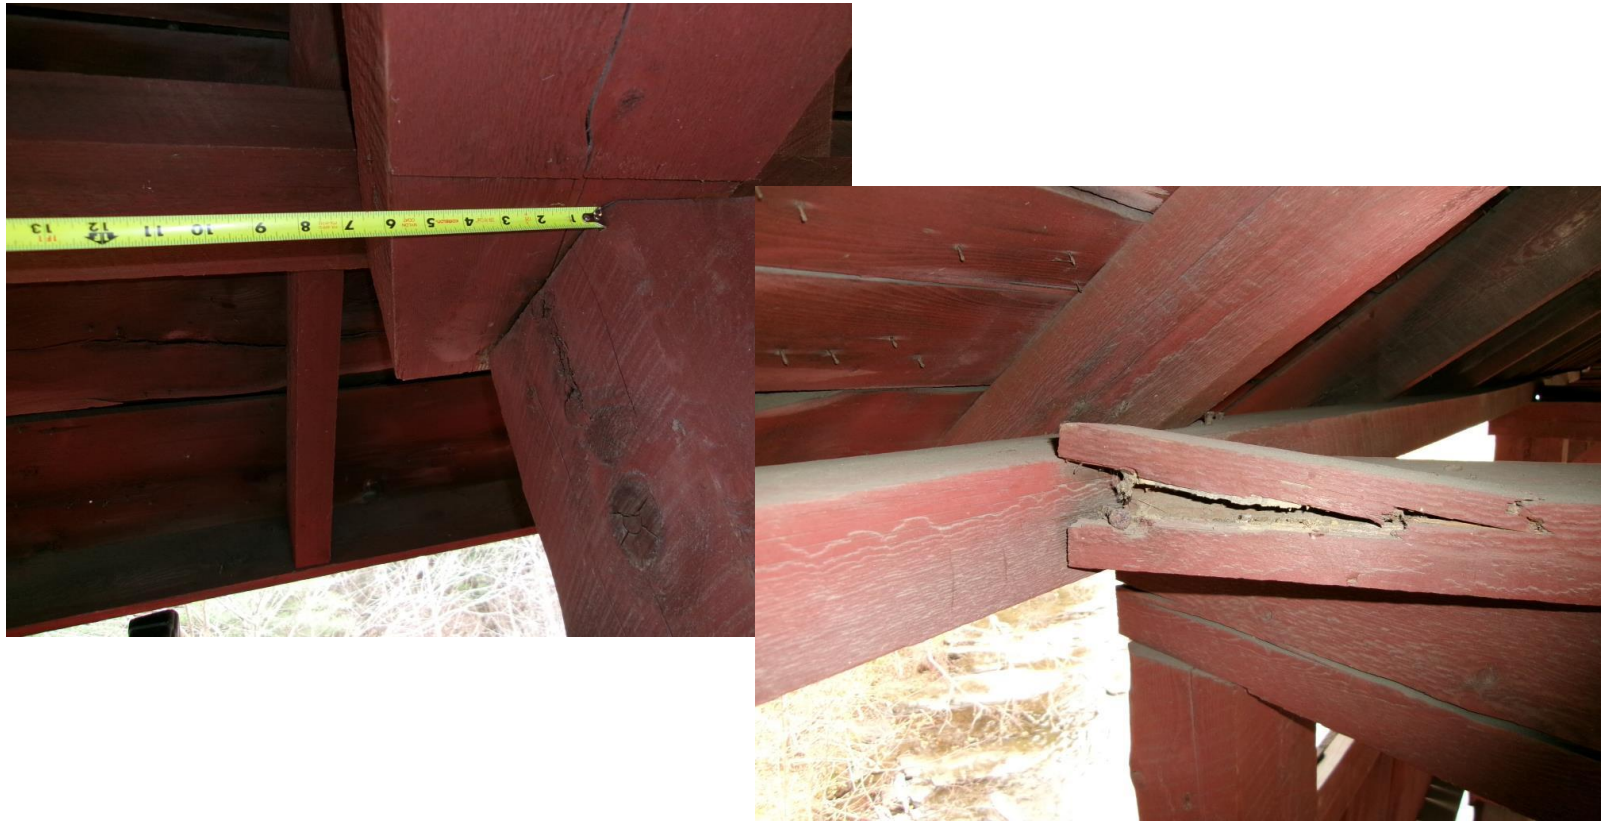
Upper Bracing Members

- Splits,
- Breaks
- Rot
- Impact Damage

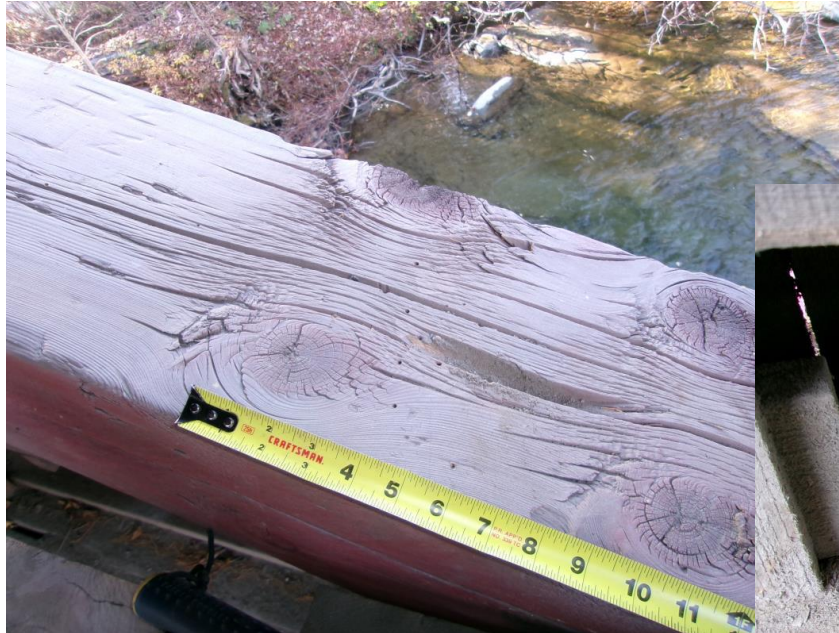
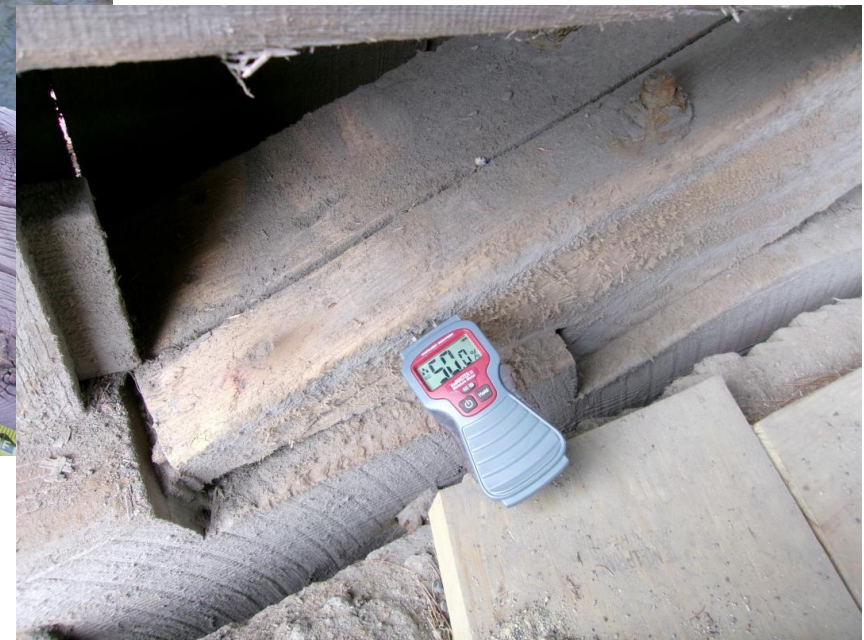
Truss Members

- Splits,
- Breaks
- Rot
- Weathering
- High Moisture Content

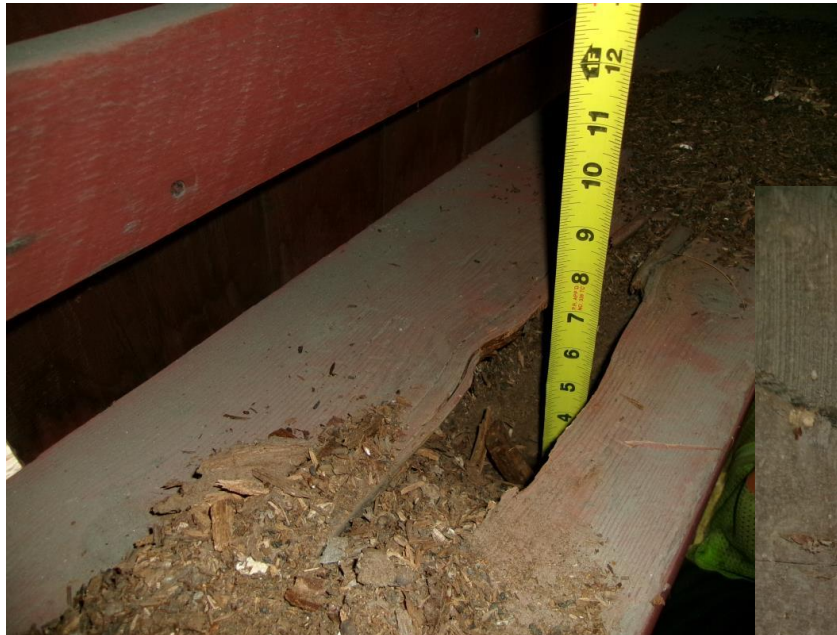
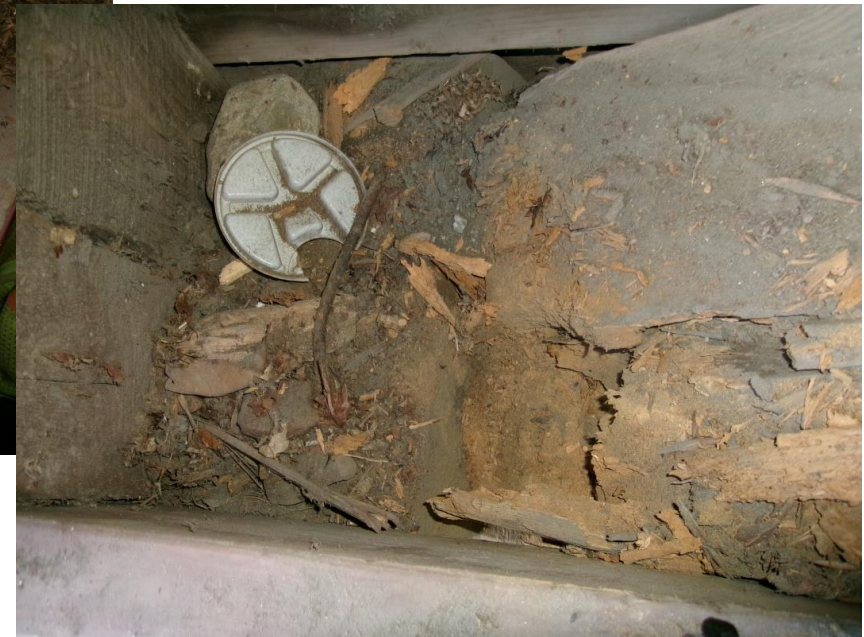
Truss Members (Continued)

- Splits,
- Breaks
- Rot
- Weathering
- High Moisture Content

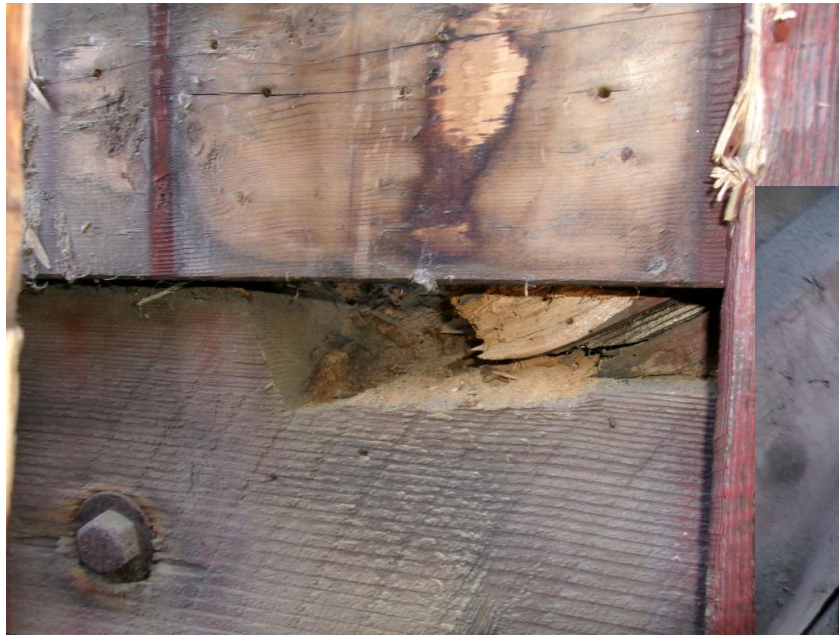
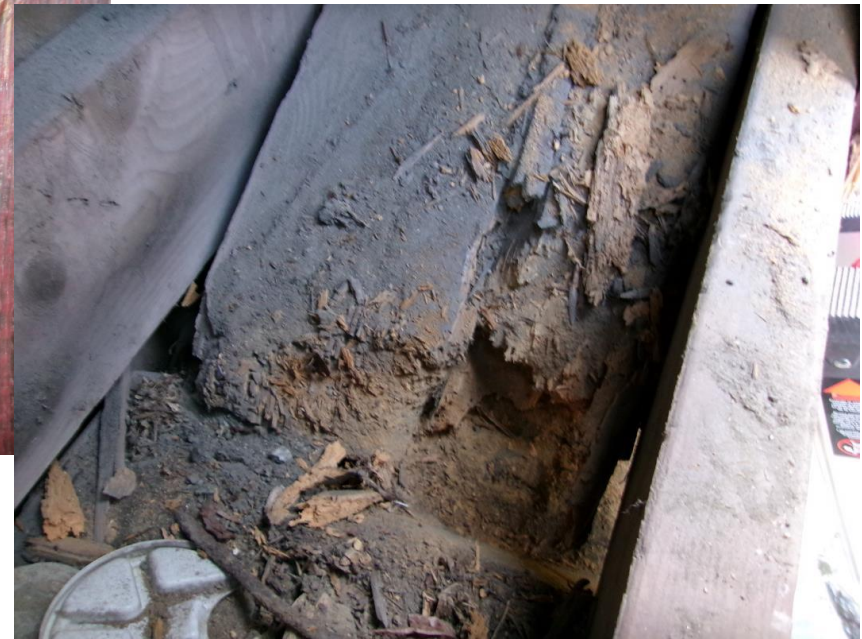
Truss Members (Continued)

- Splits,
- Breaks
- Rot
- Weathering
- High Moisture Content

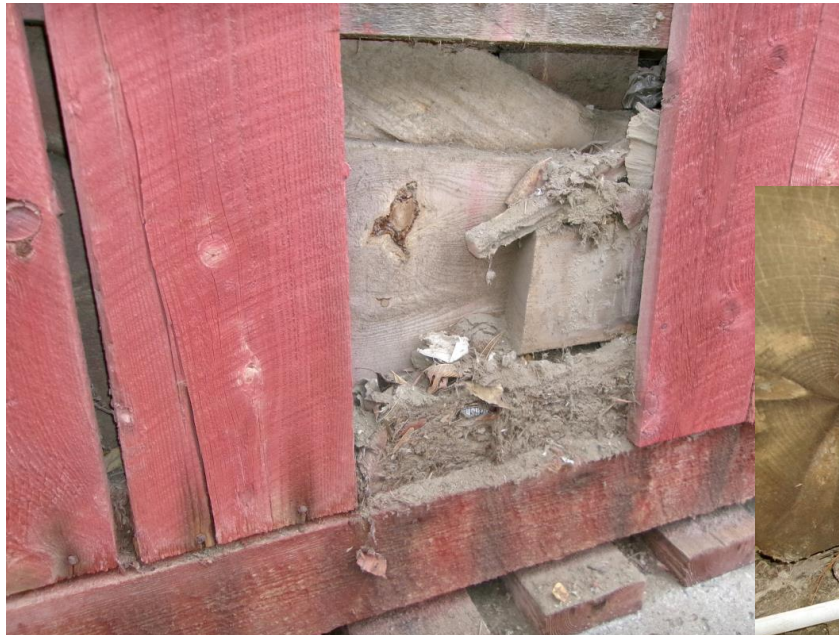
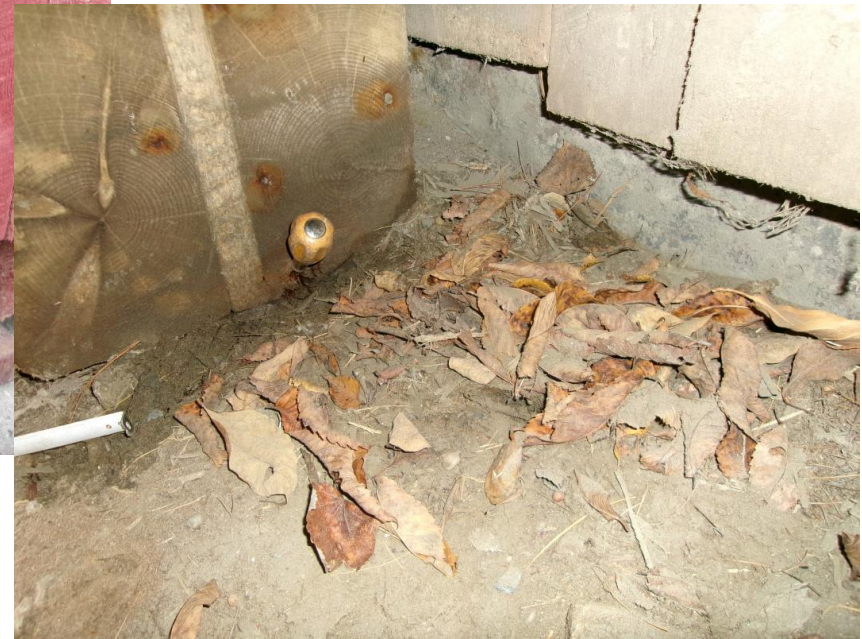
Truss Members (Continued)

- Splits,
- Breaks
- Rot
- Weathering
- High Moisture Content

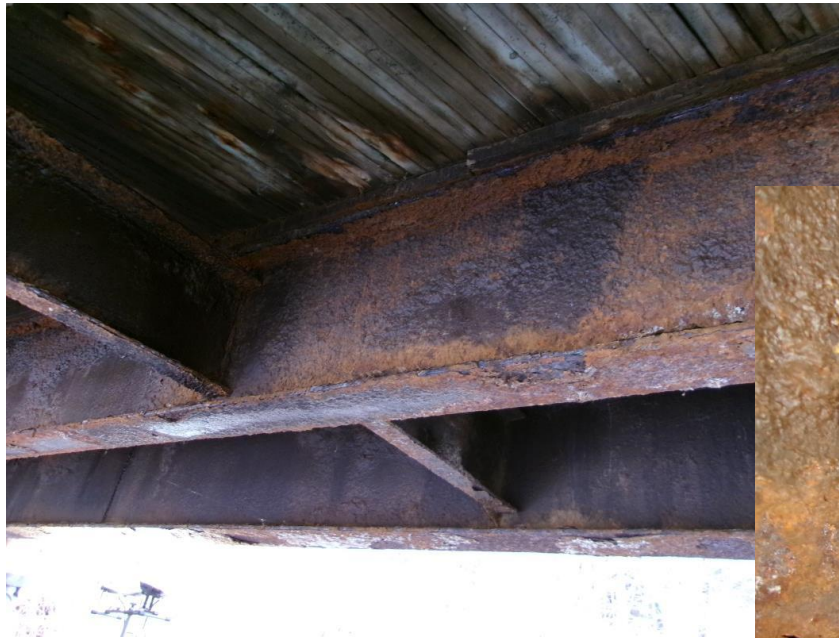
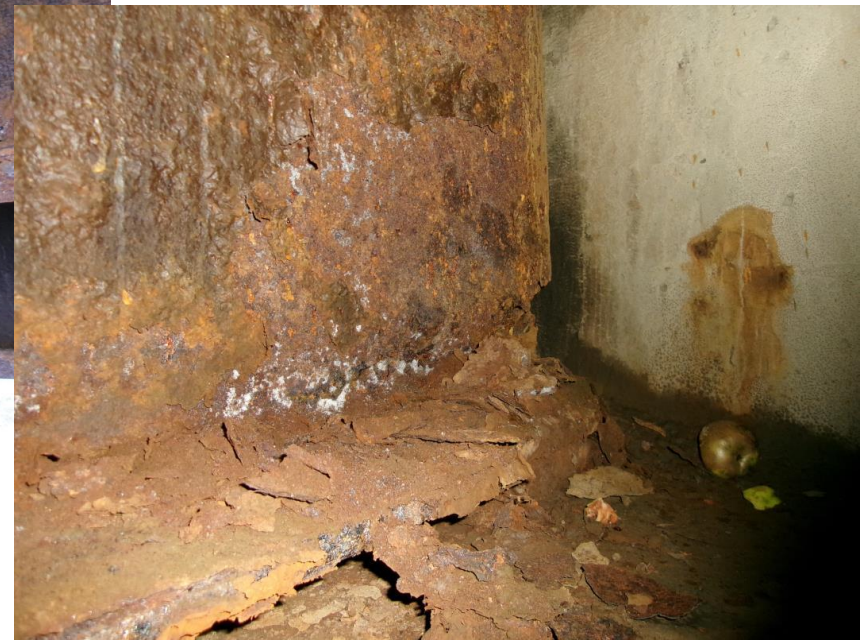
Steel Beams

- Rust Holes
- Advanced Corrosion

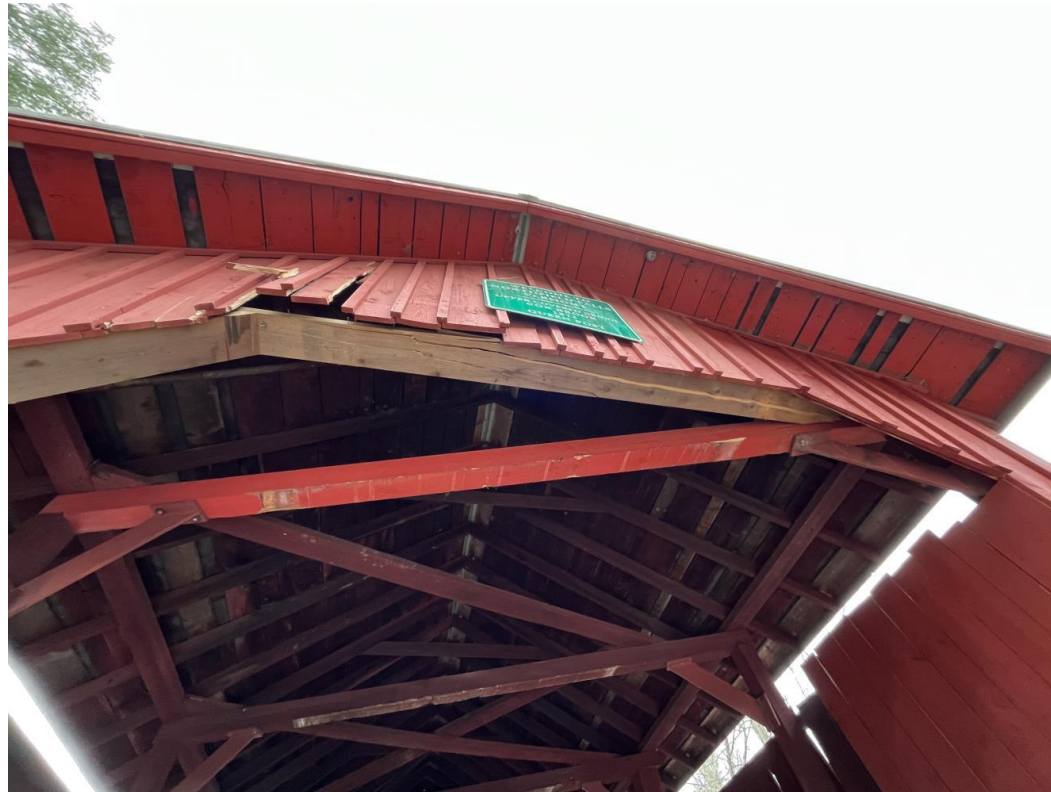
Portals

- Breaks
- Impact Damage

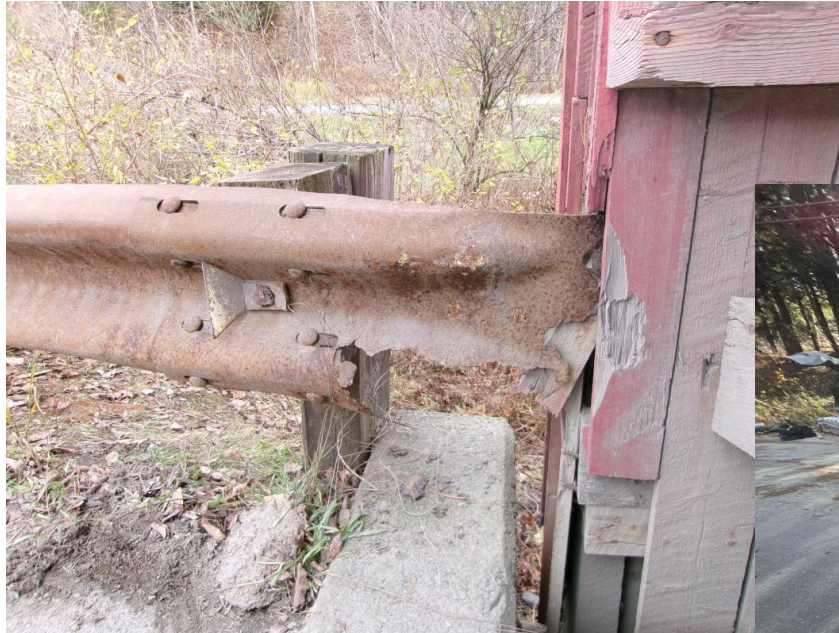
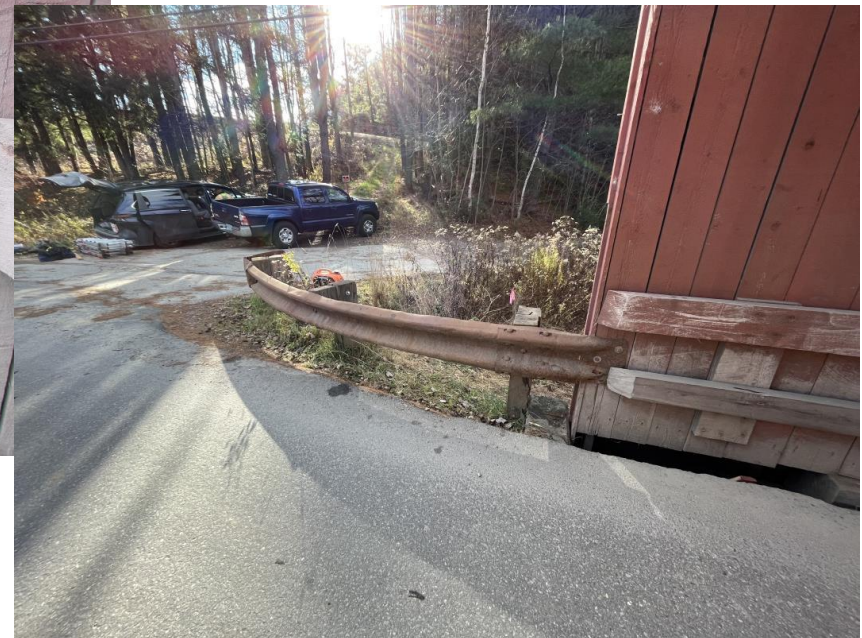
Approach Railing

- Extensive Corrosion
- Rust Holes
- Rotted Wood Posts
- Impact Damage

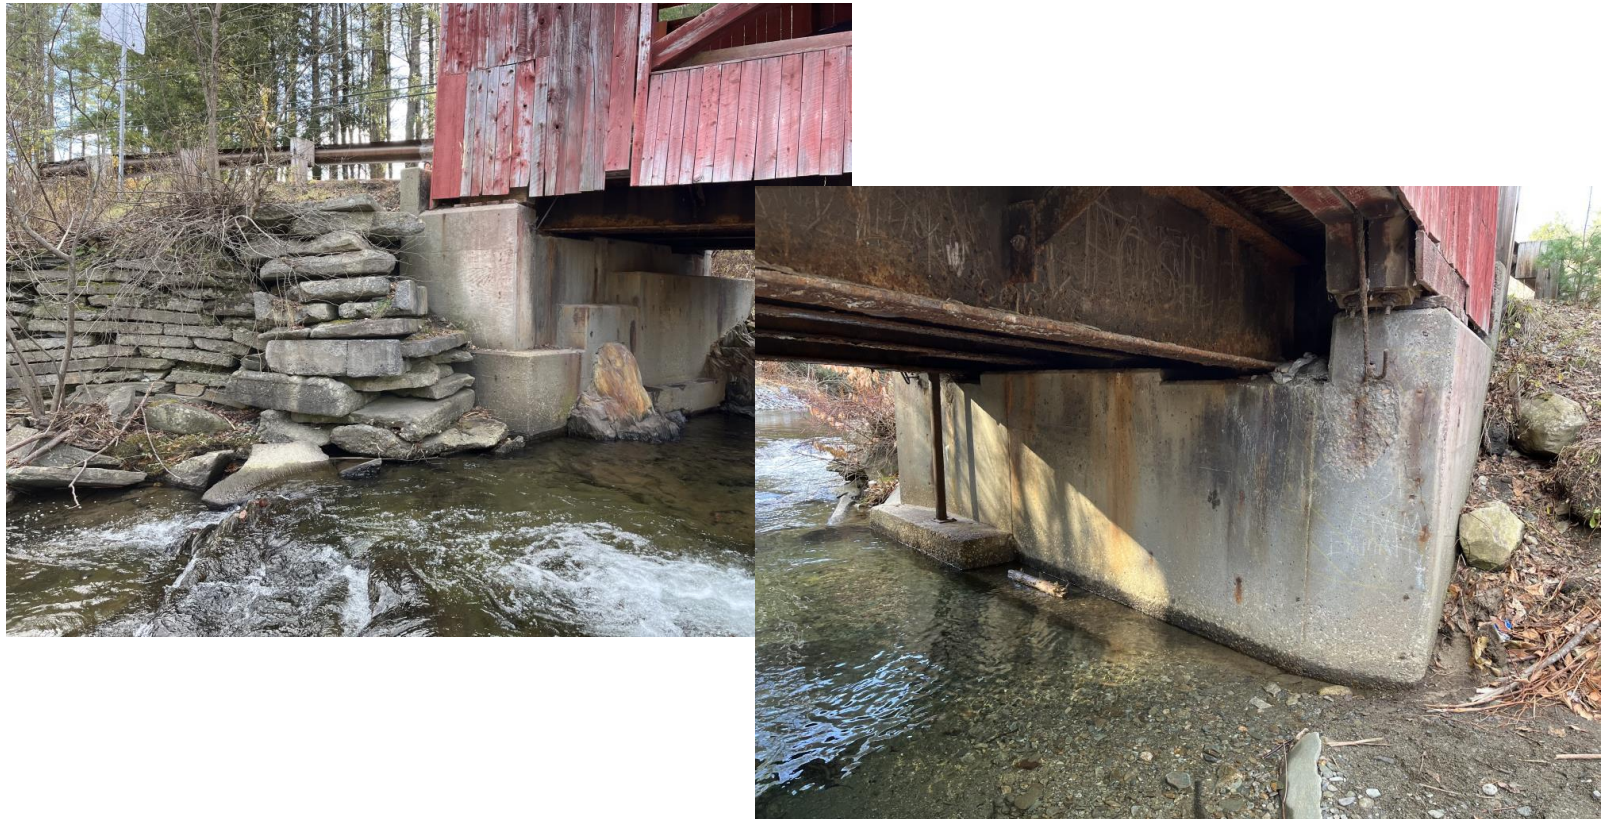
Abutments

- Voids
- Spalling
- Exposed Rebar

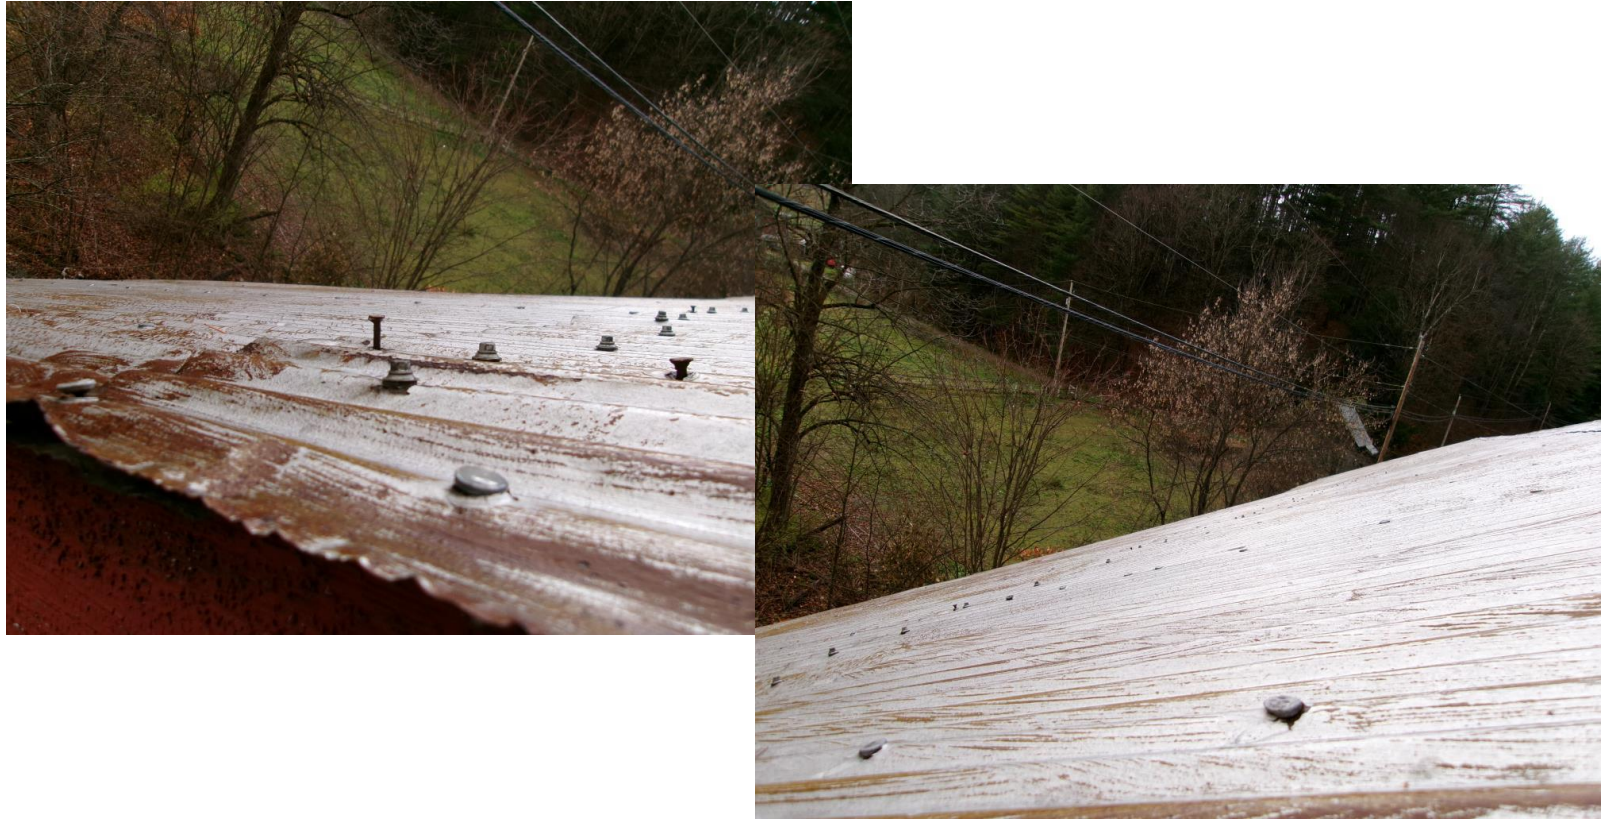
Metal Roof

- Rusting
- Leaks
- Nail Attachment

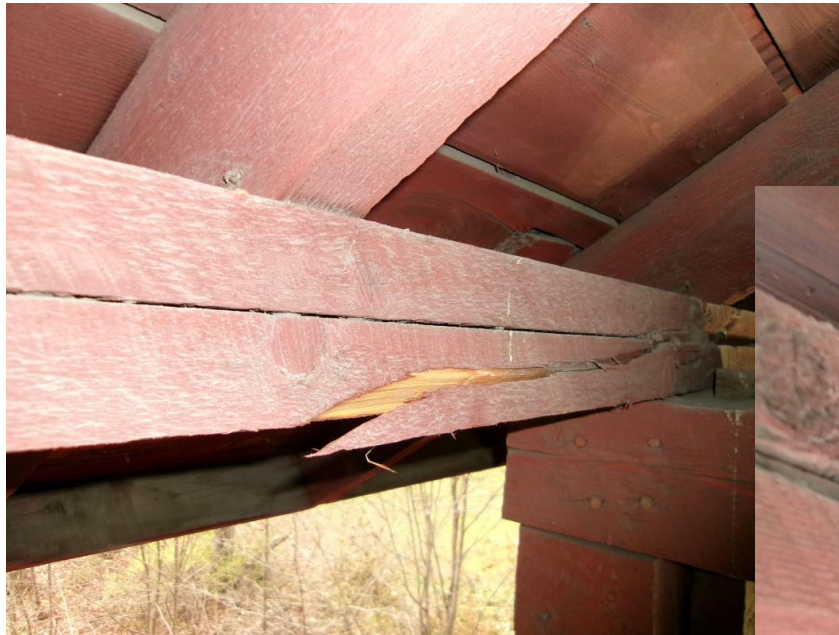
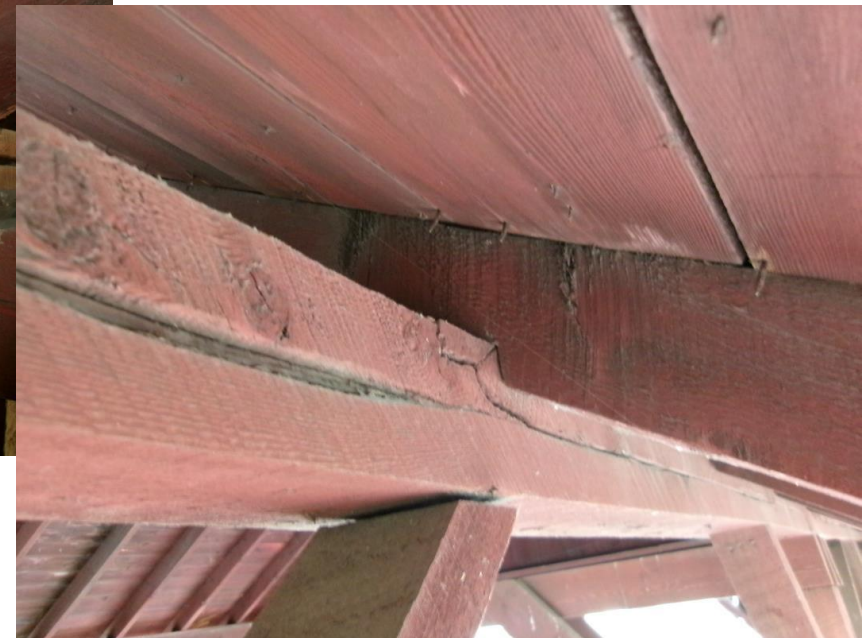
Roofboards and Rafters

- Splits,
- Breaks
- Rot
- Insect Damage

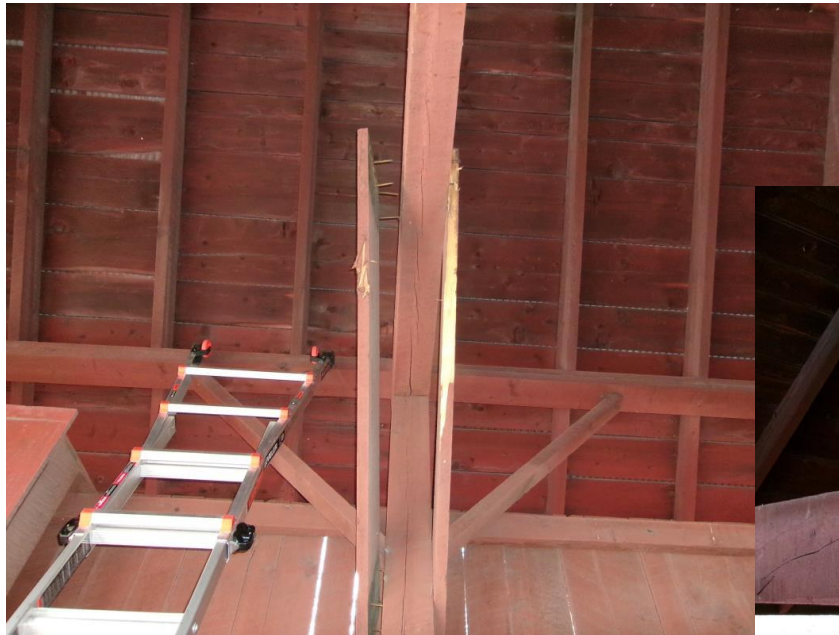
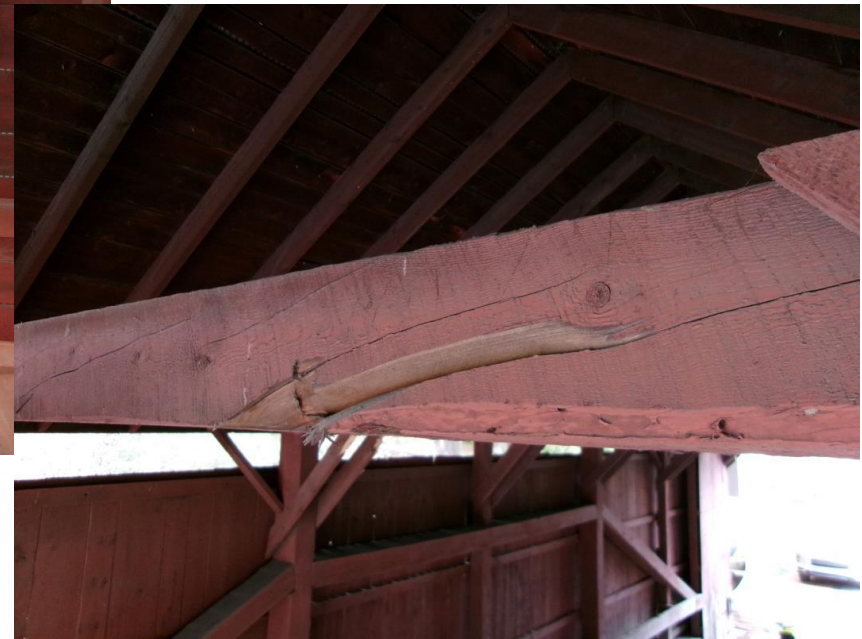
Upper Bracing Members

- Splits,
- Breaks
- Rot
- Impact Damage

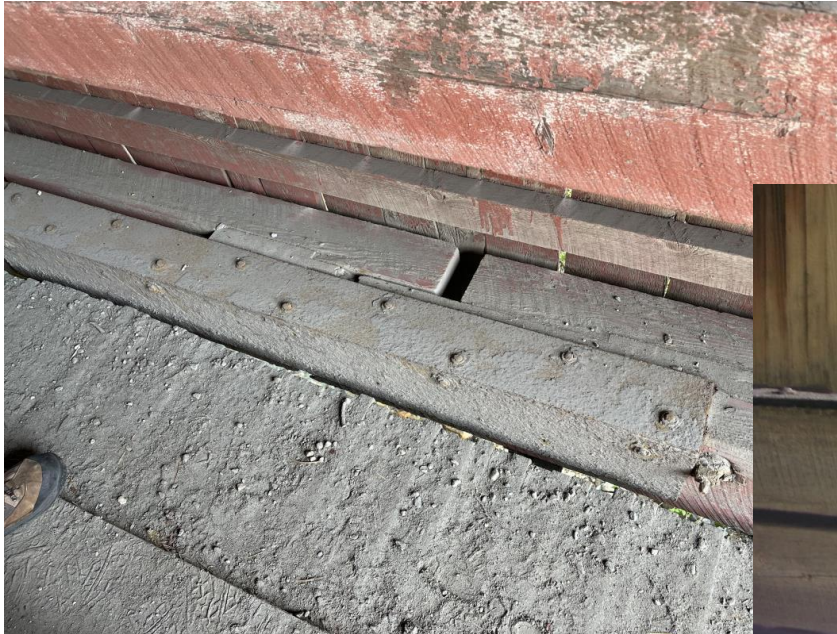
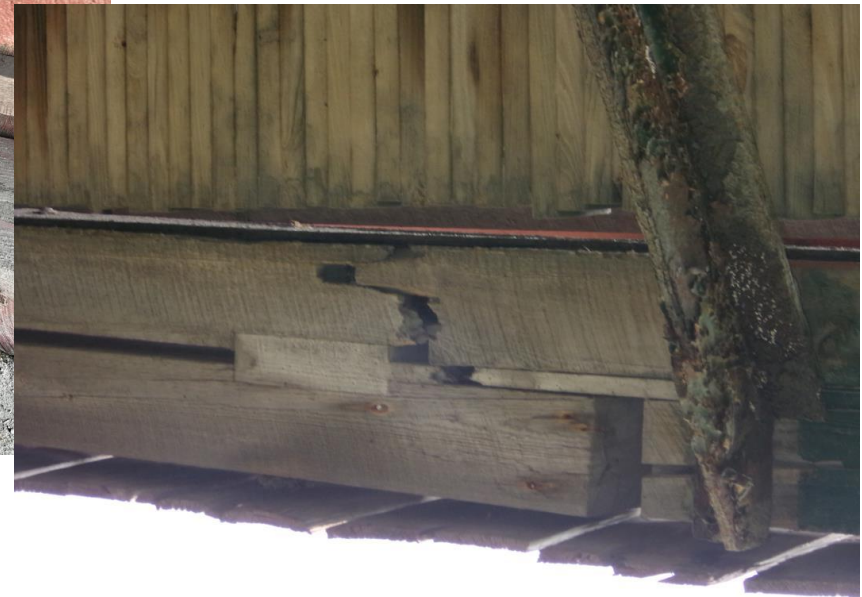
Truss Members

- Splits,
- Breaks
- Rot
- High Moisture Content

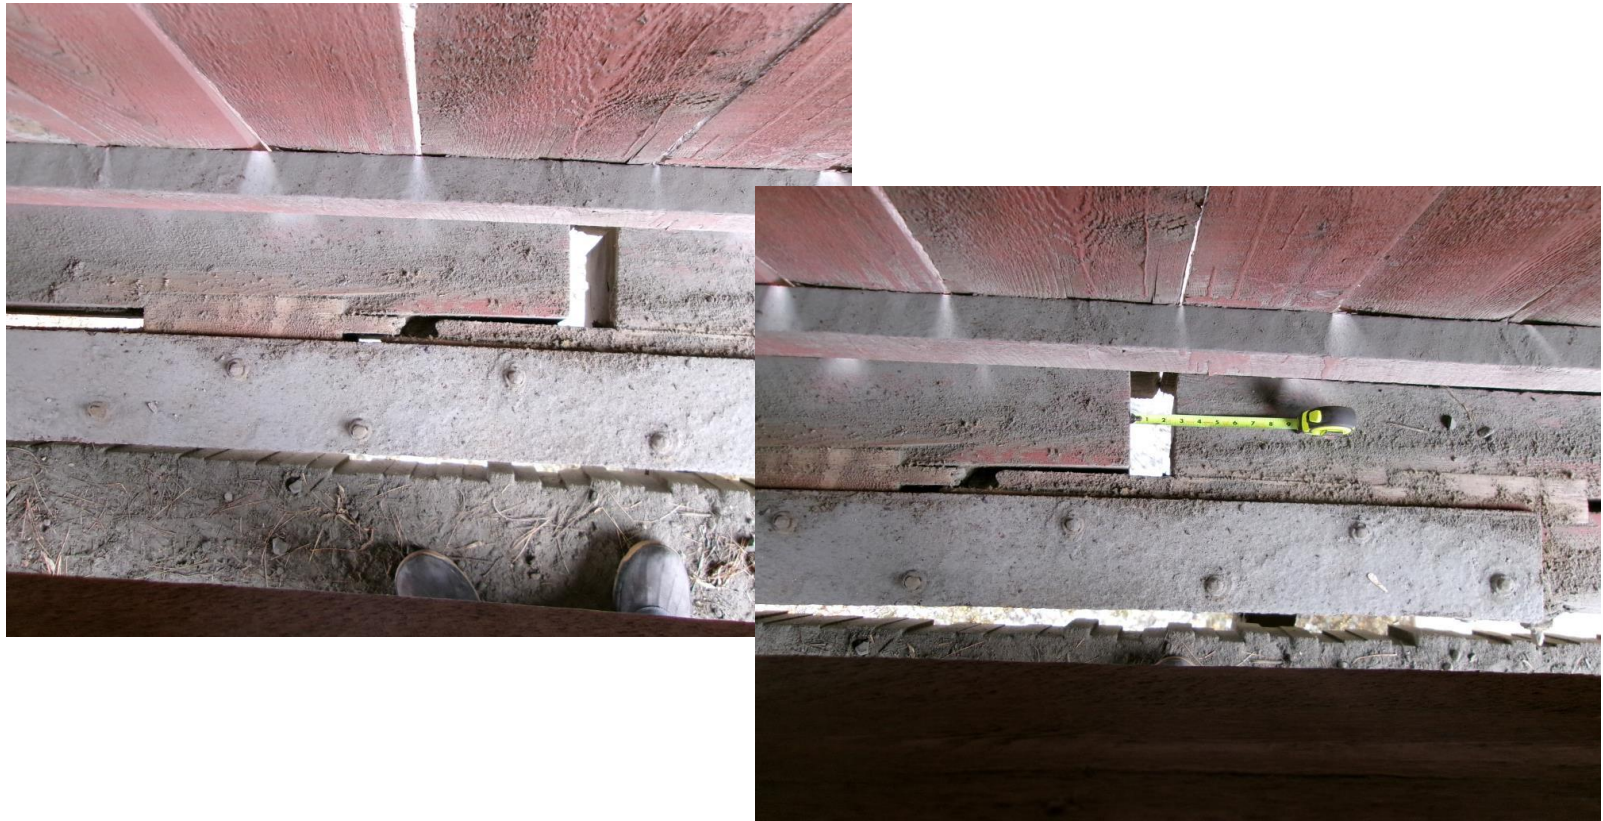
Truss Members (Continued)

- Splits,
- Breaks
- Rot
- High Moisture Content

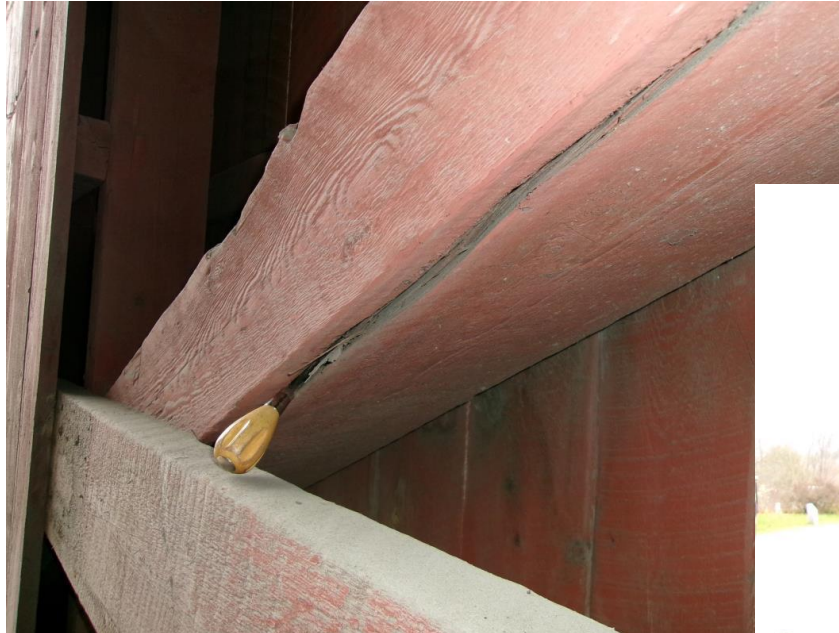
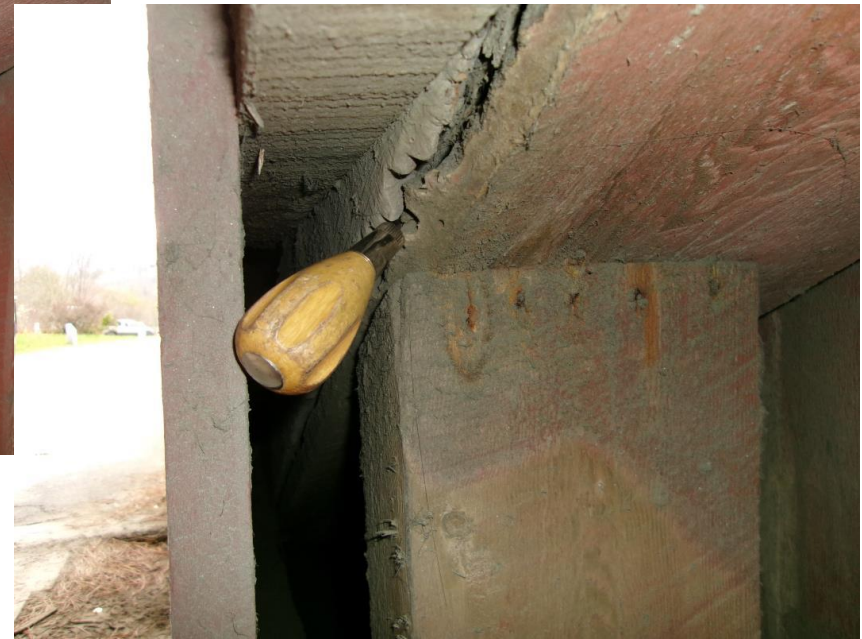
Truss Members (Continued)

- Splits,
- Breaks
- Rot
- High Moisture Content

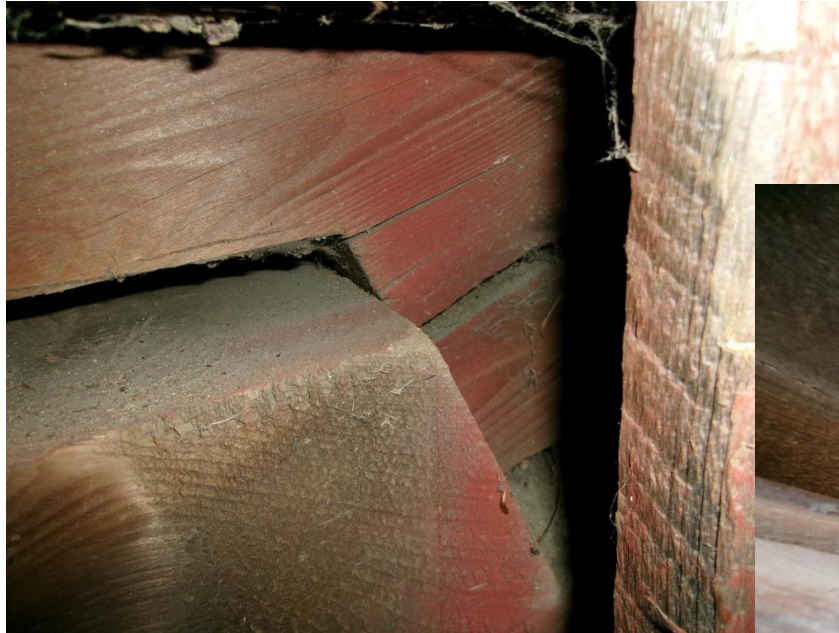
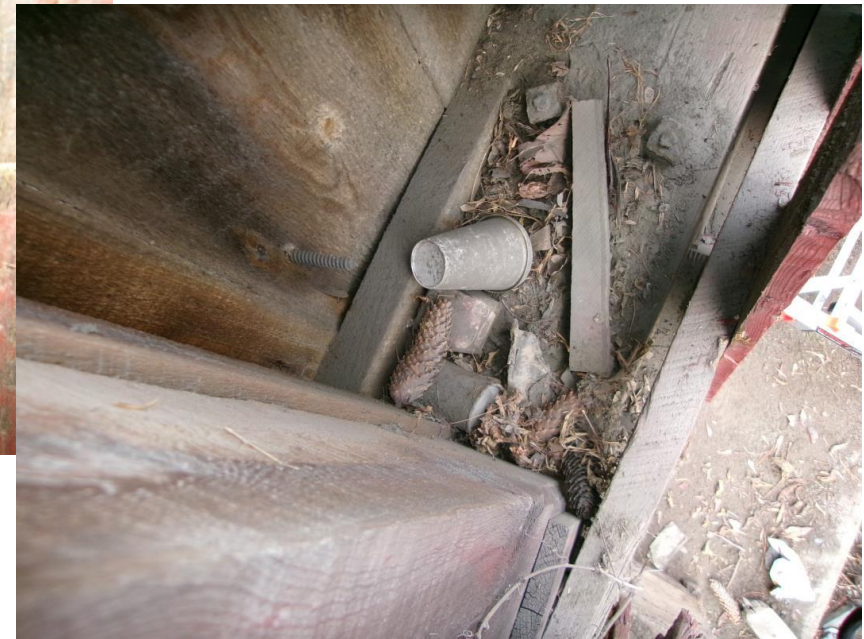
Truss Members (Continued)

- Splits,
- Breaks
- Rot
- High Moisture Content

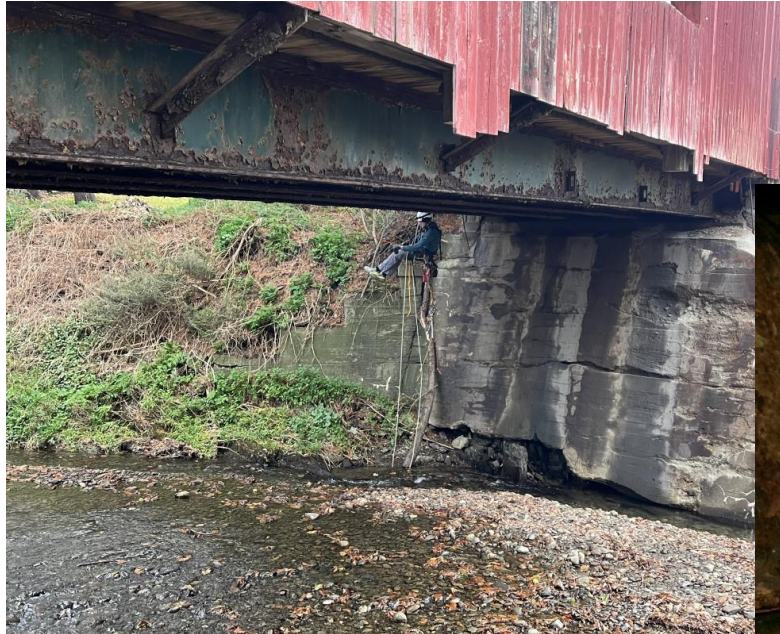
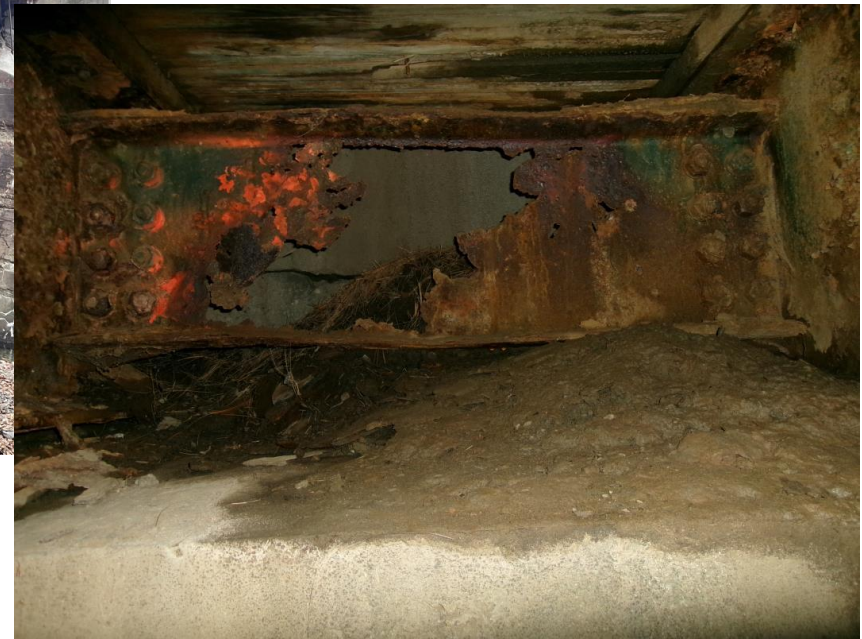
Steel Beams

- Rust Holes
- Advanced Corrosion

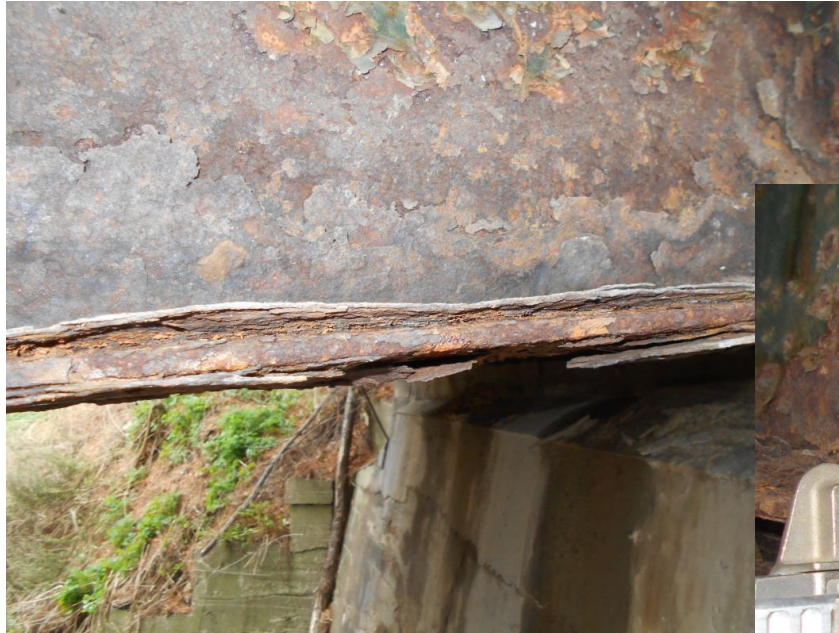
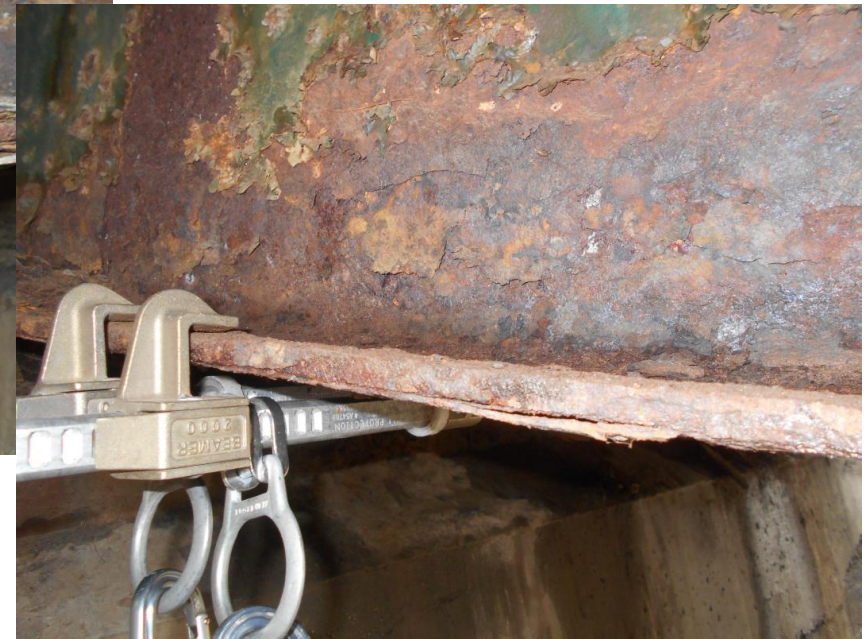
Steel Beams (Continued)

- Rust Holes
- Advanced Corrosion
