Local Concerns Meeting

Upper Cox Brook Covered Bridge

Lower Cox Brook Covered Bridge

Northfield Falls Covered Bridge

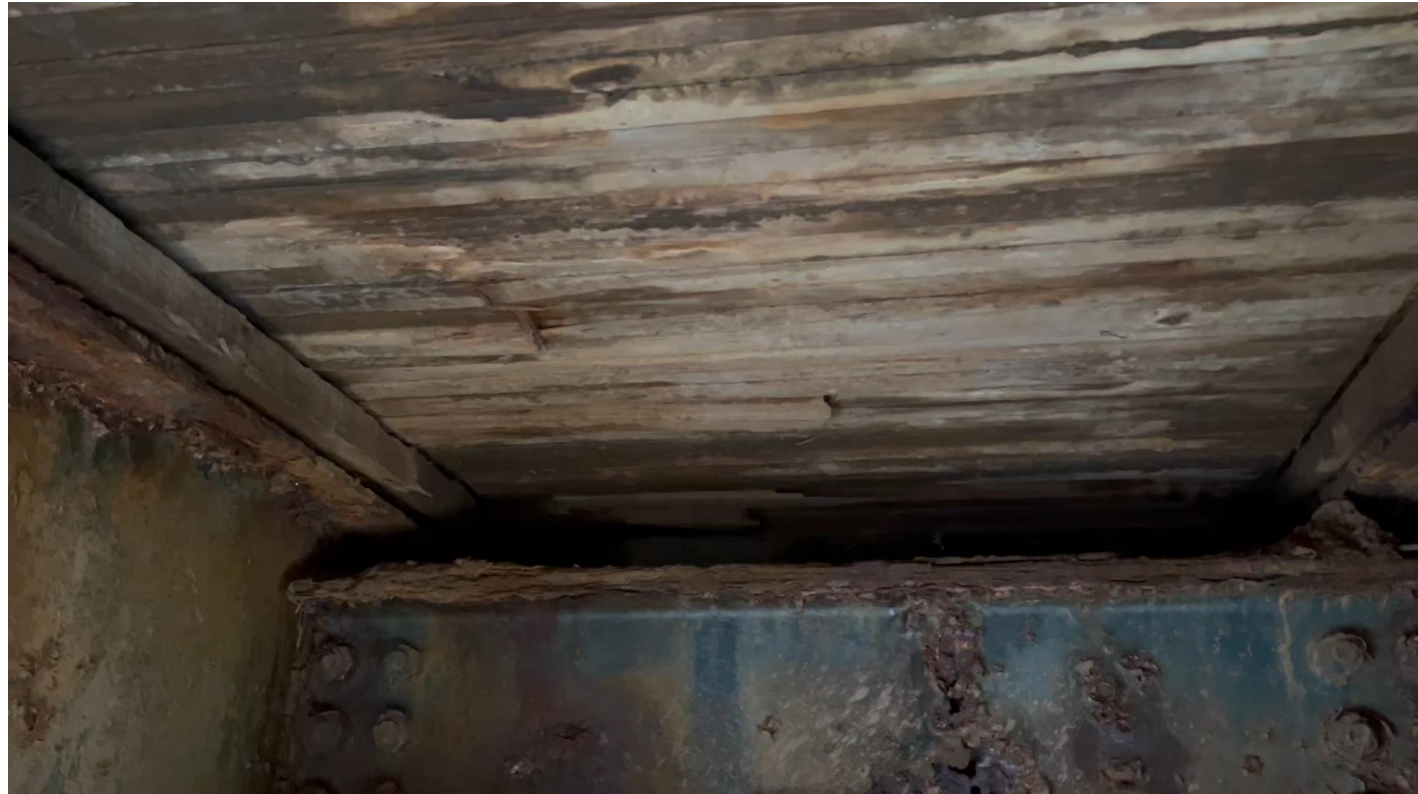
Deck

- Breaks
- Poor Attachment

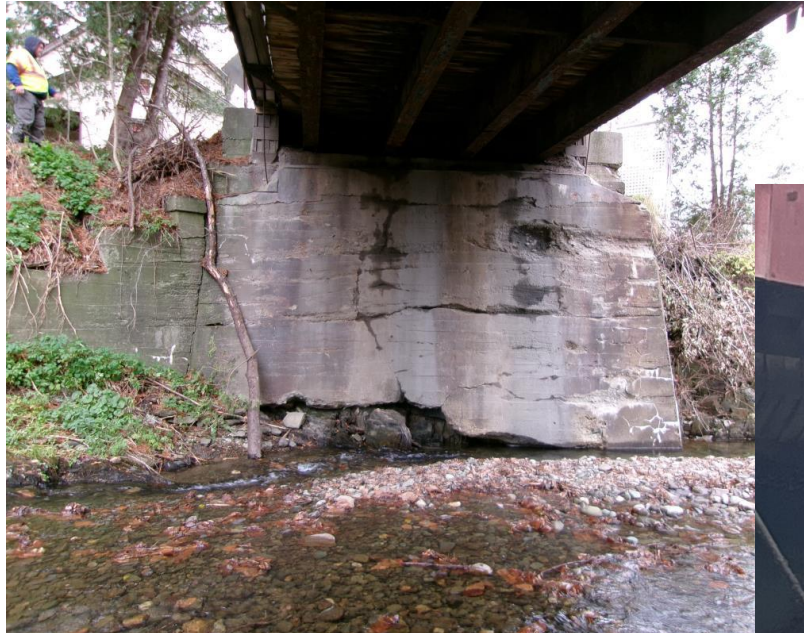
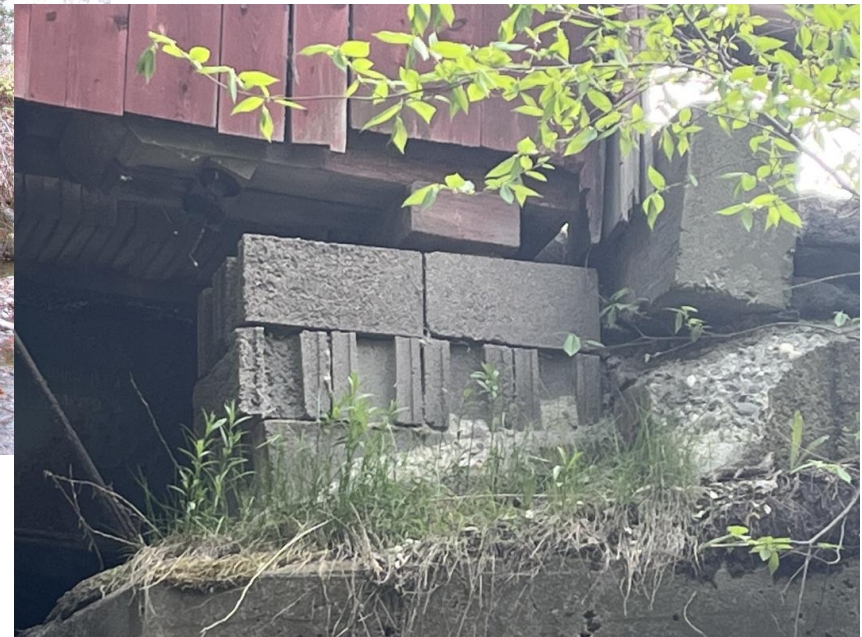
Abutments

- Voids
- Spalling
- Exposed Rebar

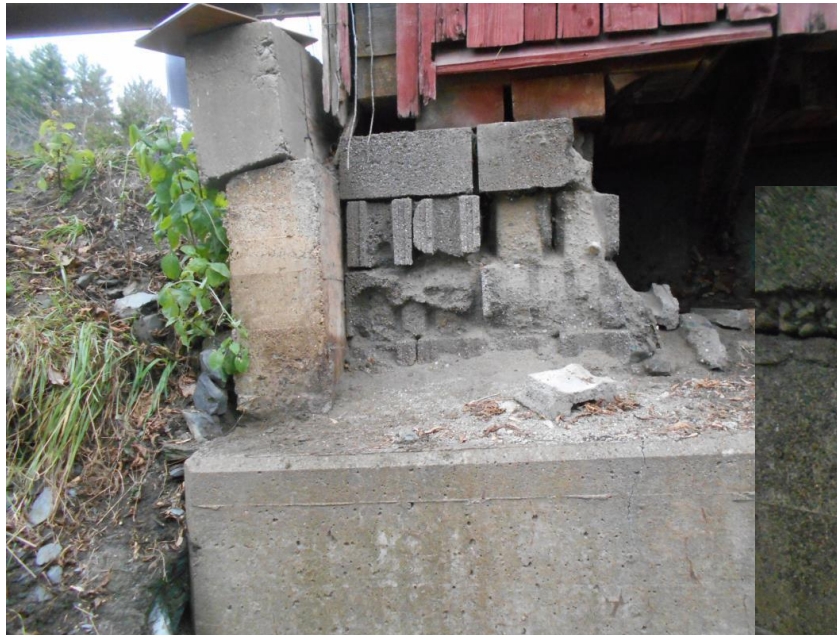
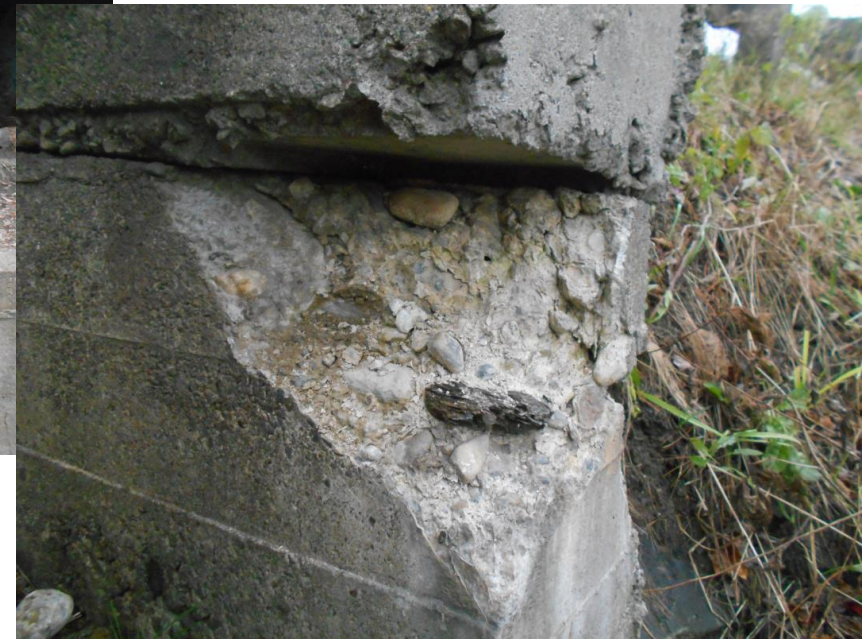
Abutments

- Voids
- Spalling
- Exposed Rebar
- CMU Truss Bearings

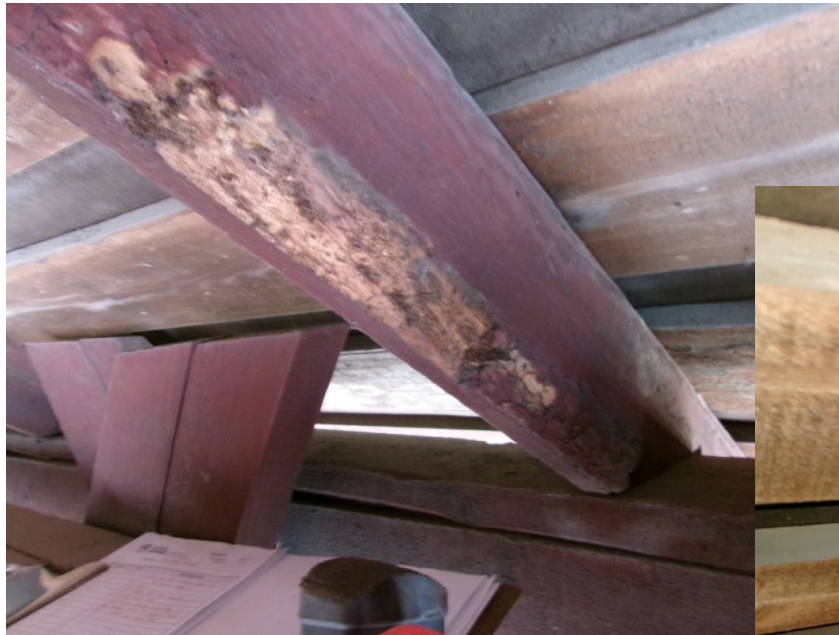
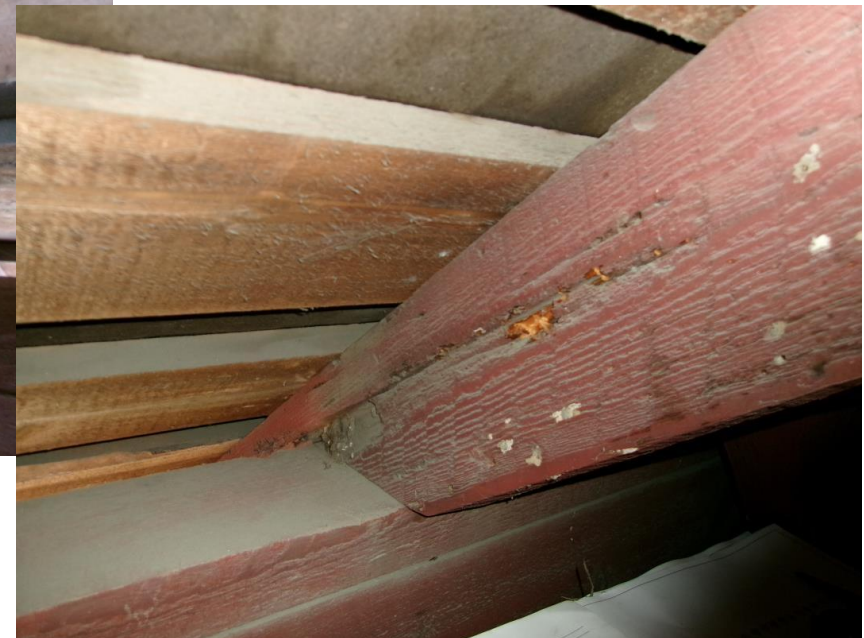
Roofboards and Rafters

- Splits,
- Breaks
- Rot
- Insect Damage

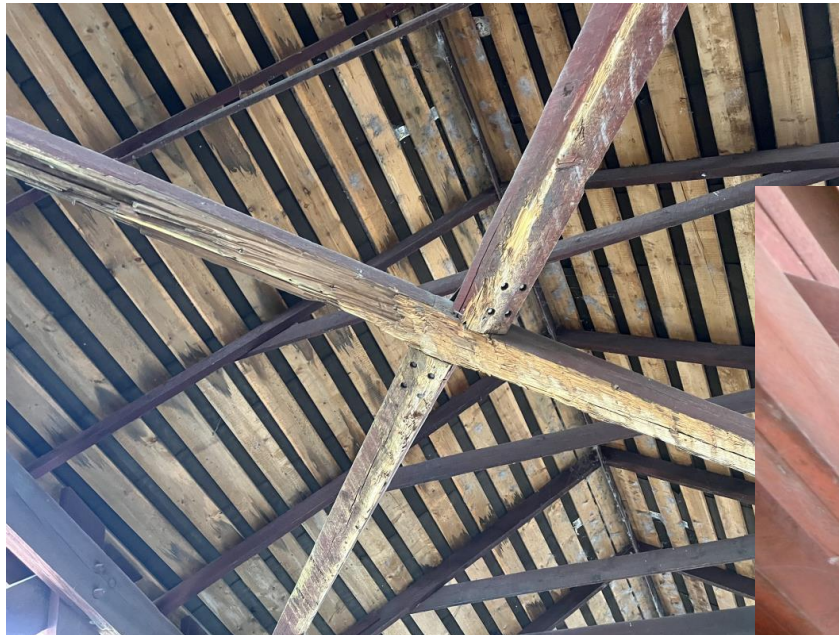
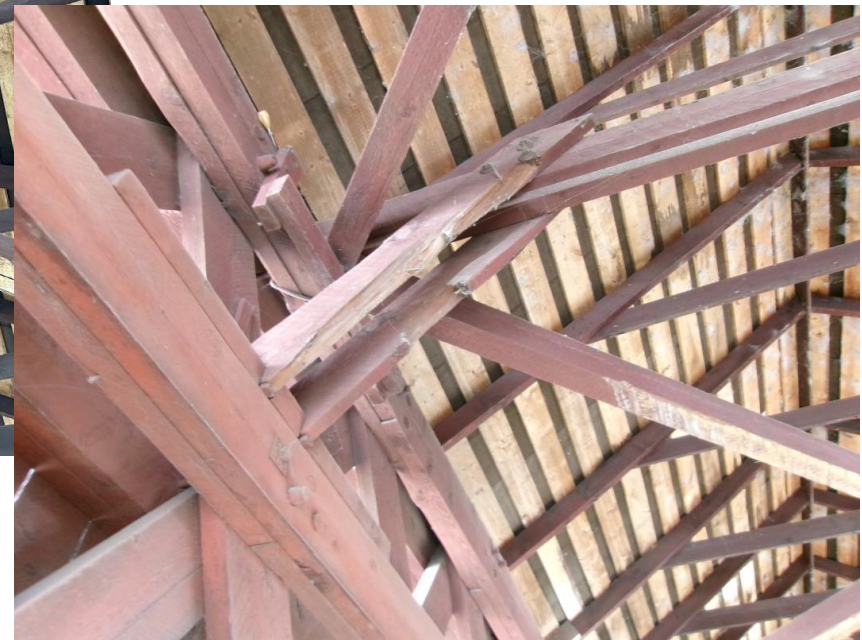
Upper Bracing Members

- Splits,
- Breaks
- Rot
- Impact Damage

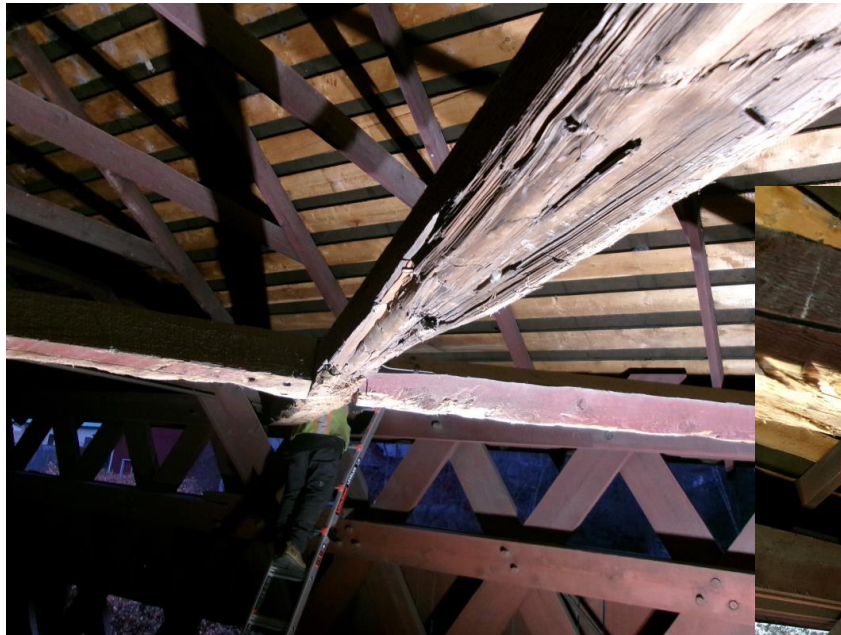
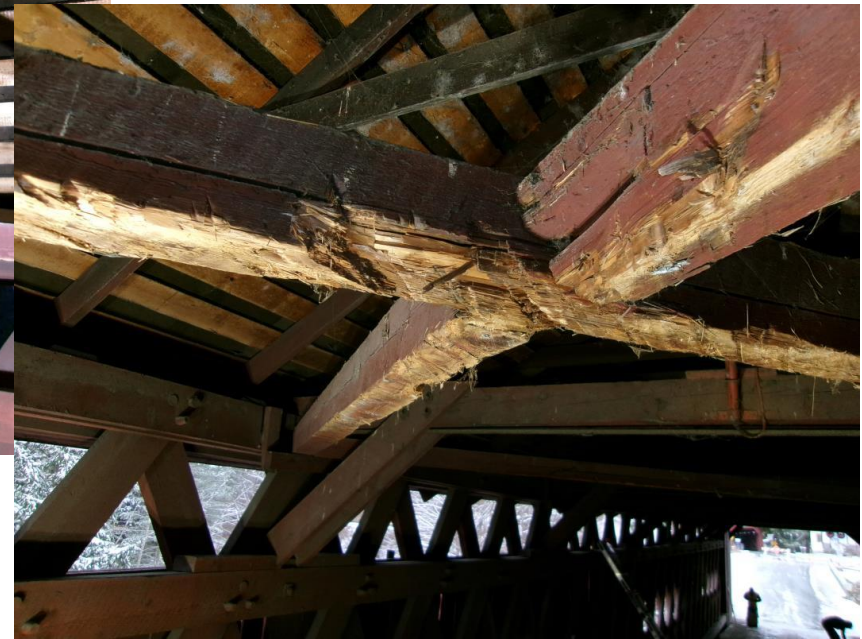
Upper Bracing Members (Continued)

- Splits,
- Breaks
- Rot
- Impact Damage

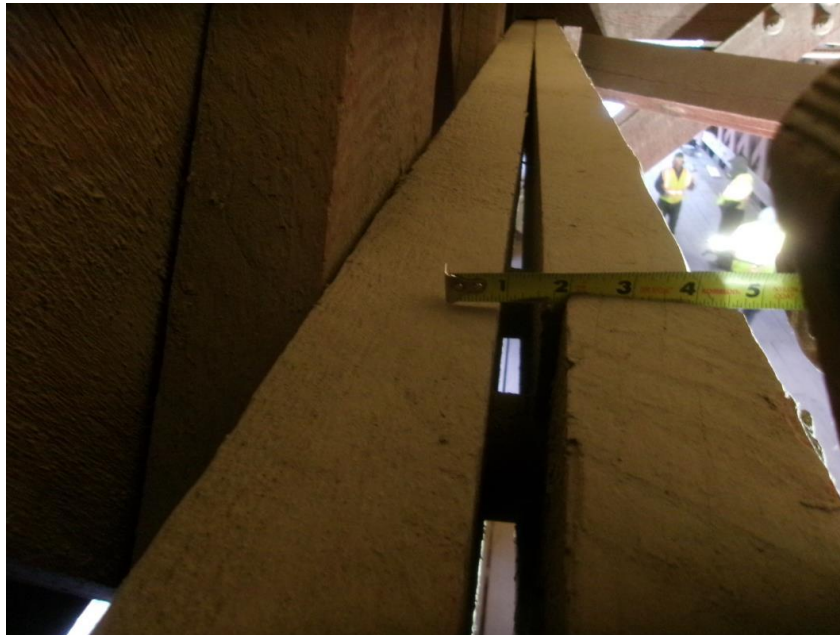
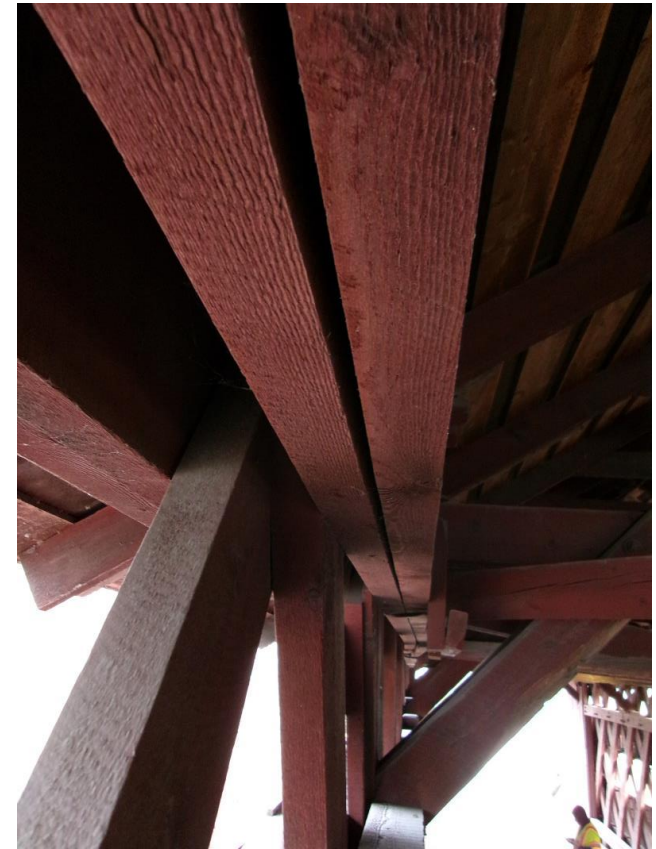
Truss Members

- Splits,
- Breaks
- Rot
- Misalignment
- High Moisture Content

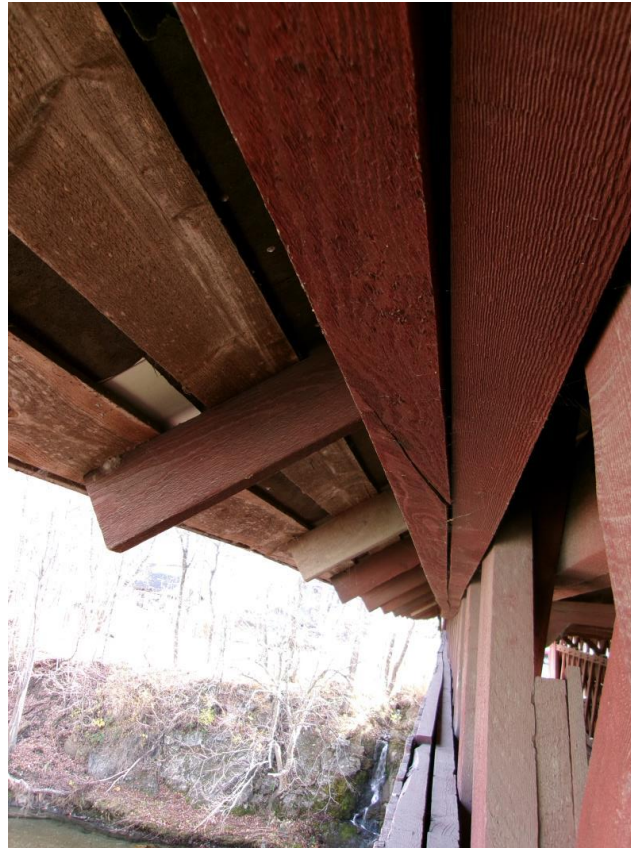
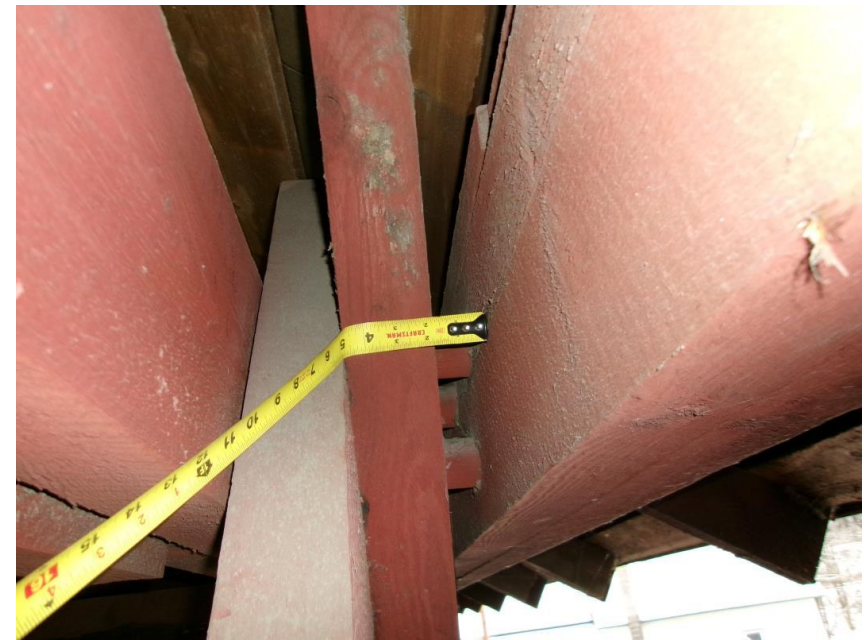
Truss Members (Continued)

- Splits,
- Breaks
- Rot
- Misalignment
- High Moisture Content

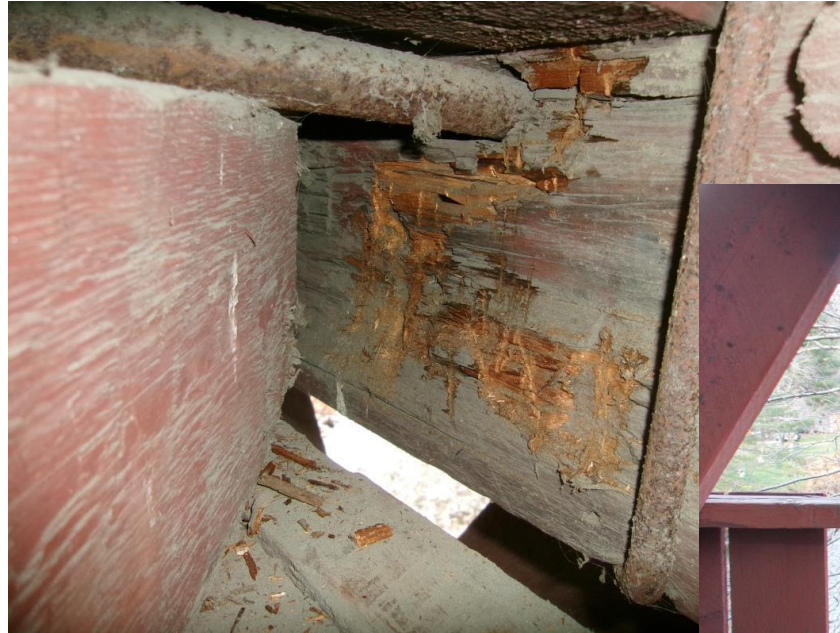
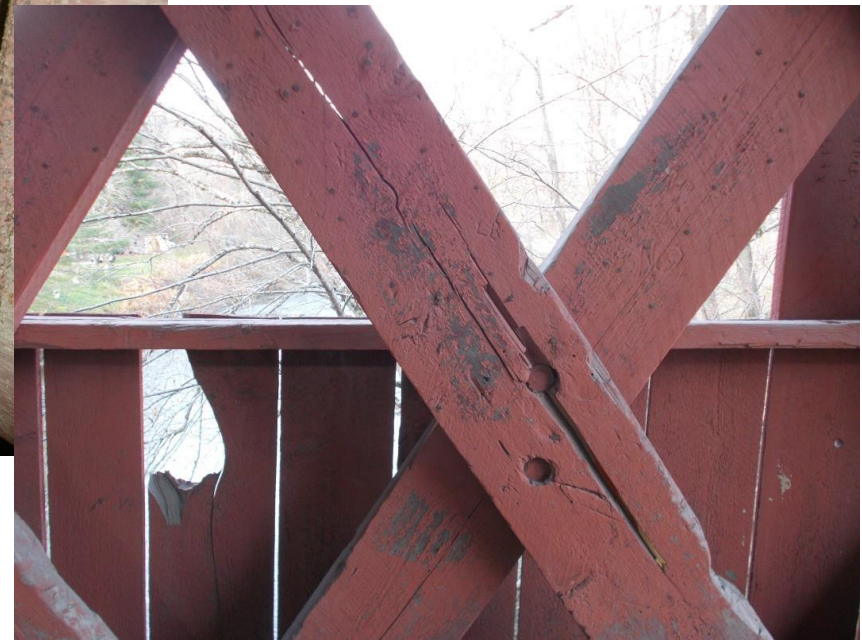
Truss Members (Continued)

- Splits,
- Breaks
- Rot
- Misalignment
- High Moisture Content

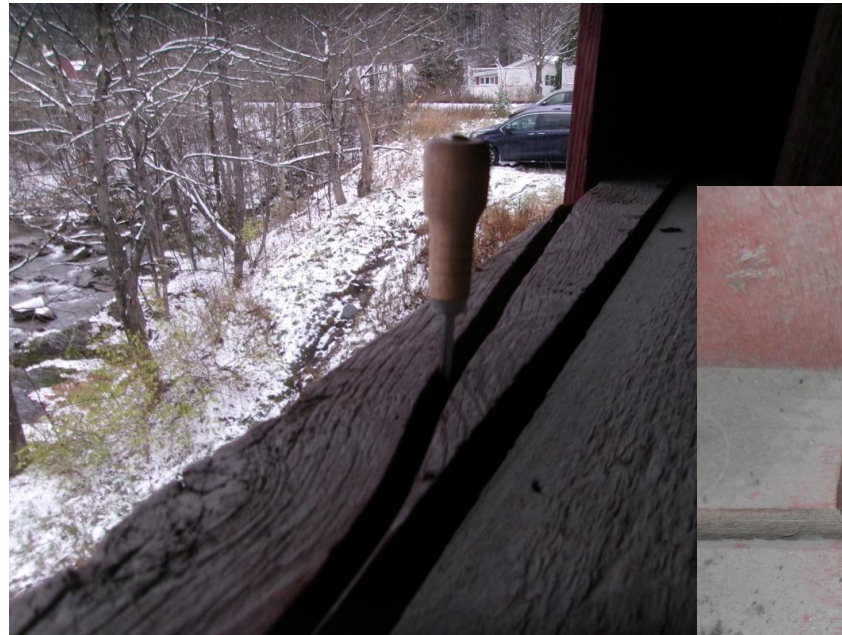
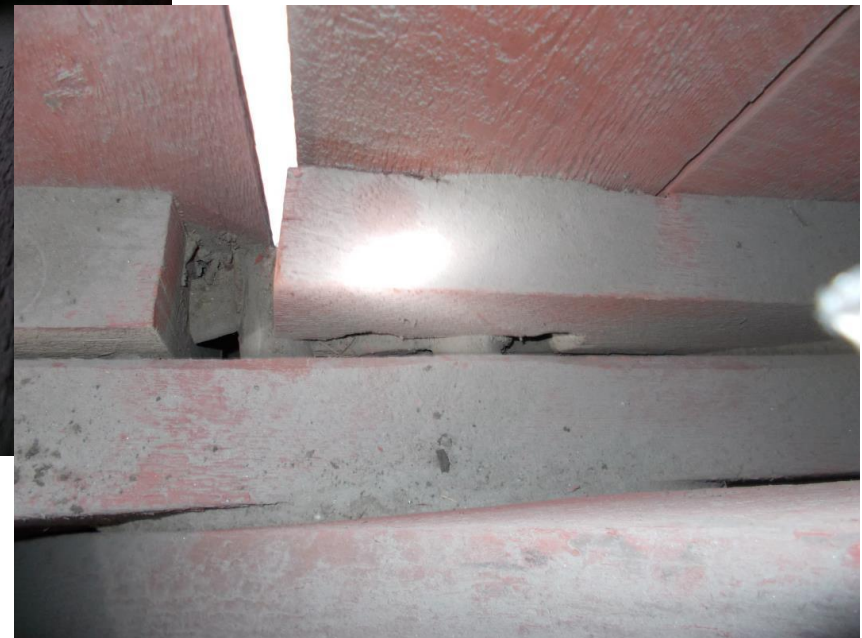
Truss Members (Continued)

- Splits,
- Breaks
- Rot
- Misalignment
- High Moisture Content

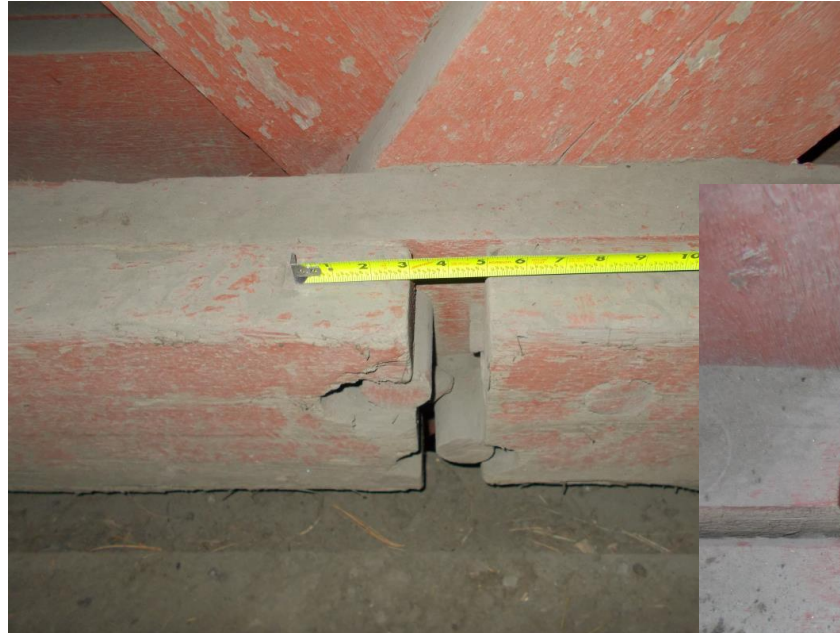
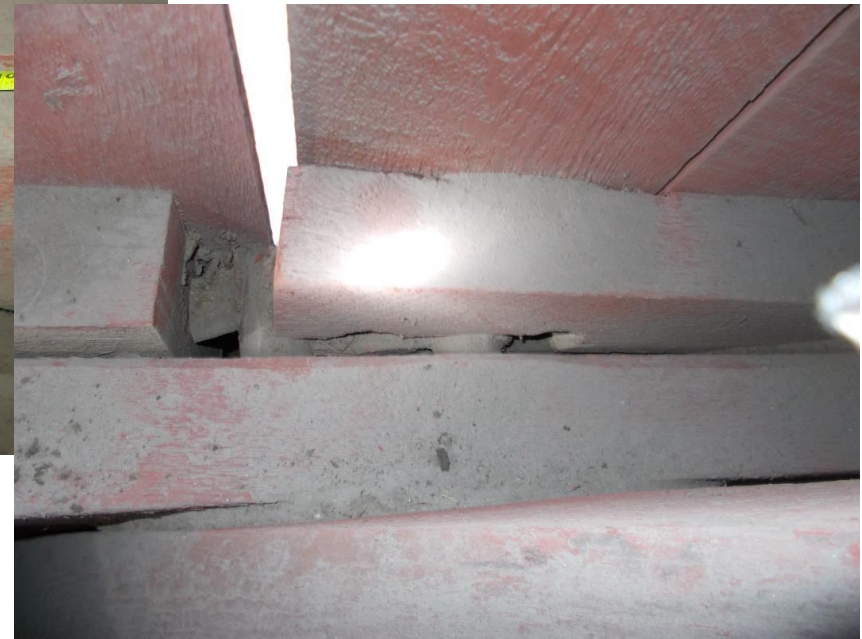
Truss Members (Continued)

- Splits,
- Breaks
- Rot
- Misalignment
- High Moisture Content

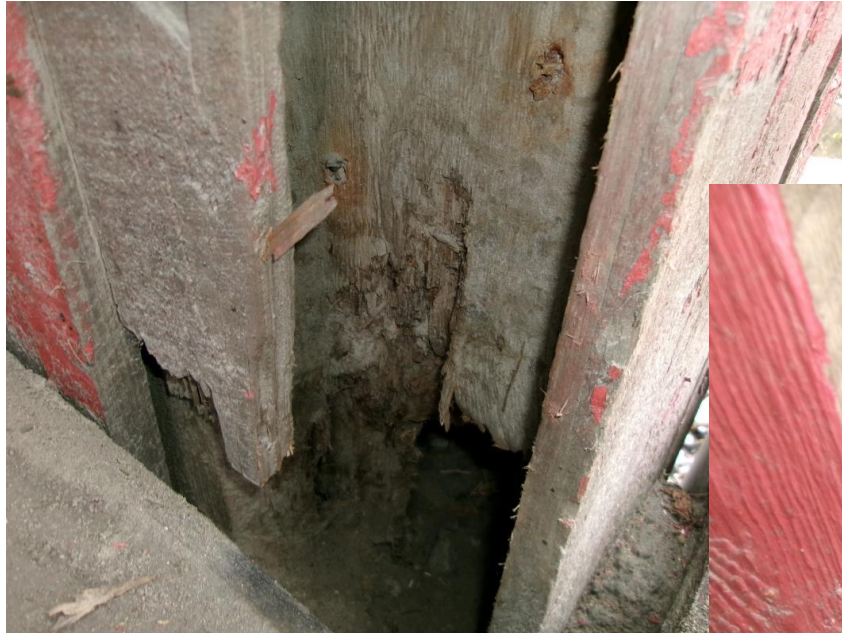
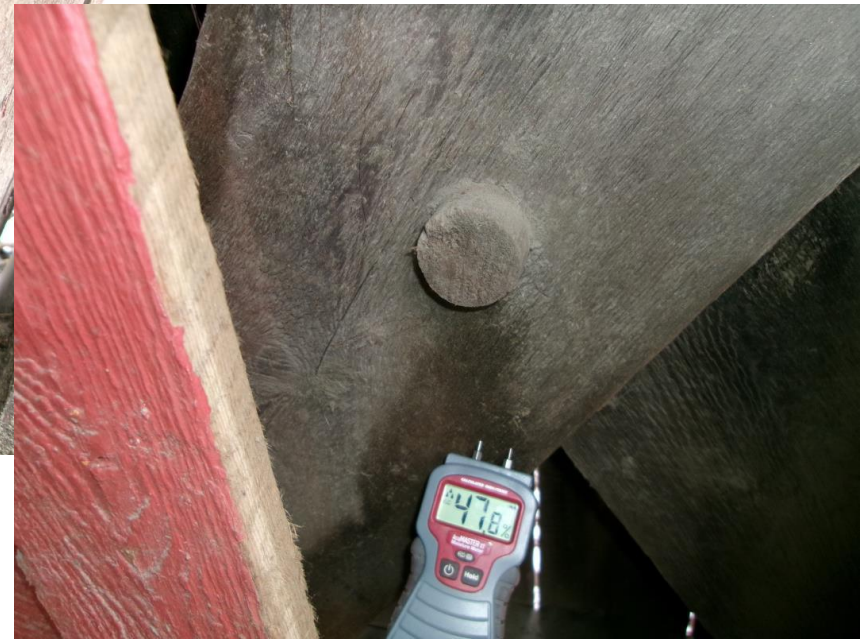
Truss Members (Continued)

- Splits,
- Breaks
- Rot
- Misalignment
- High Moisture Content

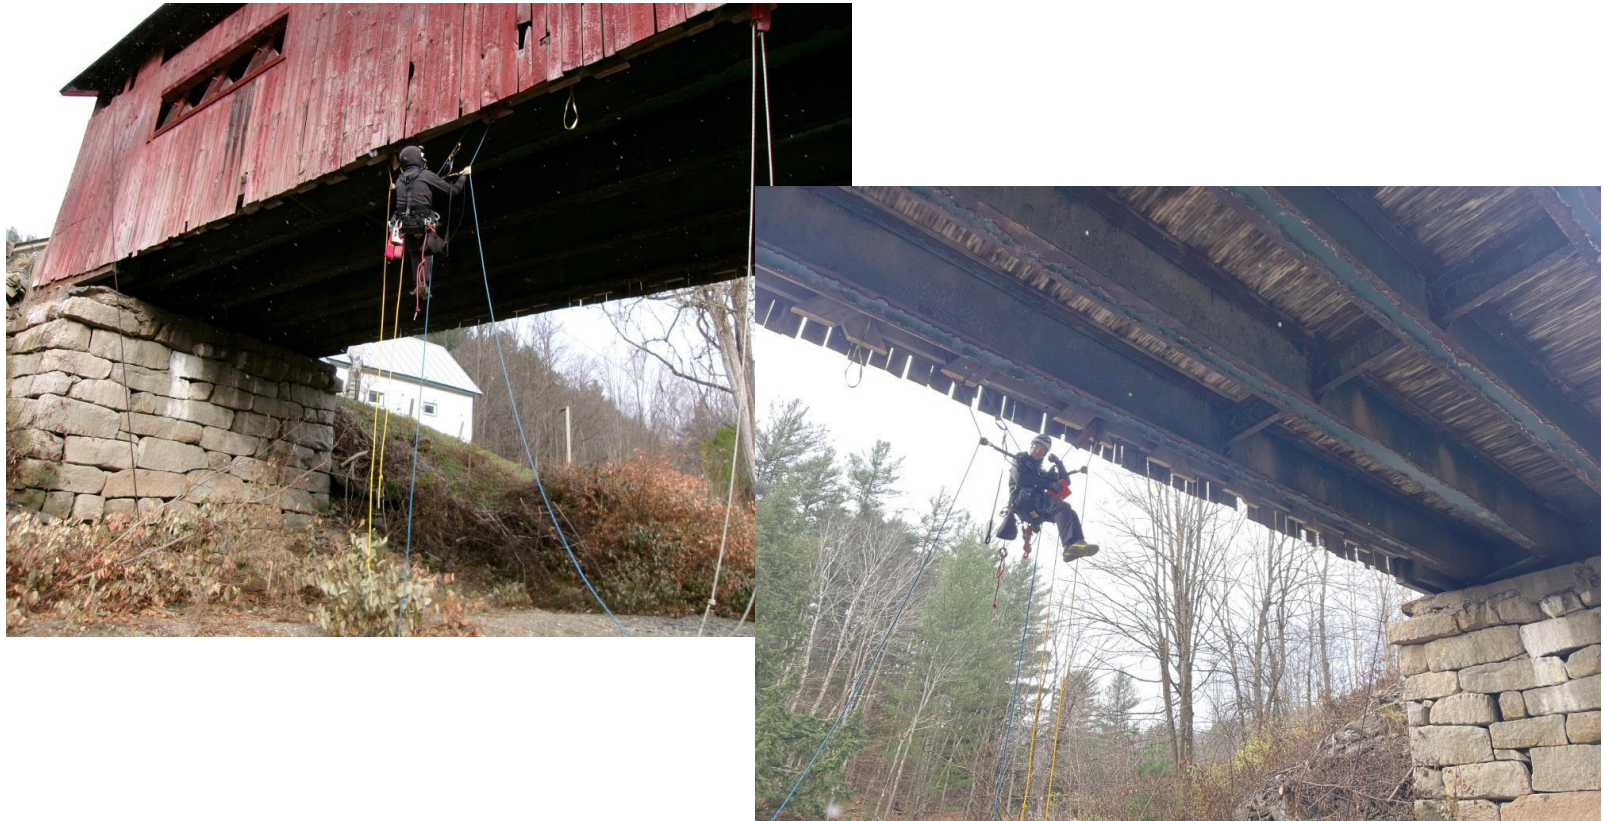
Steel Beams

- Rusting
- Advanced Corrosion

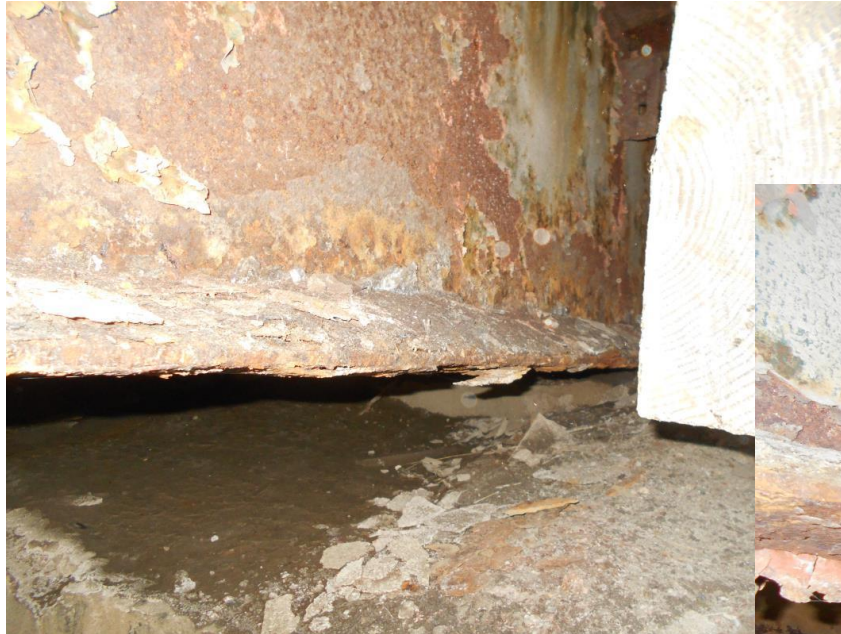
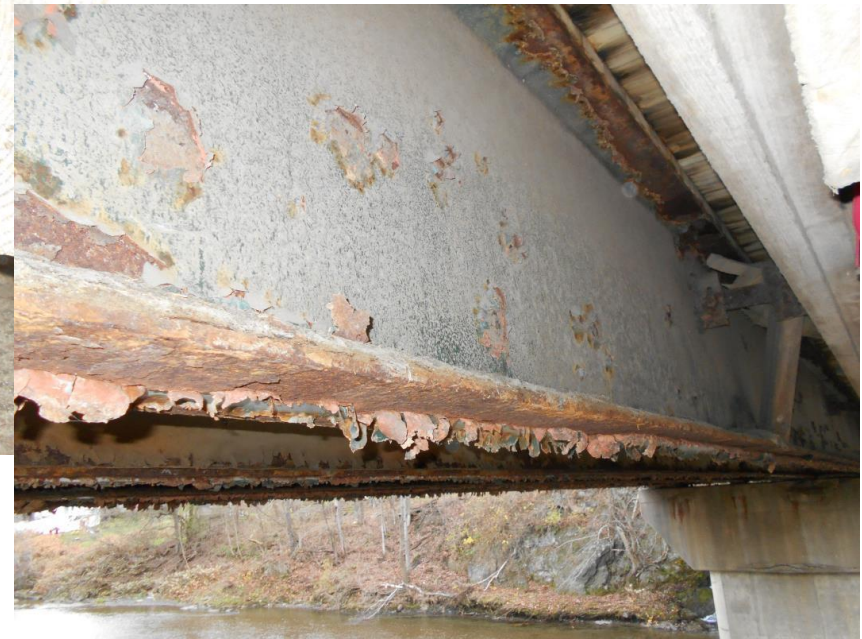
Steel Beams (Continued)

- Rusting
- Advanced Corrosion

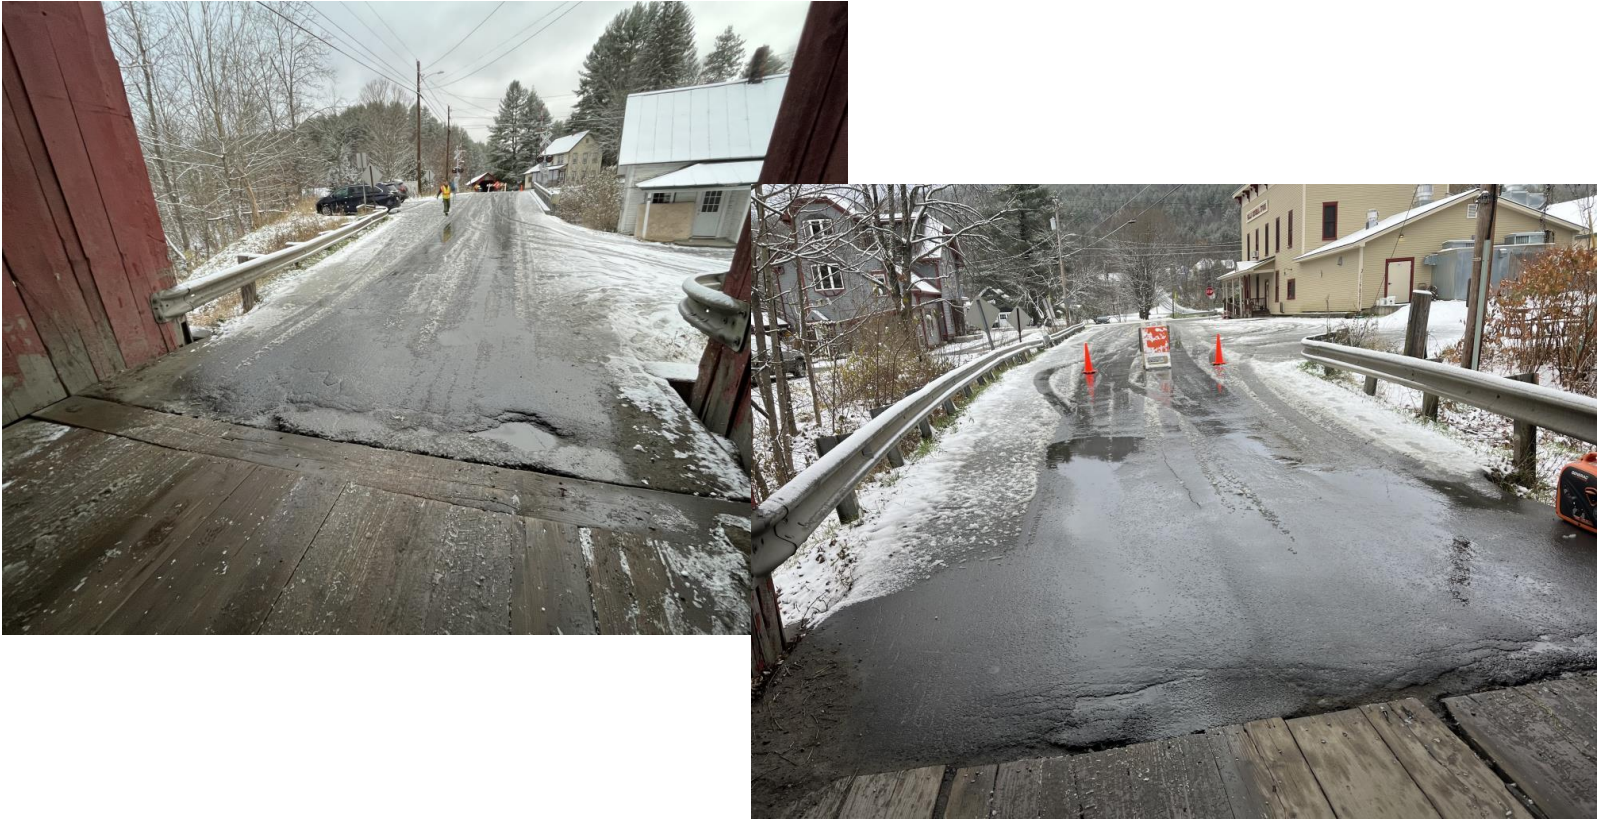
Approaches

- Drainage Issues
- Ponding

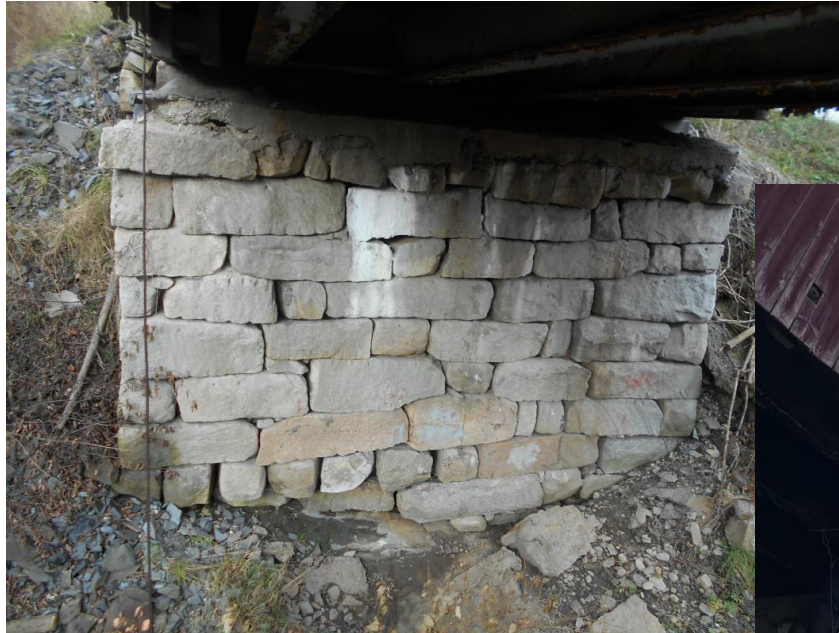
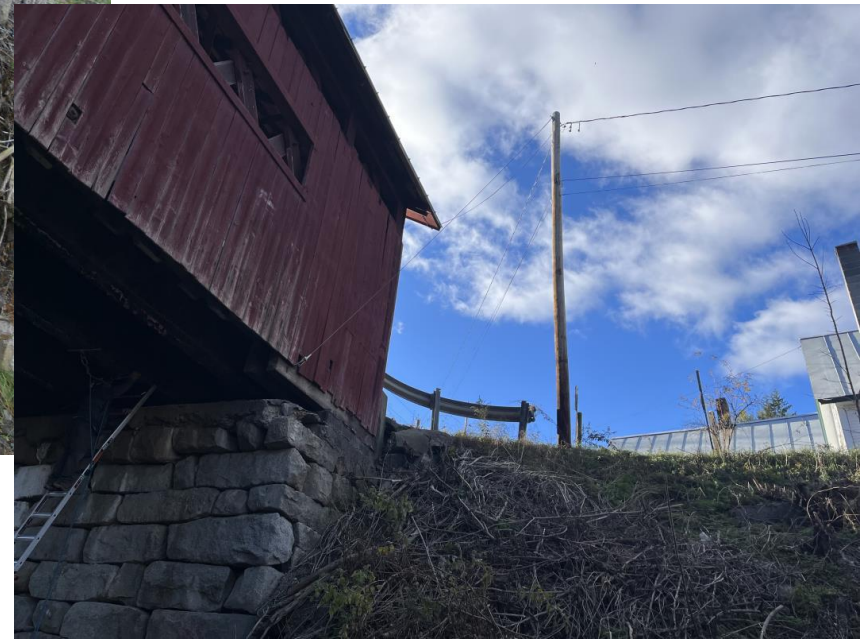
Abutments

- Voids
- Spalling
- Exposed Rebar

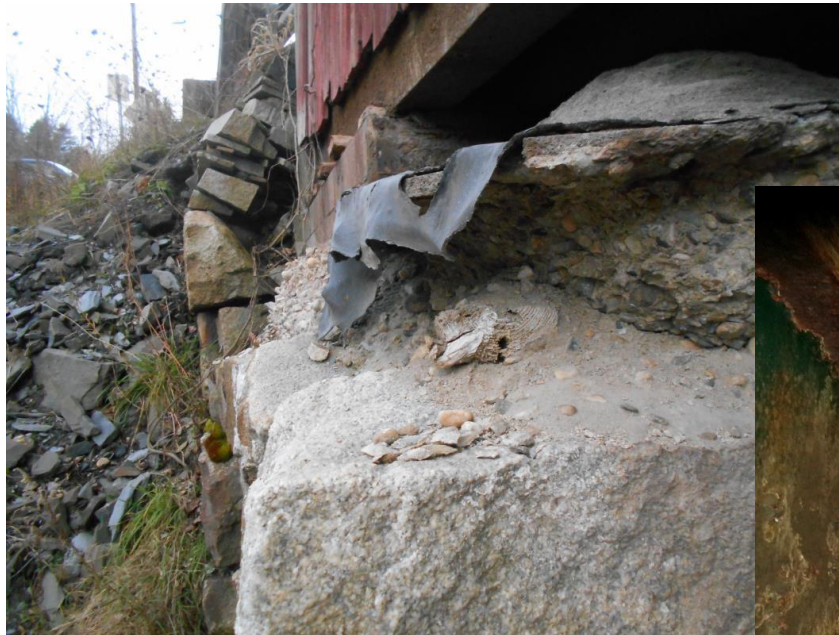
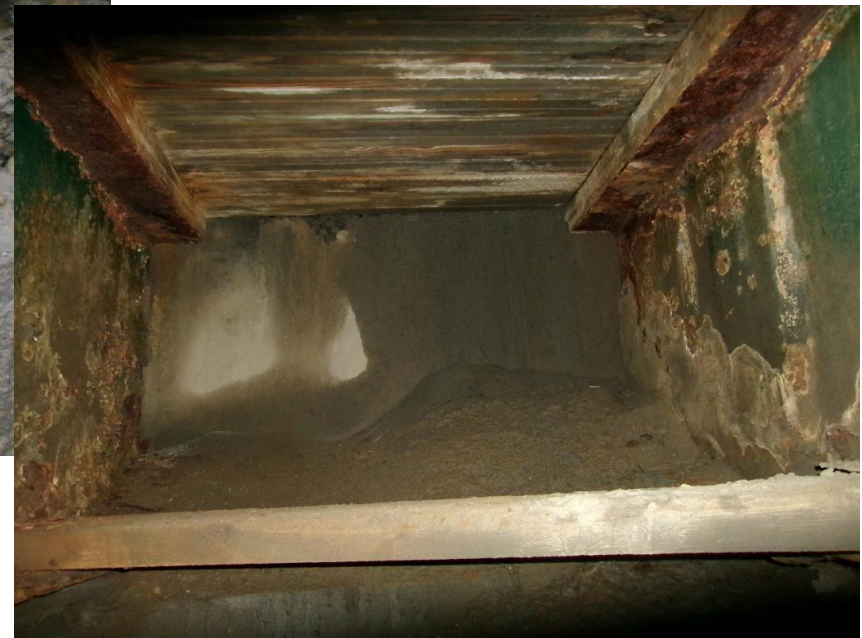
Abutments

- Voids
- Spalling
- Exposed Rebar

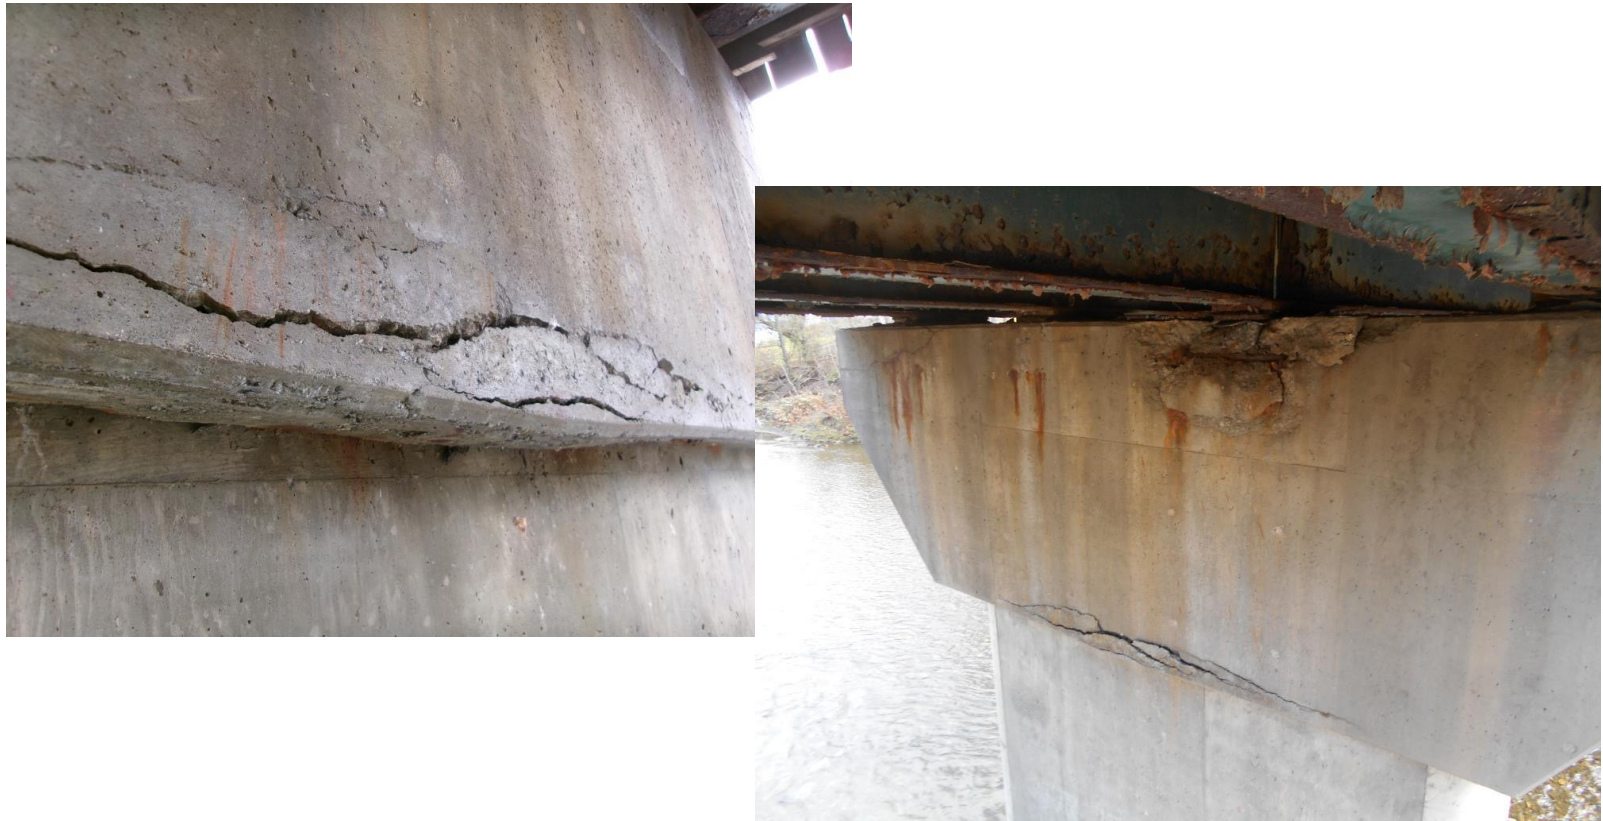
Abutments

- Voids
- Spalling
- Exposed Rebar

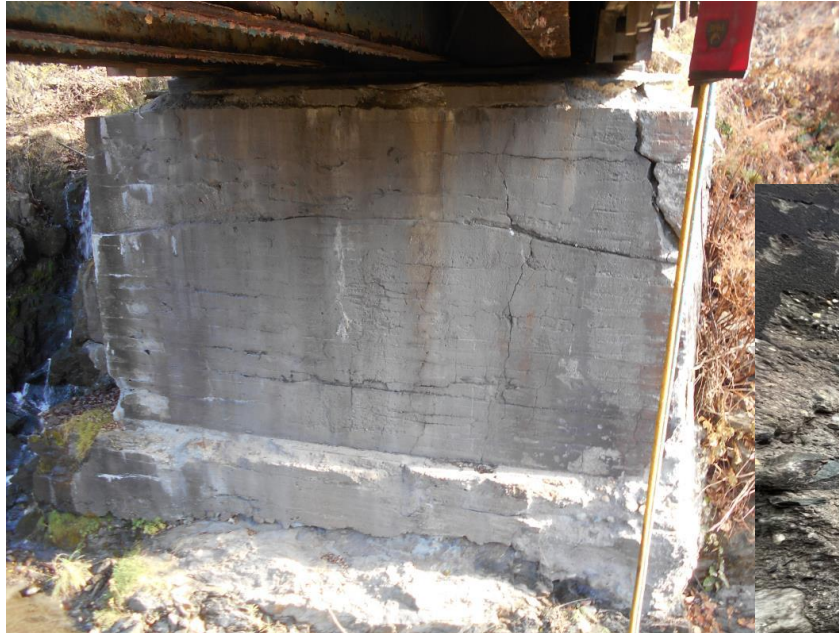
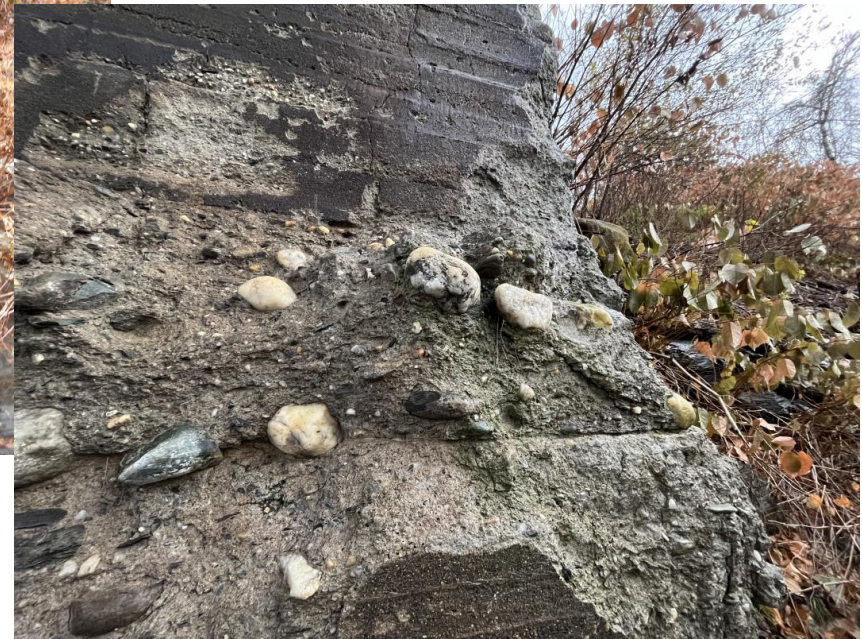
Abutments

- Voids
- Spalling
- Exposed Rebar
- CMU Truss Bearings
