Draft Scoping Report Upper Cox Brook Covered Bridge Town Highway 3 Bridge 10 over Cox Brook

Northfield BO CVBR(7)

January 24, 2026

Prepared for:
Vermont Agency of Transportation

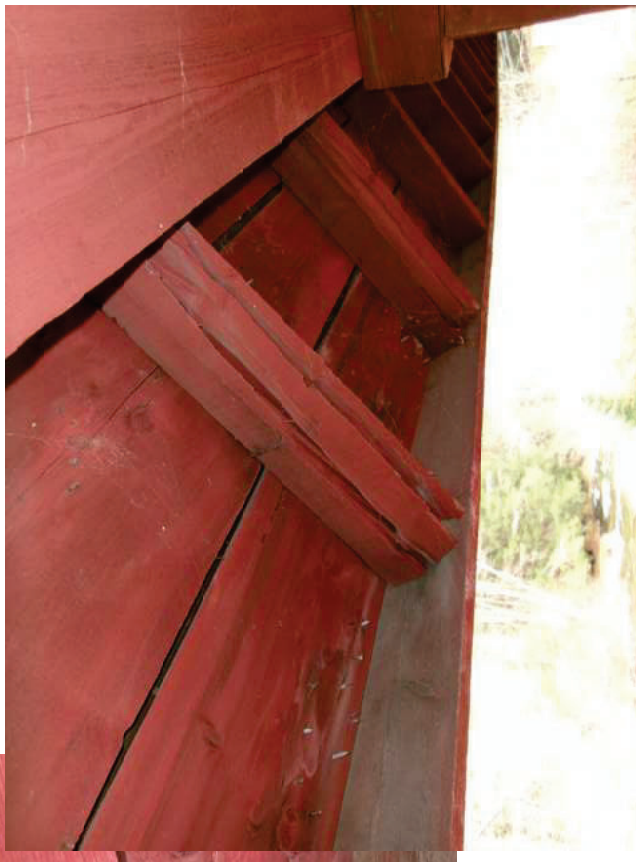
- Splits
- Breaks
- Rot

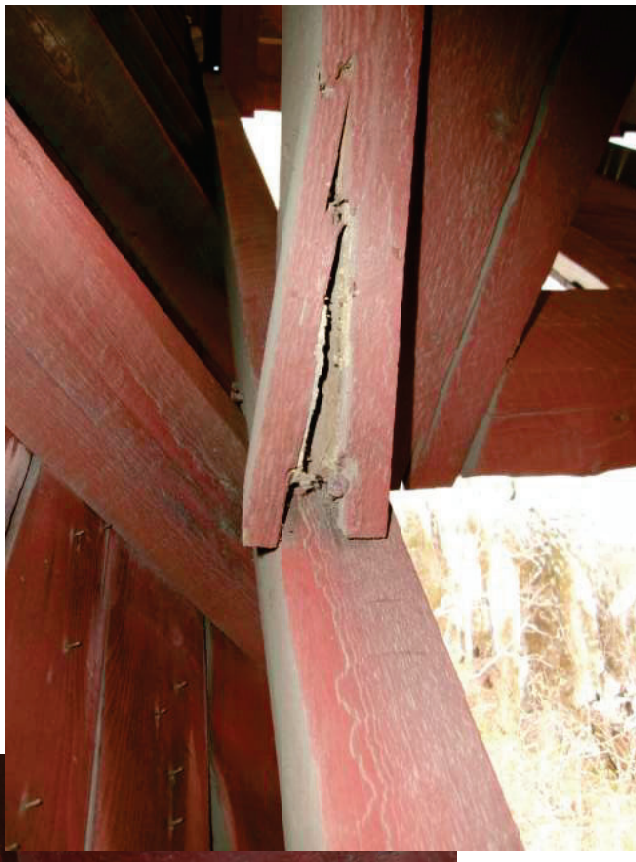
Upper Bracing Members

- Splits
- Breaks
- Rot
- Impact Damage

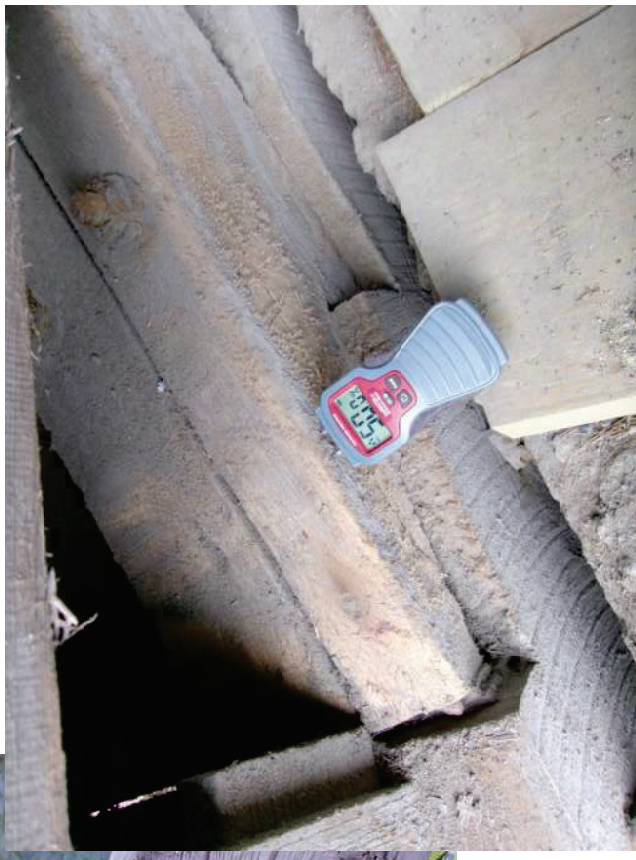
Truss Members

- Splits
- Breaks
- Rot
- Weathering
- High Moisture Content

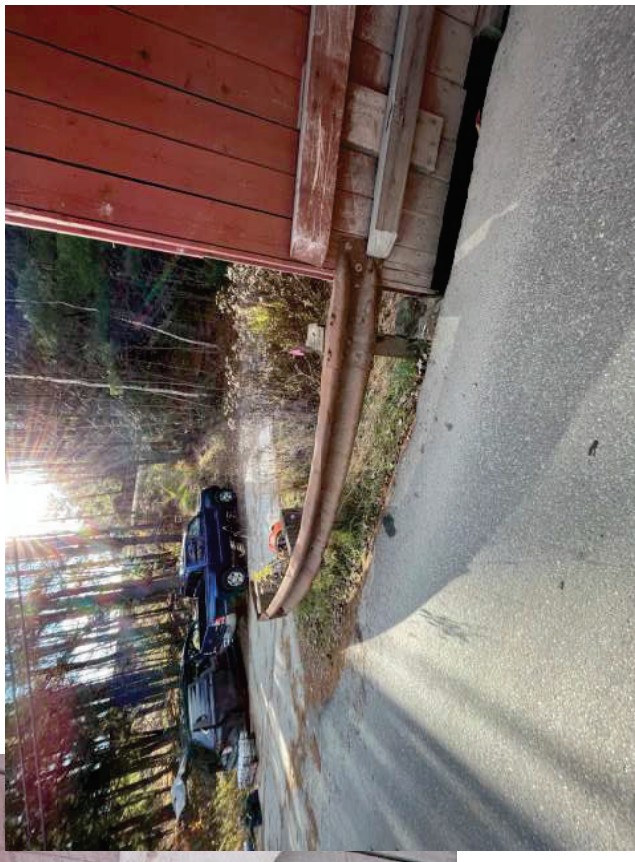
Approach Railing

- Extensive Corrosion
- Rust Holes
- Rotted Wood Posts
- Impact Damage

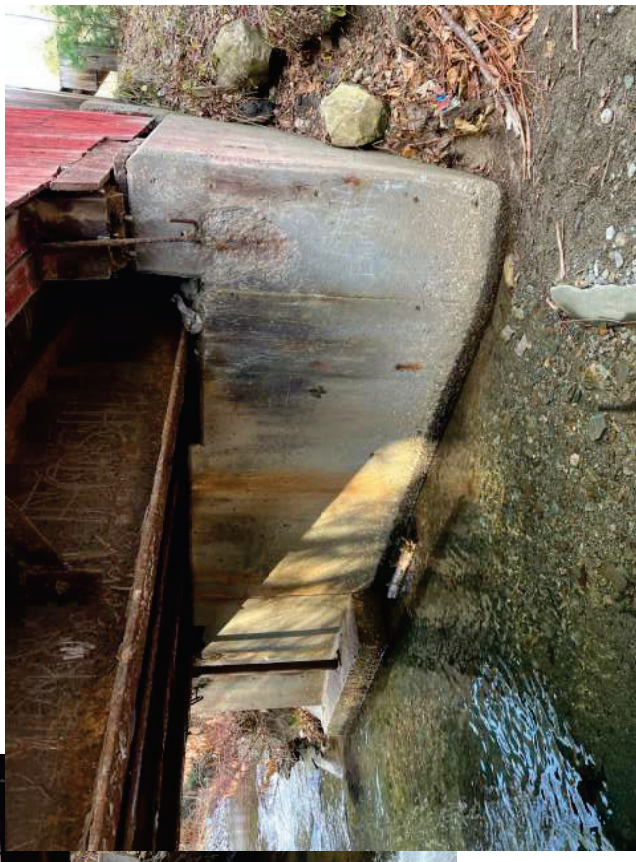
Abutments

- Voids
- Spalling
- Exposed Rebar

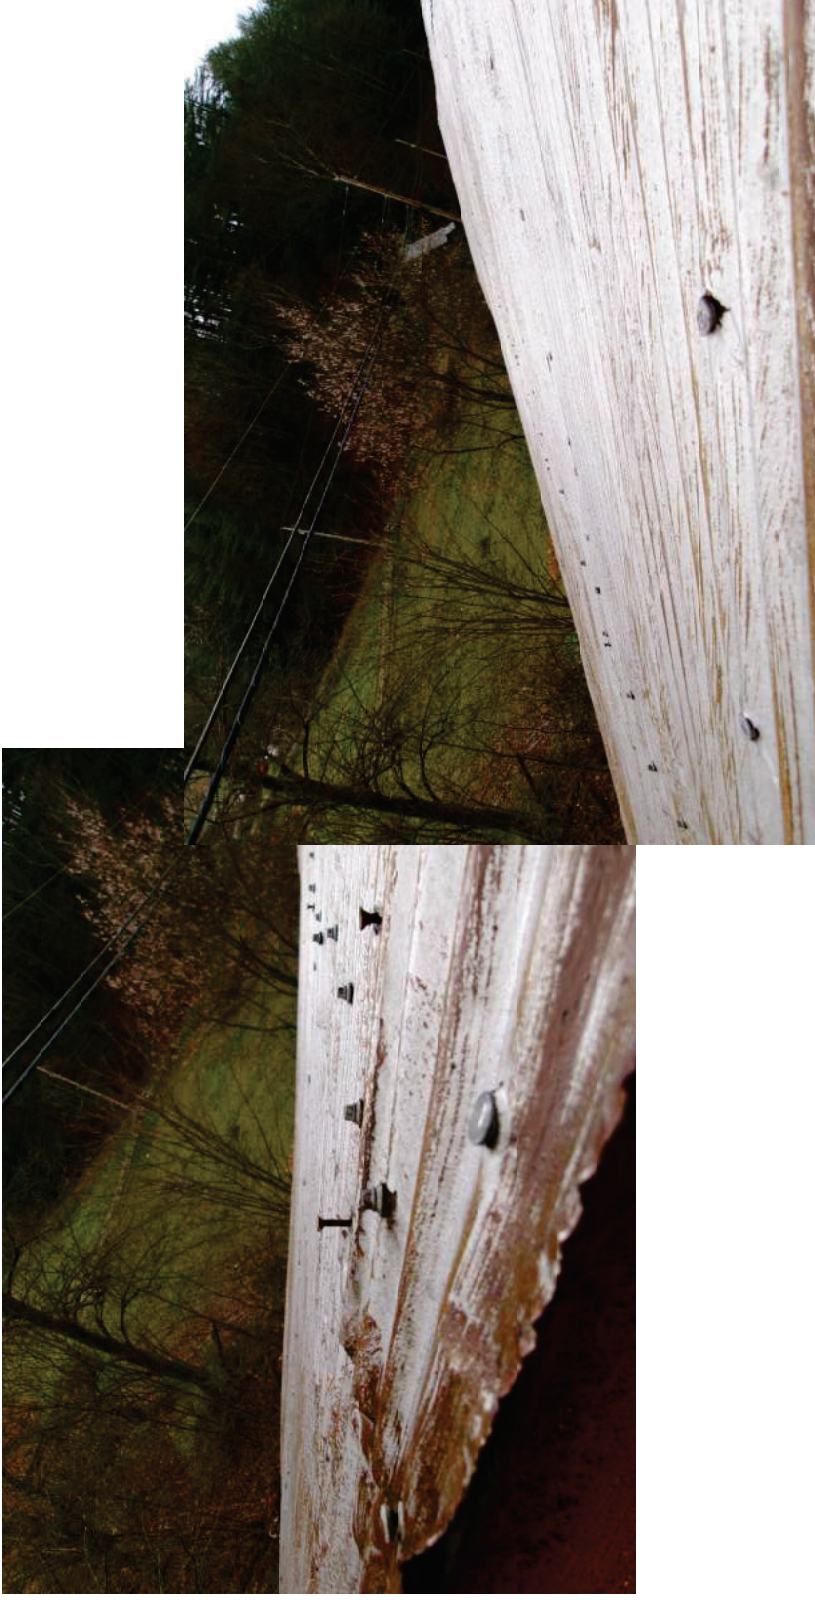
- Rusting
- Leaks
- Nail Attachment
