# Draft Scoping Report Lower Cox Brook Covered Bridge Town Highway 3 Bridge 11 over Cox Brook

Northfield BO CVBR(8)

**January 24, 2026**

Prepared for:  
Vermont Agency of Transportation

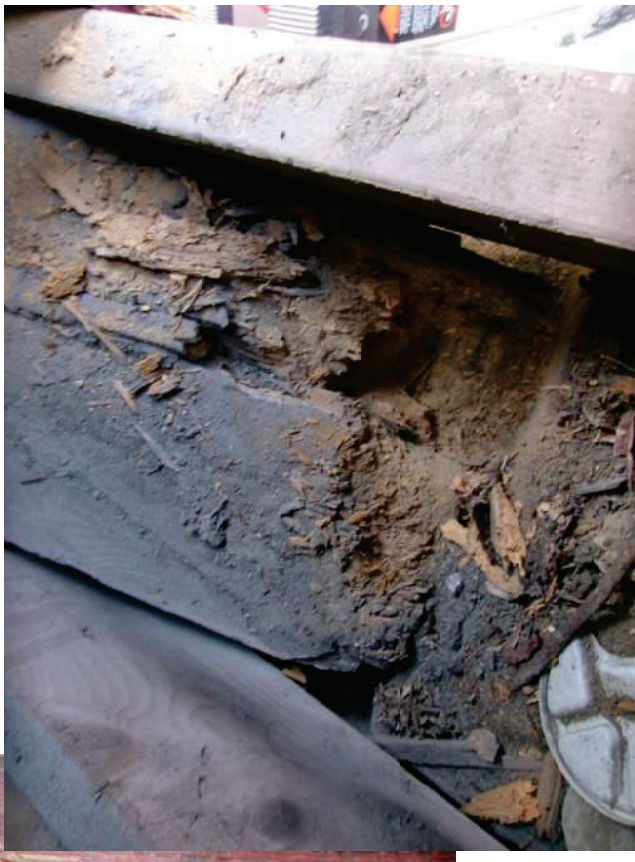
# Truss Members (Continued)

- Splits
- Breaks
- Rot
- Weathering
- High Moisture Content

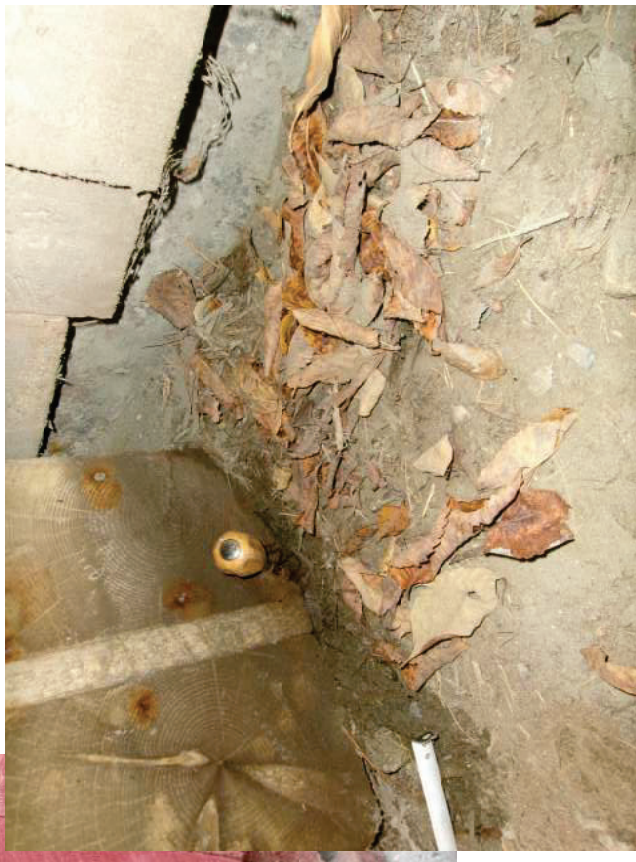
# Truss Members (Continued)

- Splits
- Breaks
- Rot
- Weathering
- High Moisture Content

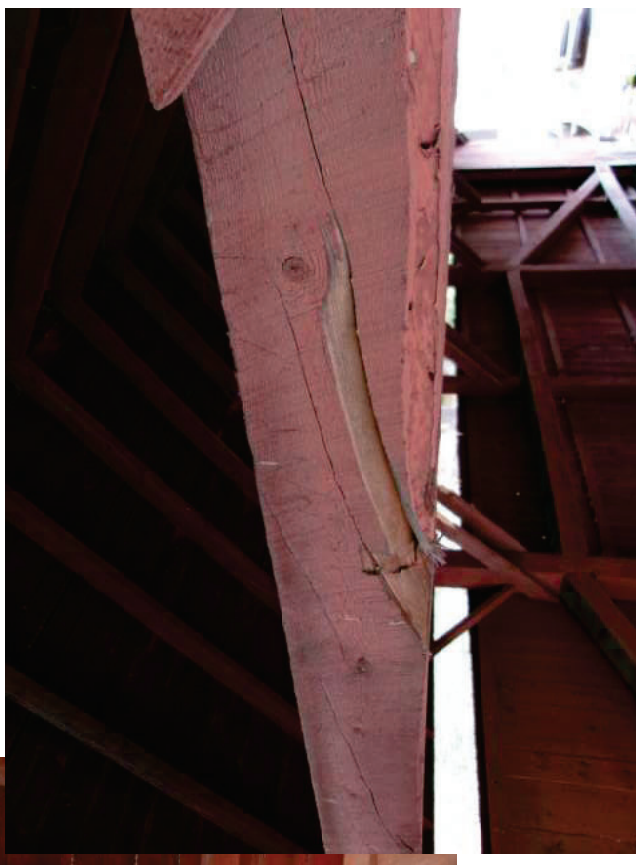
# Upper Bracing Members

- Splits
- Breaks
- Rot
- Impact Damage

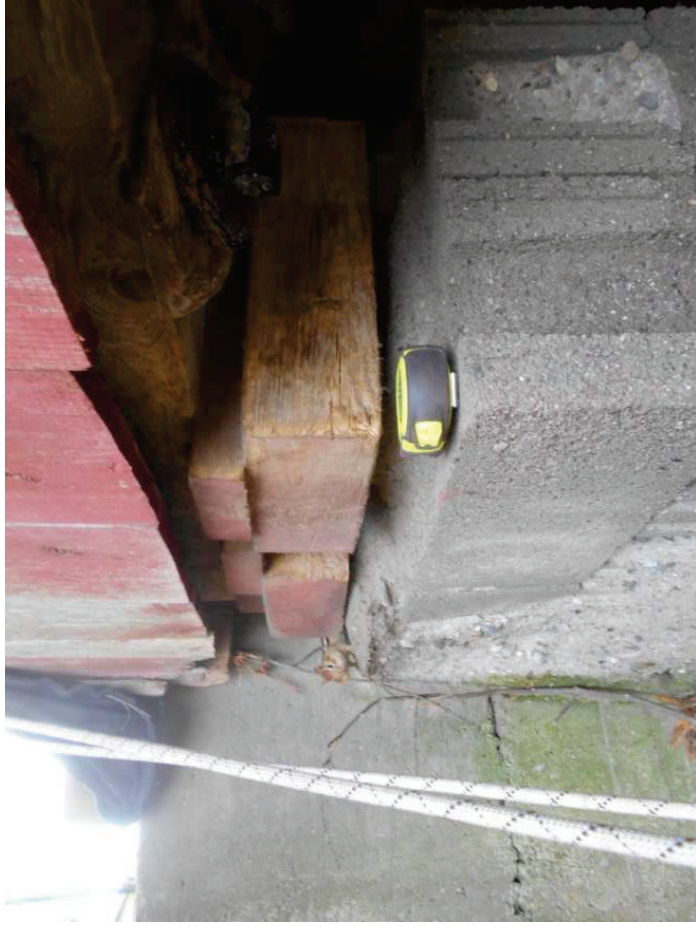
# Recommended Work : Truss Bearings

- The wooden bearing blocks exhibit extensive rot and need to be replaced.
- The CMU blocks are in poor condition and need to be replaced.

- Replace Bearing Blocks at all 4 Truss Bearing Locations (PTN 2)

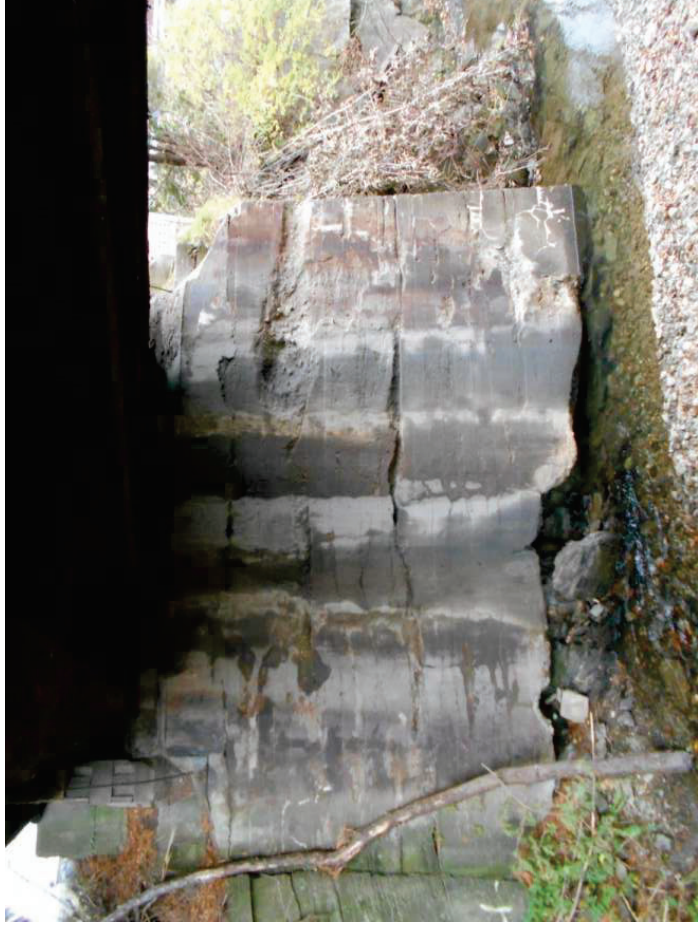
# Recommended Work: Substructure

- Both abutments exhibit some areas of concrete spalling, delamination, efflorescence staining, and vertical, horizontal, and map cracking.
- At the spalled areas the concrete was not observed to contain rebar.
- The east abutment is in poor condition and needs to be replaced.

- Replace East Abutment (PTN 2)
  - Alternative 1 – Stone Masonry
  - Alternative 2 – Reinforced Concrete
