# Draft Scoping Report Northfield Falls Covered Bridge Town Highway 3 Bridge 15 over Dog River

Northfield BO CVBR(9)

**January 24, 2026**

Prepared for:  
Vermont Agency of Transportation

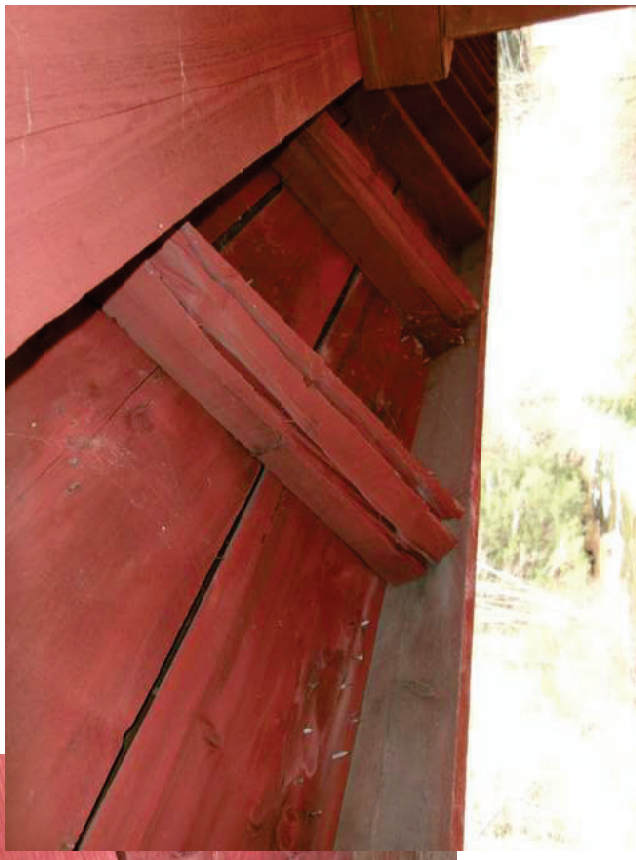
- Splits
- Breaks
- Rot

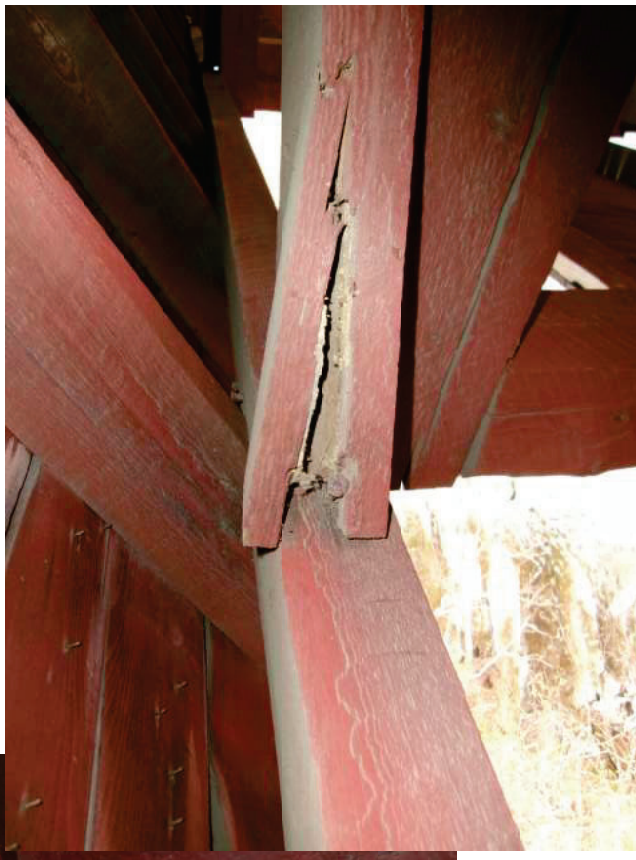
# Upper Bracing Members

- Splits
- Breaks
- Rot
- Impact Damage

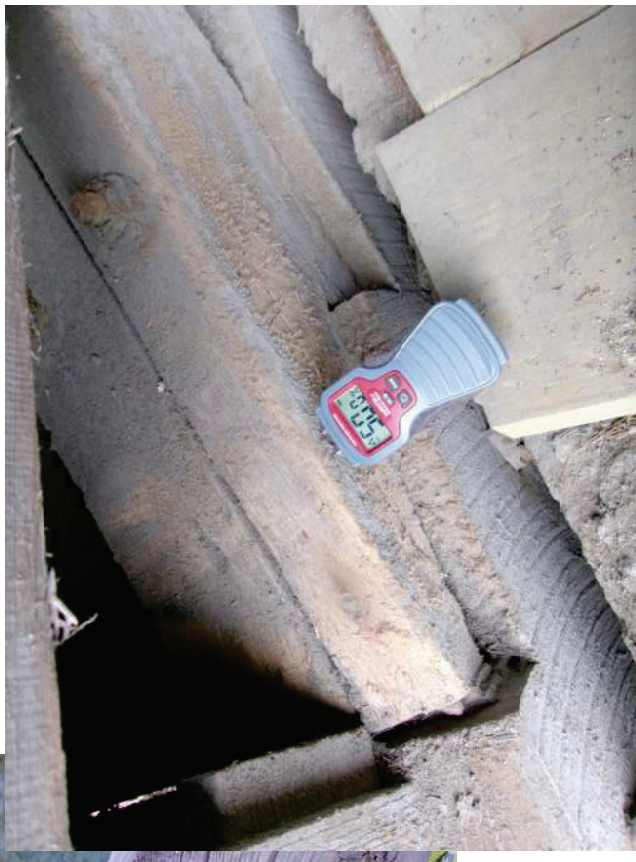
# Truss Members

- Splits
- Breaks
- Rot
- Weathering
- High Moisture Content

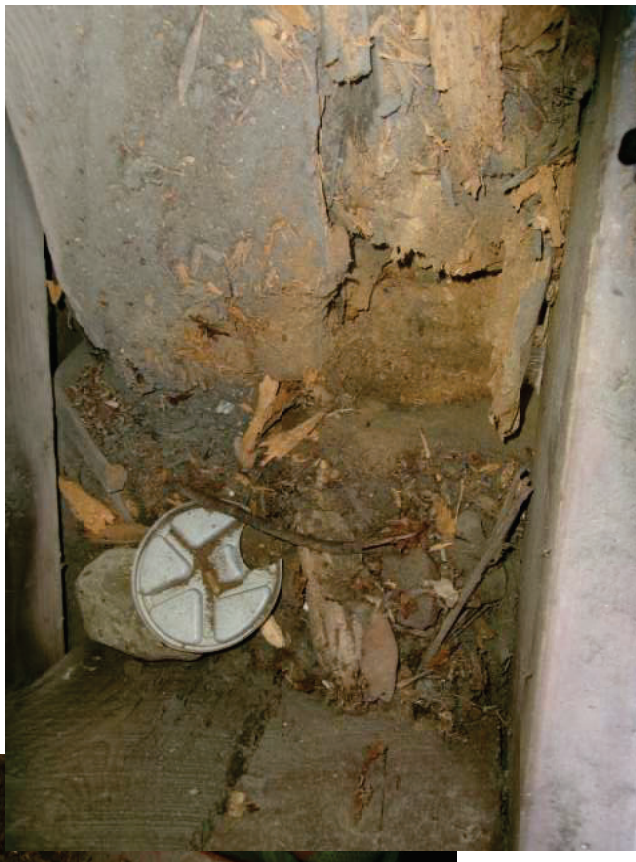
# Truss Members (Continued)

- Splits
- Breaks
- Rot
- Weathering
- High Moisture Content

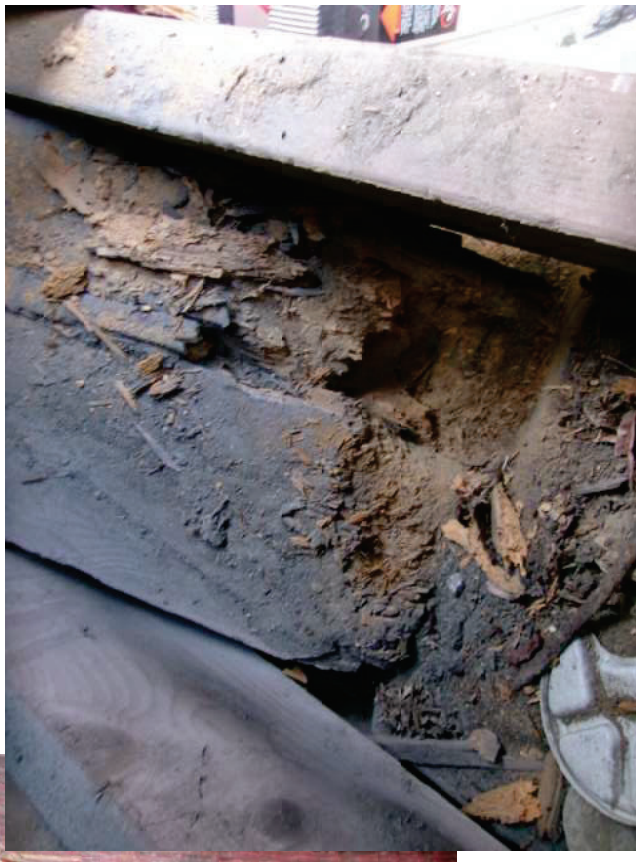
# Truss Members (Continued)

- Splits
- Breaks
- Rot
- Weathering
- High Moisture Content

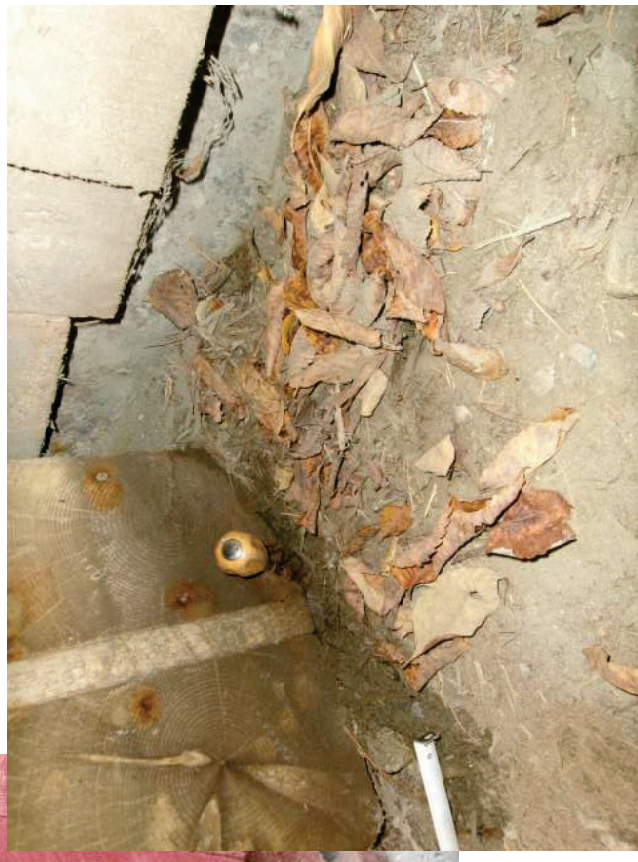
# Truss Members (Continued)

- Splits
- Breaks
- Rot
- Weathering
- High Moisture Content

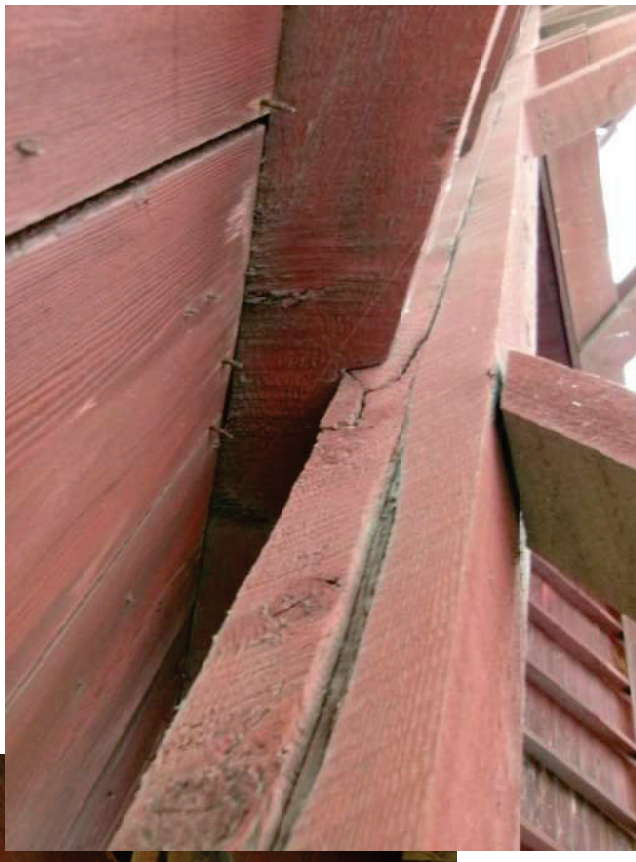
# Roofboards and Rafters

- Splits
- Breaks
- Rot
- Insect Damage

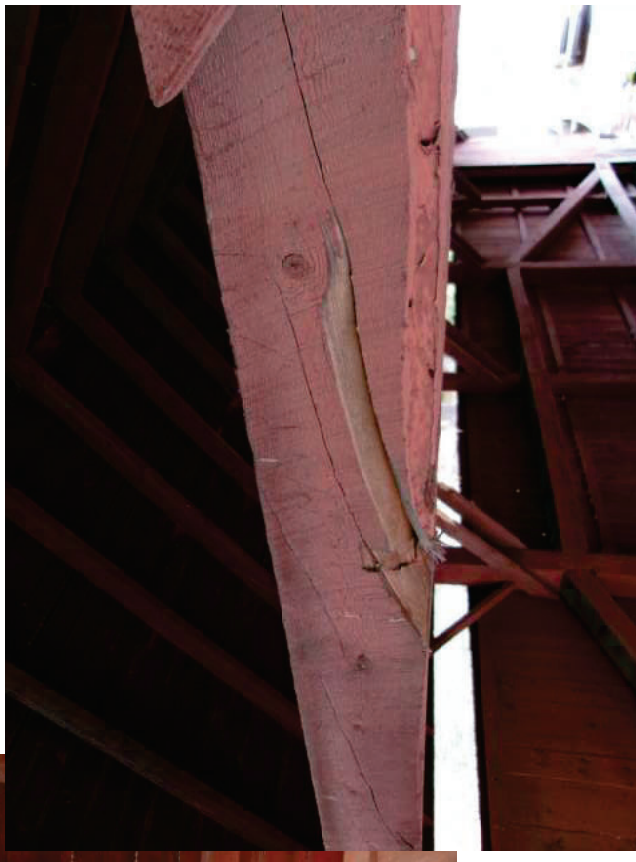
# Upper Bracing Members

- Splits
- Breaks
- Rot
- Impact Damage

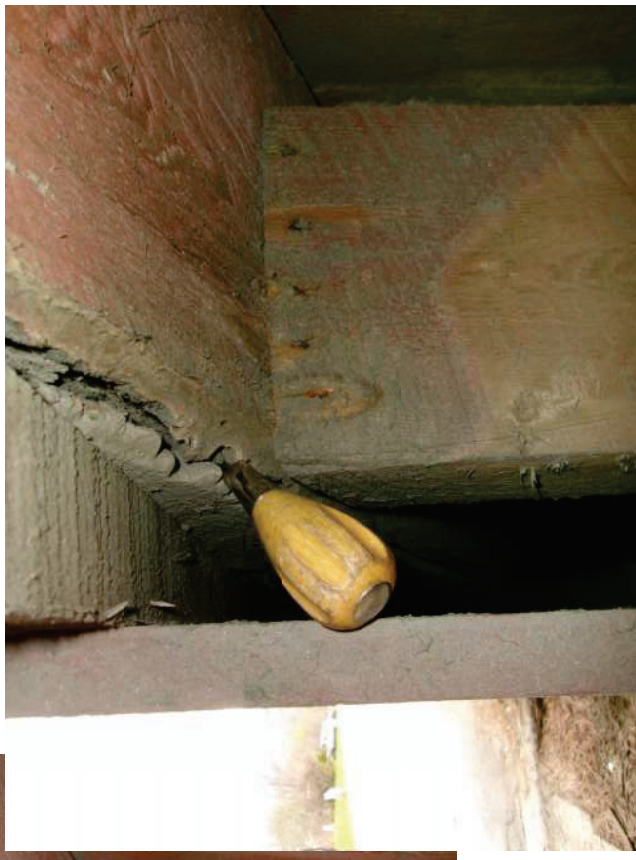
# Truss Members (Continued)

- Splits
- Breaks
- Rot
- High Moisture Content

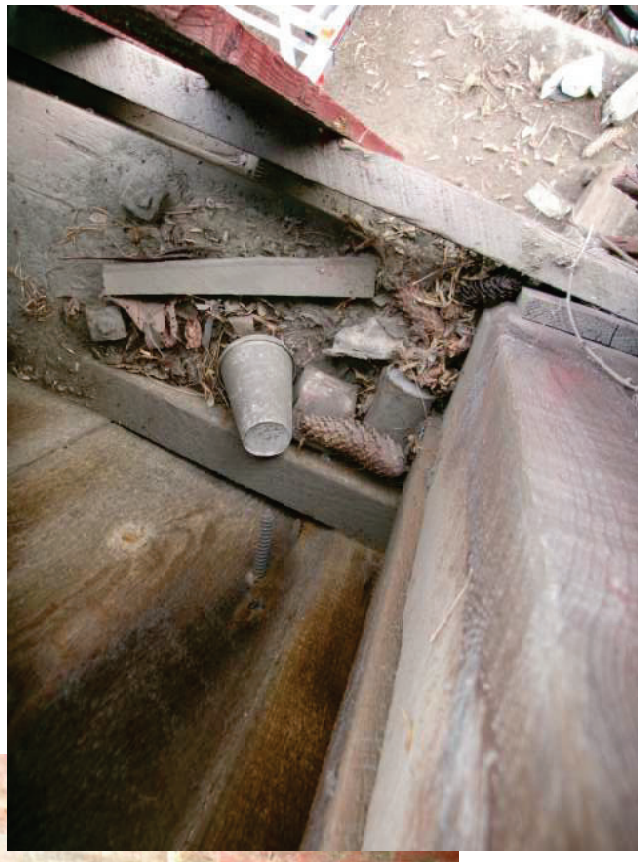
# Truss Members (Continued)

- Splits
- Breaks
- Rot
- High Moisture Content

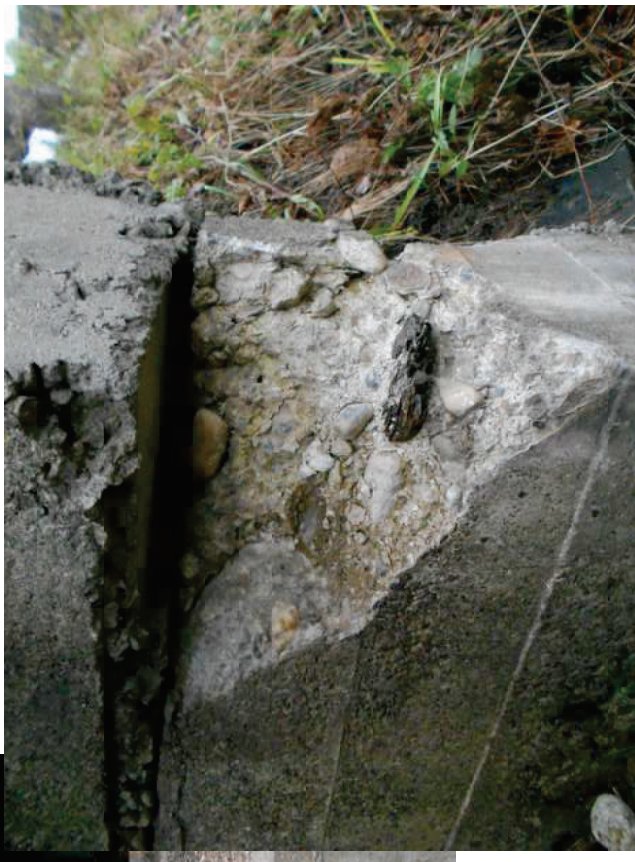
# Abutments

- Voids
- Spalling
- Exposed Rebar
- CMU Truss Bearings

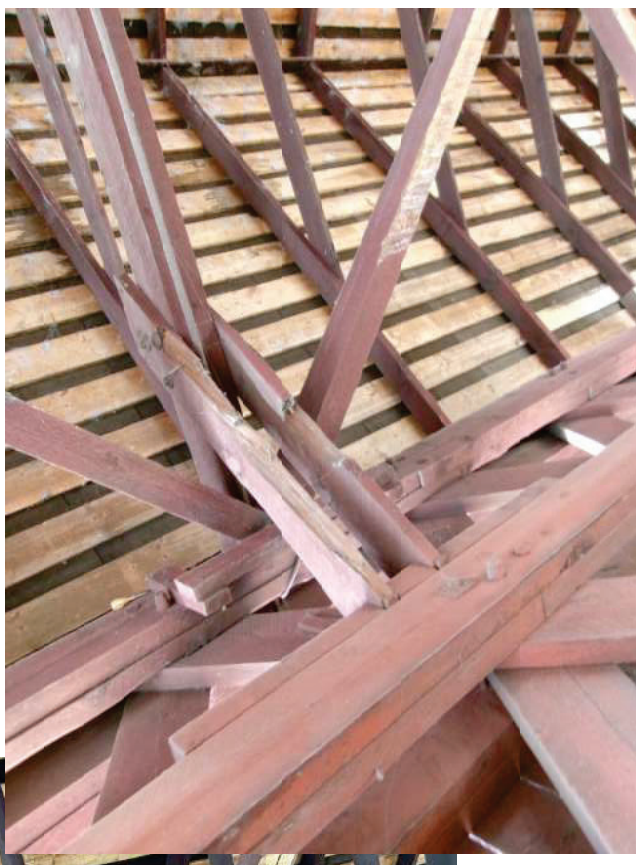
# Upper Bracing Members

- Splits
- Breaks
- Rot
- Impact Damage

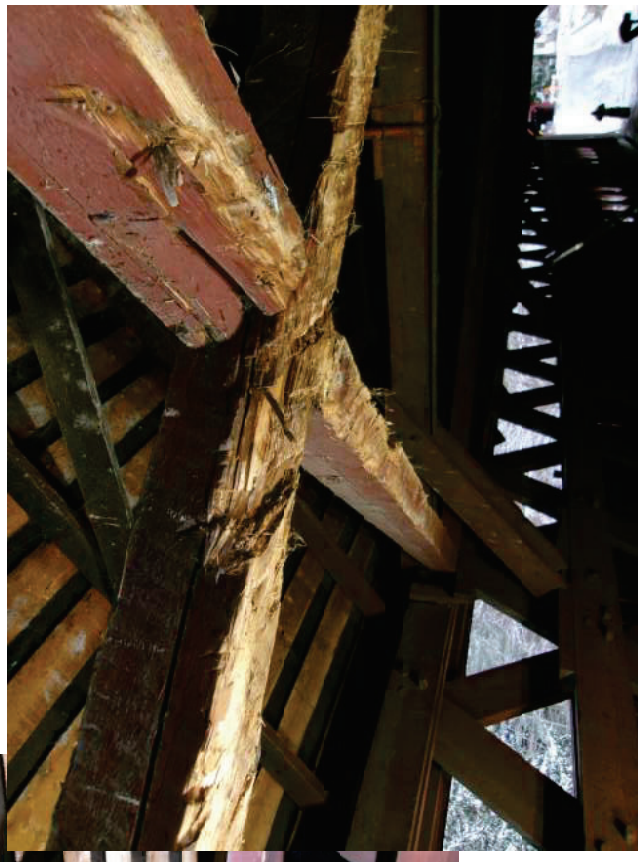
# Upper Bracing Members (Continued)

- Splits
- Breaks
- Rot
- Impact Damage

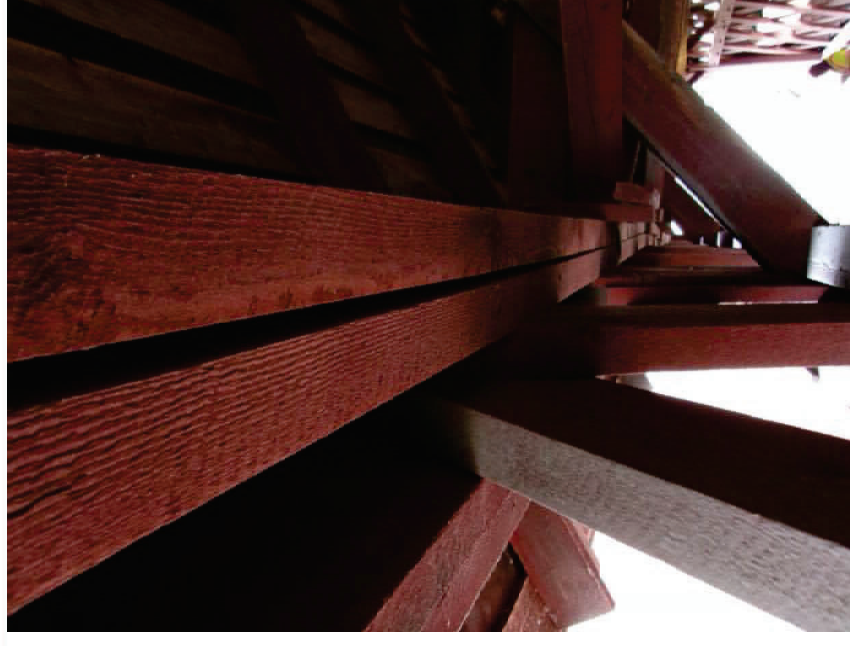
# Truss Members

- Splits
- Breaks
- Rot
- Misalignment
- High Moisture Content

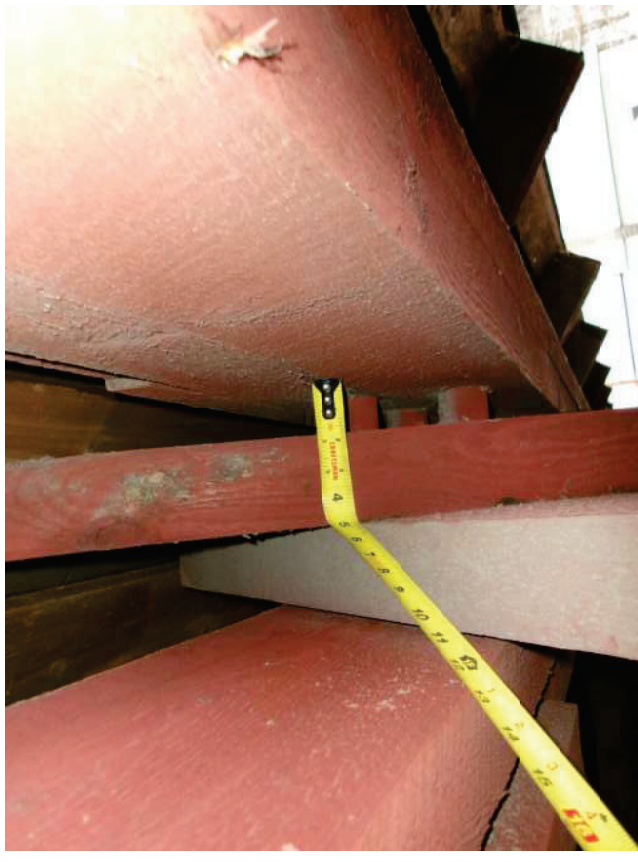
# Truss Members (Continued)

- Splits
- Breaks
- Rot
- Misalignment
- High Moisture Content

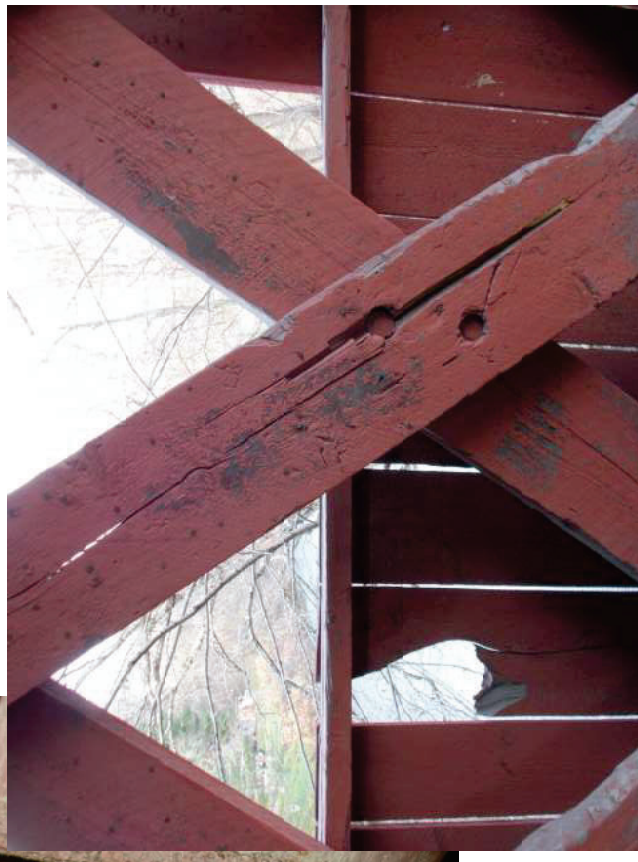
# Truss Members (Continued)

- Splits
- Breaks
- Rot
- Misalignment
- High Moisture Content

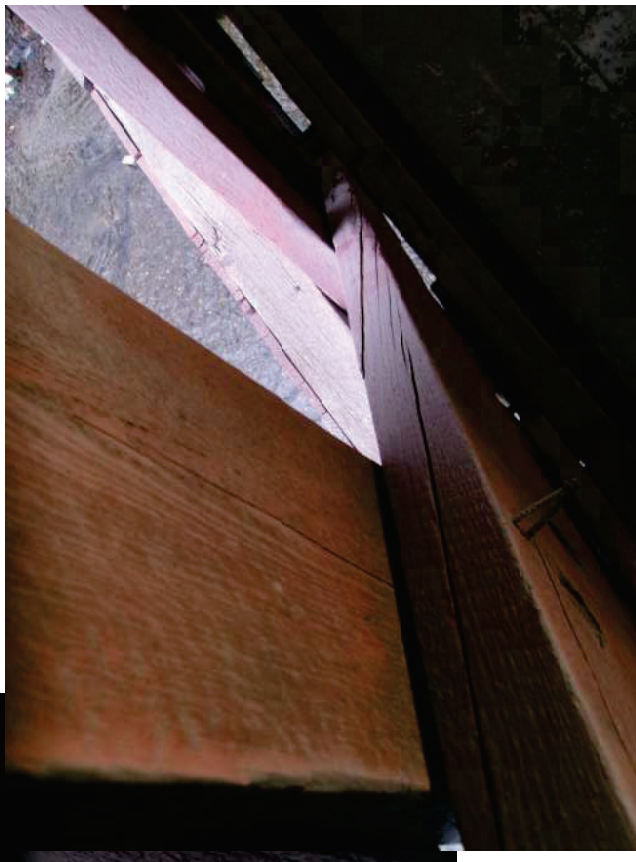
# Truss Members (Continued)

- Splits
- Breaks
- Rot
- Misalignment
- High Moisture Content

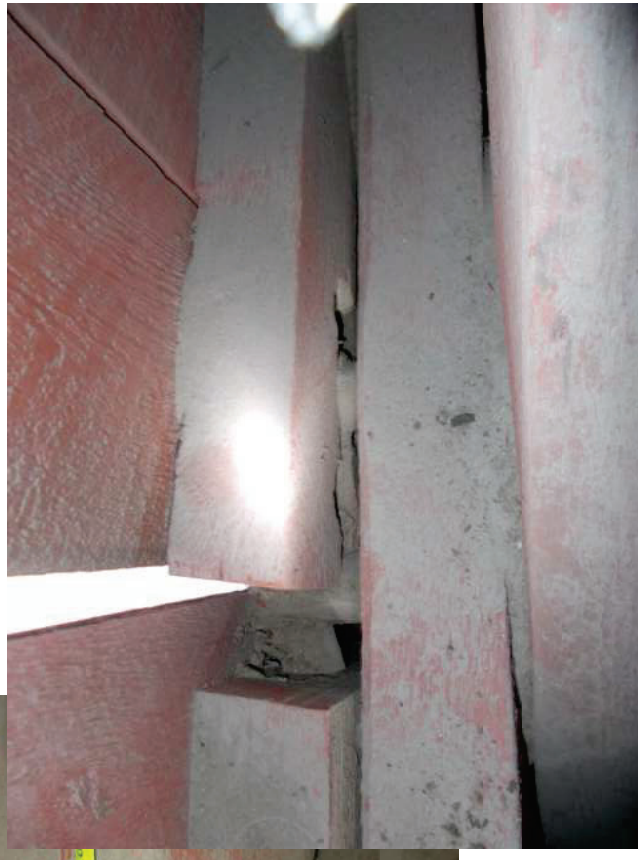
# Truss Members (Continued)

- Splits
- Breaks
- Rot
- Misalignment
- High Moisture Content

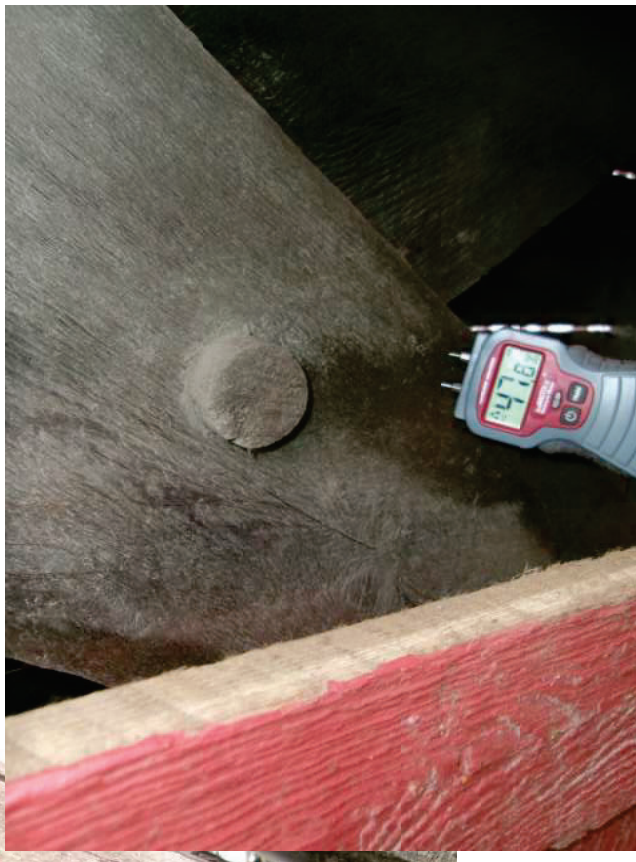
# Truss Members (Continued)

- Splits
- Breaks
- Rot
- Misalignment
- High Moisture Content

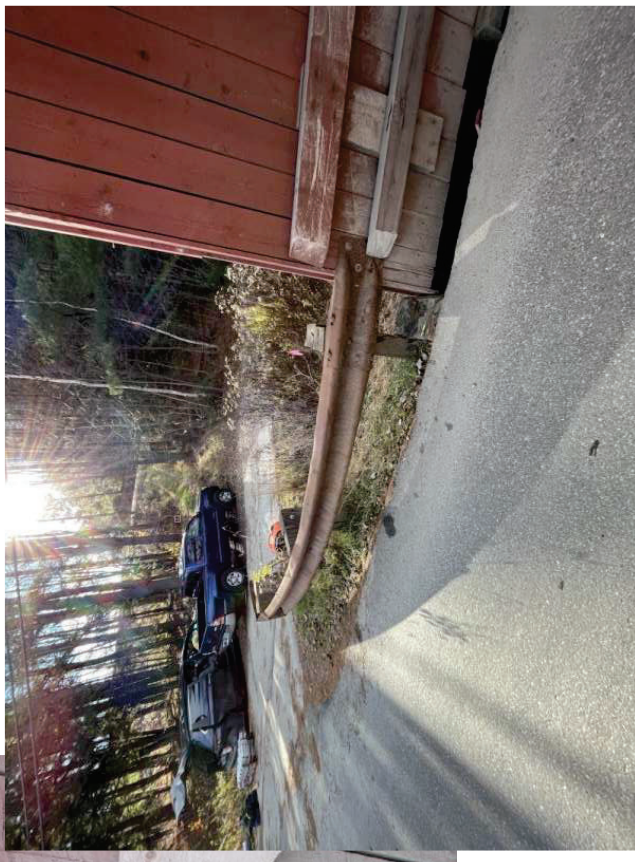
# Approach Railing

- Extensive Corrosion
- Rust Holes
- Rotted Wood Posts
- Impact Damage

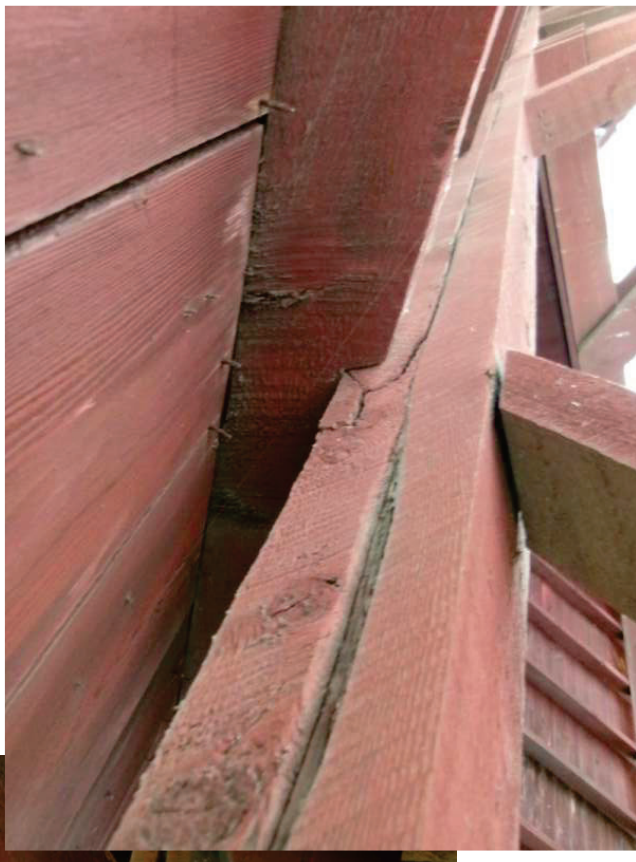
# Roofboards, Rafters & Rafter Support Beam

- Splits
- Breaks
- Rot
- Insect Damage
