**STATE OF VERMONT  
AGENCY OF TRANSPORTATION**

**Scoping Report**

**Wallingford BF 0133(18)**

**VT-155, Bridge 15 over The Mill River**

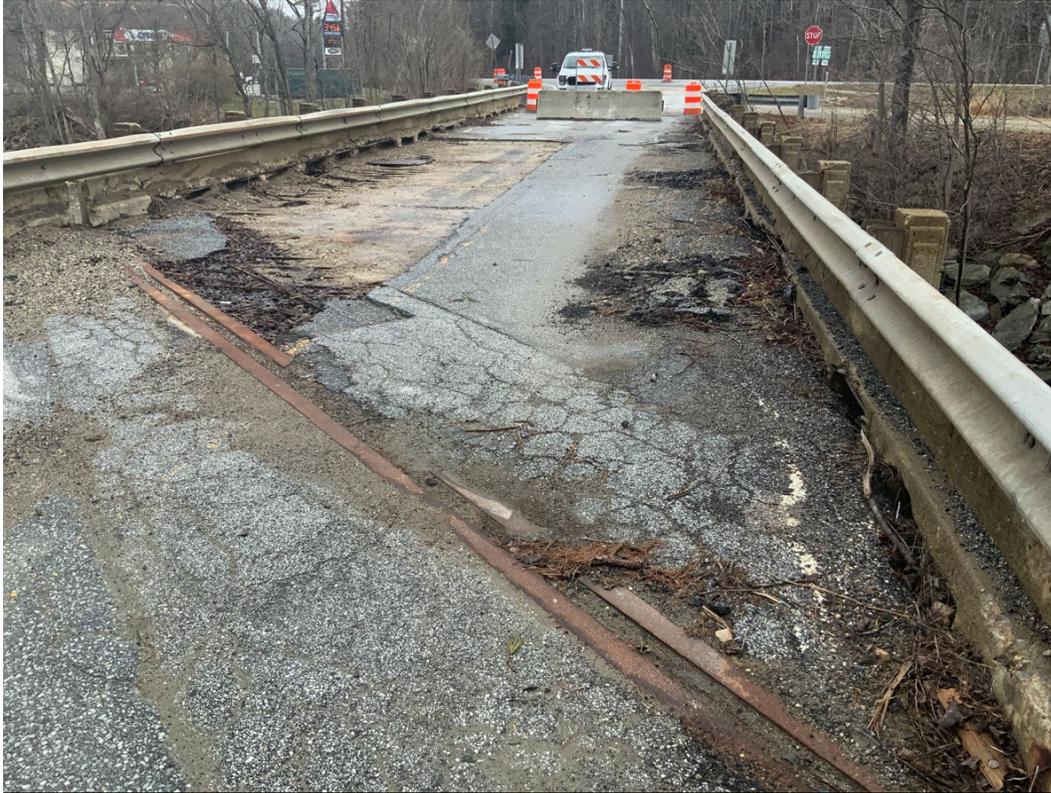
- b. The bridge joint compression seal and still armor have a couple of areas where steel has broken out.
  - c. The stringers have section loss at exterior beam ends and at the pier.

Joint over pier and deck span 2

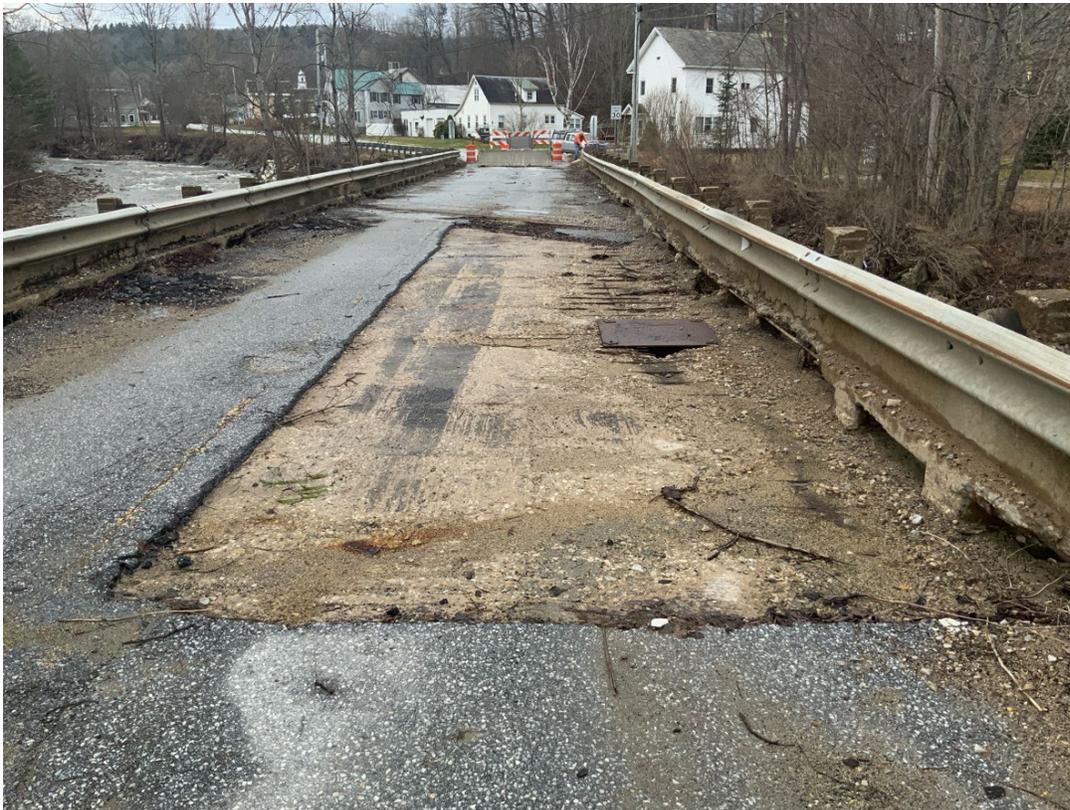
1. The bridge was closed to vehicle traffic on January 9th of 2023 due to deck failure.
  - a. The deck is in overall poor condition. A 3.5' x 2.5' hole has formed in span 2 along bay 1. Deteriorated concrete is possible for further full depth holes in the future. The condition along the curb line is poor with heavy breakup and past patching repairs. The deck curb and drain both have heavy spalling and exposed rebar.

Deck over span 2

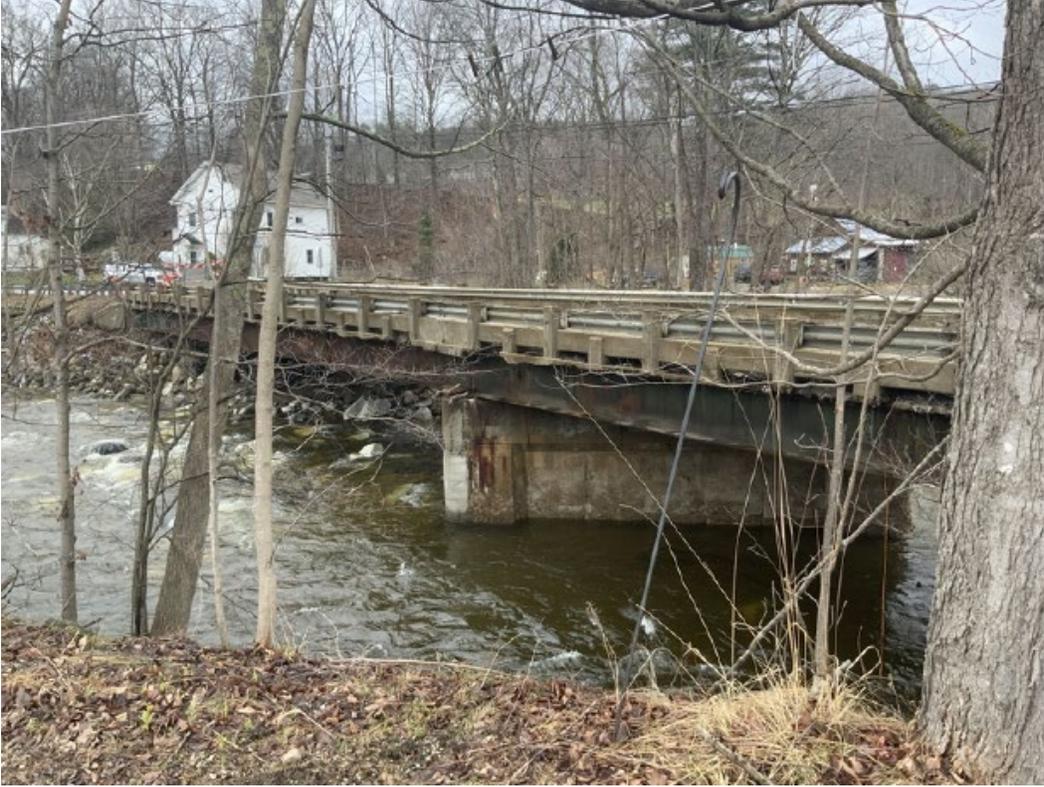
Upstream fascia

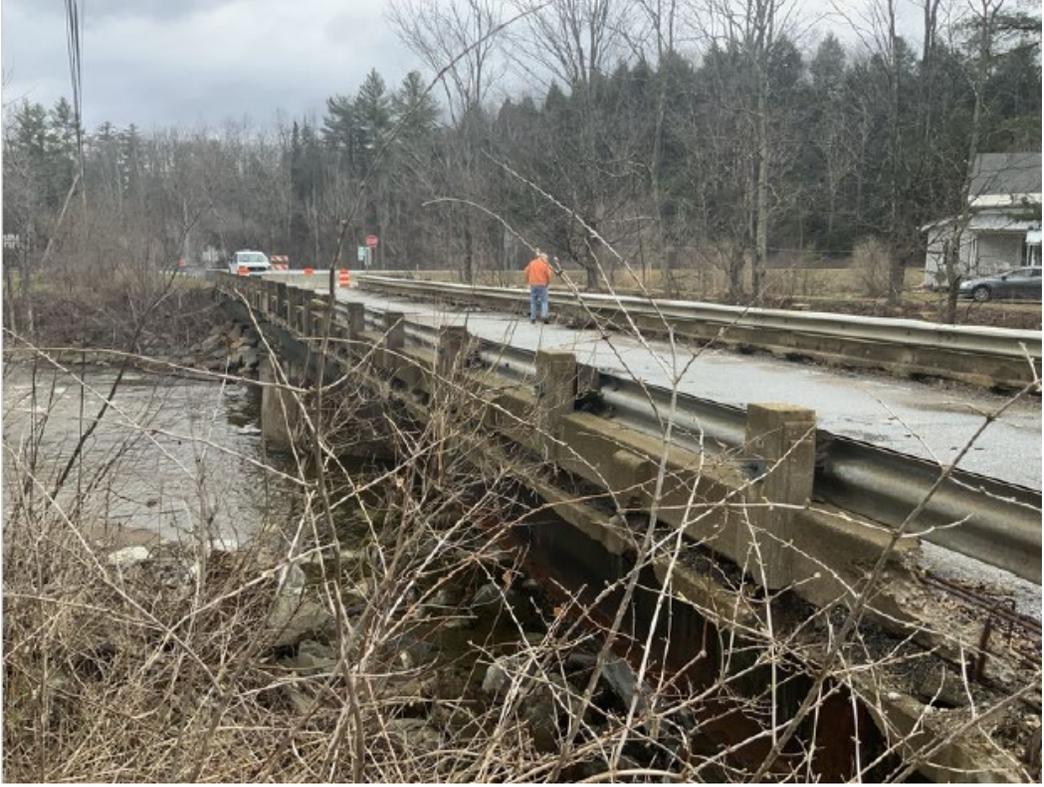
Downstream fascia

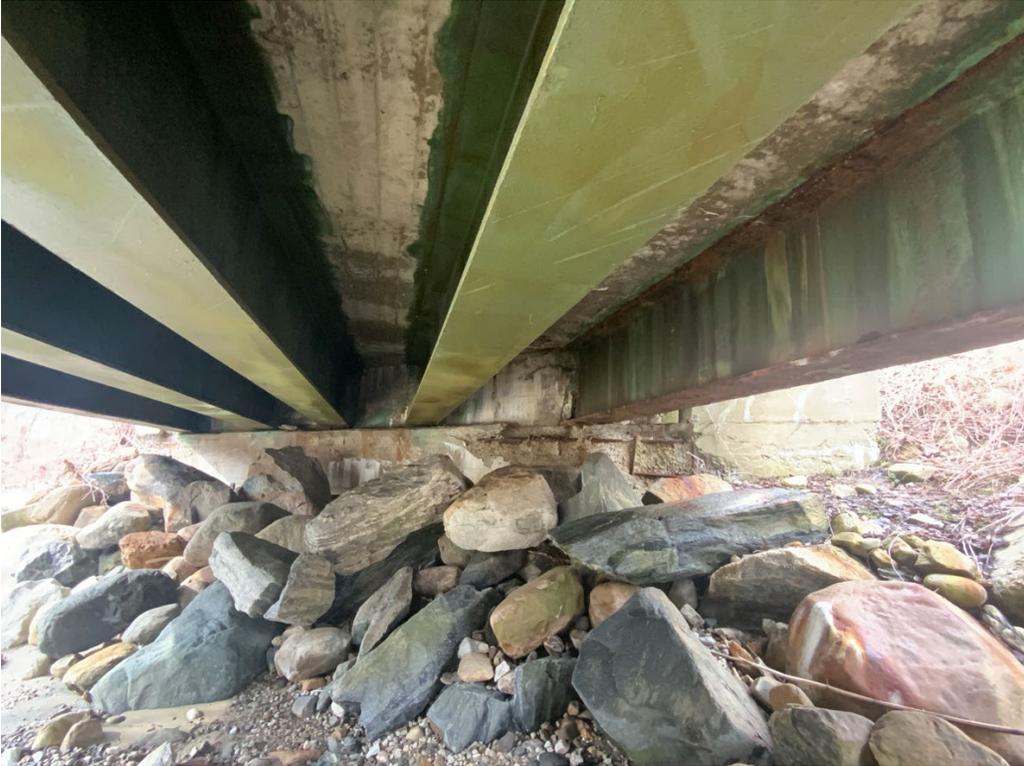
- d. The substructure is in poor condition. Abutment 1 has cracking and leakage with heavy deterioration and exposed rebar along the southwest corner. Abutment 2 also has cracking and staining, as well as heavy end deterioration along the northwest corner. Beam 5 seating area has been repaired multiple times and keeps popping off. The bearing area is undermined 50%.

Abutment 1

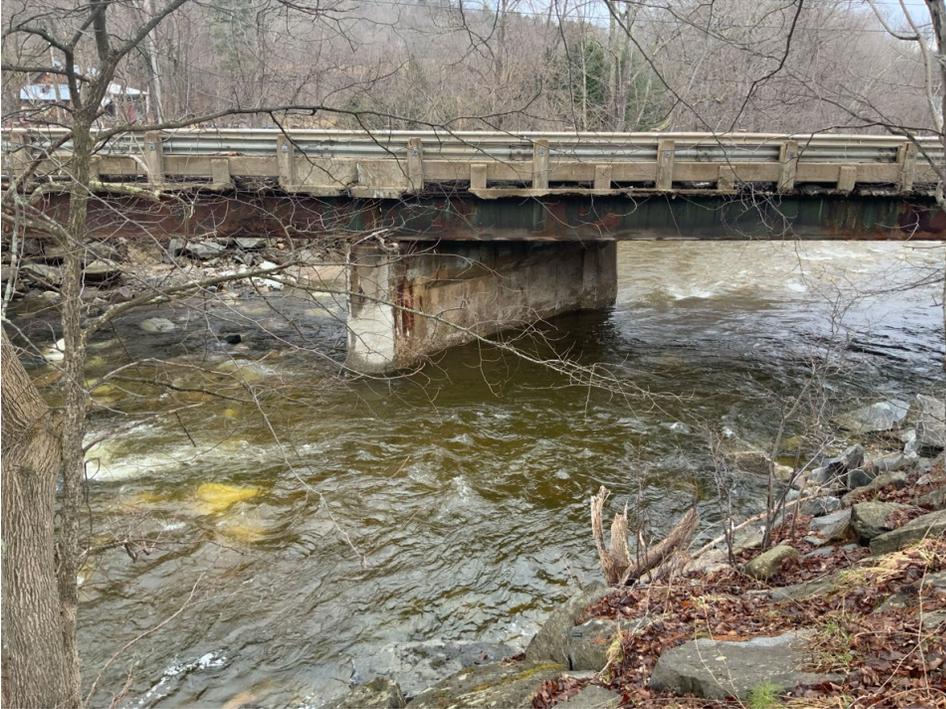
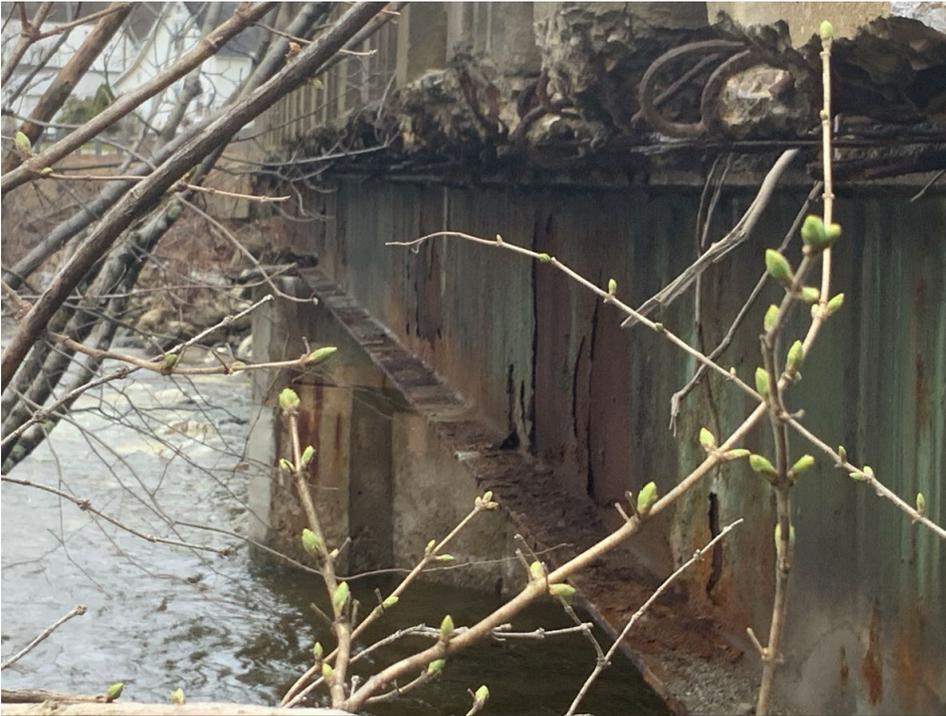
Upstream side of pier

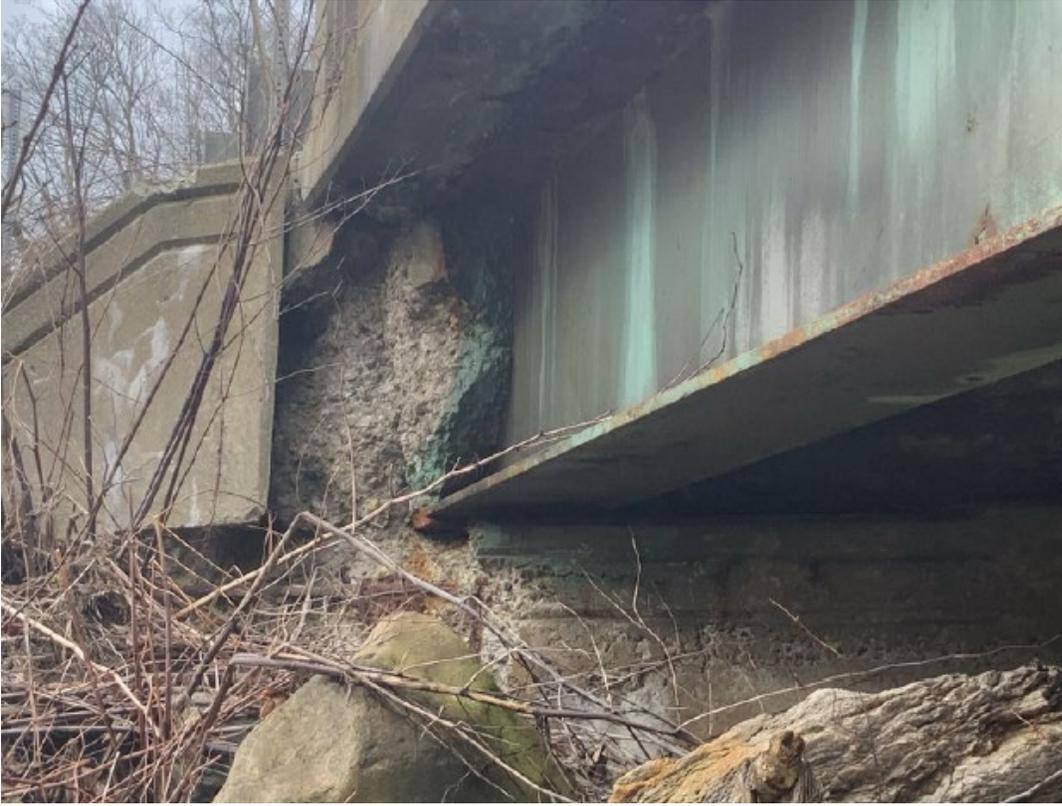
Loss of bearing area beam 5 abutment 1

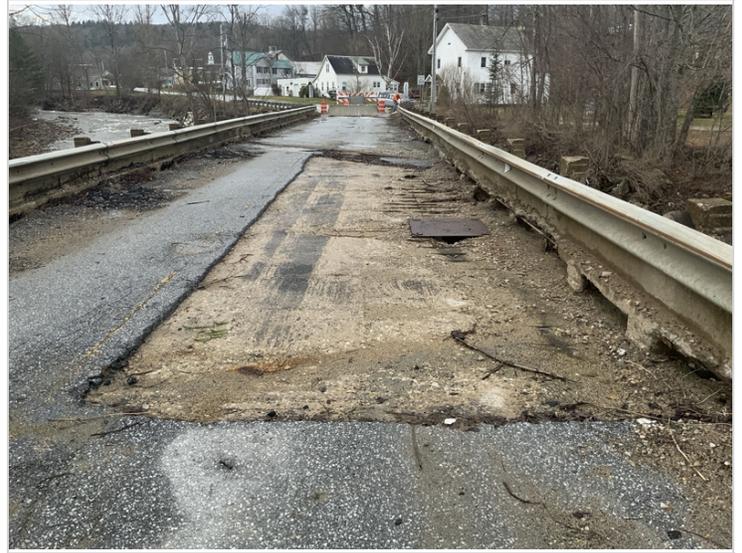
Deck over span 2

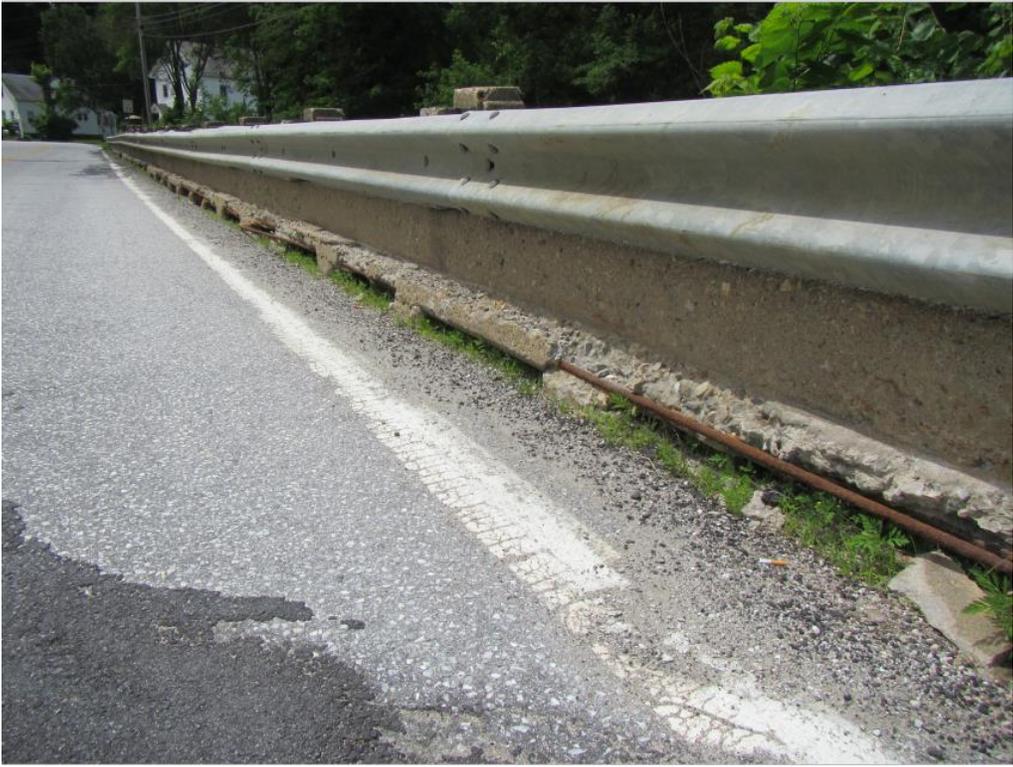
*Figure 3: VTrans inspection photo, 2017, shows the deteriorated curb and scuffer, as well as the installed w-beam.*

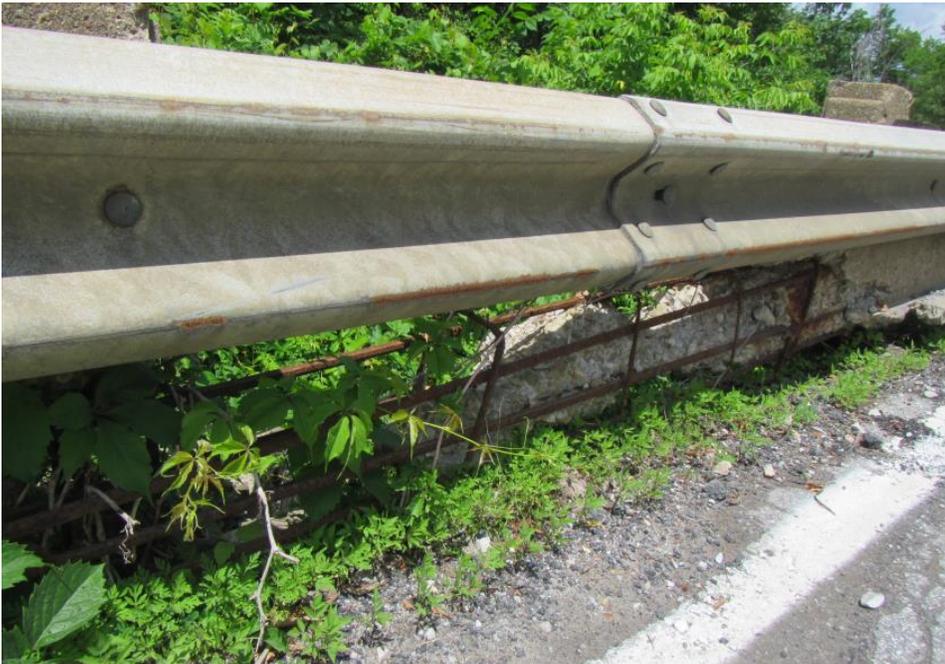
*Figure 4: VTrans inspection photo, 2017, shows the deterioration and exposed rebar.*
