**STATE OF VERMONT  
AGENCY OF TRANSPORTATION**

**Scoping Report  
FOR  
Sunderland BM20102**

**US ROUTE 7, BRIDGE 19-5 OVER UNAMED BROOK**

August 22, 2023

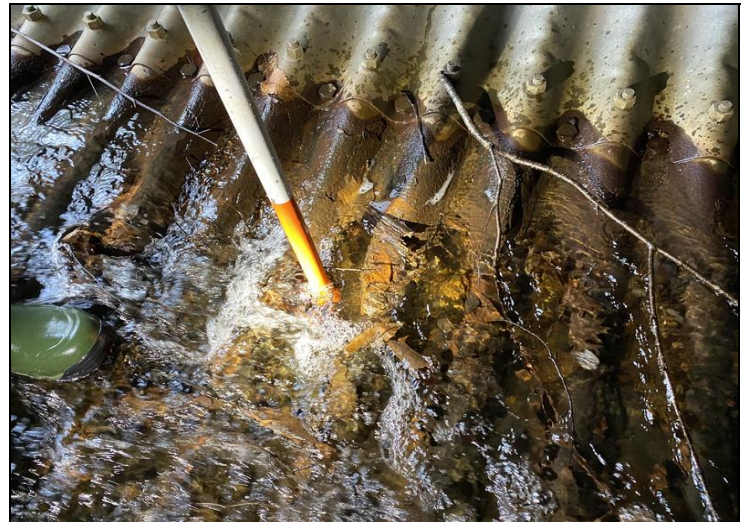
11/8/2022 – Corrugated galvanized multi plate pipe arch (CGMPPA) is in satisfactory condition however the invert is in poor condition having heavy corrosion present with large perforations throughout causing piping and voiding. Remaining structure invert has heavy pitting and rust scaling throughout. Structure should be sleeved or have concrete invert installed to prevent further piping and deterioration along the invert. No roadway settlement is present at time of inspection however invert and lower portions of barrel walls / invert have voids present due to piping. ~SP

Large Perforations along Southern Side of Culvert Invert

12/2/2020 – Structure has fairly good form however the invert has heavy deterioration present with large perforations throughout with piping present. Invert has heavy pitting and rust scaling throughout. Structure should be sleeved or have concrete invert installed to prevent further piping and deterioration along the invert. ~SMP/MAC

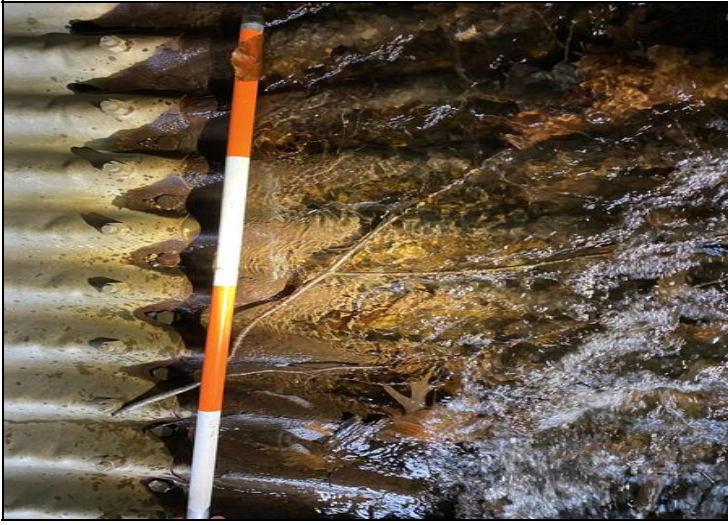
Large Perforations along Southern Side of Culvert Invert

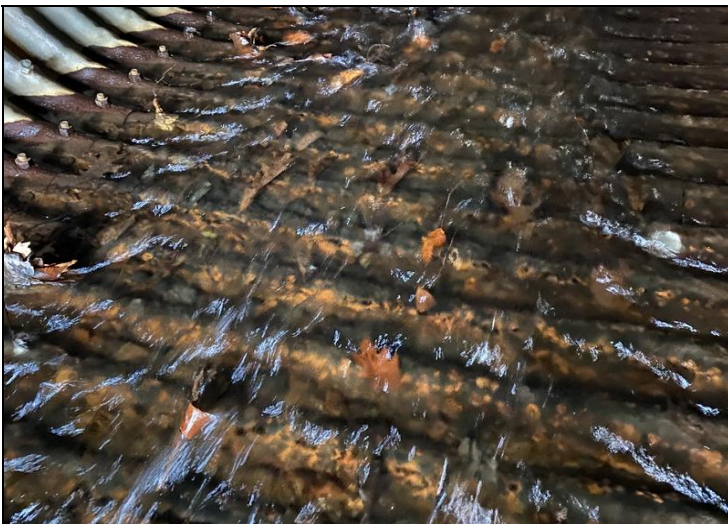
Perforations along Invert below Roadway

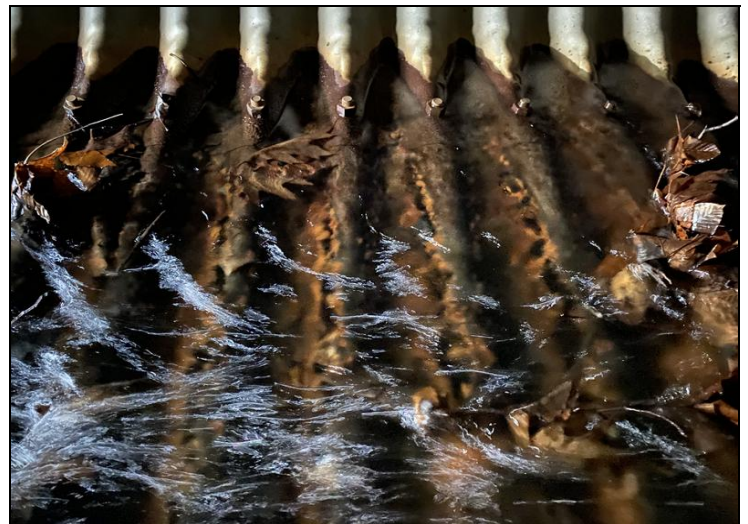
Perforations along Invert below Roadway

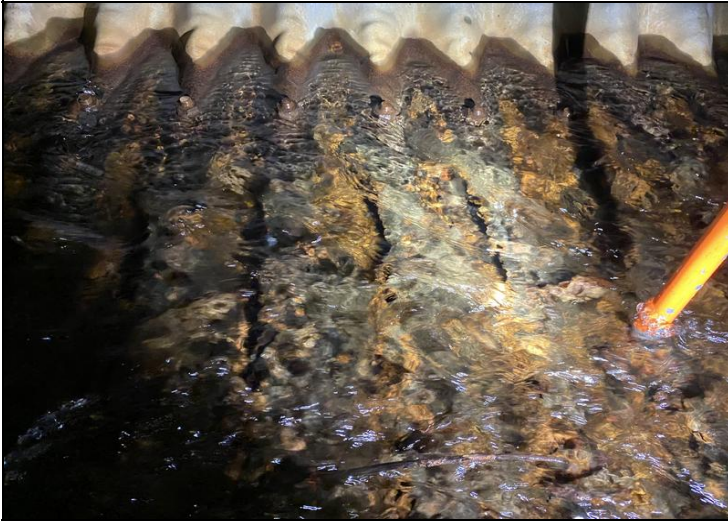
Perforations along Invert below Roadway

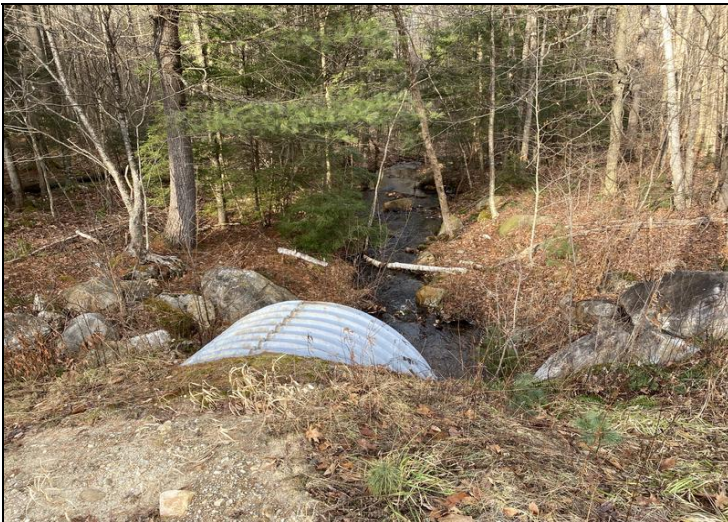
Downstream Channel

**Comment:** Moderate scour hole downstream. Minor depressions in banks above pipe.
