STATE OF VERMONT  
AGENCY OF TRANSPORTATION

**Scoping Report**

FOR  
**STATEWIDE NORTHWEST STP CULV(90):  
ESSEX VT ROUTE 2A BR #11**

**VT ROUTE 2A, BRIDGE 11 OVER UNNAMED BROOK**

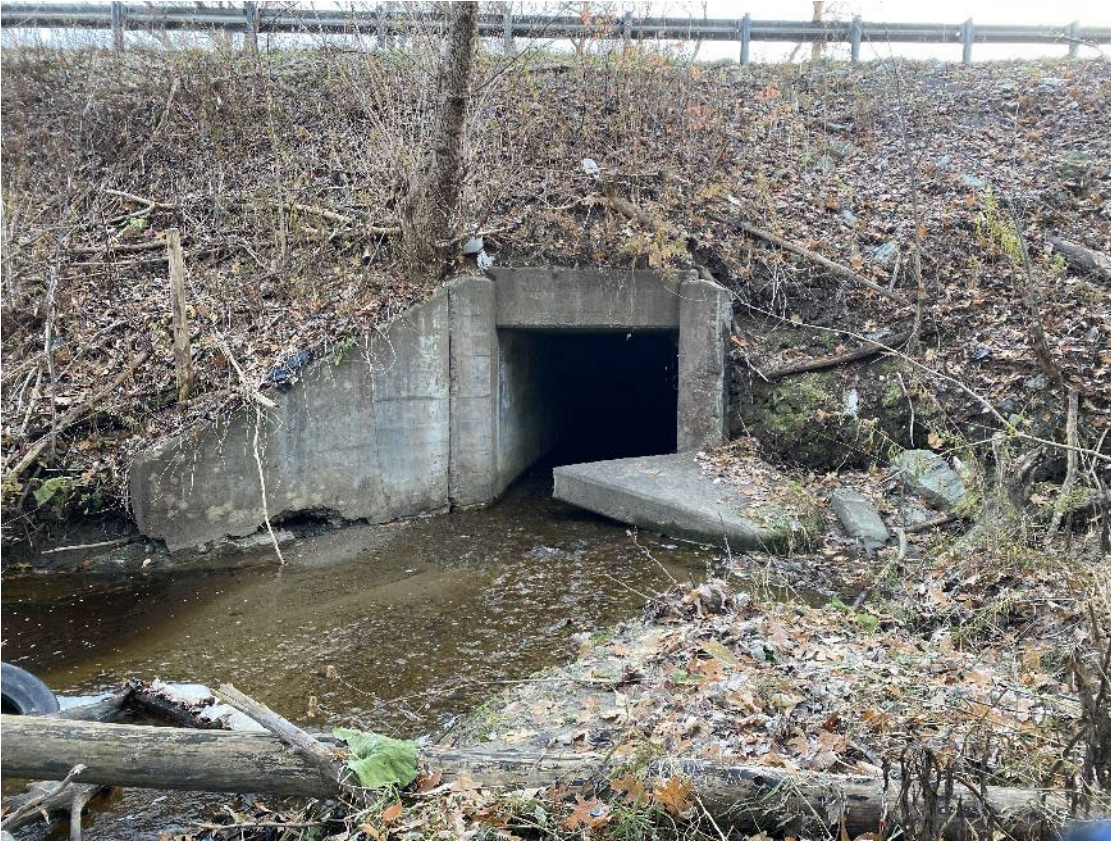
11/17/2021 Box remains in poor condition with areas of holes exposing backfill and thinning rebar. Two areas of moderate cracking through both side walls and soffit largest crack measuring up to 3/4". Southwest wing has failed. The downstream channel has moderate erosion. The heaviest erosion is around failed southwest wing wall.

Outlet of box culvert, failed southwest wingwall (Inspection photo 2021)

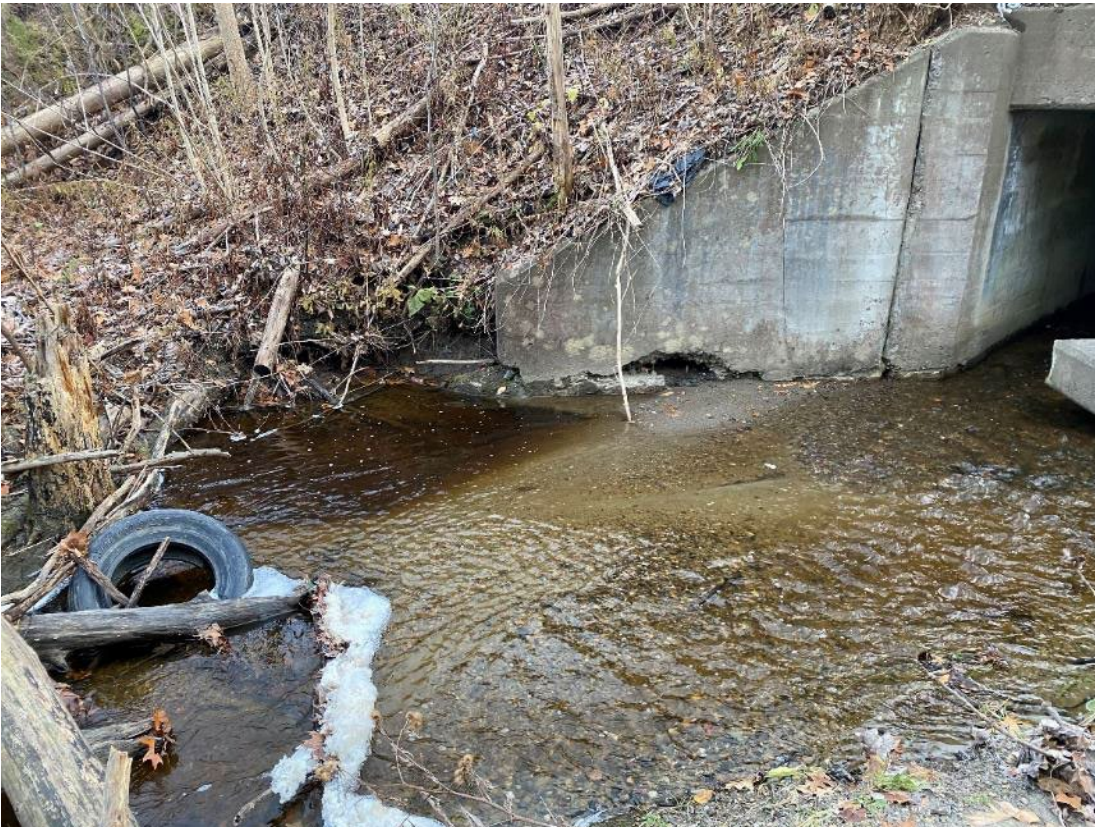
Northwest wingwall of outlet (Inspection photo 2021)

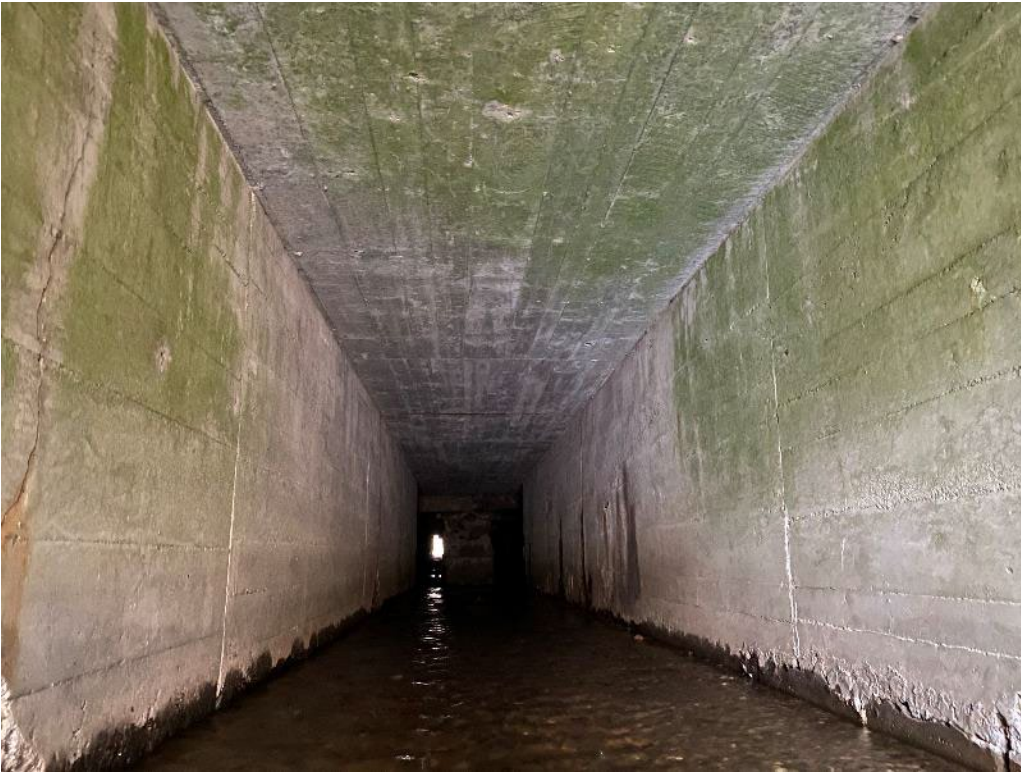
12/22/2022 Downstream full perimeter crack is wider along the invert measuring ~1/4" in width stemming up to ~1/16" in width along the upper portion having severe spalling with multiple rusted through steel reinforcing bars along the southern box wall with backfill sediment spilling out. Void behind the spalling varies in size but a rod can penetrate up to ~3'-0". The upstream full perimeter crack varies in width of up to ~3/4" in width along the box walls. Slight roadway settlement is present along the downstream end of structure with bank slumping due to failed southern wing and large voided area along the box southern wall. Box is in need of a major rehabilitation or full replacement in near future to prevent further deterioration or roadway settlement.

Facing upstream through culvert from downstream with full perimeter cracks over spalled areas (Inspection photo 11/28/2022)

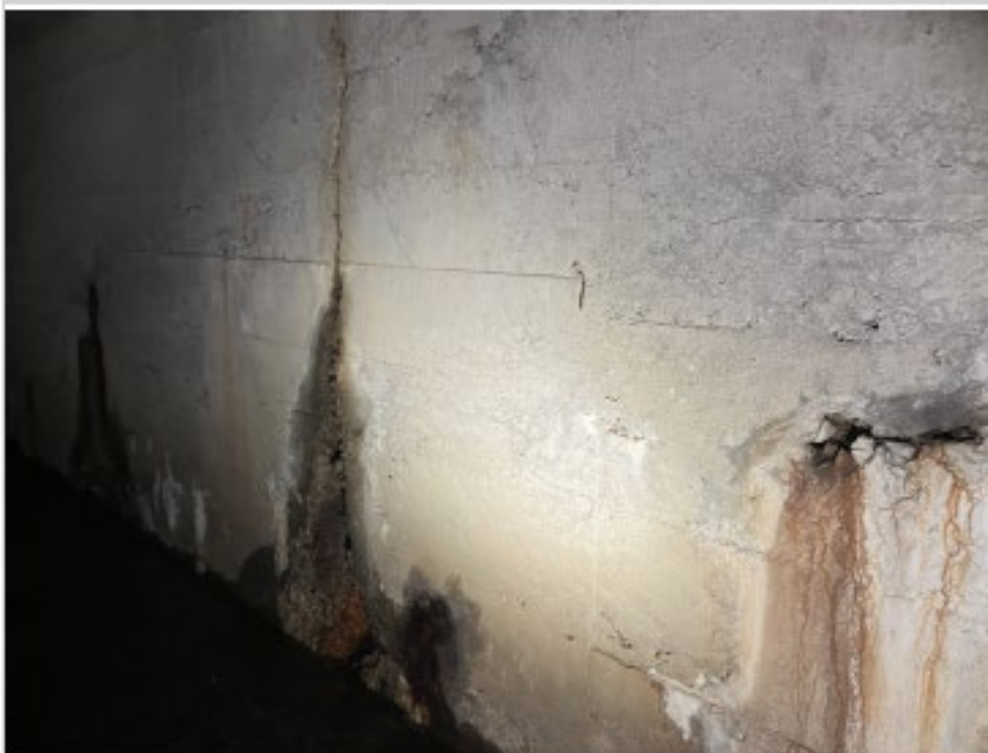
Spalling and cracking on Southern Side of Culvert between downstream and Midspan (Inspection photo 11/28/2022)

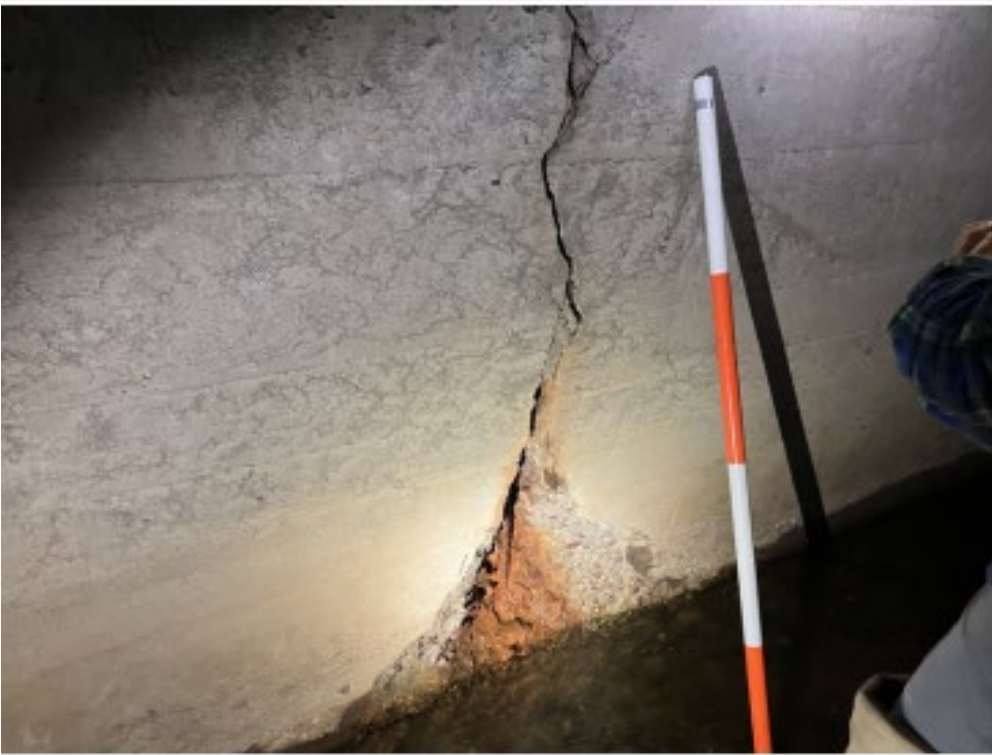
Spalling and full perimeter crack on northern side of culvert between downstream and Midspan (Inspection photo 11/28/2022)

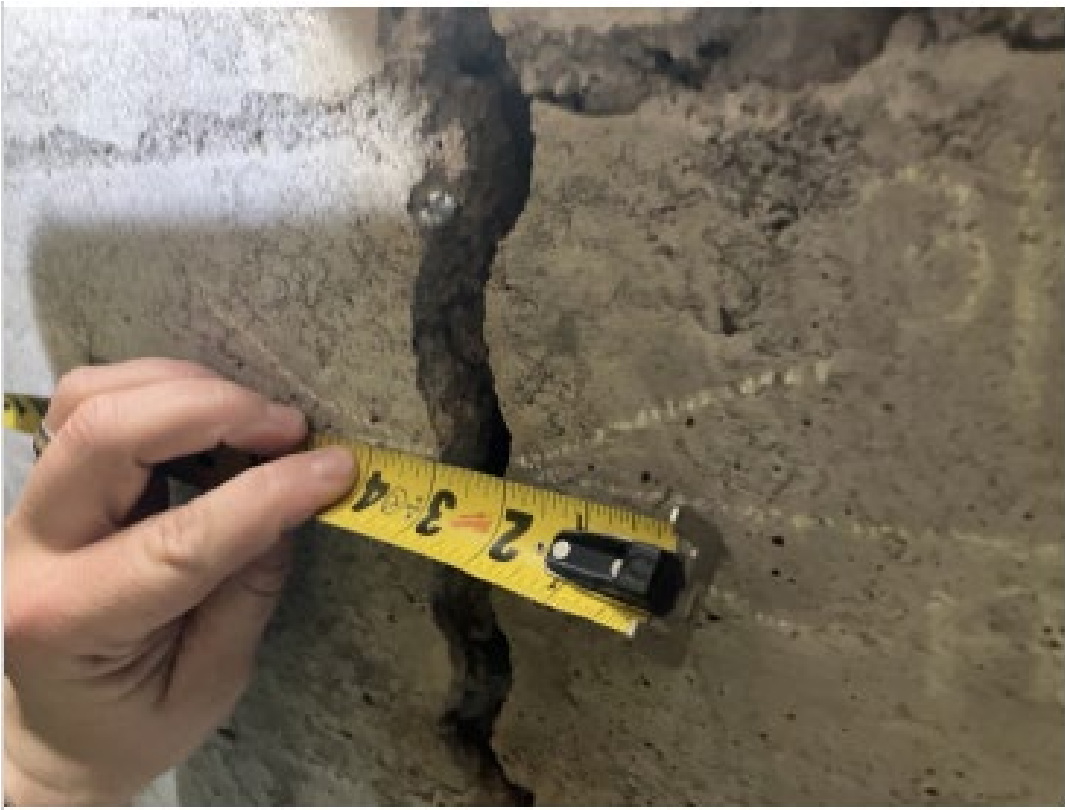
7/8 in crack near downstream end, southern side (Inspection photo 11/28/2022)

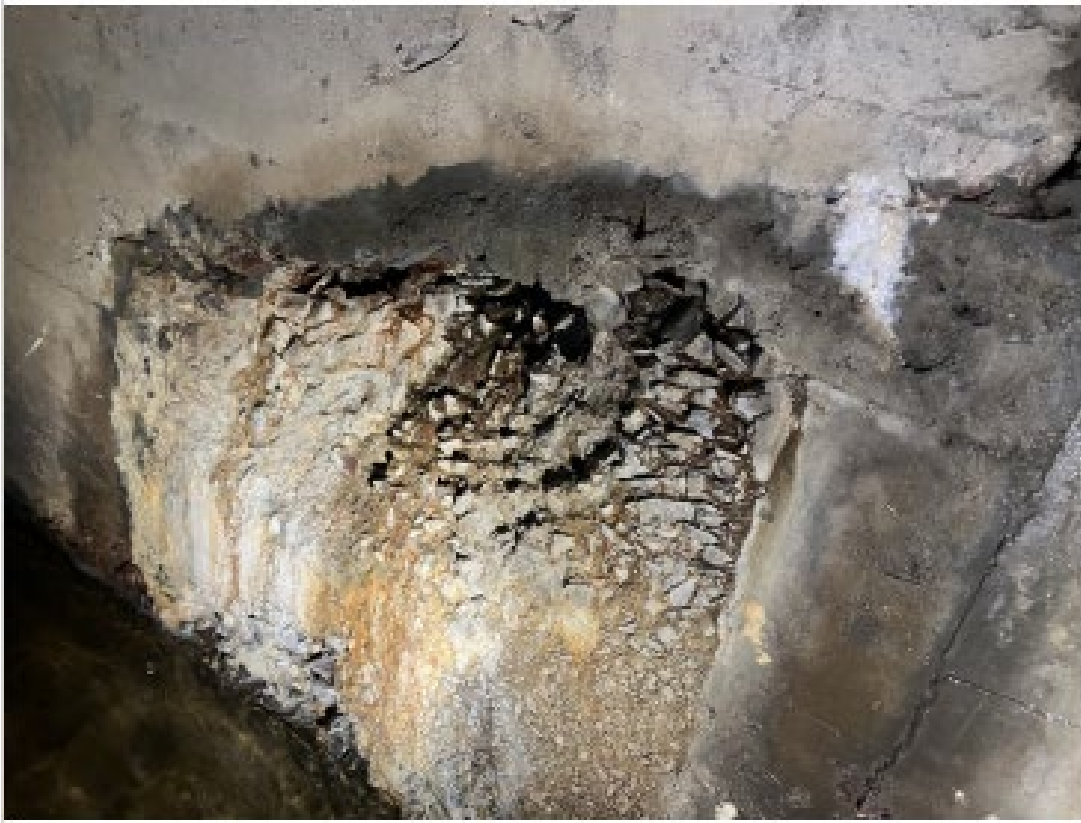
Spalling on Southern Side of culvert upstream end (Inspection photo 11/28/2022)

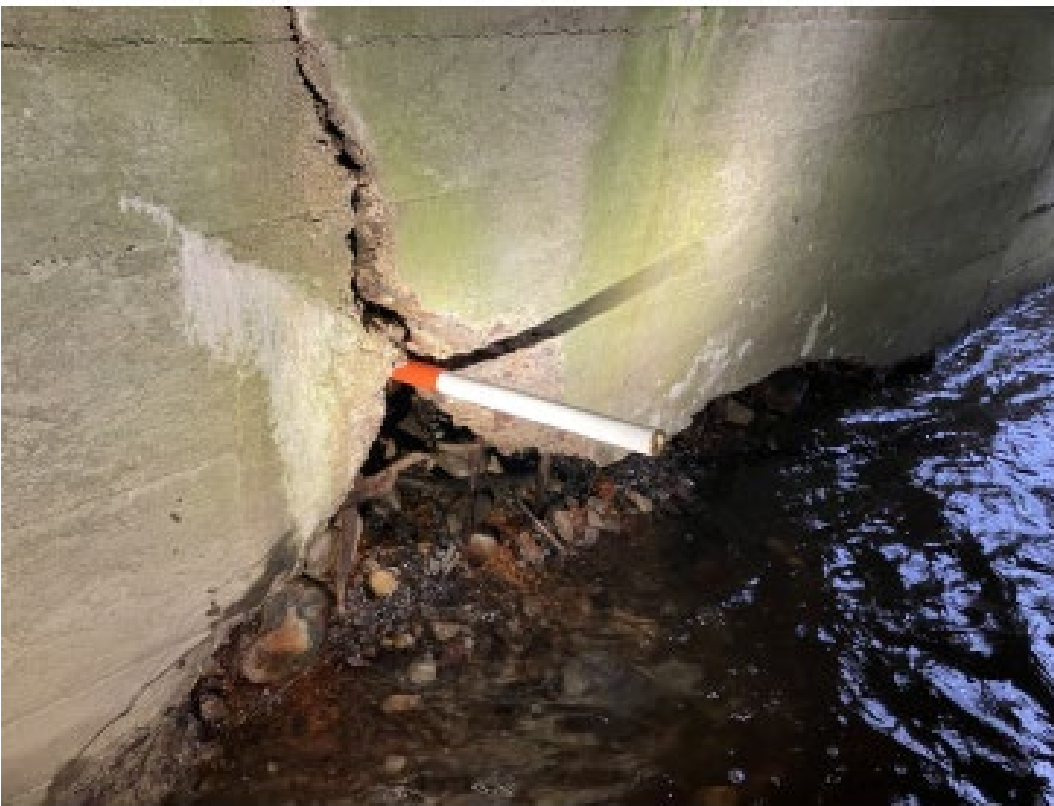
3 feet of backfill sediment loss in spalled area on downstream end southern side (Inspection photo 11/28/2022)

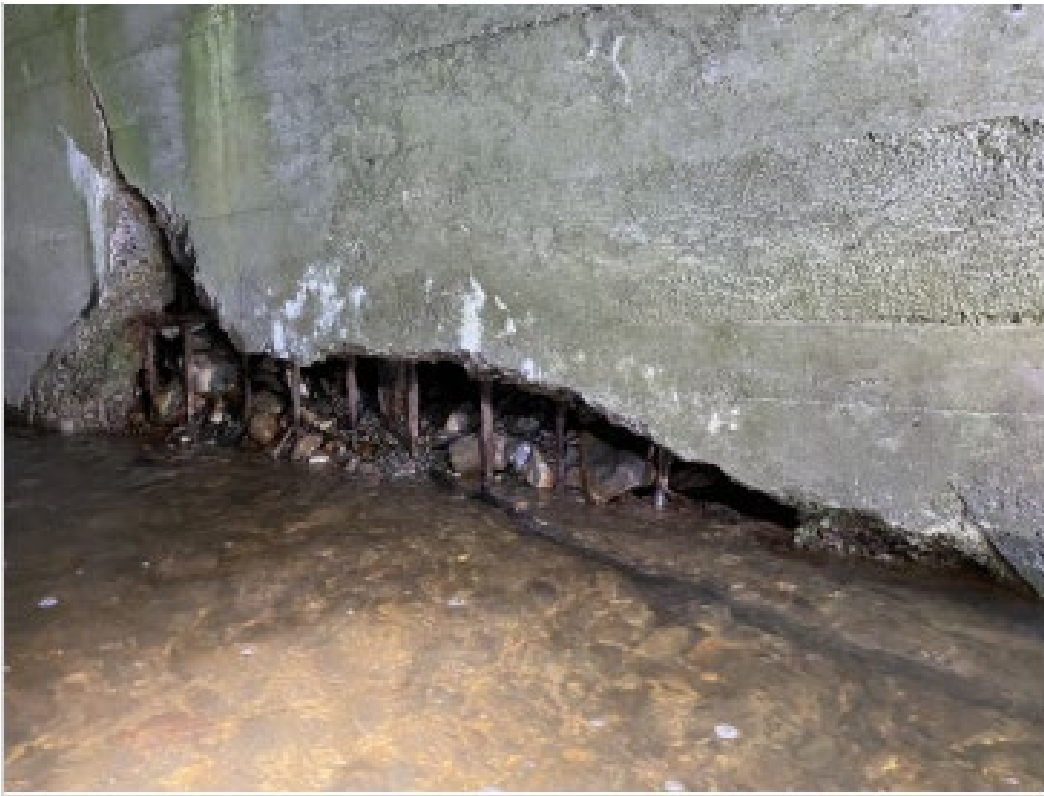
Severe Spalling with Severed Steel Reinforcing along Southern Box Wall (Inspection photo 11/28/2022)

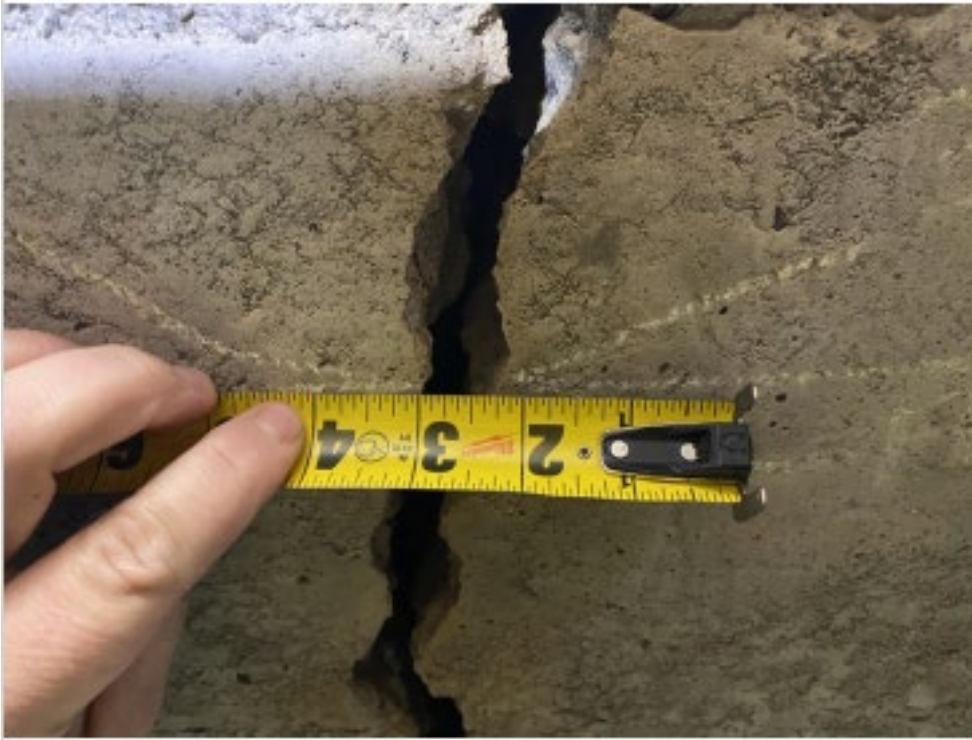
Full Perimeter Crack Below Roadway measuring ~3/4" Wide (Inspection photo 11/28/2022)

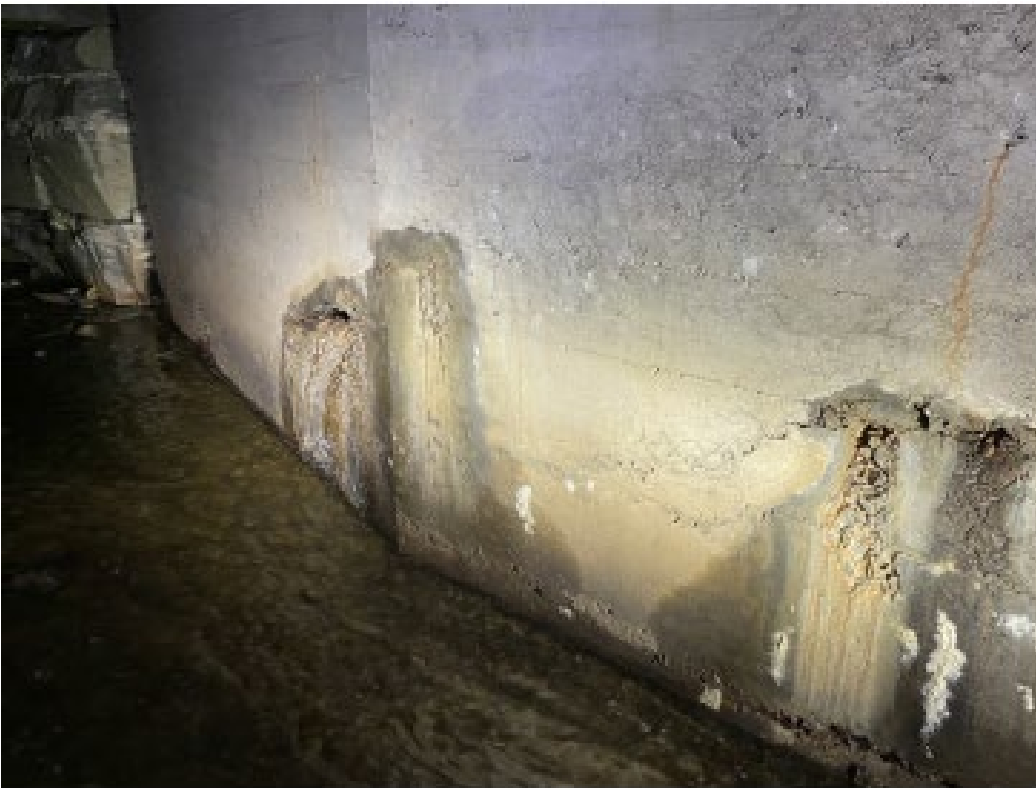
Southern Box Walls Leakage / Spalling (Inspection photo 11/28/2022)

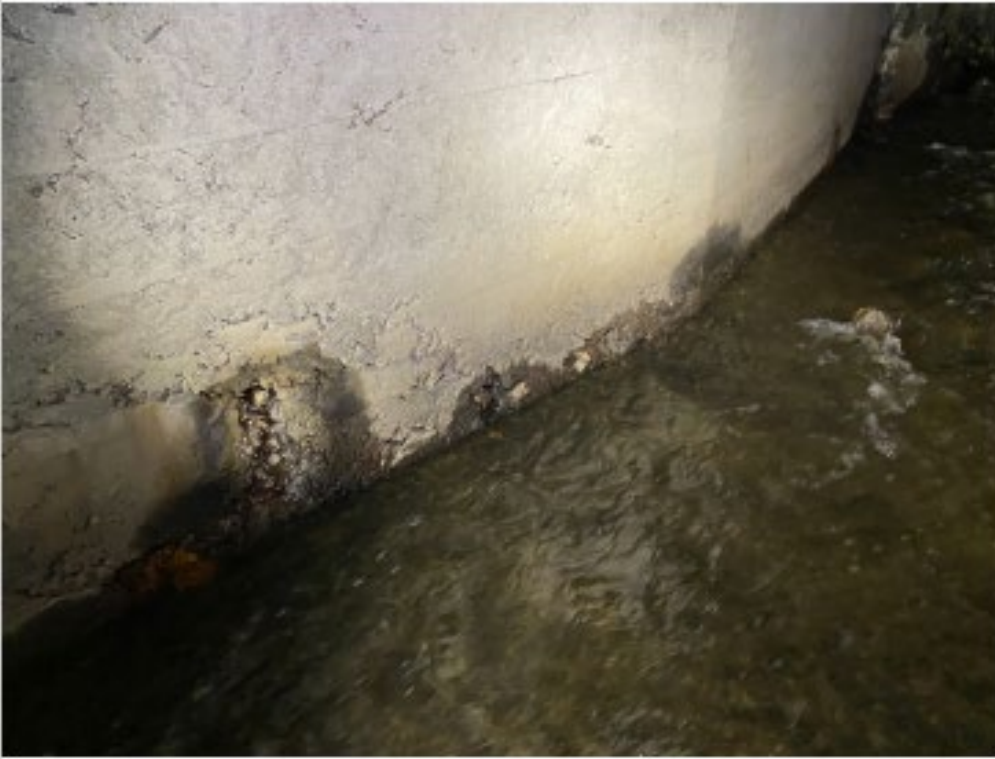
Northern Box Walls Leakage / Spalling (Inspection photo 11/28/2022)

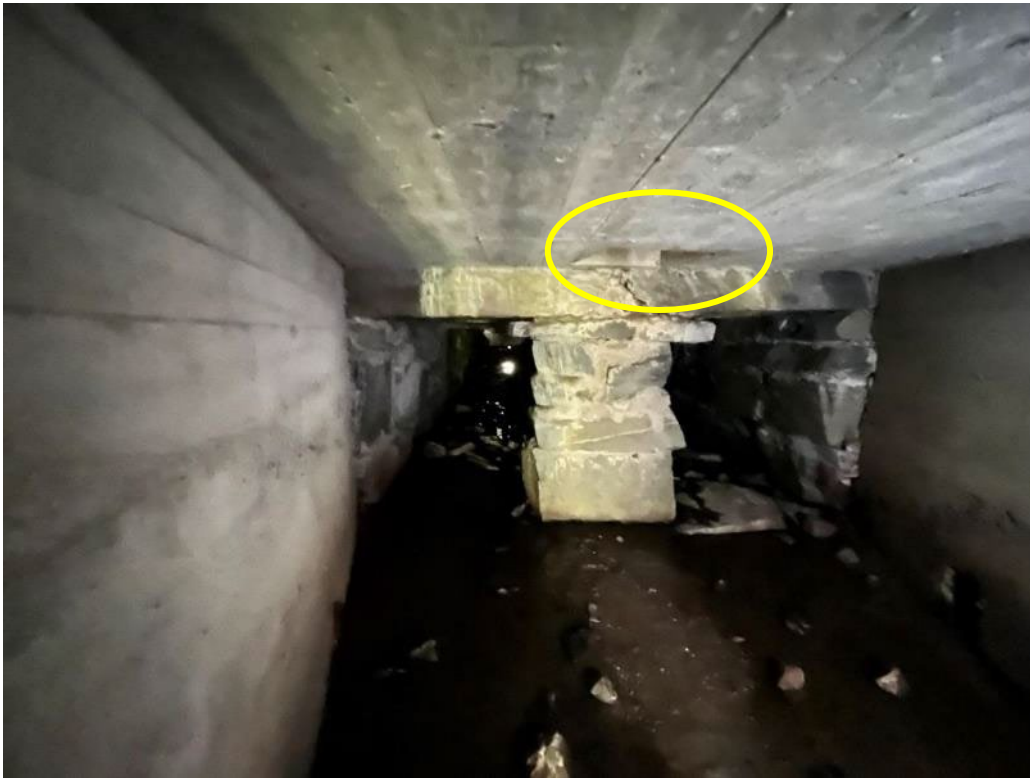
Drop inlet from median between NEC RR and VT Route 2A visible at connection point (circled in yellow)
