STATE OF VERMONT
AGENCY OF TRANSPORTATION

Scoping Report

FOR
**STATEWIDE NORTHWEST STP CULV(90):
ESSEX VT289 BR #17-A**

VT ROUTE 289, BRIDGE 17-A OVER UNNAMED BROOK

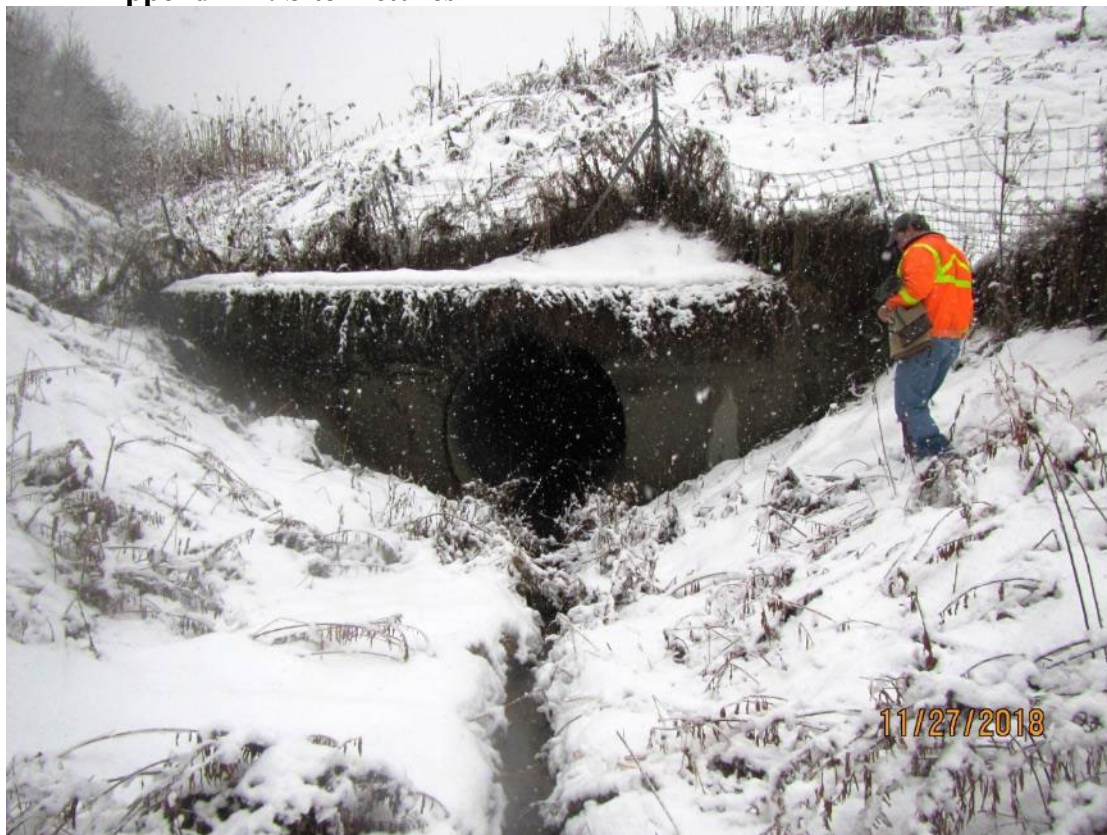
Upstream view of structure inlet (Inspection photo 2018)

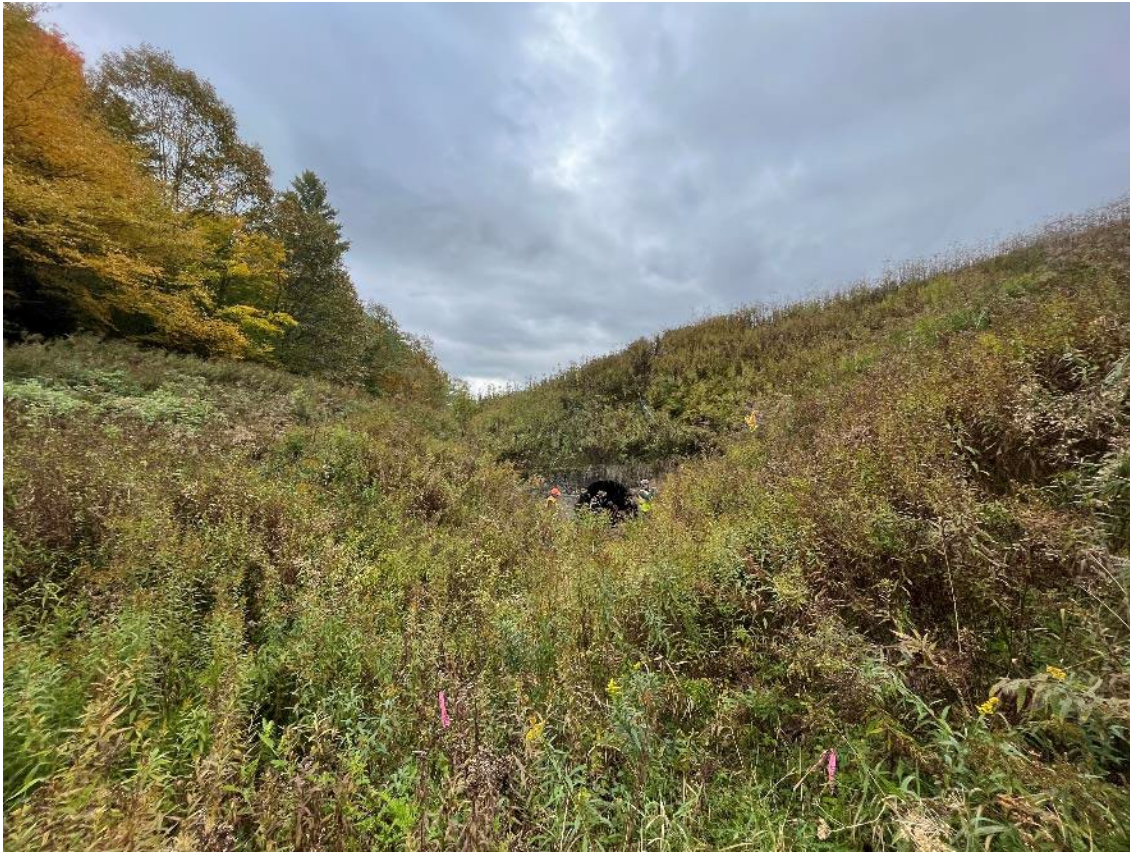
Upstream view of structure inlet (Hydraulics/Scoping site visit photo 10/10/2022)

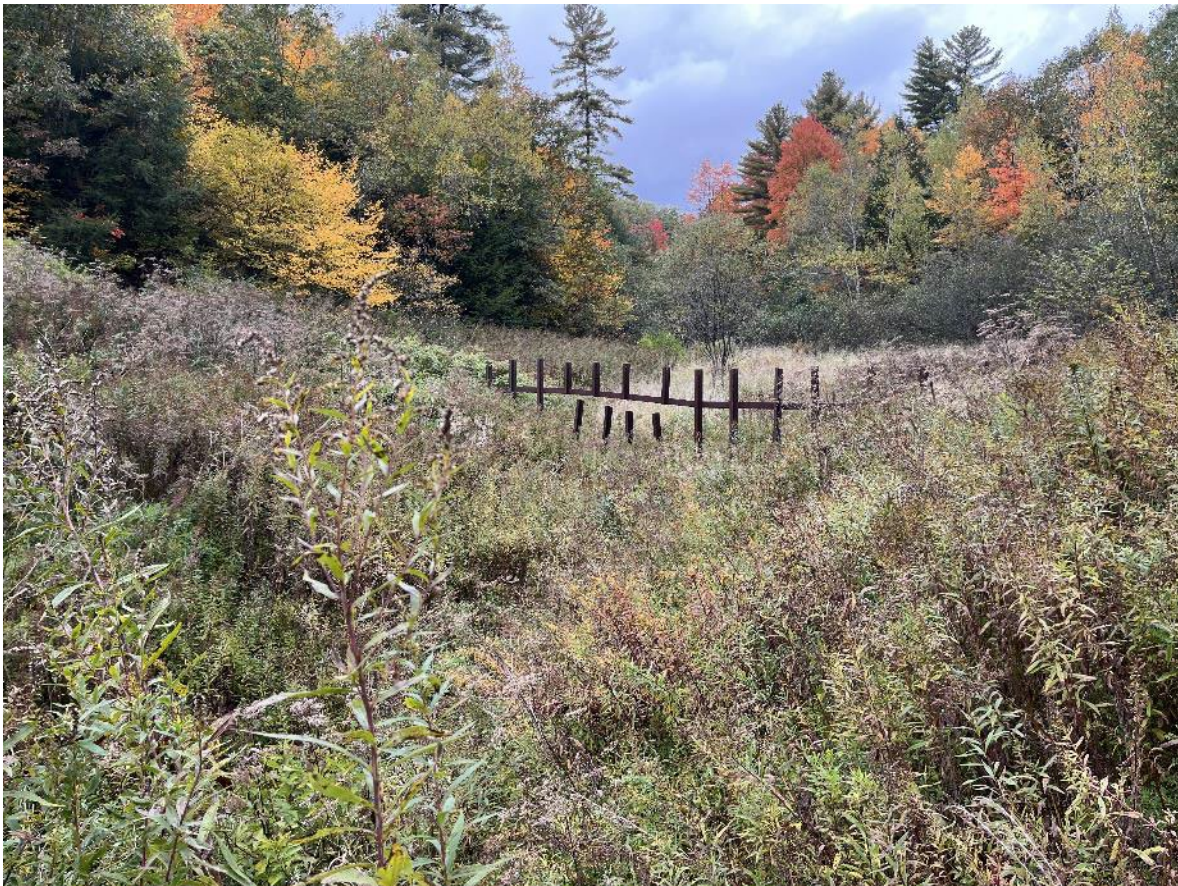
The existing upstream “debris rack” is an indication that debris clogging has been an issue at this site in the past. For this reason, the Hydraulics team recommended replacement options that are similar in size to the existing structure. The existing culvert has a span of 7 feet, which provides a generous headwater to depth ratio and ample access for maintenance activities.

Train rail beaver barrier fence at culvert inlet, (Hydraulics/Scoping site visit photo 10/10/2022)

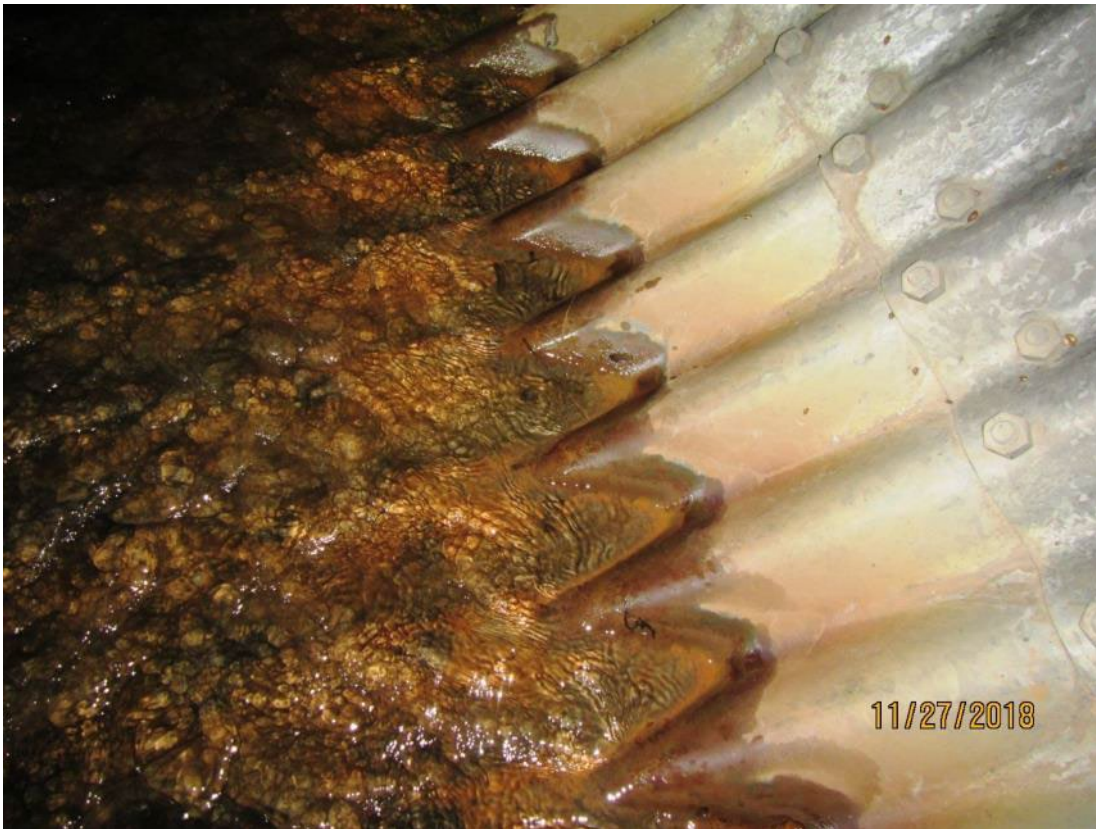
1. The culvert is in Fair condition:
 - a. The pipe has numerous small rust holes along the invert.
 - b. The second construction joint has leakage with efflorescence and rust staining.
 - c. The slopes need stabilization work to help stop the erosion.

11/27/2018 Culvert barrel: along pipe invert has numerous holes anywhere from 1/2" to 6" in diameter mostly along the first third of the pipe, then more small holes forming from outside in, along haunch areas more near outlet third portion. Culvert Invert: rusted through in areas - shape of pipe is still good - no distortion to speak of. Pipe should be considered for a poured invert repair or sleeve repair. ~ MJ/SP

Invert damage, (Inspection finding photo 2018)

Invert repair can be utilized on corrugated steel pipe, and typically consists of paving the invert or pouring a concrete invert. Much of the deterioration is located along the invert in the first third of the pipe, making this a suitable repair for the culvert. This option involves removal of the degraded invert and pouring a 2- to 3-inch-thick section of concrete in its

place. Additionally, there may be repair of any holes along the circumference of the pipe, including the large perforation at the outlet of the pipe on the south side. This option would have the least impact on the hydraulic capacity of the existing culvert. While this option is a good solution to the current degradation of the culvert invert, it adds little structural stability to the current structure. There has been no evidence of distortion, and as such, additional structural capacity is not required.

Alternative 1 is recommended; to rehabilitate the existing culvert while traffic is maintained on the existing culvert during construction.

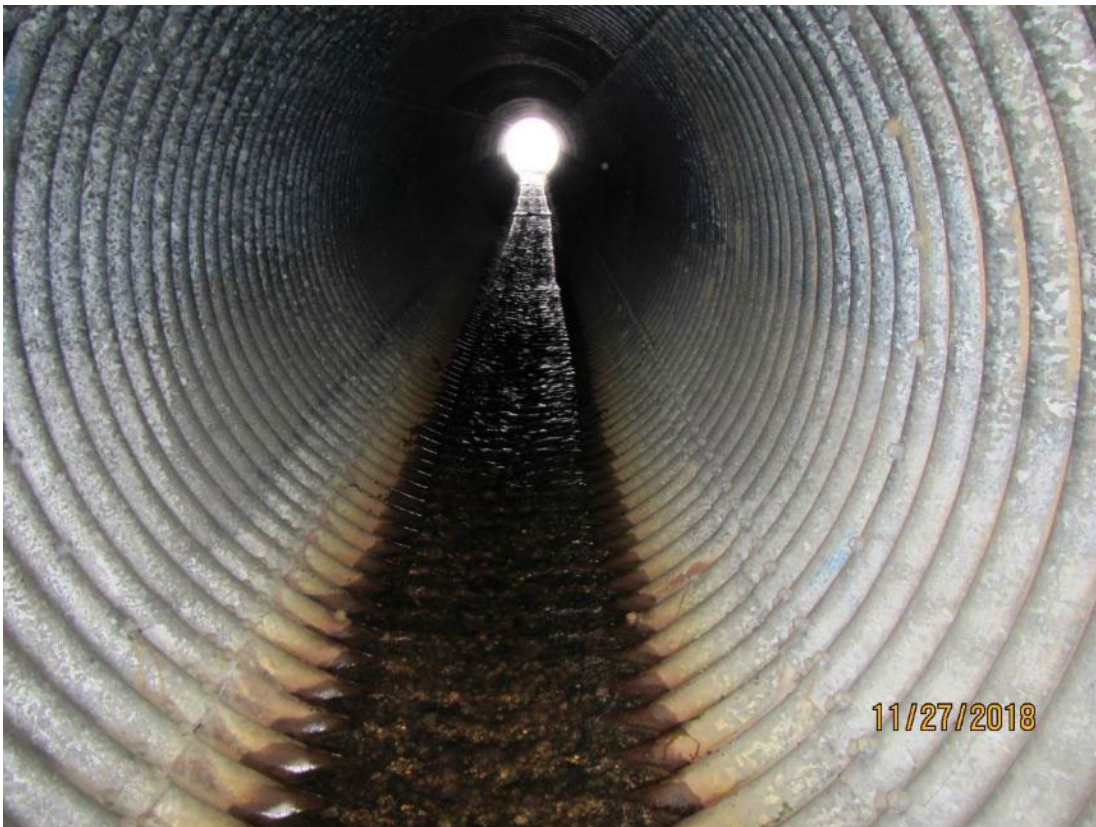
Culvert barrel (Inspection finding photo 2018)

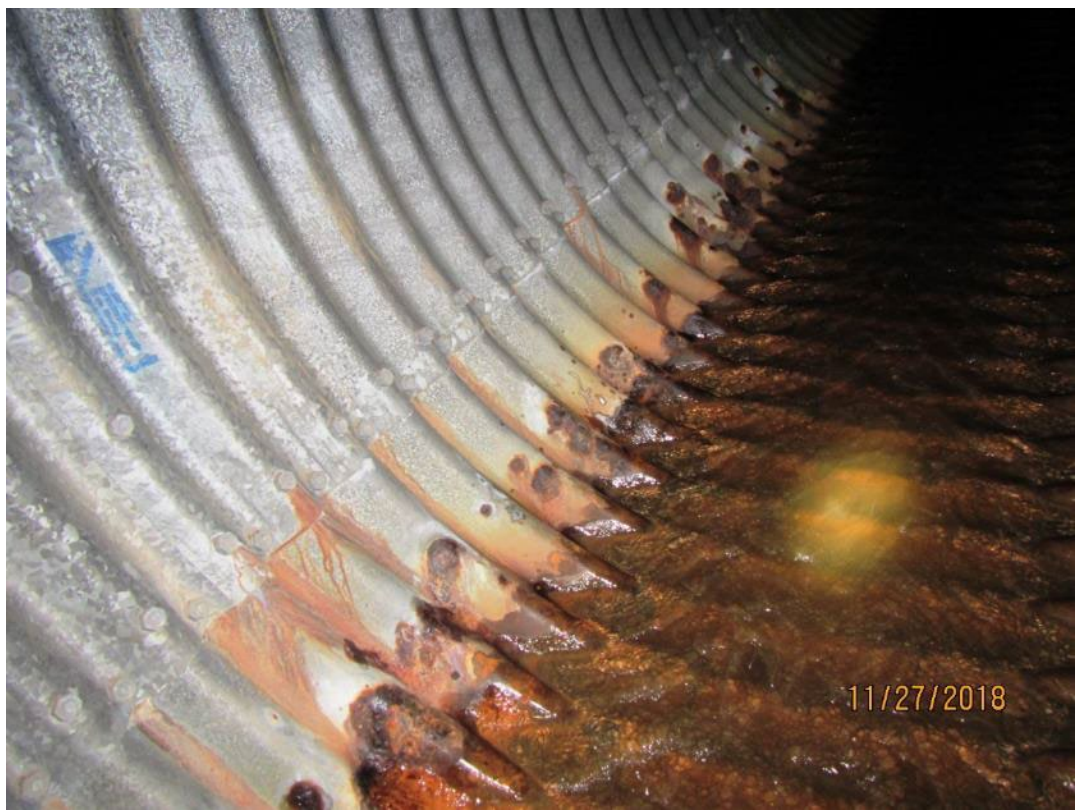
Invert damage, (Inspection finding photos 2018)

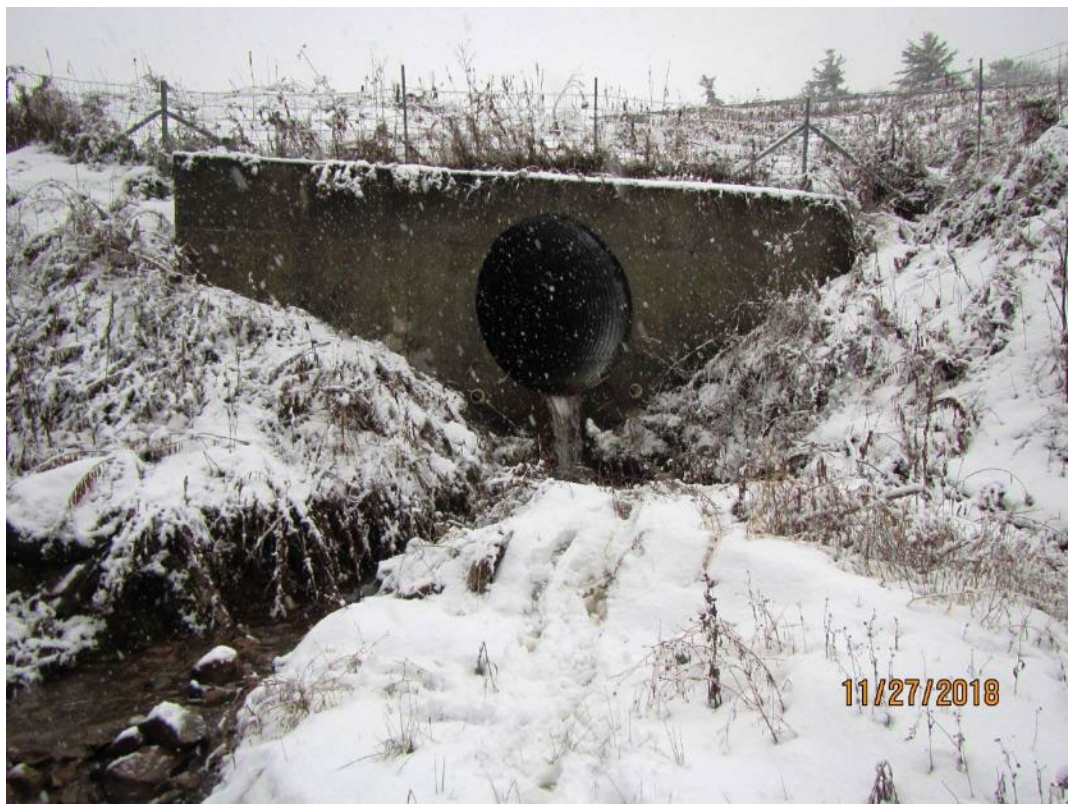
Downstream View of Culvert (Inspection photo 2018)

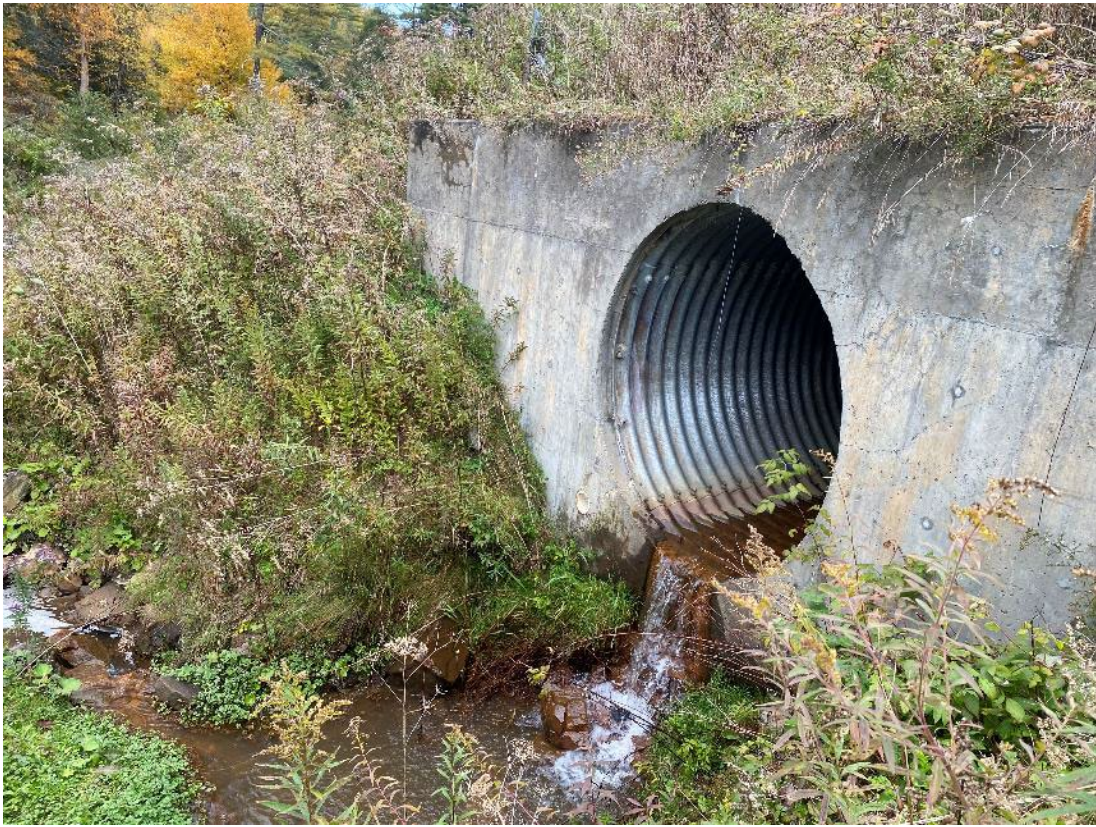
Downstream View of Culvert (Hydraulics/Scoping site visit photo 10/10/2022)

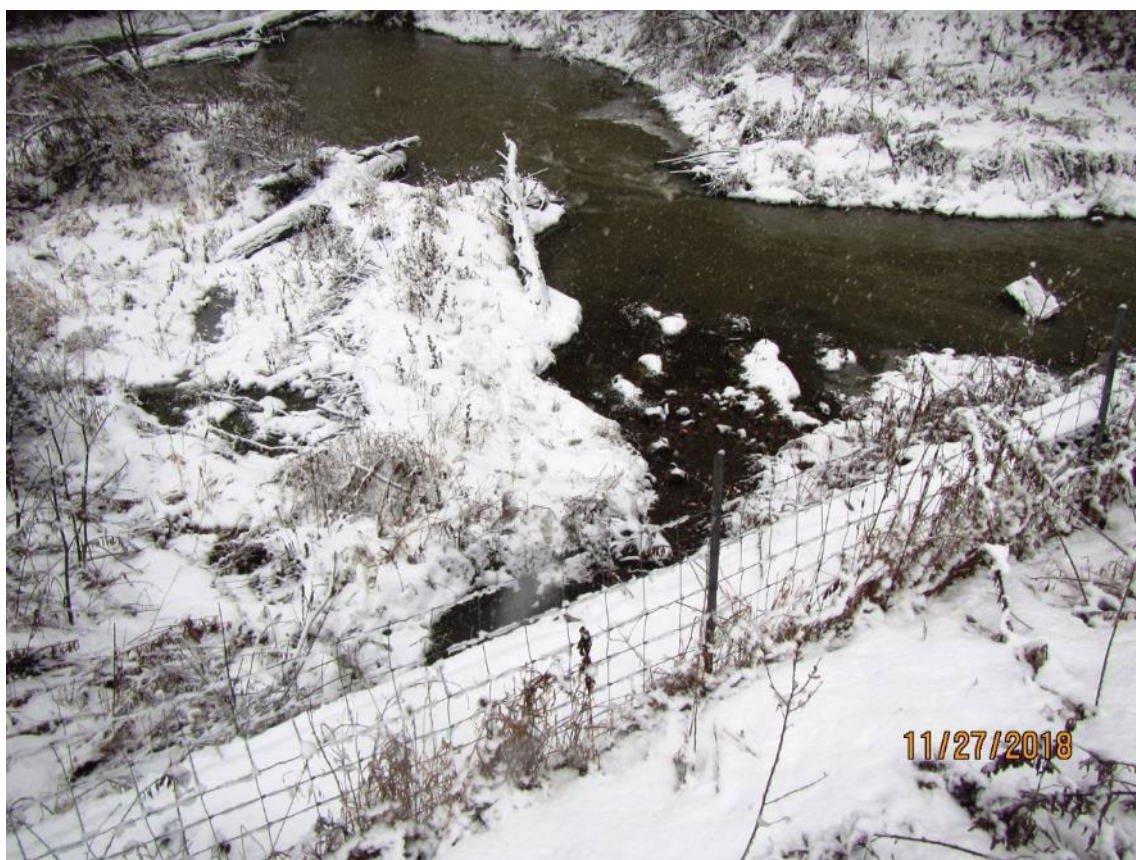
Downstream view (Inspection photo 2018)
