STATE OF VERMONT
AGENCY OF TRANSPORTATION

Scoping Report

Highgate BO 1448(43)
TH 4 (Machia Road), Bridge 25 over the Missisquoi River

December 4, 2013

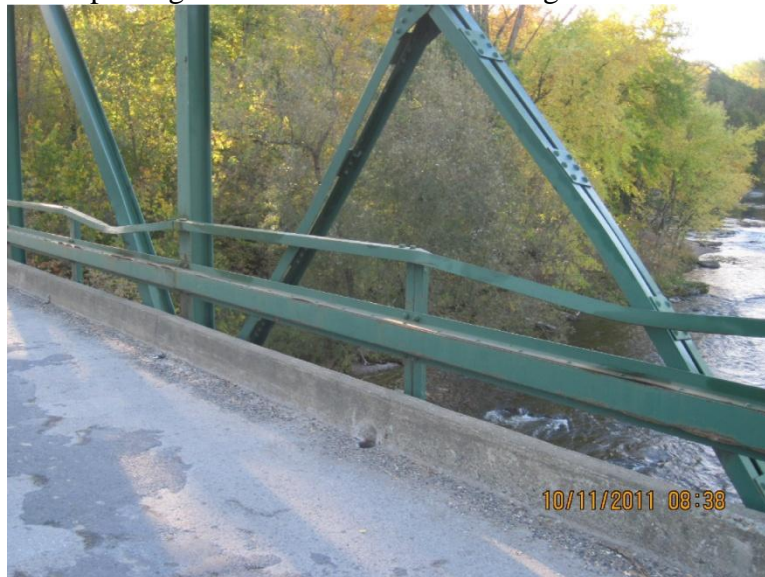
Indications of vehicles impacting the sides of the narrow bridge can be seen in the image below.

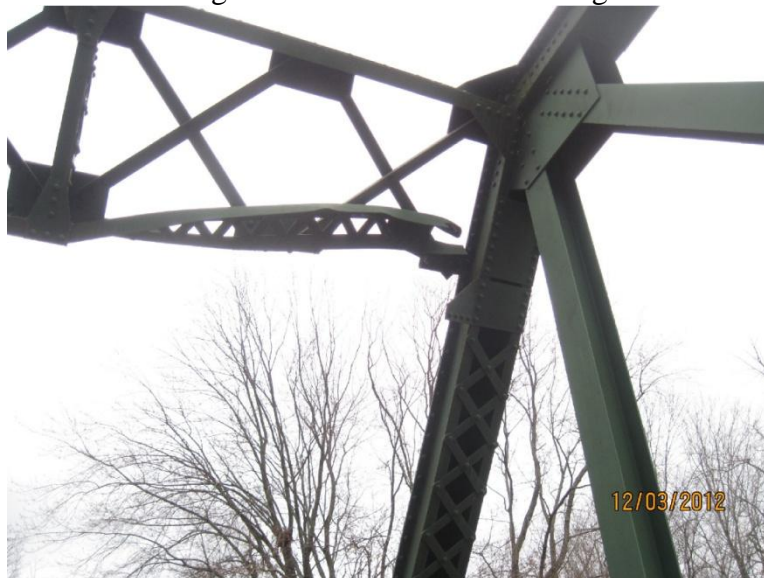
Some of the large agricultural equipment also has attachments that can extend vertically over the 14’-3” clearance envelop provided by the bridge. Indications of vehicles impacting the top lateral bracing of the height restricted bridge can also be seen in the image below.

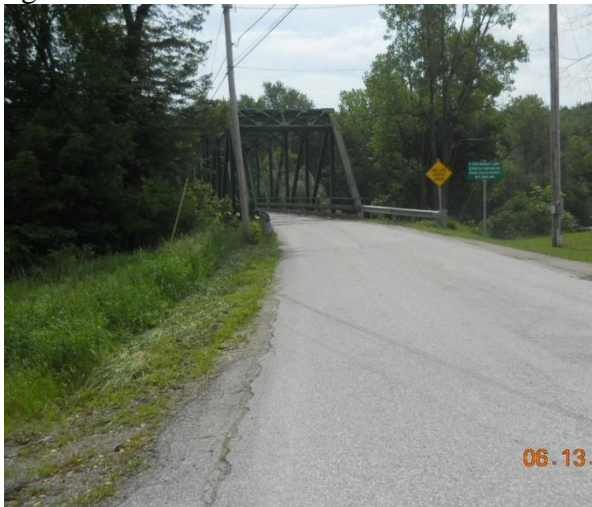
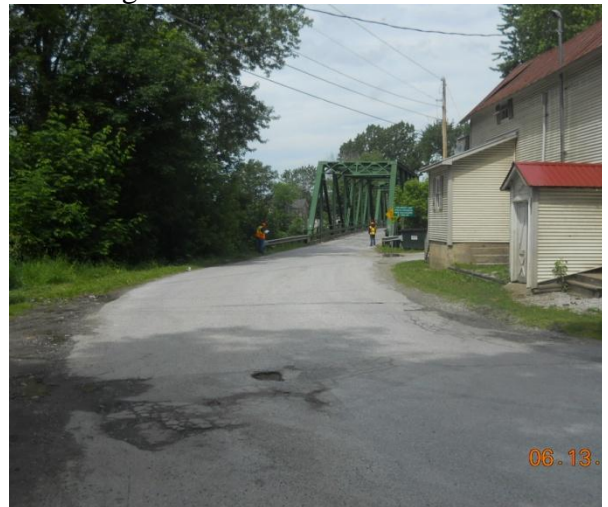
The horizontal and vertical alignments are substandard in this stretch of Machia Road. This creates poor sight distance for people travelling over the bridge. A representation of the poor sight distance can be seen from the west and the east in the images below.

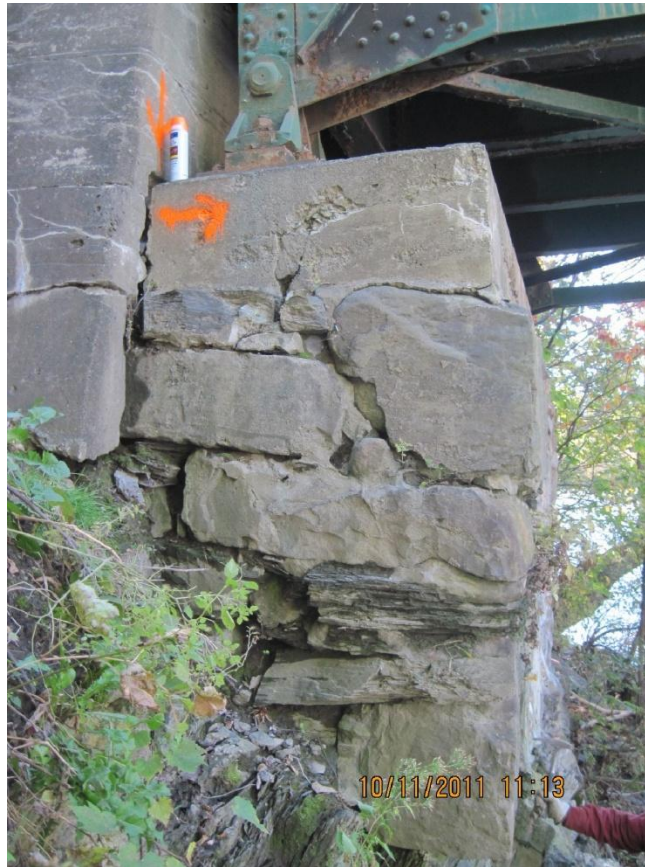
DuBois & King was procured to analyze the various rehabilitation alternatives for the east abutment of Bridge 25 at this site. Some of the deficiencies of this abutment include the following: the concrete cap has a full depth crack, the stone masonry has settled and bowed towards the river, the soft shale stones have deteriorated causing significant voids, much of the mortar between the stones is lost and saturated with water. The recommendation was to completely replace the abutment with a brand new substructure.

Eastern Abutment Slide and Settlement Failure

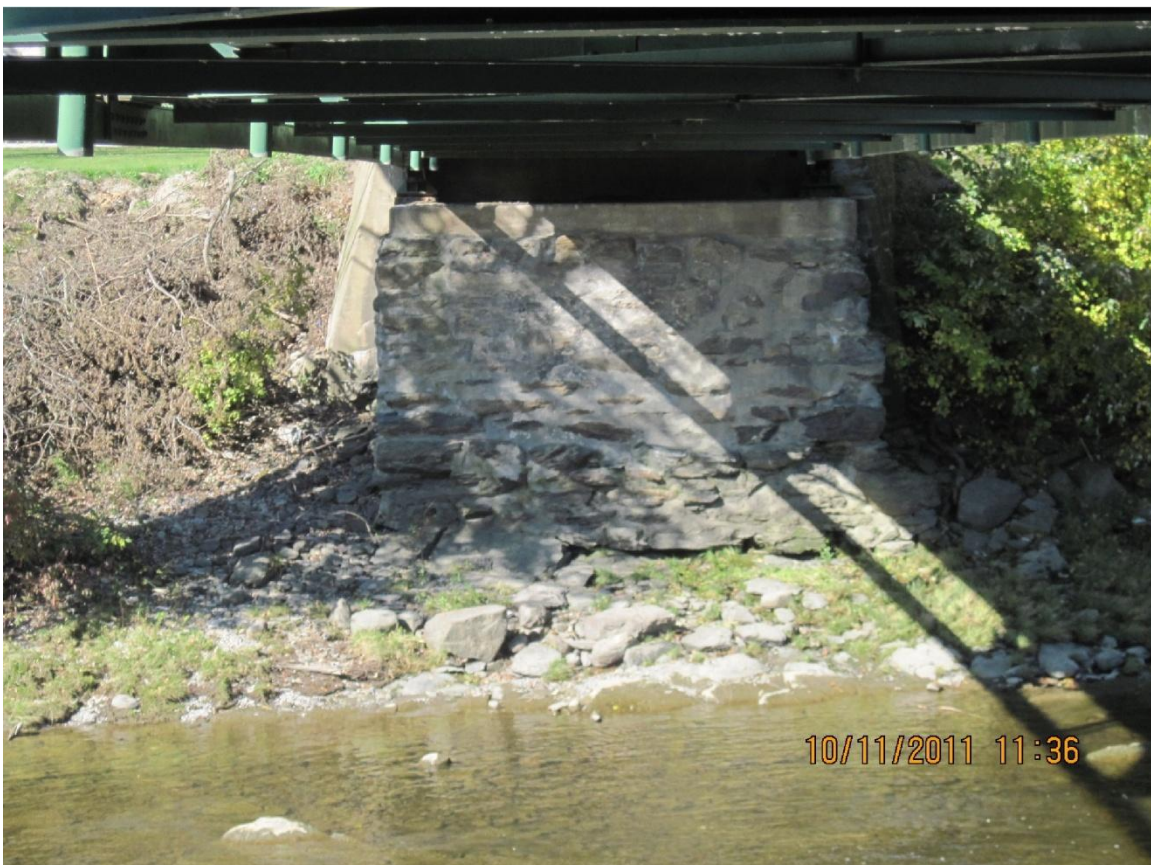
Western Abutment showing undermining

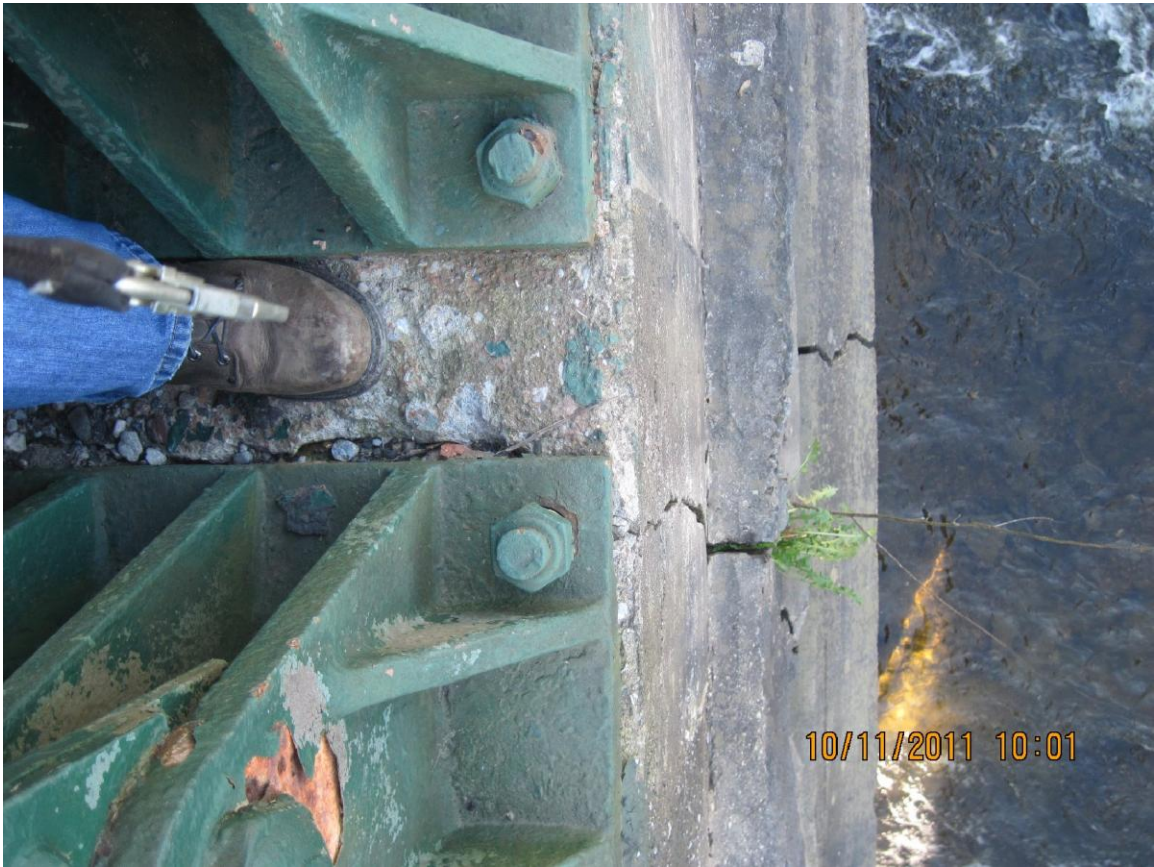
Pier Crack Before Patching

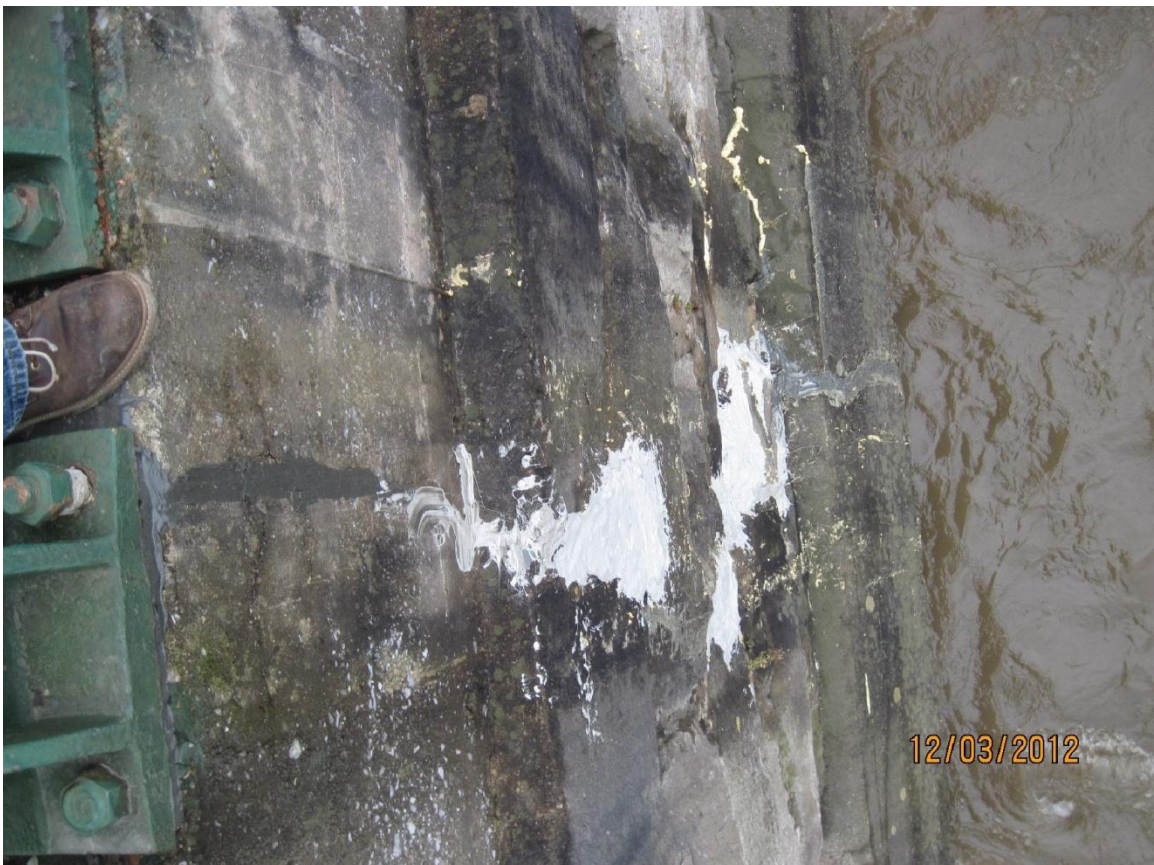
Pier Crack After Patching

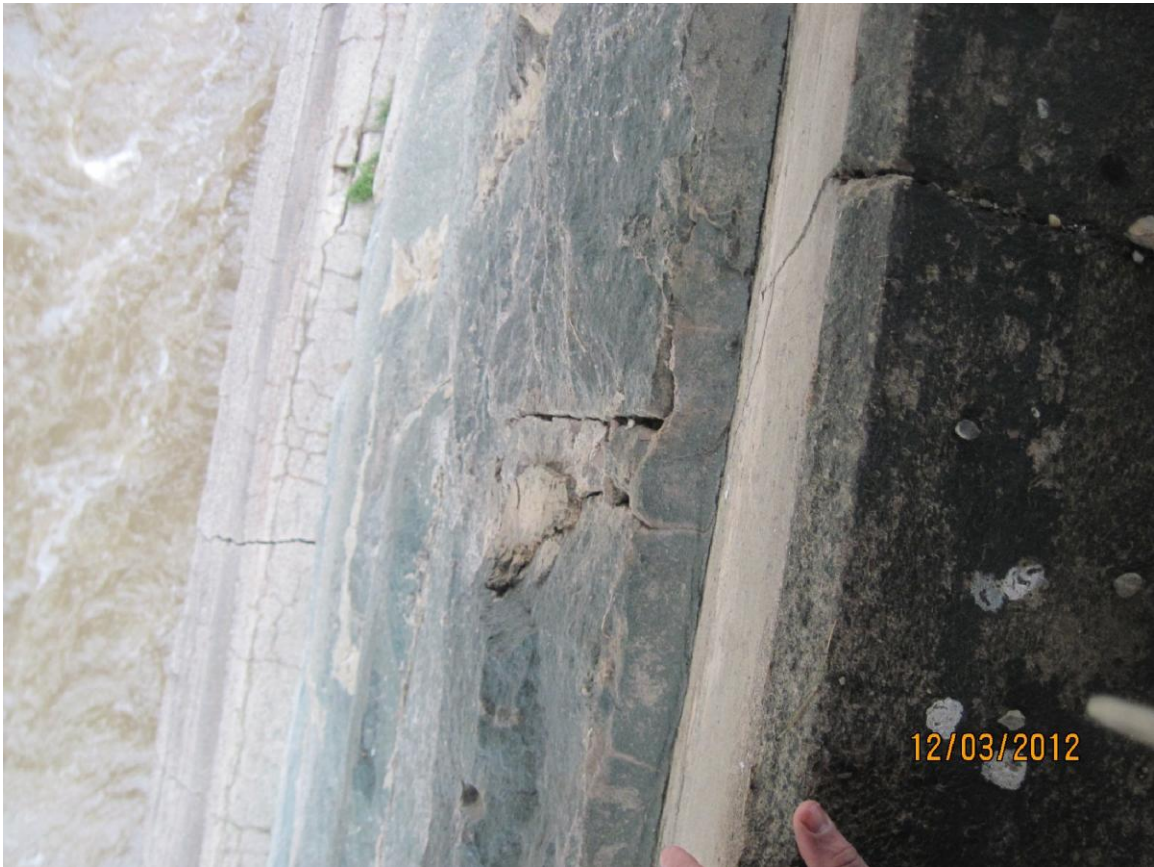
Additional Pier Cracks Continuing to form

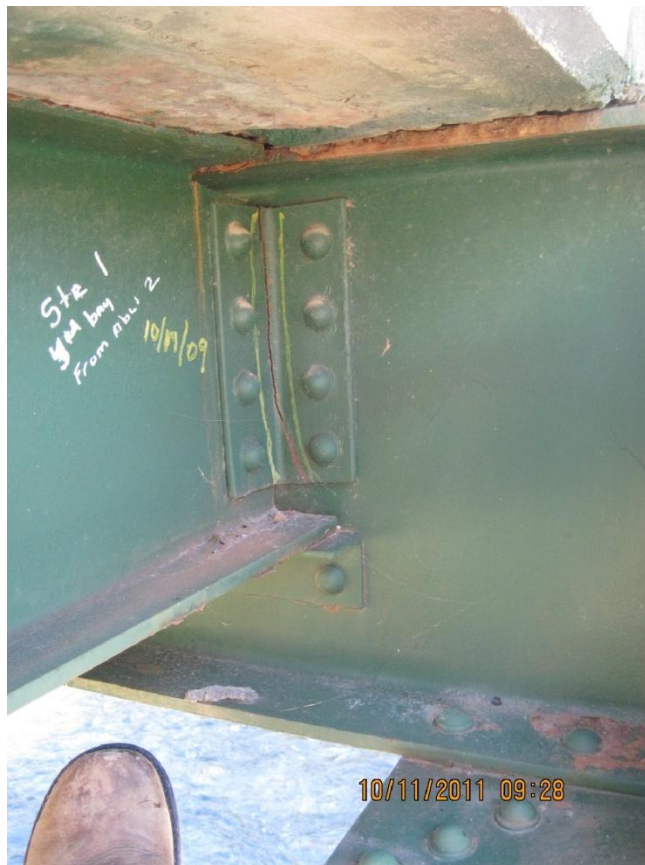
Cracked Stringer Connection Angle

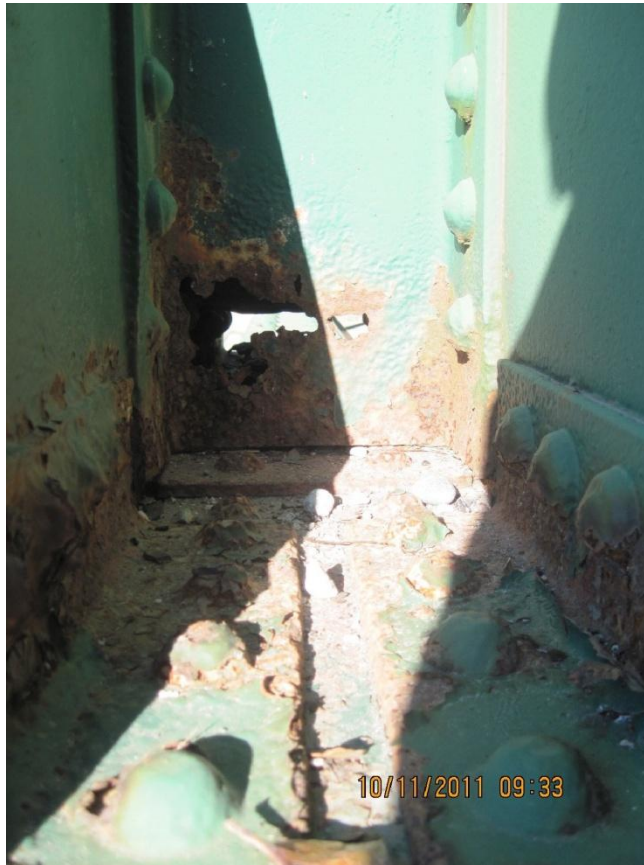
Example of Deteriorated Truss Member (Connection between Vertical member and Bottom Chord)

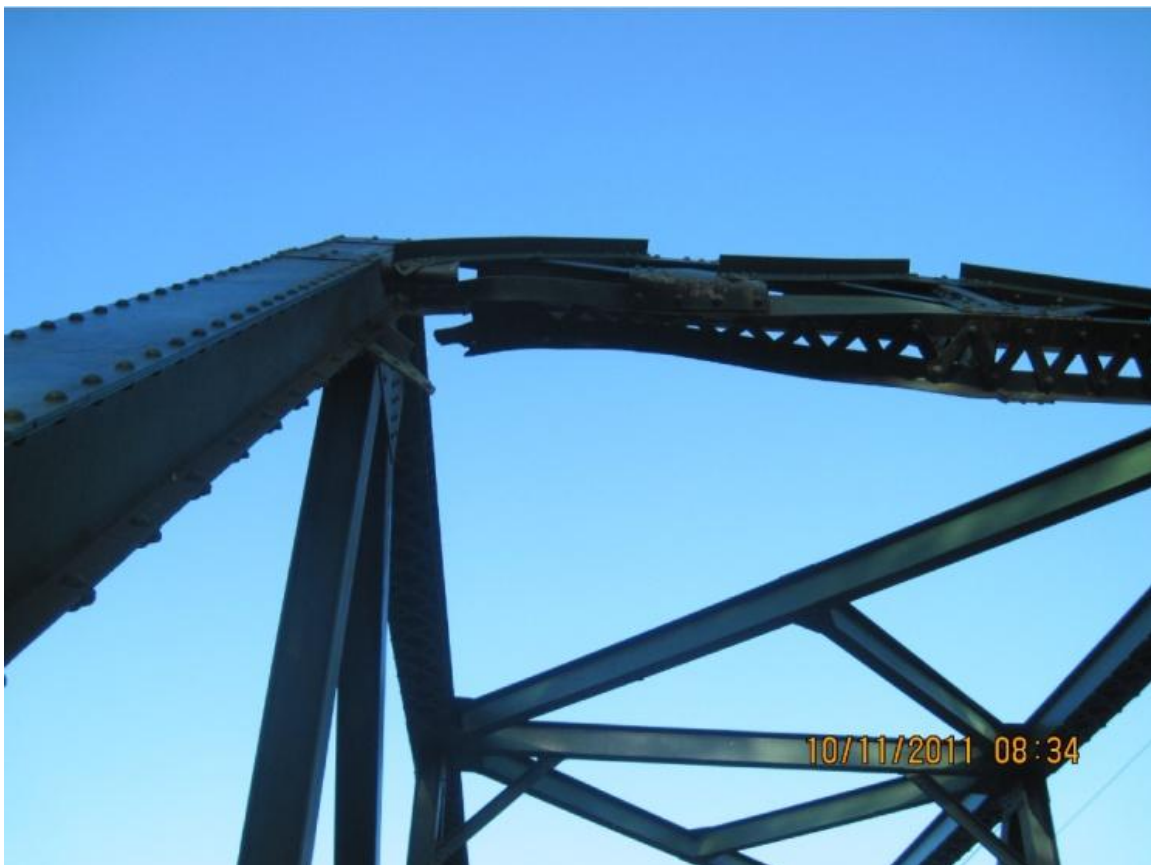
Example of Vehicle Impact Damage (End Portal Member)

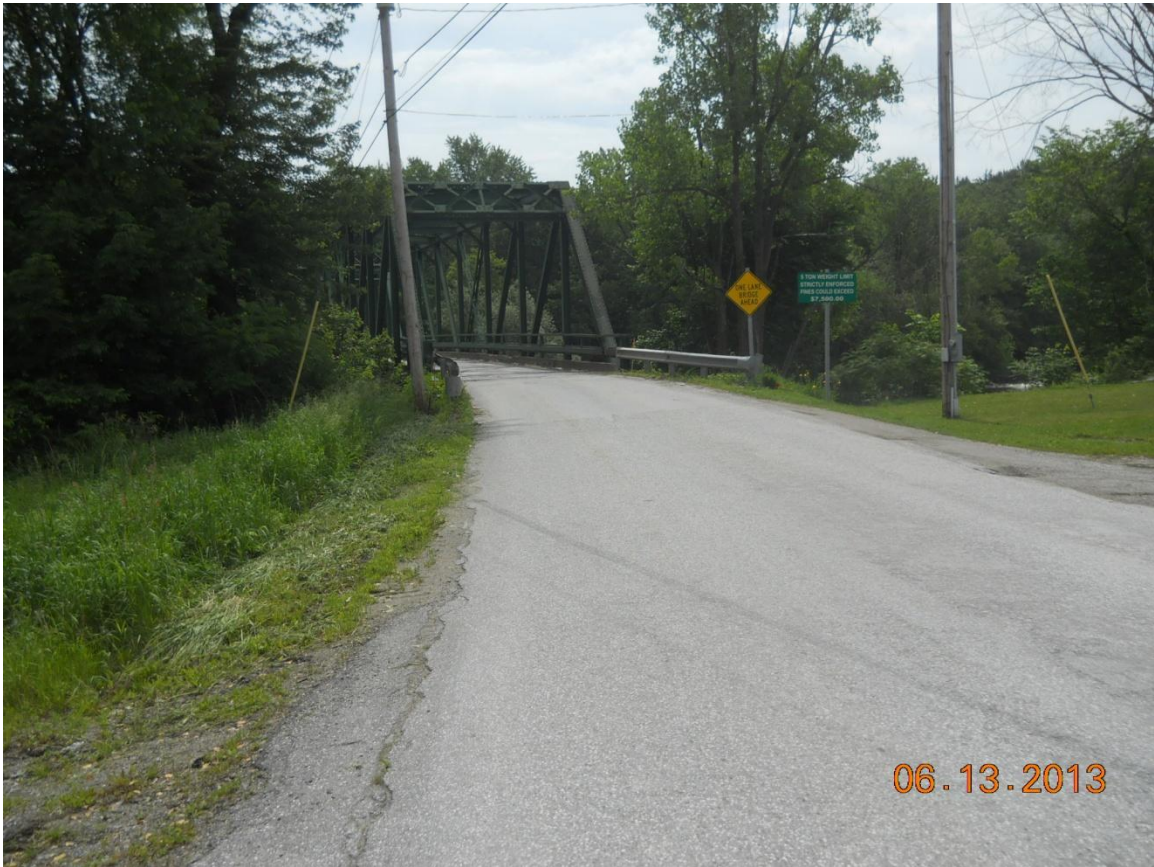
Looking East – showing narrow width and poor sight distance

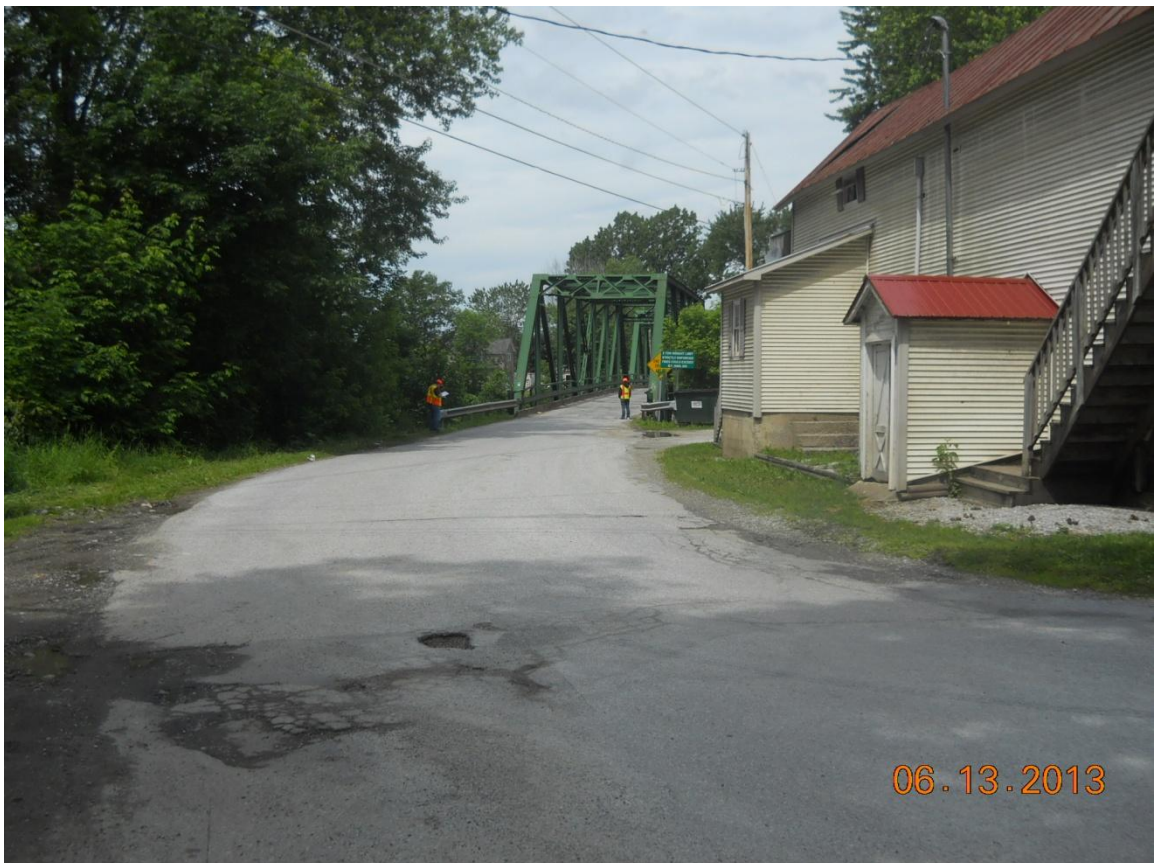
Looking West – showing narrow width and poor sight distance

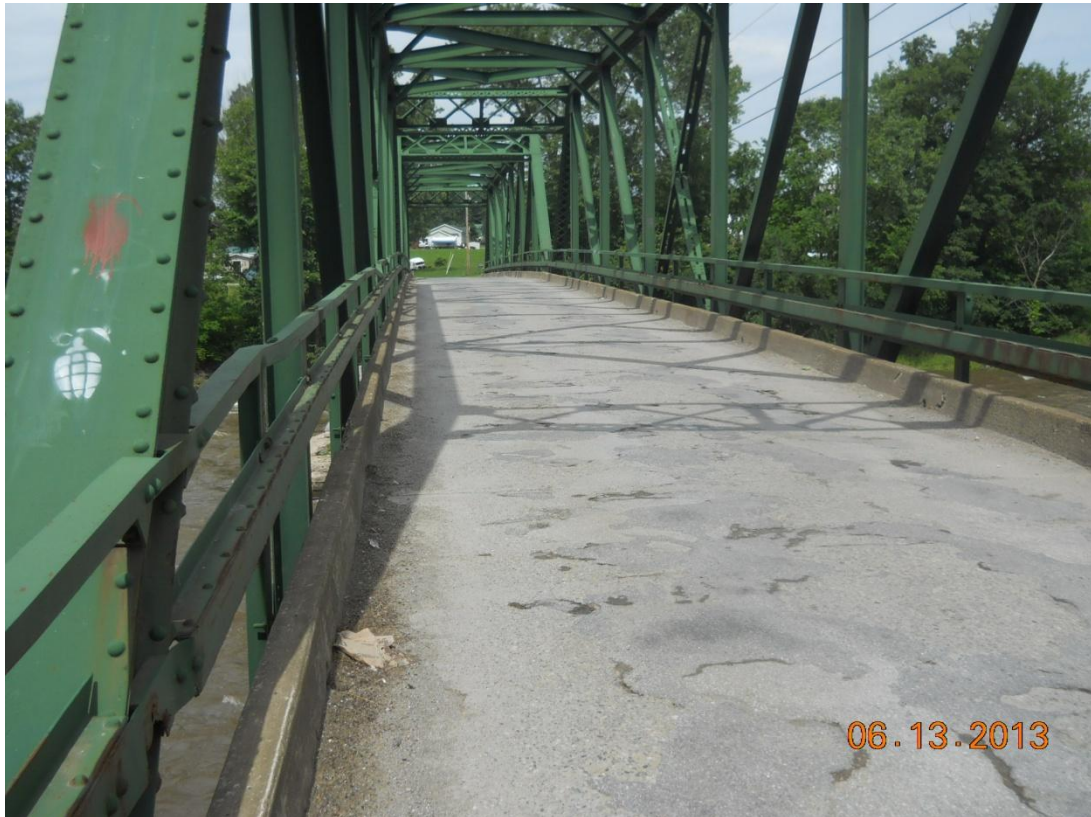
Looking West Across Bridge – Poor Condition of Deck and Pavement, Impact Damage, Narrow Bridge, Overhead Restrictions and Poor Sight Distance

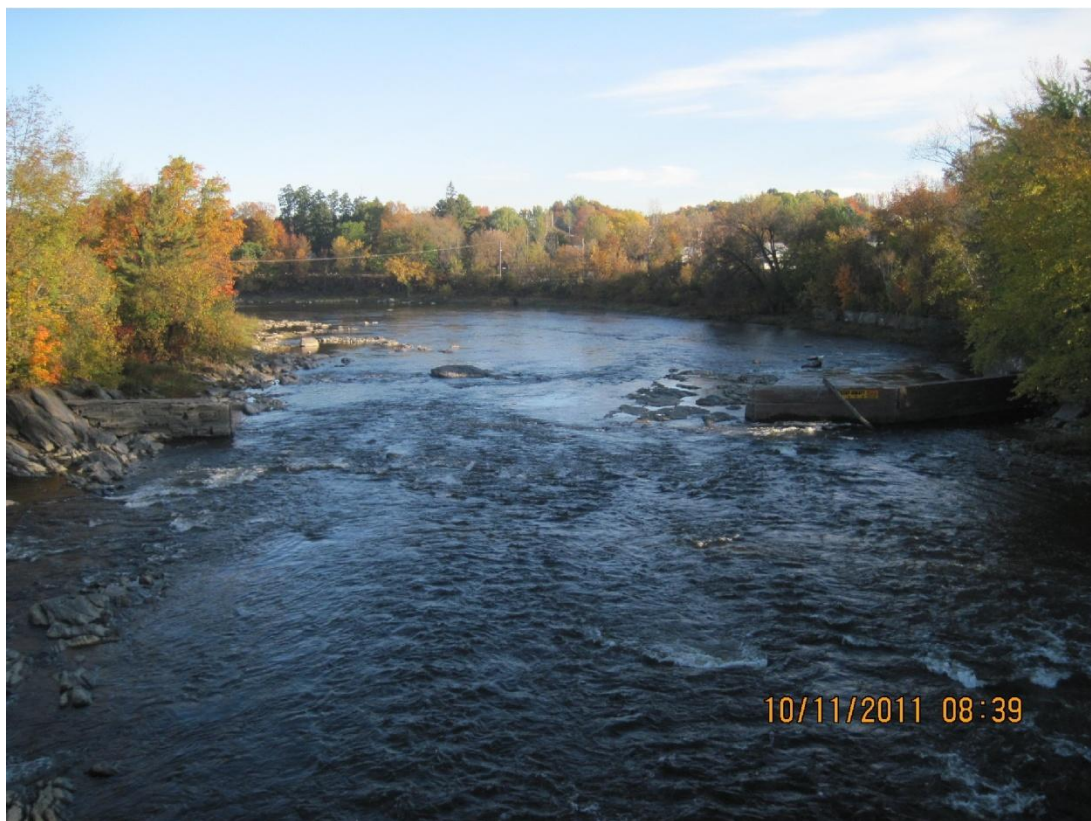
Looking Downstream – showing remains of old river control structures

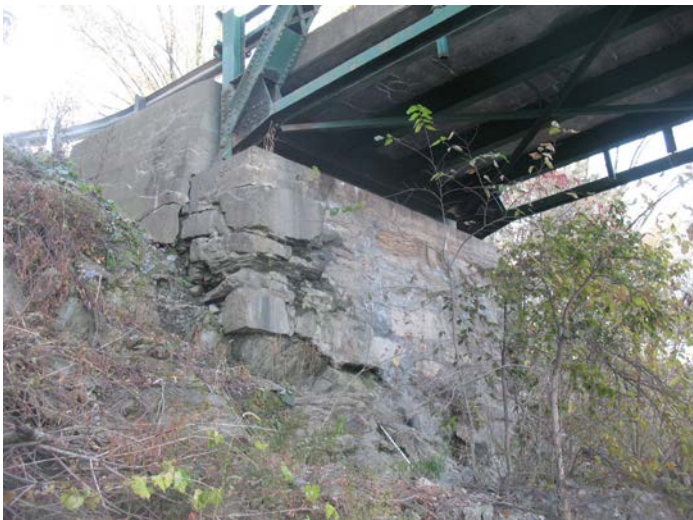
Photo 2009 – abutment no.1

- The downstream stemwall area of abutment no.1 is need of repairs or additional support.

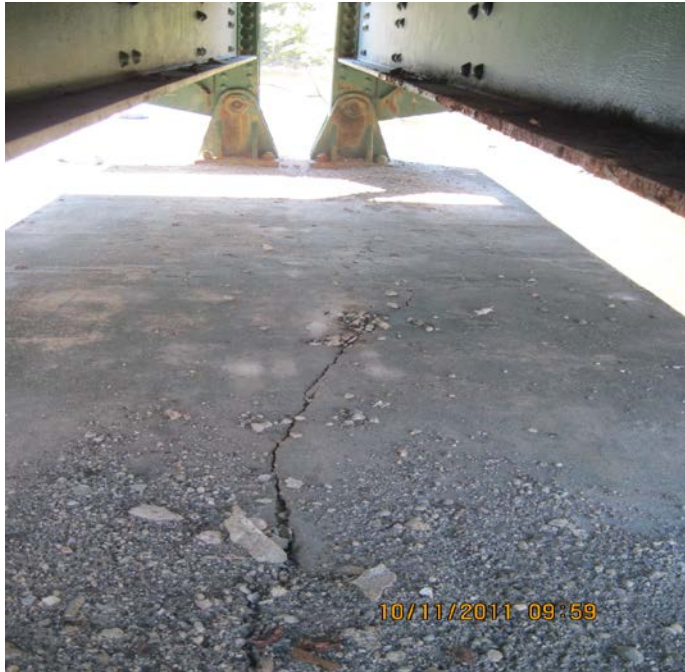
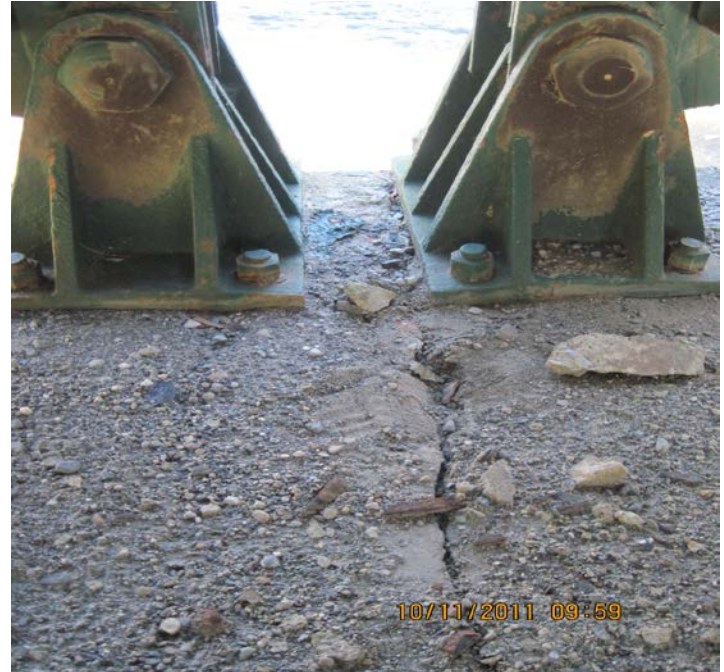
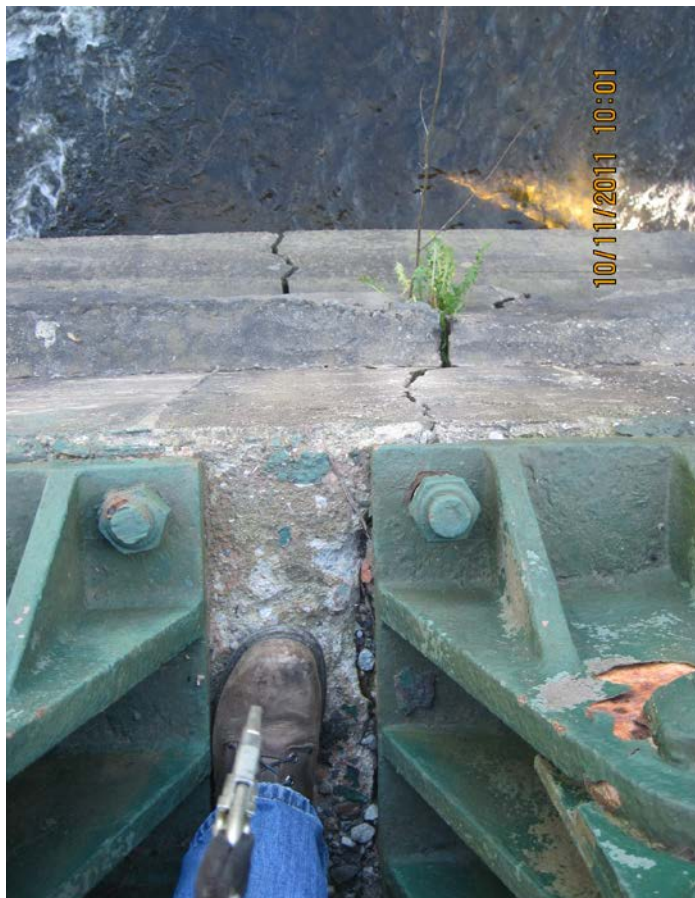
- The downstream end of the concrete pier cap has a 5/16" longitudinal crack running full depth of the cap and extends at least ½ half the distance of the pier length. The crack is situated adjacent to the base plate of the right downstream fix bearing of truss no.1. One anchor bolt on this bearing is pinching upwards due to a flexing movement. This crack flexes back and forth especially under heavy vehicular loading.
