# FACILITY CONDITION ASSESSMENT

FACILITY CONDITION ASSESSMENT  
OF  
BRADFORD INFORMATION CENTER  
I-91 NORTHBOUND, MILE MARKER 100  
BRADFORD, VT 05051

EMG  
10461 Mill Run Circle, Suite 1100  
Owings Mills, Maryland 21117  
800.733.0660  
[www.EMGcorp.com](http://www.EMGcorp.com)

June 19, 2017

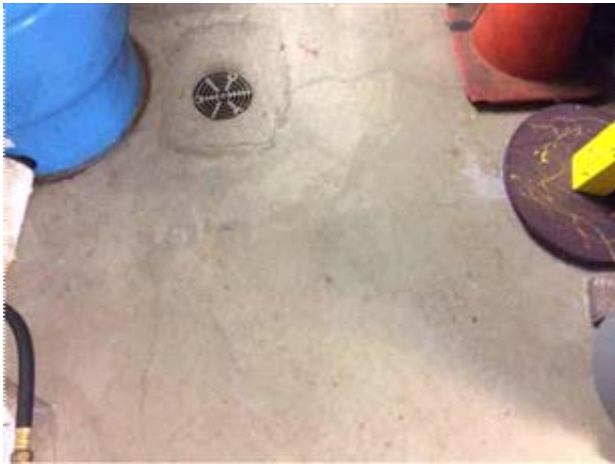
Coding / Field Name	Asset Description
A1031 Standard Slab on Grade	Concrete Slab-On-Grade
Condition	Good
Qty / UOM	2311 / SF
Unit Cost	\$10.44
Basis of Costing	Concrete Slab-On-Grade
Year in Service	1994
Expected Useful Life (EUL)	40 Year(s), Based on Industry Averages
Remaining Useful Life (RUL)	30 Year(s), Estimated, Based on Date of Observation
Location	Structure

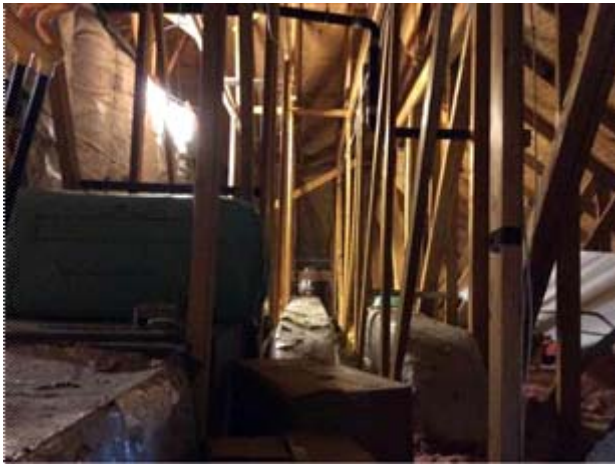
Coding / Field Name	Asset Description
<b>B1012 Upper Floors Construction</b>	Superstructure
<b>Condition</b>	Good
<b>Qty / UOM</b>	2311 / SF
<b>Unit Cost</b>	\$18.10
<b>Basis of Costing</b>	Superstructure, Structural Frame, Wood Conventional Stud
<b>Year in Service</b>	1994
<b>Expected Useful Life (EUL)</b>	50 Year(s), Based on Industry Averages
<b>Remaining Useful Life (RUL)</b>	35 Year(s), Estimated, Based on Date of Observation
<b>Location</b>	Structure

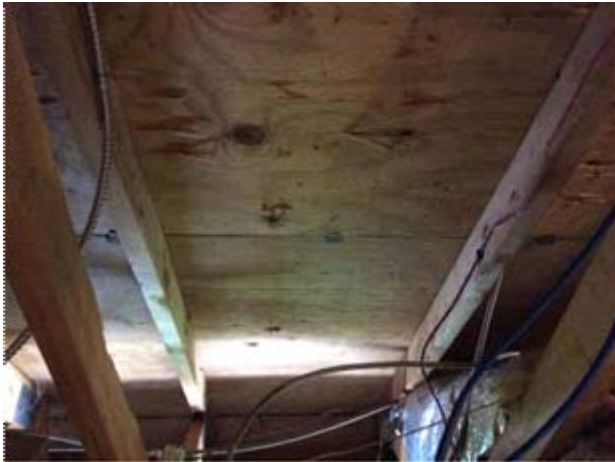
Coding / Field Name	Asset Description
<b>B1022 Pitched Roof Construction</b>	Roof Structure
<b>Condition</b>	Good
<b>Qty / UOM</b>	2311 / SF
<b>Unit Cost</b>	\$19.72
<b>Basis of Costing</b>	Roof Structure, Pitched, Wood Rafters
<b>Year in Service</b>	1994
<b>Expected Useful Life (EUL)</b>	50 Year(s), Based on Industry Averages
<b>Remaining Useful Life (RUL)</b>	27 Year(s), Estimated, Based on Date of Observation
<b>Location</b>	Structure
<b>Roofing Type</b>	Gable
<b>Parapet Wall Edge Flashing</b>	Metal
<b>Attic</b>	No
<b>Roof Access</b>	None

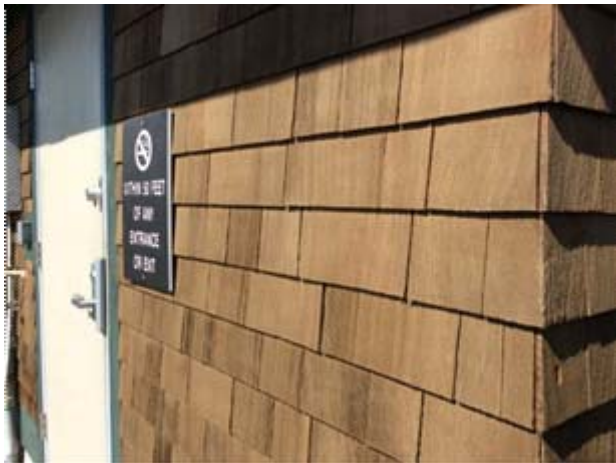
Coding / Field Name	Asset Description
<b>B2011 Exterior Wall Construction</b>	Wood Shingles
<b>Condition</b>	Good
<b>Qty / UOM</b>	2500 / SF
<b>Unit Cost</b>	\$6.69
<b>Basis of Costing</b>	Wood Shingles, 1-2 Stories
<b>Year in Service</b>	2010
<b>Expected Useful Life (EUL)</b>	20 Year(s), Based on Industry Averages
<b>Remaining Useful Life (RUL)</b>	15 Year(s), Estimated, Based on Date of Observation
<b>Location</b>	Exterior Walls
<b>Exterior Wall Construction</b>	Wood Shake Siding
<b>Parapets</b>	No
<b>Exterior Soffits</b>	Exposed

Uniformat	Action Description	Quantity	Unit Cost	Plan Type	Priority	Year	Expenditure
<b>B2011</b>	Prep & Paint/Stain Exterior Walls	2,500 SF	\$1.41	APP	Priority 3	2022	\$3,525
<b>B2011</b>	Prep & Paint/Stain Exterior Walls	2,500 SF	\$1.41	APP	Priority 3	2032	\$3,525
<b>B2011</b>	Replace Wood Shingles	2,500 SF	\$6.69	BYL	Priority 3	2032	\$16,723

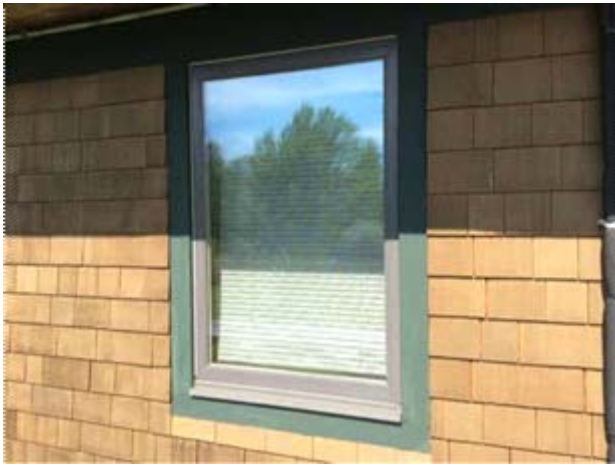
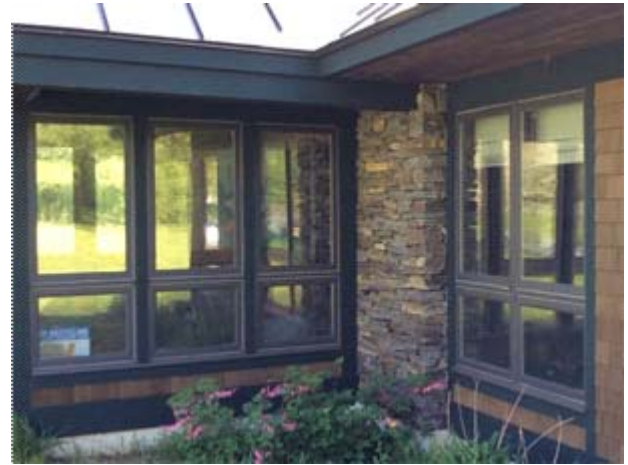
Wood with vinyl-clad exteriors.

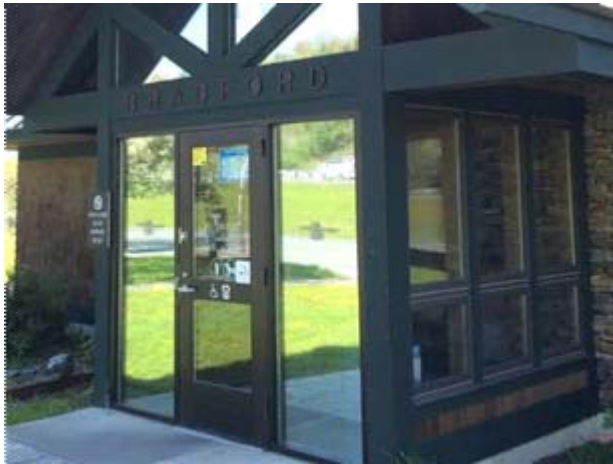
Coding / Field Name	Asset Description
<b>B2021 Windows</b>	Storefront Glazing & Framing
<b>Condition</b>	Fair
<b>Qty / UOM</b>	100 / SF
<b>Unit Cost</b>	\$11.02
<b>Basis of Costing</b>	Glass Curtain Wall, Neoprene Gaskets, Tongued Mullion (assumes 18 SF panels)
<b>Year in Service</b>	1994
<b>Expected Useful Life (EUL)</b>	15 Year(s), Based on Industry Averages
<b>Remaining Useful Life (RUL)</b>	4 Year(s), Estimated, Based on Date of Observation
<b>Location</b>	Exterior Walls

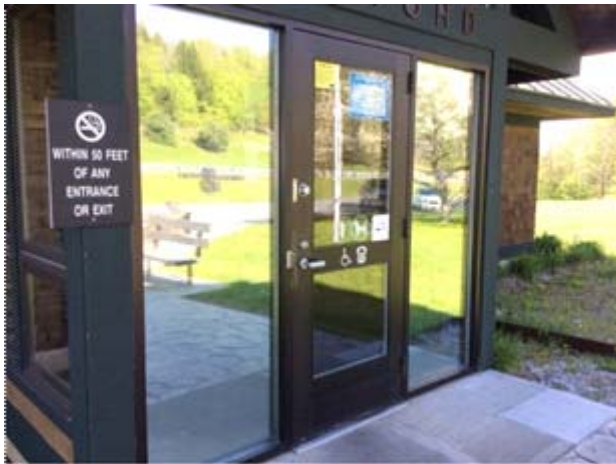
Coding / Field Name	Asset Description
<b>B2031 Glazed Doors &amp; Entrances</b>	Aluminum Frame, Fully Glazed, Exterior Door
<b>Condition</b>	Fair
<b>Qty / UOM</b>	2 / EA
<b>Unit Cost</b>	\$1,368.37
<b>Basis of Costing</b>	Aluminum Frame, Fully Glazed, Exterior Door
<b>Year in Service</b>	1994
<b>Expected Useful Life (EUL)</b>	30 Year(s), Based on Industry Averages
<b>Remaining Useful Life (RUL)</b>	15 Year(s), Estimated, Based on Date of Observation
<b>Location</b>	Exterior Walls
<b>Door Hardware</b>	Lever
<b>Door Operation</b>	Manual
<b>Glass Type</b>	Tempered Glass
<b>Door Frame</b>	Metal Framed
<b>Door Use</b>	Entrance

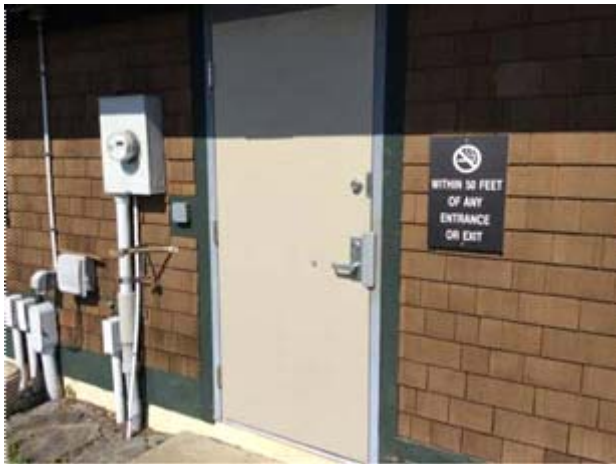
Coding / Field Name	Asset Description
<b>B2032 Solid Exterior Doors</b>	Steel, Insulated, Exterior Door
<b>Condition</b>	Fair
<b>Qty / UOM</b>	1 / EA
<b>Unit Cost</b>	\$1,577.53
<b>Basis of Costing</b>	Steel, Insulated, Exterior Door
<b>Year in Service</b>	1994
<b>Expected Useful Life (EUL)</b>	25 Year(s), Based on Industry Averages
<b>Remaining Useful Life (RUL)</b>	12 Year(s), Estimated, Based on Date of Observation
<b>Location</b>	Exterior Walls
<b>Door Hardware</b>	Lever
<b>Door Operation</b>	Manual
<b>Core Type</b>	Hollow Core
<b>Door Frame</b>	Metal Framed

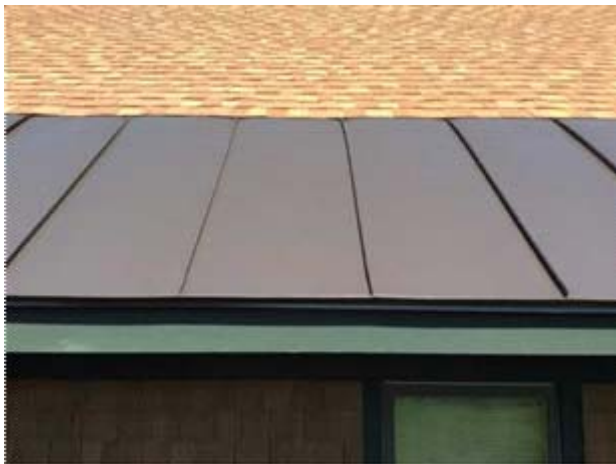
Coding / Field Name	Asset Description
<b>B3011 Roof Finishes</b>	Metal Roof
<b>Condition</b>	Good
<b>Qty / UOM</b>	1000 / SF
<b>Unit Cost</b>	\$32.41
<b>Basis of Costing</b>	Metal Roof (Includes Tear-Off of Old)
<b>Year in Service</b>	2016
<b>Expected Useful Life (EUL)</b>	40 Year(s), Based on Industry Averages
<b>Remaining Useful Life (RUL)</b>	39 Year(s), Estimated, Based on Date of Observation
<b>Location</b>	Roof

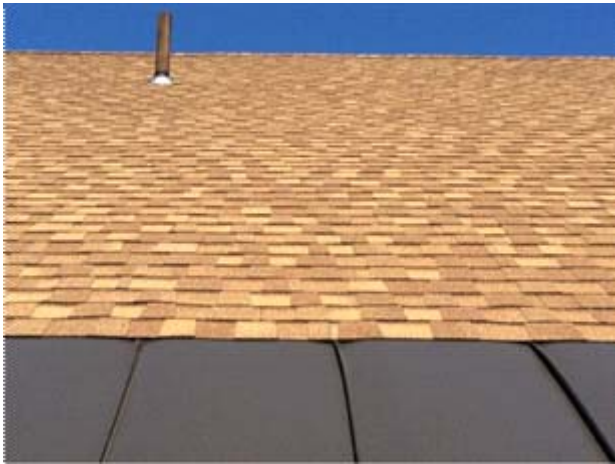
Coding / Field Name	Asset Description
<b>B3011 Roof Finishes</b>	Asphalt Shingle Roof
<b>Condition</b>	Good
<b>Qty / UOM</b>	3000 / SF
<b>Unit Cost</b>	\$16.16
<b>Basis of Costing</b>	Asphalt Shingle Roof (Includes Tear-Off of Old)
<b>Year in Service</b>	2016
<b>Expected Useful Life (EUL)</b>	20 Year(s), Based on Industry Averages
<b>Remaining Useful Life (RUL)</b>	19 Year(s), Estimated, Based on Date of Observation
<b>Location</b>	Roof

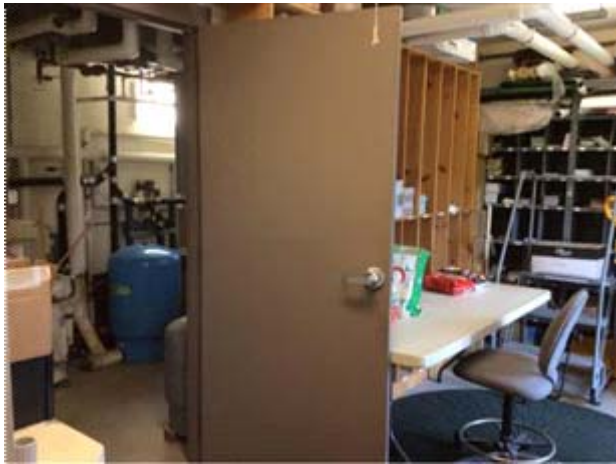
Coding / Field Name	Asset Description
<b>C1021 Interior Doors</b>	Steel, Interior Door
<b>Condition</b>	Fair
<b>Qty / UOM</b>	7 / EA
<b>Unit Cost</b>	\$950.12
<b>Basis of Costing</b>	Steel, Interior Door
<b>Year in Service</b>	1994
<b>Expected Useful Life (EUL)</b>	25 Year(s), Based on Industry Averages
<b>Remaining Useful Life (RUL)</b>	15 Year(s), Estimated, Based on Date of Observation
<b>Location</b>	Building Interior (General)

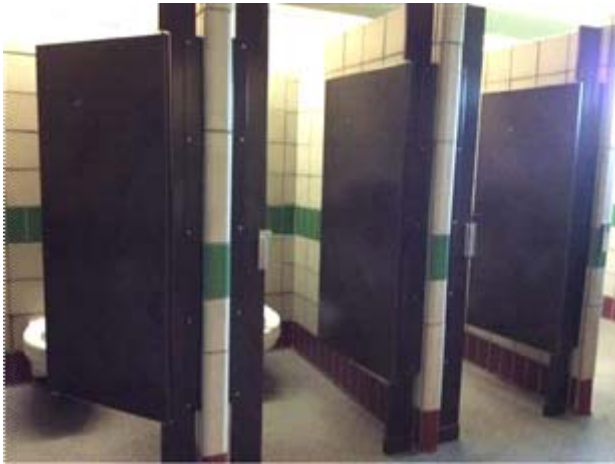
Coding / Field Name	Asset Description
<b>C1031 Fabricated Toilet Partitions</b>	Toilet Partitions, Metal, Overhead Braced
<b>Condition</b>	Fair
<b>Qty / UOM</b>	6 / EA
<b>Unit Cost</b>	\$850.00
<b>Basis of Costing</b>	Toilet Partitions, Metal, Overhead Braced
<b>Year in Service</b>	1994
<b>Expected Useful Life (EUL)</b>	20 Year(s), Based on Industry Averages
<b>Remaining Useful Life (RUL)</b>	10 Year(s), Estimated, Based on Date of Observation
<b>Location</b>	Restrooms

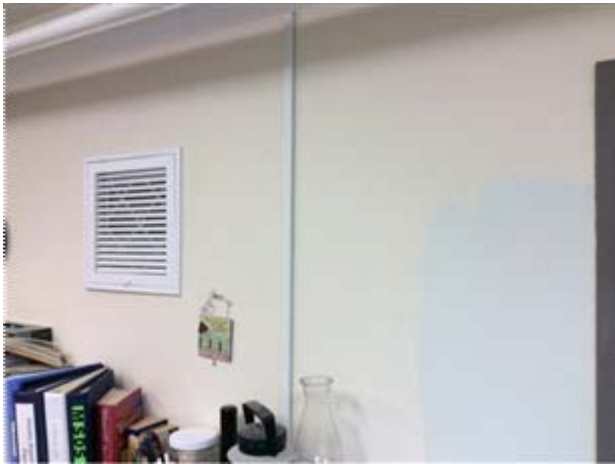
Coding / Field Name	Asset Description
<b>C3012 Wall Finishes to Interior Walls</b>	Gypsum Board, Wall
<b>Condition</b>	Fair
<b>Qty / UOM</b>	4000 / SF
<b>Unit Cost</b>	\$3.38
<b>Basis of Costing</b>	Gypsum Board/Plaster, Interior Wall
<b>Year in Service</b>	1994
<b>Expected Useful Life (EUL)</b>	40 Year(s), Based on Industry Averages
<b>Remaining Useful Life (RUL)</b>	25 Year(s), Estimated, Based on Date of Observation
<b>Location</b>	Building Interior (General)

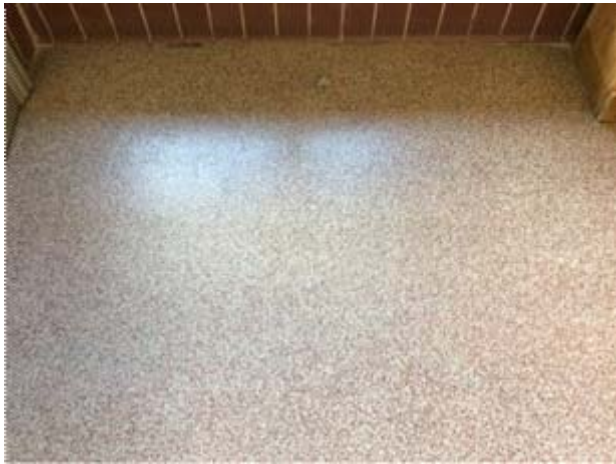
Coding / Field Name	Asset Description
<b>C3021 Floor Toppings</b>	Epoxy Floor Finish
<b>Condition</b>	Fair
<b>Qty / UOM</b>	2000 / SF
<b>Unit Cost</b>	\$8.74
<b>Basis of Costing</b>	Epoxy Floor Finish
<b>Year in Service</b>	1995
<b>Expected Useful Life (EUL)</b>	10 Year(s), Based on Industry Averages
<b>Remaining Useful Life (RUL)</b>	5 Year(s), Estimated, Based on Date of Observation
<b>Location</b>	Building Interior (General)

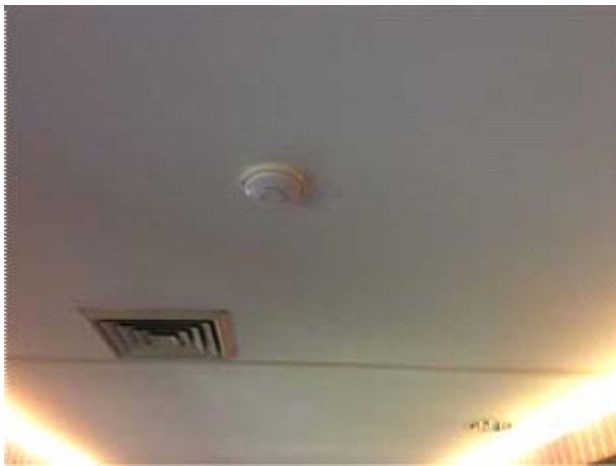
Coding / Field Name	Asset Description
<b>C3031 Ceiling Finishes</b>	Gypsum Board Ceiling
<b>Condition</b>	Fair
<b>Qty / UOM</b>	2400 / SF
<b>Unit Cost</b>	\$7.13
<b>Basis of Costing</b>	Gypsum Board/Plaster, Ceiling
<b>Year in Service</b>	1994
<b>Expected Useful Life (EUL)</b>	50 Year(s), Based on Industry Averages
<b>Remaining Useful Life (RUL)</b>	27 Year(s), Estimated, Based on Date of Observation
<b>Location</b>	Building Interior (General)

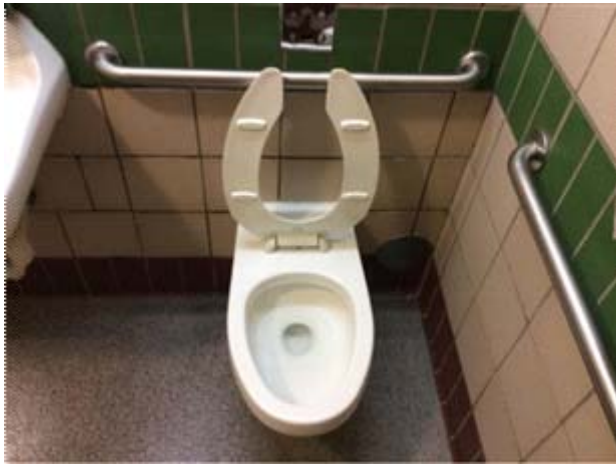
Coding / Field Name	Asset Description
D2011 Water Closets	Tankless Water Closet
Condition	Fair
Qty / UOM	7 / EA
Unit Cost	\$842.97
Basis of Costing	Tankless Water Closet
Year in Service	1994
Expected Useful Life (EUL)	20 Year(s), Based on Industry Averages
Remaining Useful Life (RUL)	10 Year(s), Estimated, Based on Date of Observation
Location	Restrooms

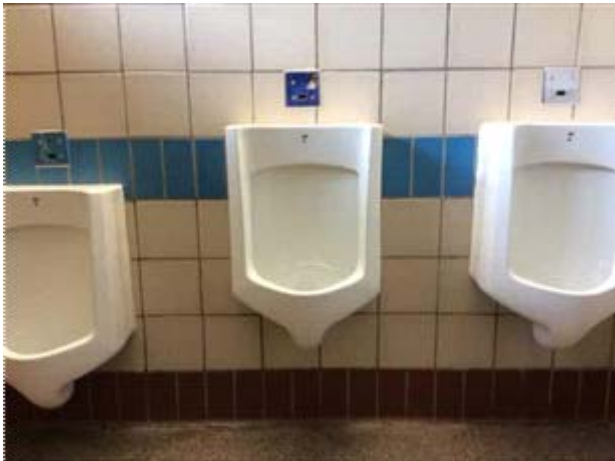
Coding / Field Name	Asset Description
<b>D2012 Urinals</b>	Urinal, Vitreous China
<b>Condition</b>	Fair
<b>Qty / UOM</b>	3 / EA
<b>Unit Cost</b>	\$1,193.44
<b>Basis of Costing</b>	Urinal, Vitreous China
<b>Year in Service</b>	2008
<b>Expected Useful Life (EUL)</b>	20 Year(s), Based on Industry Averages
<b>Remaining Useful Life (RUL)</b>	11 Year(s), Estimated, Based on Date of Observation
<b>Location</b>	Restrooms
<b>System Grade</b>	Commercial Grade

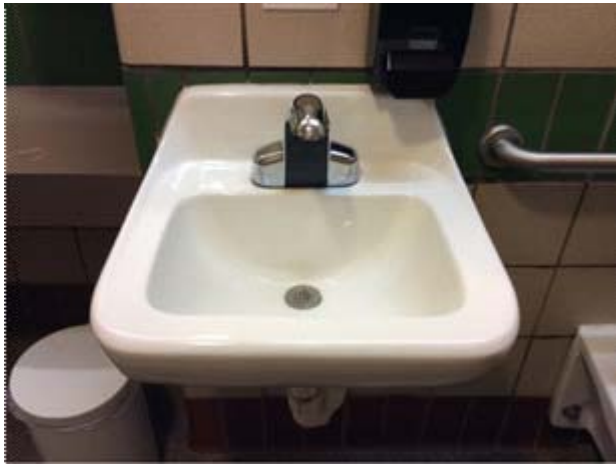
Coding / Field Name	Asset Description
D2013 Lavatories	Lavatory, Enameled Steel
Condition	Fair
Qty / UOM	7 / EA
Unit Cost	\$353.05
Basis of Costing	Lavatory, Enameled Steel
Year in Service	1994
Expected Useful Life (EUL)	20 Year(s), Based on Industry Averages
Remaining Useful Life (RUL)	10 Year(s), Estimated, Based on Date of Observation
Location	Restrooms

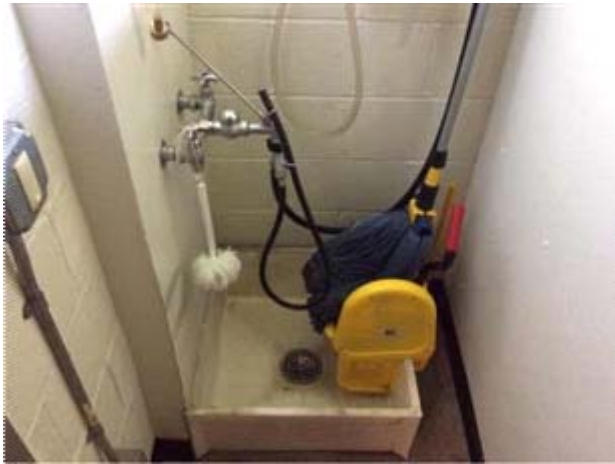
Coding / Field Name	Asset Description
D2014 Sinks	Service Sink, Floor
Condition	Good
Qty / UOM	2 / EA
Unit Cost	\$1,599.51
Basis of Costing	Service Sink, Floor
Year in Service	2008
Expected Useful Life (EUL)	35 Year(s), Based on Industry Averages
Remaining Useful Life (RUL)	26 Year(s), Estimated, Based on Date of Observation
Location	MEP Closet

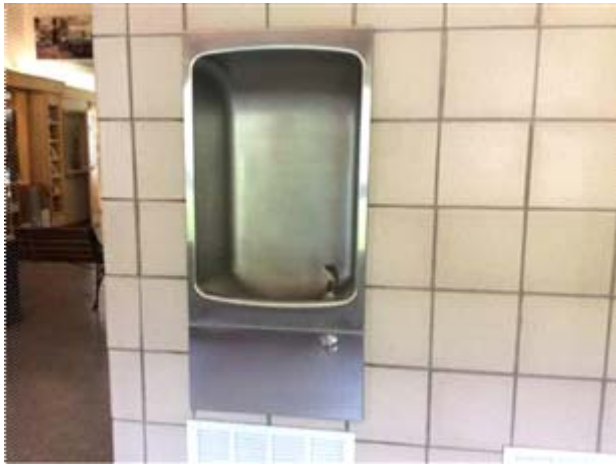
Coding / Field Name	Asset Description
<b>D2018 Drinking Fountains and Coolers</b>	Drinking Fountain, Refrigerated
<b>Condition</b>	Fair
<b>Qty / UOM</b>	2 / EA
<b>Unit Cost</b>	\$1,257.51
<b>Basis of Costing</b>	Drinking Fountain, Refrigerated
<b>Year in Service</b>	1995
<b>Expected Useful Life (EUL)</b>	10 Year(s), Based on Industry Averages
<b>Remaining Useful Life (RUL)</b>	4 Year(s), Estimated, Based on Date of Observation
<b>Location</b>	Building Interior (General)

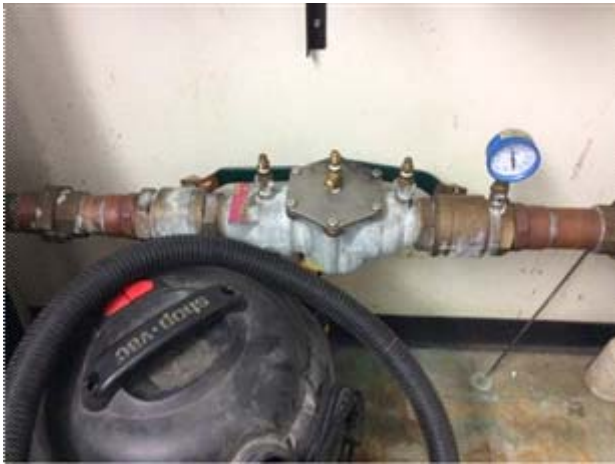
Coding / Field Name	Asset Description
D2021 Cold Water Service	Backflow Preventer, 2"
Condition	Fair
Qty / UOM	1 / EA
Unit Cost	\$2,603.17
Basis of Costing	Backflow Preventer, 2"
Year in Service	2010
Expected Useful Life (EUL)	15 Year(s), Based on Industry Averages
Remaining Useful Life (RUL)	8 Year(s), Estimated, Based on Date of Observation
Location	Mechanical Room (Primary)

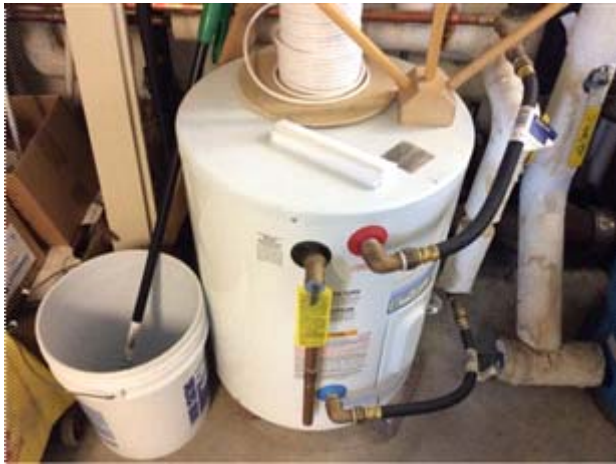
Coding / Field Name	Asset Description
<b>D2023 Domestic Water Supply Equipment</b>	Water Heater, Electric, Residential, 20 Gal
<b>Condition</b>	Fair
<b>Qty / UOM</b>	1 / EA
<b>Unit Cost</b>	\$1,249.92
<b>Basis of Costing</b>	Water Heater, Electric, Residential, 16 to 30 GAL
<b>Year in Service</b>	2007
<b>Expected Useful Life (EUL)</b>	15 Year(s), Based on Industry Averages
<b>Remaining Useful Life (RUL)</b>	5 Year(s), Estimated, Based on Date of Observation
<b>Location</b>	Mechanical Room (Primary)

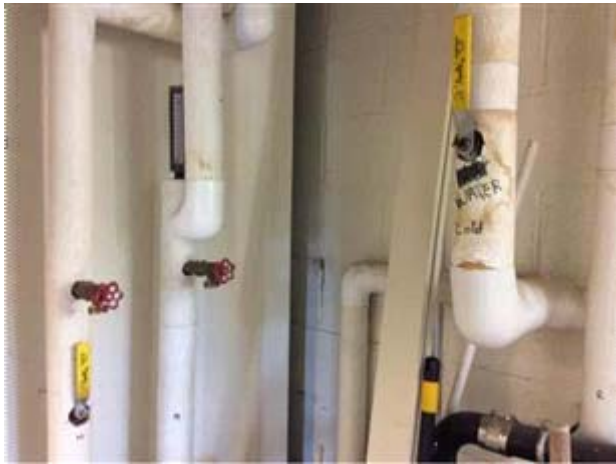
Coding / Field Name	Asset Description
D2029 Plumbing Systems	Plumbing System, Domestic Supply
Condition	Fair
Qty / UOM	2311 / SF
Unit Cost	\$7.59
Basis of Costing	Plumbing System, Domestic Supply
Year in Service	1994
Expected Useful Life (EUL)	40 Year(s), Based on Industry Averages
Remaining Useful Life (RUL)	17 Year(s), Estimated, Based on Date of Observation
Location	Building Interior (General)

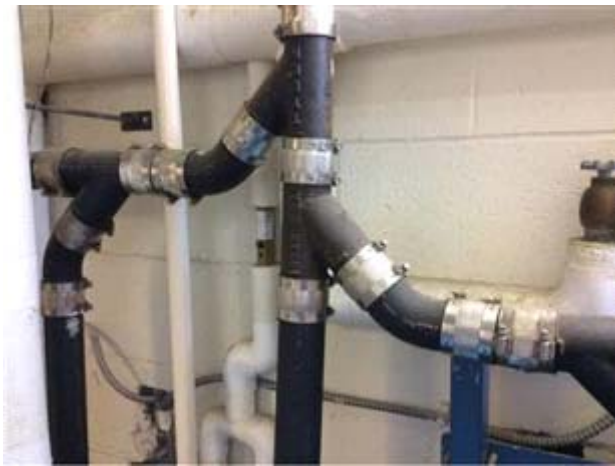
Coding / Field Name	Asset Description
D2034 Sanitary Waste Equipment	Plumbing System, Sanitary Waste
Condition	Fair
Qty / UOM	2311 / SF
Unit Cost	\$5.06
Basis of Costing	Plumbing System, Sanitary Waste
Year in Service	1994
Expected Useful Life (EUL)	40 Year(s), Based on Industry Averages
Remaining Useful Life (RUL)	25 Year(s), Estimated, Based on Date of Observation
Location	Building Interior (General)

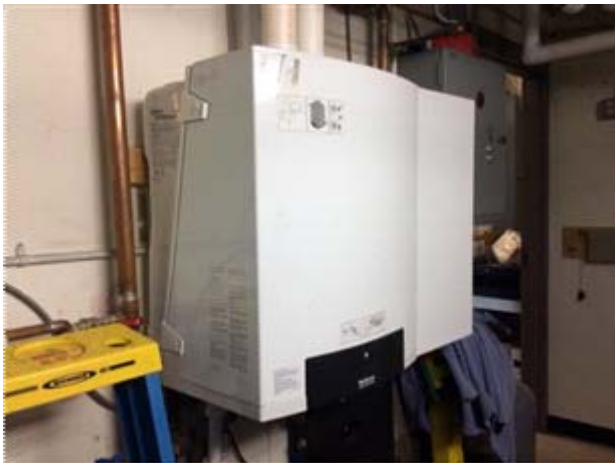
Coding / Field Name	Asset Description
D3021 Boilers	Boiler, Propane
Condition	Good
Qty / UOM	1 / EA
Unit Cost	\$14,377.52
Basis of Costing	Boiler, Gas, 126 to 250 MBH
Year in Service	2008
Expected Useful Life (EUL)	25 Year(s), Based on Industry Averages
Remaining Useful Life (RUL)	16 Year(s), Estimated, Based on Date of Observation
Location	Mechanical Room (Primary)
Boiler Draft Type	Forced Draft
Boiler Manufacturer	Buderus
Boiler Model	GAB 142-45

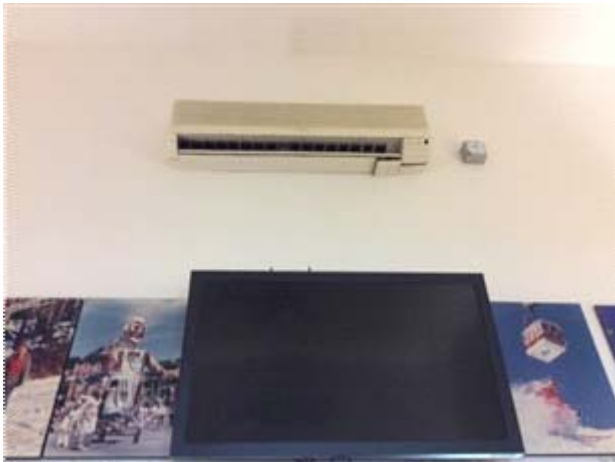
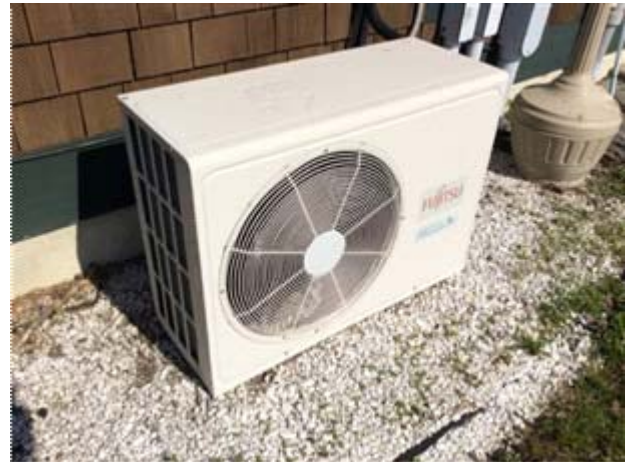
Coding / Field Name	Asset Description
D3032 Direct Expansion Systems	Ductless Split System
Condition	Fair
Qty / UOM	2 / EA
Unit Cost	\$4,473.11
Basis of Costing	Ductless Split System, Single Zone, 1.5 to 2 Ton
Year in Service	2010
Expected Useful Life (EUL)	15 Year(s), Based on Industry Averages
Remaining Useful Life (RUL)	8 Year(s), Estimated, Based on Date of Observation
Location	Building Interior (General)

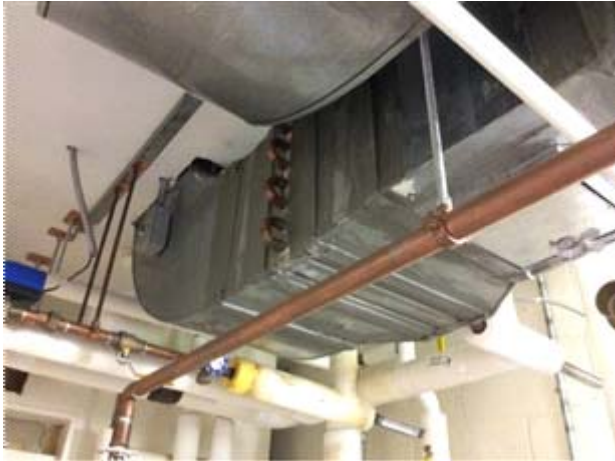
Coding / Field Name	Asset Description
<b>D3041 Air Distribution Systems</b>	HVAC System Ductwork, Sheetmetal
<b>Condition</b>	Fair
<b>Qty / UOM</b>	2311 / SF
<b>Cost Adjustment Factor/Reason</b>	0.7 / Basic
<b>Unit Cost (Adjusted)</b>	\$13.65
<b>Basis of Costing</b>	HVAC System Ductwork, Sheet Metal
<b>Year in Service</b>	1994
<b>Expected Useful Life (EUL)</b>	30 Year(s), Based on Industry Averages
<b>Remaining Useful Life (RUL)</b>	7 Year(s), Estimated, Based on Date of Observation
<b>Location</b>	Building Interior (General)

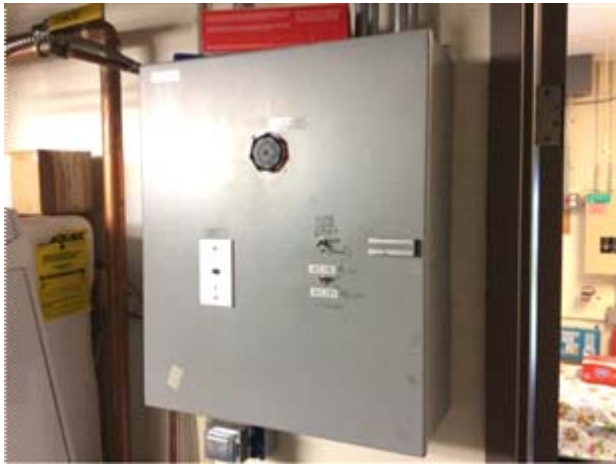
Coding / Field Name	Asset Description
<b>D3068 Building Automation Systems</b>	Direct Digital (DDC) HVAC Controls
<b>Condition</b>	Good
<b>Qty / UOM</b>	2311 / SF
<b>Unit Cost</b>	\$5.36
<b>Basis of Costing</b>	Building Automation System (HVAC Controls), Full Upgrade (per SF)
<b>Year in Service</b>	2010
<b>Expected Useful Life (EUL)</b>	20 Year(s), Based on Industry Averages
<b>Remaining Useful Life (RUL)</b>	13 Year(s), Estimated, Based on Date of Observation
<b>Location</b>	Building Interior (General)

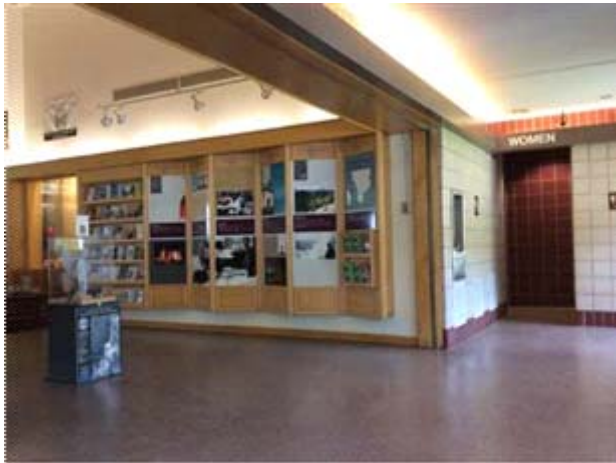
An automated wet sprinkler fire suppression system was not observed. Though likely grandfathered, installation is recommended for life safety and asset protection reasons.

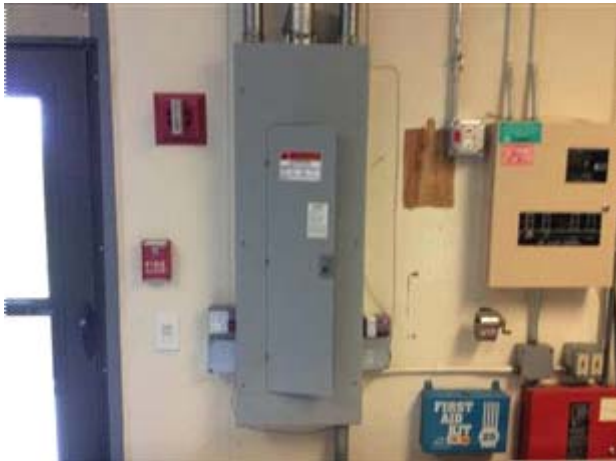
Coding / Field Name	Asset Description
<b>D5012 Low Tension Service &amp; Dist.</b>	Power Panel Board
<b>Condition</b>	Fair
<b>Qty / UOM</b>	1 / EA
<b>Unit Cost</b>	\$7,951.00
<b>Basis of Costing</b>	Power Panel Board, 208 Y, 120 V, 225 Amp
<b>Year in Service</b>	1994
<b>Expected Useful Life (EUL)</b>	30 Year(s), Based on Industry Averages
<b>Remaining Useful Life (RUL)</b>	7 Year(s), Estimated, Based on Date of Observation
<b>Location</b>	Building Interior (General)
<b>Service Size (Amperage)</b>	225

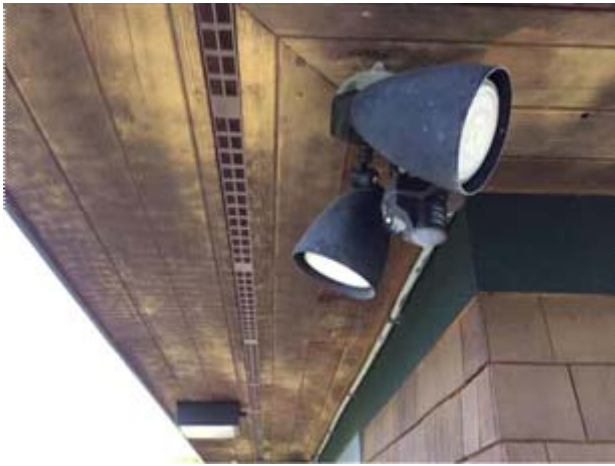
Coding / Field Name	Asset Description
<b>D5022 Lighting Equipment</b>	Exterior Lighting Fixture
<b>Condition</b>	Fair
<b>Qty / UOM</b>	6 / EA
<b>Unit Cost</b>	\$180.19
<b>Basis of Costing</b>	LED Lighting Fixture, Basic, 20 W
<b>Year in Service</b>	2010
<b>Expected Useful Life (EUL)</b>	20 Year(s), Based on Industry Averages
<b>Remaining Useful Life (RUL)</b>	13 Year(s), Estimated, Based on Date of Observation
<b>Location</b>	Exterior Walls

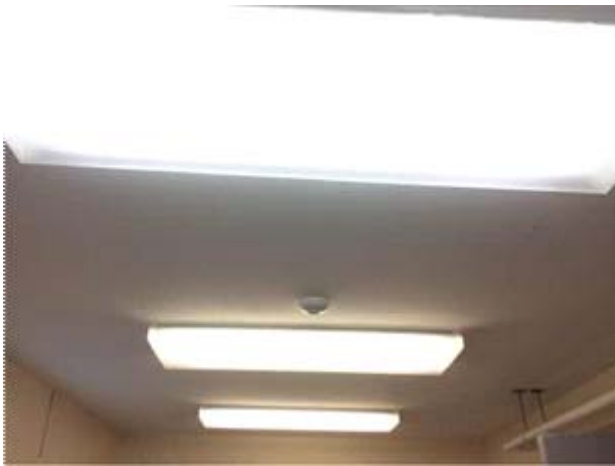
Coding / Field Name	Asset Description
<b>D5029 Lighting Systems</b>	Lighting System, Interior
<b>Condition</b>	Fair
<b>Qty / UOM</b>	2311 / SF
<b>Unit Cost</b>	\$9.24
<b>Basis of Costing</b>	Lighting System, Full Upgrade, Office (per SF)
<b>Year in Service</b>	1994
<b>Expected Useful Life (EUL)</b>	25 Year(s), Based on Industry Averages
<b>Remaining Useful Life (RUL)</b>	10 Year(s), Estimated, Based on Date of Observation
<b>Location</b>	Building Interior (General)

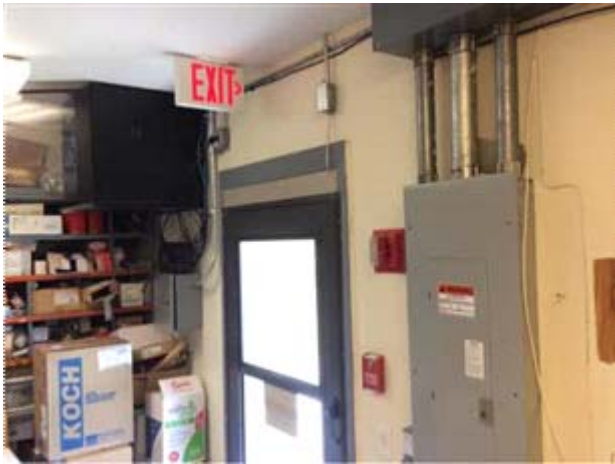
Coding / Field Name	Asset Description
D5037 Fire Alarm Systems	Fire Alarm System
Condition	Fair
Qty / UOM	2311 / SF
Unit Cost	\$2.36
Basis of Costing	Fire Alarm System, Full Upgrade/Install, Office (per SF)
Year in Service	1994
Expected Useful Life (EUL)	20 Year(s), Based on Industry Averages
Remaining Useful Life (RUL)	4 Year(s), Estimated, Based on Date of Observation
Location	Building Interior (General)

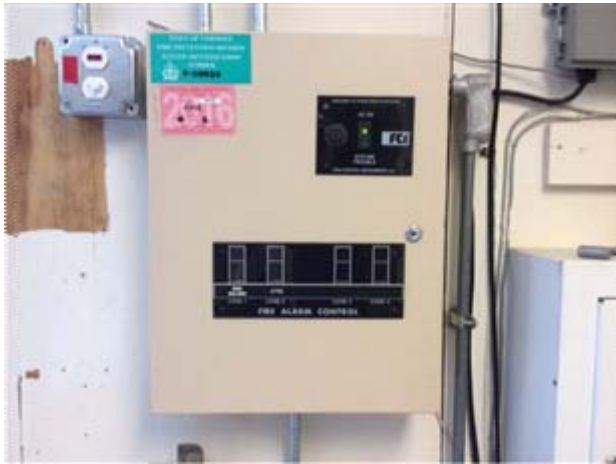
Coding / Field Name	Asset Description
D5037 Fire Alarm Systems	Fire Alarm Control Panel, Addressable
Condition	Fair
Qty / UOM	1 / EA
Unit Cost	\$20,297.59
Basis of Costing	Fire Alarm Control Panel, Addressable
Year in Service	1995
Expected Useful Life (EUL)	15 Year(s), Based on Industry Averages
Remaining Useful Life (RUL)	3 Year(s), Estimated, Based on Date of Observation
Location	Building Interior (General)

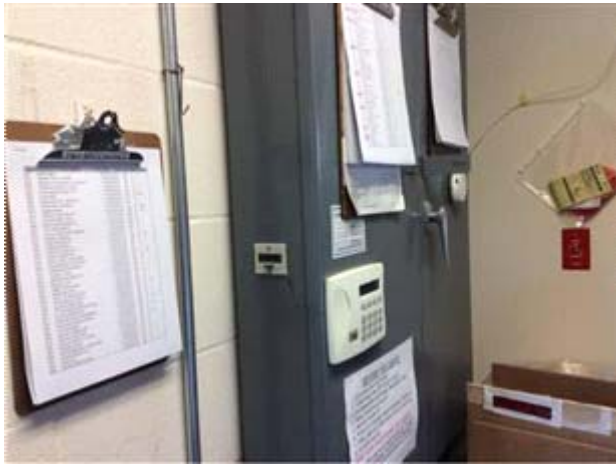
Coding / Field Name	Asset Description
D5039 Local Area Networks	Security System
Condition	Fair
Qty / UOM	2311 / SF
Unit Cost	\$4.35
Basis of Costing	Security System, Full Upgrade/Install, Cameras and CCTV (per SF)
Year in Service	1994
Expected Useful Life (EUL)	10 Year(s), Based on Industry Averages
Remaining Useful Life (RUL)	3 Year(s), Estimated, Based on Date of Observation
Location	Building Interior (General)

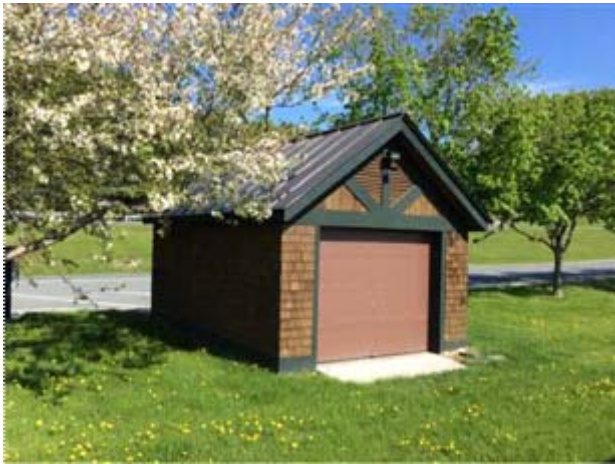
Coding / Field Name	Asset Description
<b>F1013 Other Special Structures</b>	Ancillary Structure, All Components, Shed
<b>Condition</b>	Fair
<b>Qty / UOM</b>	200 / SF
<b>Unit Cost</b>	\$125.19
<b>Basis of Costing</b>	Prefabricated Temporary Building, All Components
<b>Year in Service</b>	1994
<b>Expected Useful Life (EUL)</b>	30 Year(s), Based on Industry Averages
<b>Remaining Useful Life (RUL)</b>	15 Year(s), Estimated, Based on Date of Observation
<b>Location</b>	Site

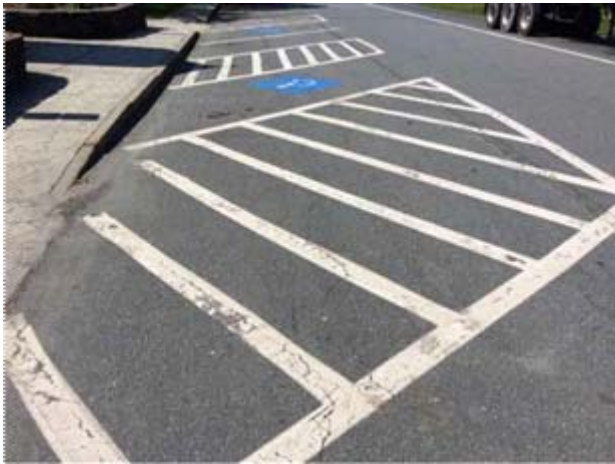
Coding / Field Name	Asset Description
<b>G2022 Paving &amp; Surfacing</b>	Asphalt Pavement, Parking Lot
<b>Condition</b>	Fair
<b>Qty / UOM</b>	7000 / SF
<b>Unit Cost</b>	\$5.90
<b>Basis of Costing</b>	Asphalt Pavement, Parking Lot
<b>Year in Service</b>	1994
<b>Expected Useful Life (EUL)</b>	25 Year(s), Based on Industry Averages
<b>Remaining Useful Life (RUL)</b>	8 Year(s), Estimated, Based on Date of Observation
<b>Location</b>	Site

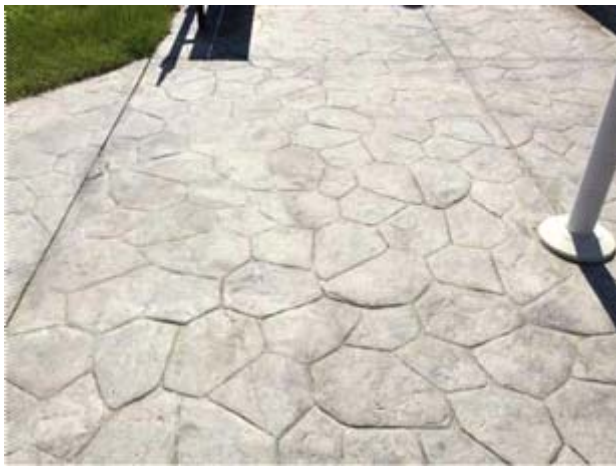
Coding / Field Name	Asset Description
<b>G2031 Paving &amp; Surfacing</b>	Concrete Sidewalk
<b>Condition</b>	Good
<b>Qty / UOM</b>	3000 / SF
<b>Unit Cost</b>	\$19.82
<b>Basis of Costing</b>	Concrete Sidewalk
<b>Year in Service</b>	2012
<b>Expected Useful Life (EUL)</b>	30 Year(s), Based on Industry Averages
<b>Remaining Useful Life (RUL)</b>	25 Year(s), Estimated, Based on Date of Observation
<b>Location</b>	Site
