FACILITY CONDITION ASSESSMENT

106686.17R000-087.305

July 03, 2017

FACILITY CONDITION ASSESSMENT
OF
HARTFORD SOUTH INFORMATION CENTER
I-91 SOUTHBOUND MILE MARKER 68.2
HARTFORD, VT 05047

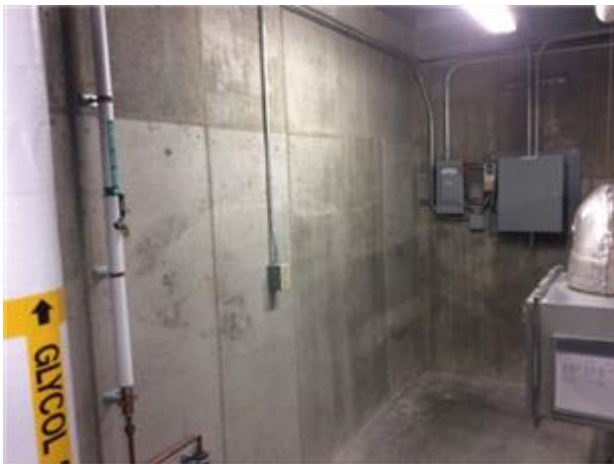
Coding / Field Name	Asset Description
A1011 Wall Foundations	Foundation System
Condition	Good
Qty / UOM	350 / LF
Unit Cost	\$105.56
Basis of Costing	Foundation Wall, Concrete or CMU w/ Continuous Footings, 1-2 Stories
Year in Service	2012
Expected Useful Life (EUL)	50 Year(s), Based on Industry Averages
Remaining Useful Life (RUL)	45 Year(s), Estimated, Based on Date of Observation
Location	Structure

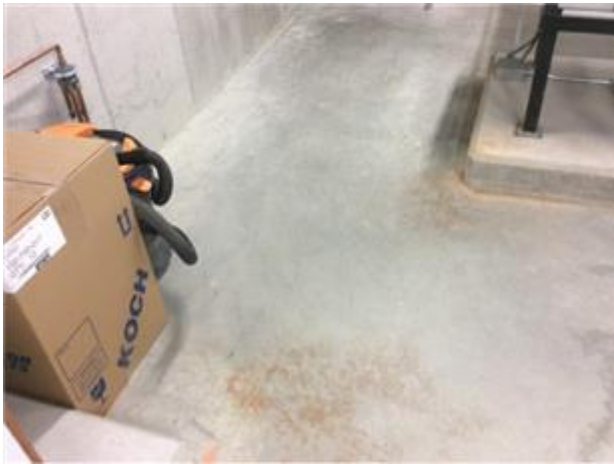
Coding / Field Name	Asset Description
A1031 Standard Slab on Grade	Slab on Grade
Condition	Good
Qty / UOM	1500 / SF
Unit Cost	\$10.00
Basis of Costing	Concrete Slab-On-Grade
Year in Service	2012
Expected Useful Life (EUL)	50 Year(s), Based on Industry Averages
Remaining Useful Life (RUL)	45 Year(s), Estimated, Based on Date of Observation
Location	Structure

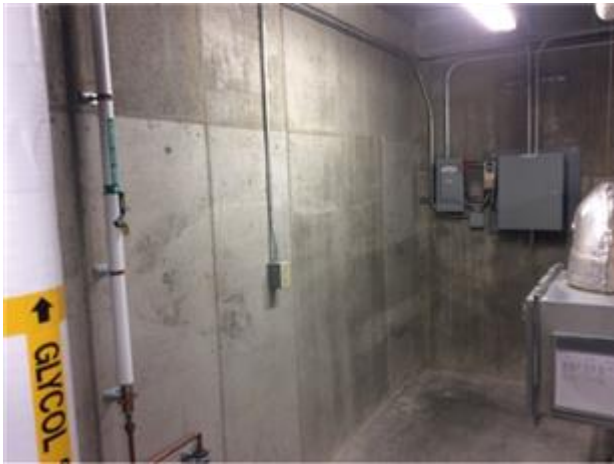
Coding / Field Name	Asset Description
A2022 Moisture Protection	Basement Wall
Condition	Good
Qty / UOM	2800 / SF
Unit Cost	\$10.00
Basis of Costing	Foundation Wall
Year in Service	2012
Expected Useful Life (EUL)	40 Year(s), Based on Industry Averages
Remaining Useful Life (RUL)	35 Year(s), Estimated, Based on Date of Observation
Location	Structure

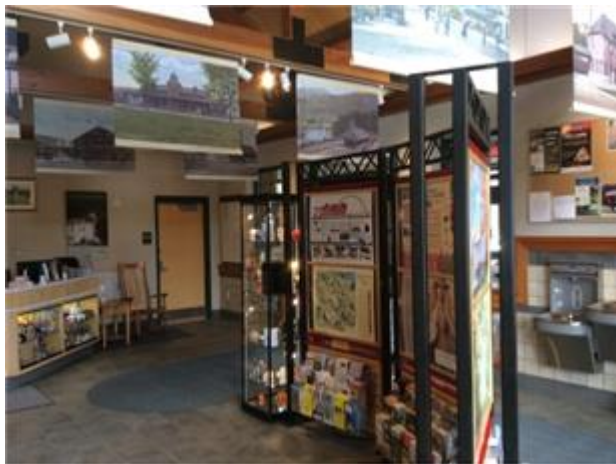
Coding / Field Name	Asset Description
B1012 Upper Floors Construction	Superstructure, Structural Frame, Masonry (CMU) Bearing Walls
Condition	Good
Qty / UOM	2000 / SF
Unit Cost	\$25.64
Basis of Costing	Superstructure, Structural Frame, Masonry (CMU) Bearing Walls, 1-2 Stories
Year in Service	2012
Expected Useful Life (EUL)	50 Year(s), Based on Industry Averages
Remaining Useful Life (RUL)	45 Year(s), Estimated, Based on Date of Observation
Location	Structure

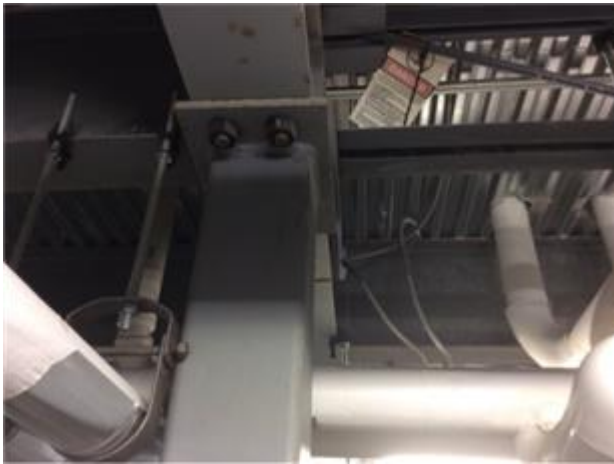
Coding / Field Name	Asset Description
B1012 Upper Floors Construction	Superstructure, Structural Frame, Steel Columns & Beams, Lower Level
Condition	Good
Qty / UOM	2000 / SF
Unit Cost	\$32.16
Basis of Costing	Superstructure, Structural Frame, Steel Columns & Beams, 1-2 Stories
Year in Service	2012
Expected Useful Life (EUL)	50 Year(s), Based on Industry Averages
Remaining Useful Life (RUL)	45 Year(s), Estimated, Based on Date of Observation
Location	Structure

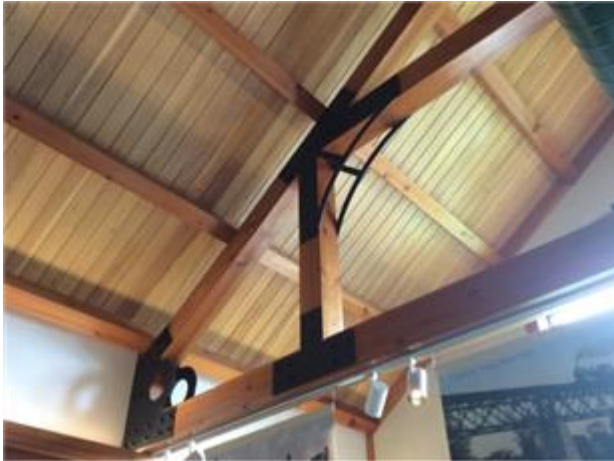
Coding / Field Name	Asset Description
B1022 Pitched Roof Construction	Roof Construction
Condition	Good
Qty / UOM	4718 / SF
Cost Adjustment Factor/Reason	1.2 / Decorative
Unit Cost (Adjusted)	\$37.58
Basis of Costing	Roof Structure, Pitched, Heavy Timber Framing
Year in Service	2012
Expected Useful Life (EUL)	50 Year(s), Based on Industry Averages
Remaining Useful Life (RUL)	45 Year(s), Estimated, Based on Date of Observation
Location	Structure

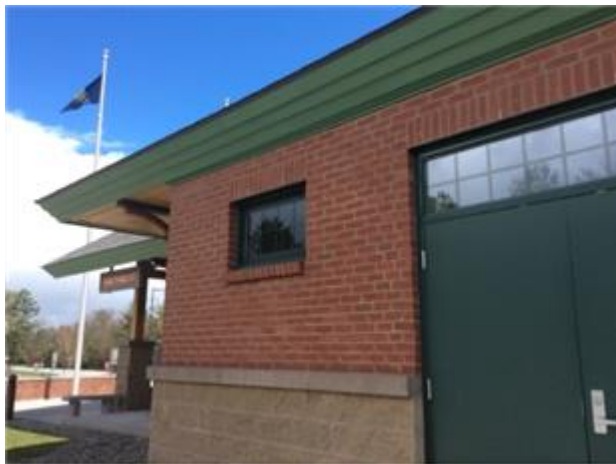
Coding / Field Name	Asset Description
B2011 Exterior Wall Construction	Brick Veneer, Exterior
Condition	Good
Qty / UOM	2000 / SF
Unit Cost	\$48.58
Basis of Costing	Brick Veneer, Exterior, 1-2 Stories
Year in Service	2012
Expected Useful Life (EUL)	40 Year(s), Based on Industry Averages
Remaining Useful Life (RUL)	35 Year(s), Estimated, Based on Date of Observation
Location	Exterior Walls

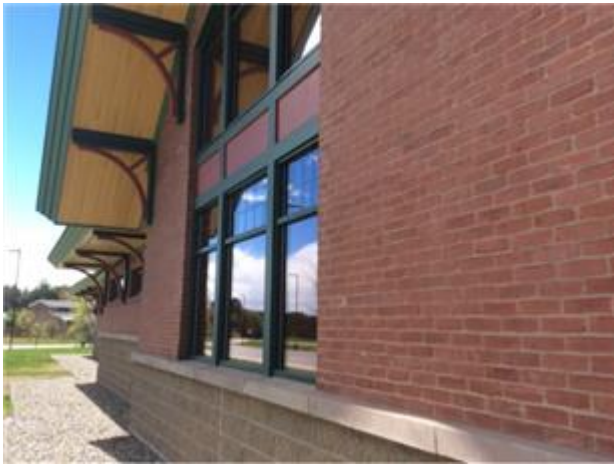
Coding / Field Name	Asset Description
B2022 Curtain Walls	Storefront Glazing & Framing
Condition	Good
Qty / UOM	250 / SF
Unit Cost	\$182.55
Basis of Costing	Aluminum Curtain Wall System
Year in Service	2012
Expected Useful Life (EUL)	30 Year(s), Based on Industry Averages
Remaining Useful Life (RUL)	25 Year(s), Estimated, Based on Date of Observation
Location	Exterior Walls

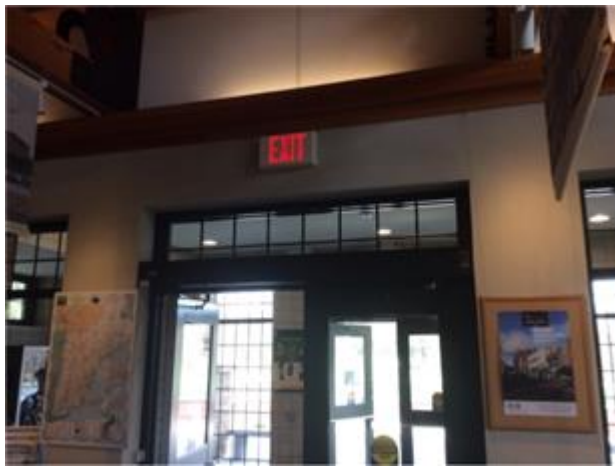
Coding / Field Name	Asset Description
B2031 Glazed Doors & Entrances	Glazed Entrance Doors
Condition	Good
Qty / UOM	7 / EA
Unit Cost	\$1,368.37
Basis of Costing	Aluminum Frame, Fully Glazed, Exterior Door
Year in Service	2012
Expected Useful Life (EUL)	30 Year(s), Based on Industry Averages
Remaining Useful Life (RUL)	25 Year(s), Estimated, Based on Date of Observation
Location	Exterior Walls

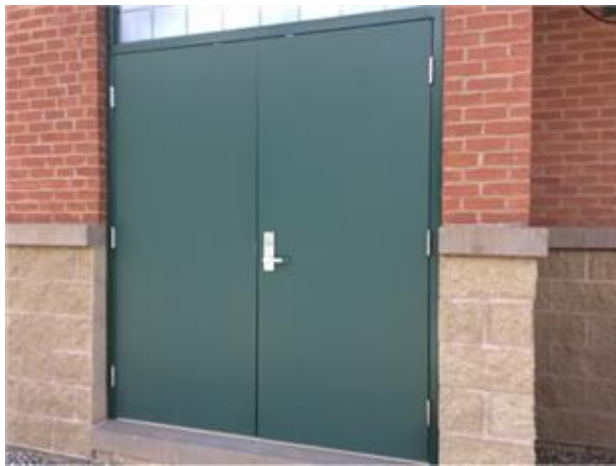
Coding / Field Name	Asset Description
B2032 Solid Exterior Doors	Steel, Insulated, Exterior Door
Condition	Good
Qty / UOM	2 / EA
Unit Cost	\$1,577.53
Basis of Costing	Steel, Insulated, Exterior Door
Year in Service	2012
Expected Useful Life (EUL)	25 Year(s), Based on Industry Averages
Remaining Useful Life (RUL)	20 Year(s), Estimated, Based on Date of Observation
Location	Exterior Walls

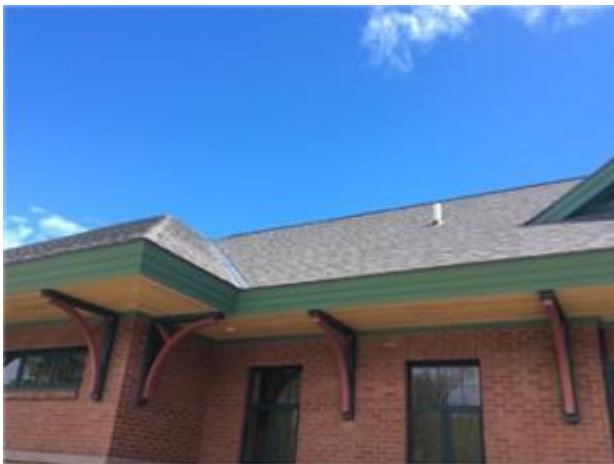
Coding / Field Name	Asset Description
B3011 Roof Finishes	Roof, Asphalt
Condition	Good
Qty / UOM	5500 / SF
Unit Cost	\$16.16
Basis of Costing	Asphalt Shingle Roof (Includes Tear-Off of Old)
Year in Service	2012
Expected Useful Life (EUL)	20 Year(s), Based on Industry Averages
Remaining Useful Life (RUL)	15 Year(s), Estimated, Based on Date of Observation
Location	Roof

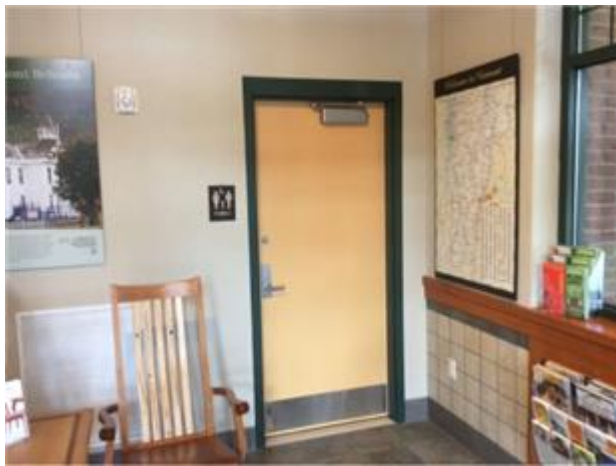
Coding / Field Name	Asset Description
C1021 Interior Doors	Interior Doors, Wood
Condition	Good
Qty / UOM	17 / EA
Unit Cost	\$1,423.11
Basis of Costing	Wood, Solid Core, Painted/Stained, Interior Door
Year in Service	2012
Expected Useful Life (EUL)	20 Year(s), Based on Industry Averages
Remaining Useful Life (RUL)	15 Year(s), Estimated, Based on Date of Observation
Location	Building Interior (General)

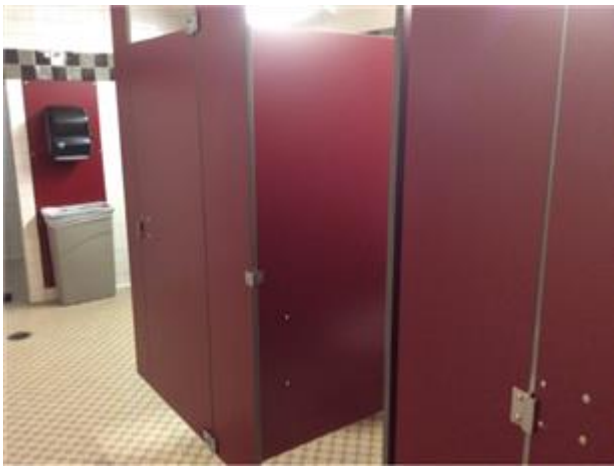
Coding / Field Name	Asset Description
C1031 Fabricated Toilet Partitions	Toilet Partitions, Metal
Condition	Good
Qty / UOM	12 / EA
Unit Cost	\$850.00
Basis of Costing	Toilet Partitions, Metal, Overhead Braced
Year in Service	2012
Expected Useful Life (EUL)	20 Year(s), Based on Industry Averages
Remaining Useful Life (RUL)	15 Year(s), Estimated, Based on Date of Observation
Location	Restrooms

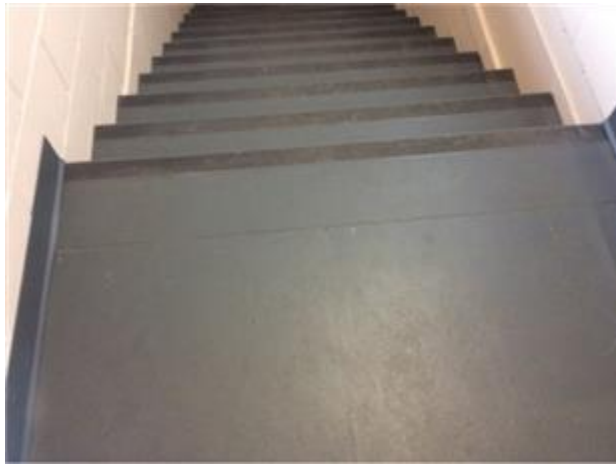
Coding / Field Name	Asset Description
C2011 Regular Stairs	Stairs, Concrete
Condition	Good
Qty / UOM	100 / SF
Unit Cost	\$44.14
Basis of Costing	Concrete, Interior Stairs
Year in Service	2012
Expected Useful Life (EUL)	50 Year(s), Based on Industry Averages
Remaining Useful Life (RUL)	45 Year(s), Estimated, Based on Date of Observation
Location	Stair Tower

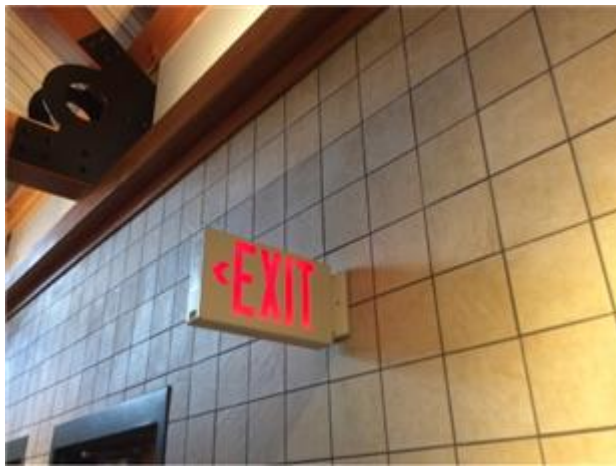
Coding / Field Name	Asset Description
C3012 Wall Finishes to Interior Walls	Ceramic Tile, Wall
Condition	Good
Qty / UOM	400 / SF
Unit Cost	\$24.30
Basis of Costing	Quarry Tile Wall Finish
Year in Service	2012
Expected Useful Life (EUL)	40 Year(s), Based on Industry Averages
Remaining Useful Life (RUL)	35 Year(s), Estimated, Based on Date of Observation
Location	Building Interior (General)

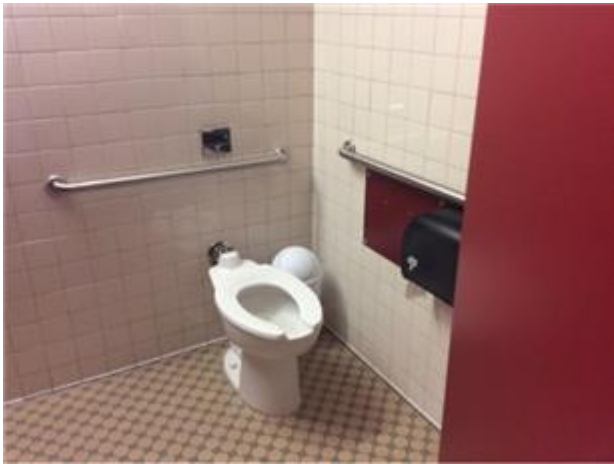
Coding / Field Name	Asset Description
C3012 Wall Finishes to Interior Walls	Ceramic Tile, Wall - Bathroom
Condition	Good
Qty / UOM	800 / SF
Unit Cost	\$24.30
Basis of Costing	Quarry Tile Wall Finish
Year in Service	2012
Expected Useful Life (EUL)	40 Year(s), Based on Industry Averages
Remaining Useful Life (RUL)	35 Year(s), Estimated, Based on Date of Observation
Location	Building Interior (General)

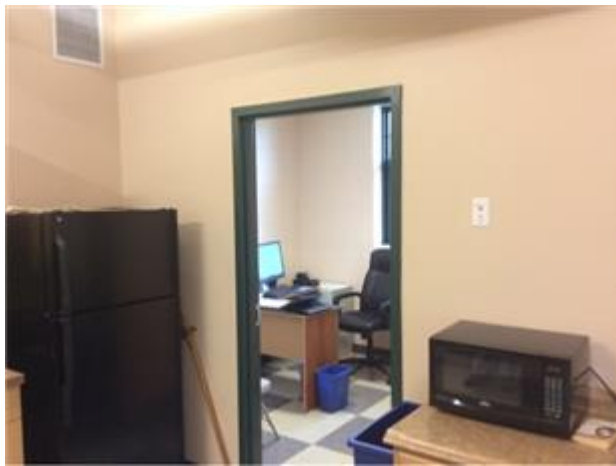
Coding / Field Name	Asset Description
C3012 Wall Finishes to Interior Walls	Gypsum Board, Wall
Condition	Good
Qty / UOM	1900 / SF
Unit Cost	\$3.38
Basis of Costing	Gypsum Board/Plaster, Interior Wall
Year in Service	2012
Expected Useful Life (EUL)	40 Year(s), Based on Industry Averages
Remaining Useful Life (RUL)	35 Year(s), Estimated, Based on Date of Observation
Location	Building Interior (General)

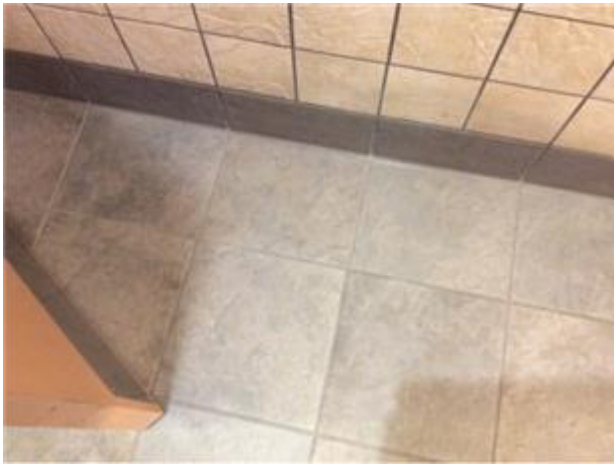
Coding / Field Name	Asset Description
C3024 Flooring	Ceramic Tile Flooring
Condition	Good
Qty / UOM	1200 / SF
Unit Cost	\$15.75
Basis of Costing	Ceramic Tile Flooring
Year in Service	2012
Expected Useful Life (EUL)	50 Year(s), Based on Industry Averages
Remaining Useful Life (RUL)	45 Year(s), Estimated, Based on Date of Observation
Location	Restrooms

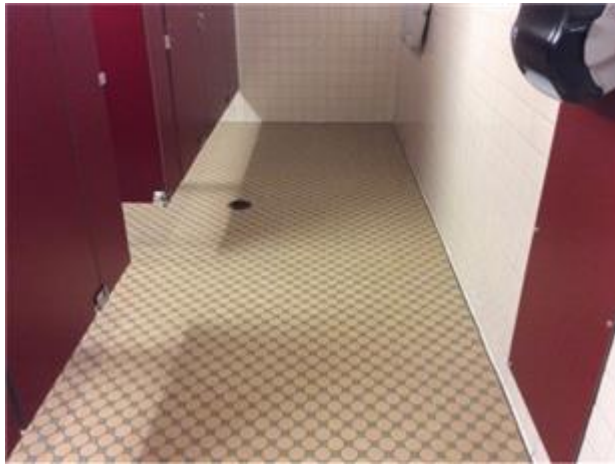
Coding / Field Name	Asset Description
C3024 Flooring	Ceramic Tile Flooring - Restrooms
Condition	Good
Qty / UOM	400 / SF
Unit Cost	\$15.75
Basis of Costing	Ceramic Tile Flooring
Year in Service	2012
Expected Useful Life (EUL)	50 Year(s), Based on Industry Averages
Remaining Useful Life (RUL)	45 Year(s), Estimated, Based on Date of Observation
Location	Restrooms

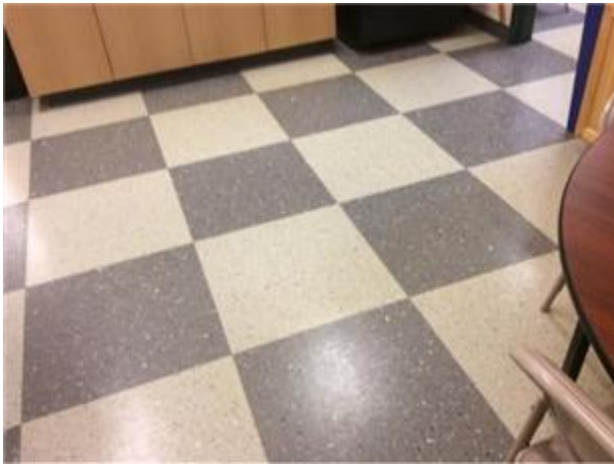
Coding / Field Name	Asset Description
C3024 Flooring	Resilient Floor Tile
Condition	Fair
Qty / UOM	1800 / SF
Unit Cost	\$4.80
Basis of Costing	Vinyl Tile Flooring
Year in Service	2012
Expected Useful Life (EUL)	15 Year(s), Based on Industry Averages
Remaining Useful Life (RUL)	10 Year(s), Estimated, Based on Date of Observation
Location	Building Interior (General)

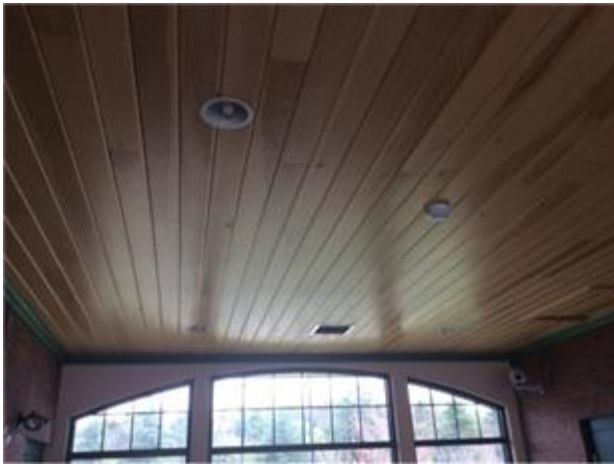
Coding / Field Name	Asset Description
C3031 Ceiling Finishes	Wood Ceiling
Condition	Good
Qty / UOM	1800 / SF
Unit Cost	\$9.22
Basis of Costing	Wood Ceiling
Year in Service	2012
Expected Useful Life (EUL)	30 Year(s), Based on Industry Averages
Remaining Useful Life (RUL)	25 Year(s), Estimated, Based on Date of Observation
Location	Building Interior (General)

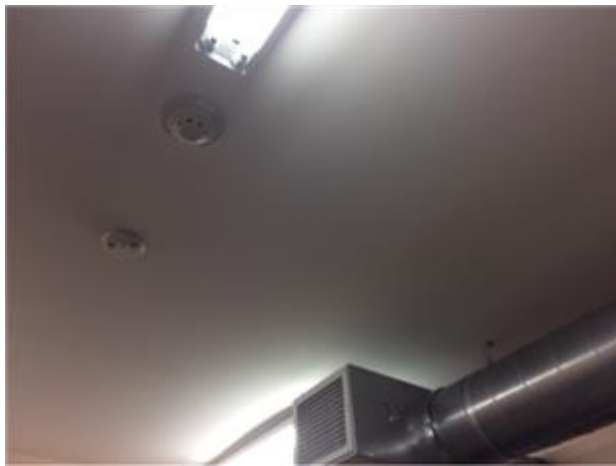
Coding / Field Name	Asset Description
C3031 Ceiling Finishes	Gypsum Board Ceiling
Condition	Good
Qty / UOM	1800 / SF
Unit Cost	\$7.13
Basis of Costing	Gypsum Board/Plaster, Ceiling
Year in Service	2012
Expected Useful Life (EUL)	50 Year(s), Based on Industry Averages
Remaining Useful Life (RUL)	45 Year(s), Estimated, Based on Date of Observation
Location	Building Interior (General)

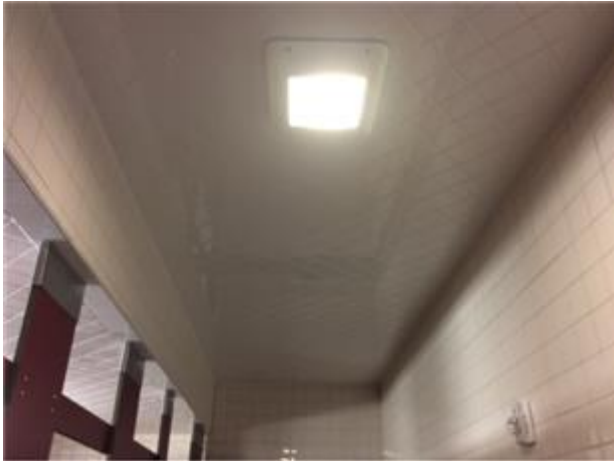
Coding / Field Name	Asset Description
C3031 Ceiling Finishes	Ceramic Tile Ceiling
Condition	Good
Qty / UOM	400 / SF
Cost Adjustment Factor/Reason	2 /
Unit Cost (Adjusted)	\$14.26
Basis of Costing	Gypsum Board/Plaster, Ceiling
Year in Service	2012
Expected Useful Life (EUL)	50 Year(s), Based on Industry Averages
Remaining Useful Life (RUL)	45 Year(s), Estimated, Based on Date of Observation
Location	Building Interior (General)

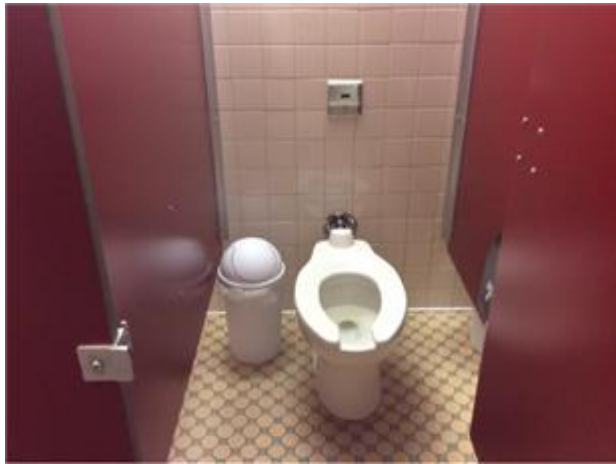
Coding / Field Name	Asset Description
D2011 Water Closets	Toilets (Water Closets)
Condition	Good
Qty / UOM	11 / EA
Unit Cost	\$1,055.15
Basis of Costing	Flush Tank Water Closet, One Piece
Year in Service	2012
Expected Useful Life (EUL)	20 Year(s), Based on Industry Averages
Remaining Useful Life (RUL)	15 Year(s), Estimated, Based on Date of Observation
Location	Restrooms

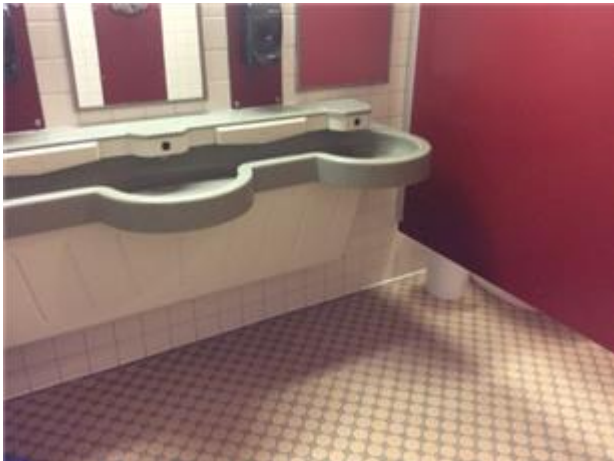
Coding / Field Name	Asset Description
D2013 Lavatories	Sink
Condition	Good
Qty / UOM	4 / EA
Cost Adjustment Factor/Reason	3 / Multiple user sinks
Unit Cost (Adjusted)	\$1,717.97
Basis of Costing	Lavatory, Vitreous China
Year in Service	2012
Expected Useful Life (EUL)	20 Year(s), Based on Industry Averages
Remaining Useful Life (RUL)	15 Year(s), Estimated, Based on Date of Observation
Location	Restrooms

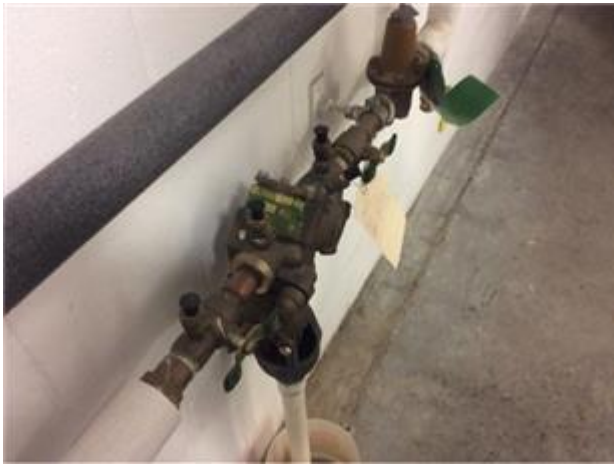
Coding / Field Name	Asset Description
D2021 Cold Water Service	Backflow Preventer, 1"
Condition	Fair
Qty / UOM	1 / EA
Unit Cost	\$1,276.01
Basis of Costing	Backflow Preventer, 1"
Year in Service	2012
Expected Useful Life (EUL)	15 Year(s), Based on Industry Averages
Remaining Useful Life (RUL)	10 Year(s), Estimated, Based on Date of Observation
Location	Lower Level

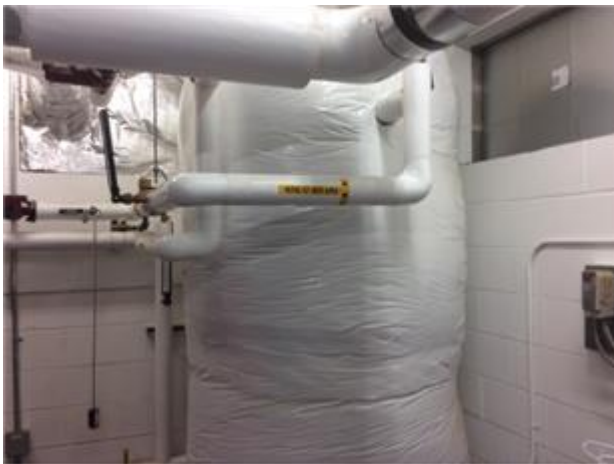
Coding / Field Name	Asset Description
D2023 Domestic Water Supply Equipment	Water Storage Tank
Condition	Good
Qty / UOM	1 / EA
Unit Cost	\$4,446.52
Basis of Costing	Water Storage Tank, 251 to 500 GAL
Year in Service	2012
Expected Useful Life (EUL)	20 Year(s), Based on Industry Averages
Remaining Useful Life (RUL)	15 Year(s), Estimated, Based on Date of Observation
Location	Lower Level

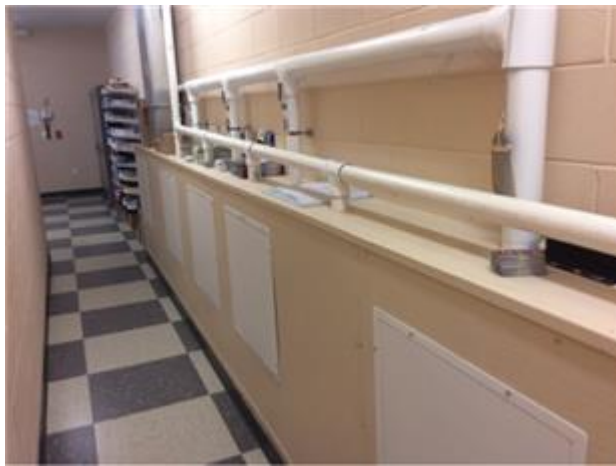
Coding / Field Name	Asset Description
D2034 Sanitary Waste Equipment	Plumbing System, Sanitary Waste
Condition	Good
Qty / UOM	4718 / SF
Unit Cost	\$5.06
Basis of Costing	Plumbing System, Sanitary Waste
Year in Service	2012
Expected Useful Life (EUL)	40 Year(s), Based on Industry Averages
Remaining Useful Life (RUL)	35 Year(s), Estimated, Based on Date of Observation
Location	Building Interior (General)

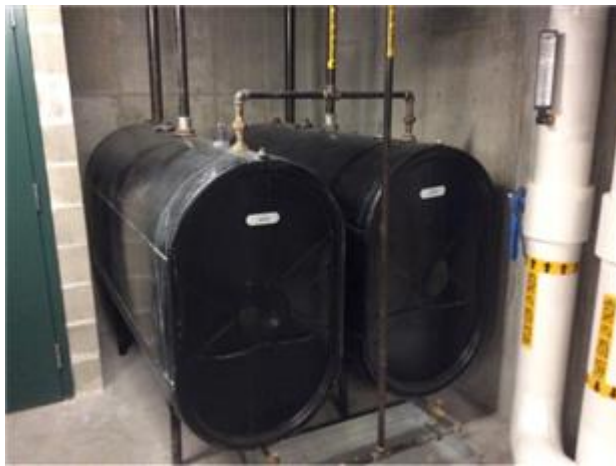
Coding / Field Name	Asset Description
D3011 Oil Supply System	Oil Storage Tank
Condition	Good
Qty / UOM	2 / EA
Unit Cost	\$935.73
Basis of Costing	Oil Storage Tank, 31 to 275 GAL
Year in Service	2012
Expected Useful Life (EUL)	25 Year(s), Based on Industry Averages
Remaining Useful Life (RUL)	20 Year(s), Estimated, Based on Date of Observation
Location	Lower Level

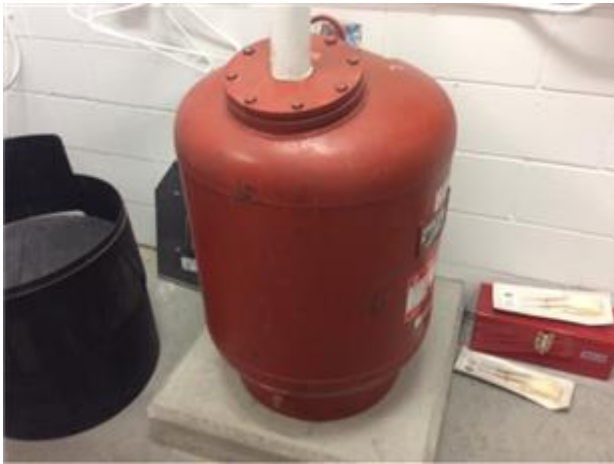
Coding / Field Name	Asset Description
D3022 Boiler Room Piping & Specialties	Expansion Tank
Condition	Good
Qty / UOM	1 / EA
Unit Cost	\$2,483.48
Basis of Costing	Expansion Tank, 31 to 60 GAL
Year in Service	2012
Expected Useful Life (EUL)	25 Year(s), Based on Industry Averages
Remaining Useful Life (RUL)	20 Year(s), Estimated, Based on Date of Observation
Location	Lower Level

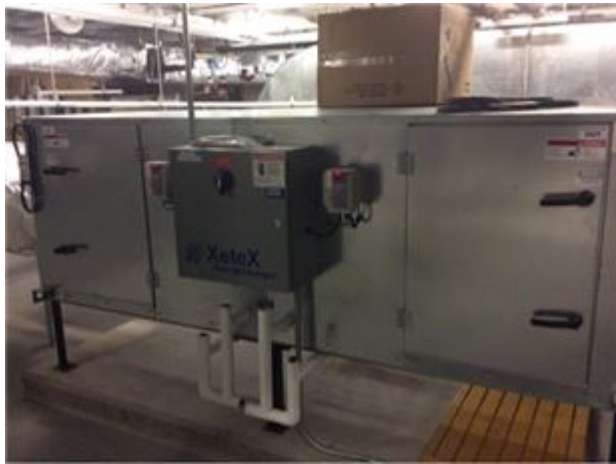
Coding / Field Name	Asset Description
D3023 Auxiliary Equipment	Heat Exchanger
Condition	Good
Qty / UOM	1 / EA
Unit Cost	\$2,954.50
Basis of Costing	Heat Exchanger, Steam-to-Water, 6 to 10 GPM
Year in Service	2012
Expected Useful Life (EUL)	35 Year(s), Based on Industry Averages
Remaining Useful Life (RUL)	30 Year(s), Estimated, Based on Date of Observation
Location	Lower Level

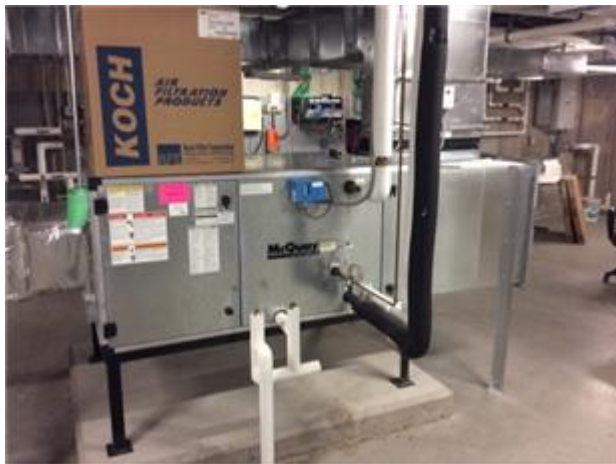
Coding / Field Name	Asset Description
D3041 Air Distribution Systems	Air Handler Unit
Condition	Good
Qty / UOM	2 / EA
Unit Cost	\$9,002.57
Basis of Costing	Air Handler, Single Zone, 1,301 to 2,500 CFM
Year in Service	2012
Expected Useful Life (EUL)	15 Year(s), Based on Industry Averages
Remaining Useful Life (RUL)	10 Year(s), Estimated, Based on Date of Observation
Location	Lower Level

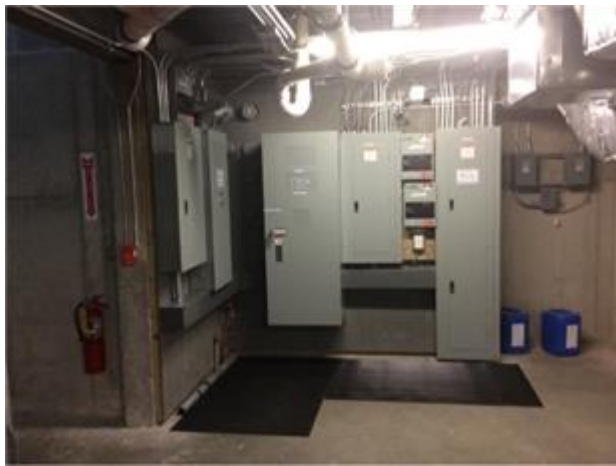
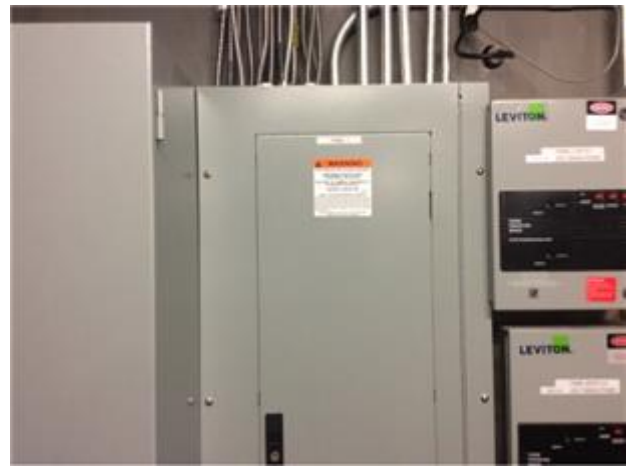
Coding / Field Name	Asset Description
D5012 Low Tension Service & Dist.	Distribution Panel - L
Condition	Good
Qty / UOM	1 / EA
Unit Cost	\$7,906.20
Basis of Costing	Power Panel Board, 208 Y, 120 V, 200 Amp
Year in Service	2012
Expected Useful Life (EUL)	30 Year(s), Based on Industry Averages
Remaining Useful Life (RUL)	25 Year(s), Estimated, Based on Date of Observation
Location	Lower Level

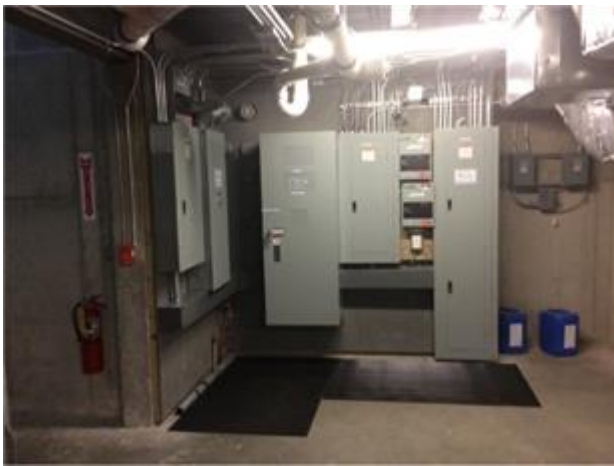
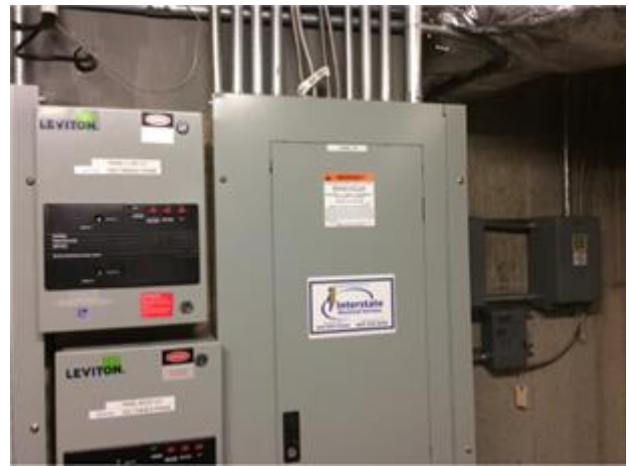
Coding / Field Name	Asset Description
D5012 Low Tension Service & Dist.	Distribution Panel - M
Condition	Good
Qty / UOM	1 / EA
Unit Cost	\$9,487.85
Basis of Costing	Power Panel Board, 208 Y, 120 V, 400 Amp
Year in Service	2012
Expected Useful Life (EUL)	30 Year(s), Based on Industry Averages
Remaining Useful Life (RUL)	25 Year(s), Estimated, Based on Date of Observation
Location	Lower Level

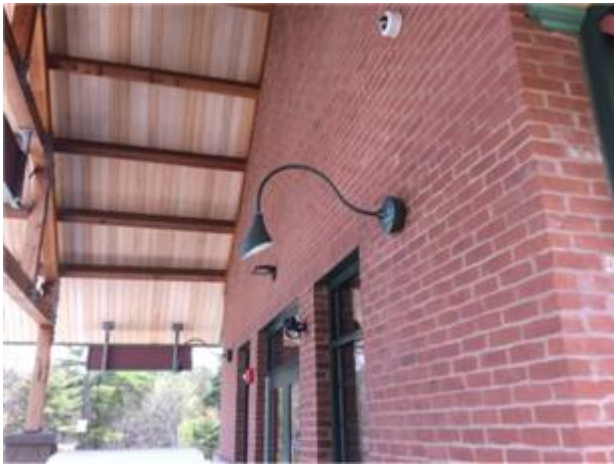
Coding / Field Name	Asset Description
D5022 Lighting Equipment	LED Lighting Fixture
Condition	Good
Qty / UOM	20 / EA
Unit Cost	\$180.19
Basis of Costing	LED Lighting Fixture, Basic, 15 W
Year in Service	2012
Expected Useful Life (EUL)	20 Year(s), Based on Industry Averages
Remaining Useful Life (RUL)	15 Year(s), Estimated, Based on Date of Observation
Location	Exterior Walls
