FACILITY CONDITION ASSESSMENT

106686.17R000-138.305

July 6, 2017

09437 RANDOLPH INFORMATION CENTER I89 SOUTH
I-89 SOUTHBOUND MILE MARKER 33.5
RANDOLPH, VT 05060

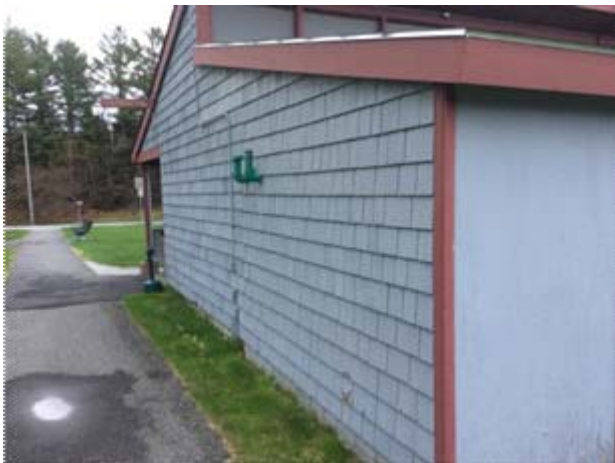
Asset age is unknown but estimated based on observed condition. The Condition and RUL are based on observation only. The Asset appears to be functioning as required. However, paint in some areas is deteriorated.

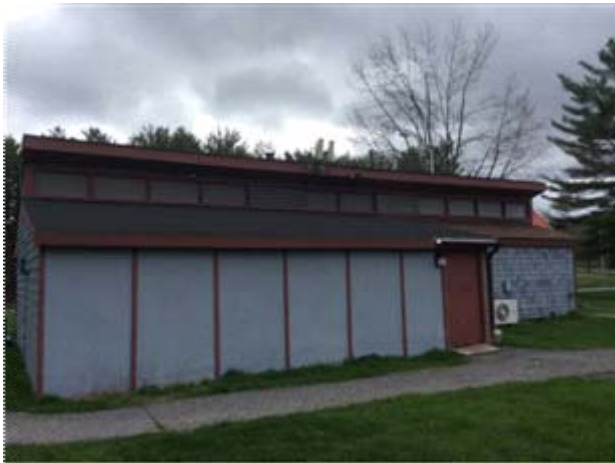
Asset age is unknown but estimated based on observed condition. The Condition and RUL are based on observation only. The Asset significantly deteriorated at base of door.
