FACILITY CONDITION ASSESSMENT

FACILITY CONDITION ASSESSMENT
OF
ALBURGH WELCOME CENTER
70 ROUTE 2 NORTH MAIN STREET
ALBURGH, VT 05440

EMG
10461 Mill Run Circle, Suite 1100
Owings Mills, Maryland 21117
800.733.0660
www.EMGcorp.com

July 2, 2018

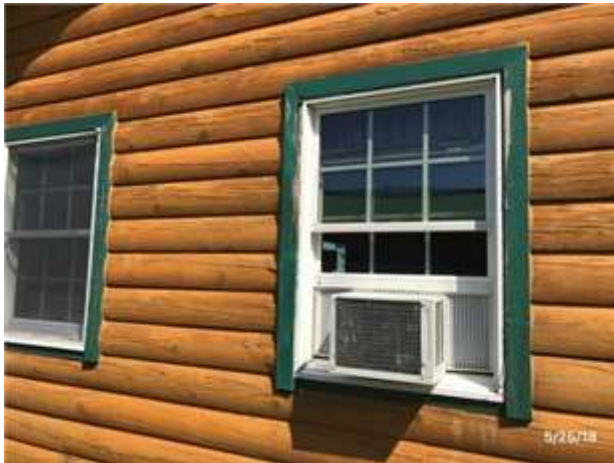
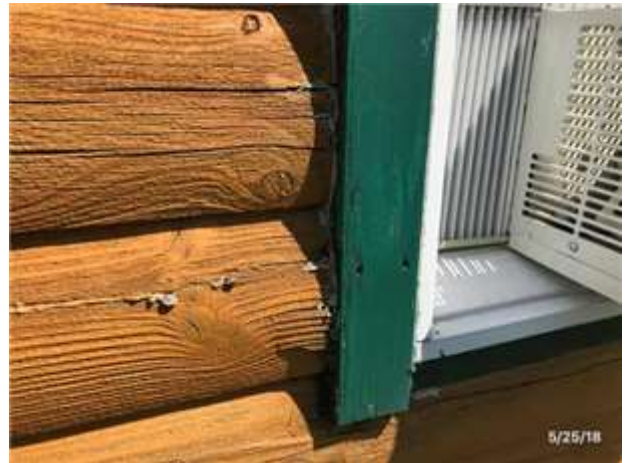
Log cabin

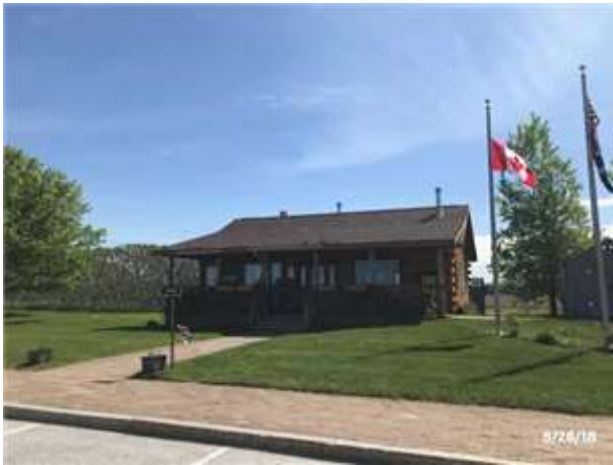
Asphalt roof shingles are curled and deformed from strong winds, recommend replacing.

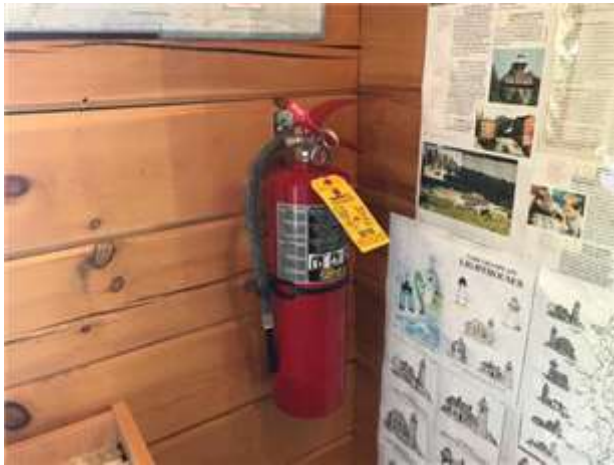
Fire alarm system is limited to smoke detectors. It is recommended the system be upgraded to an addressable system with visual and audio alarms.

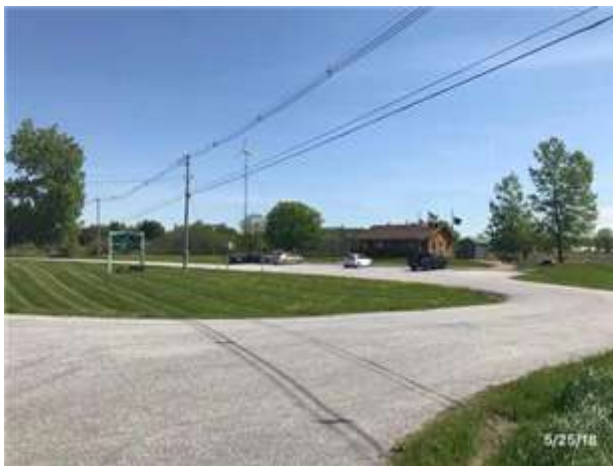
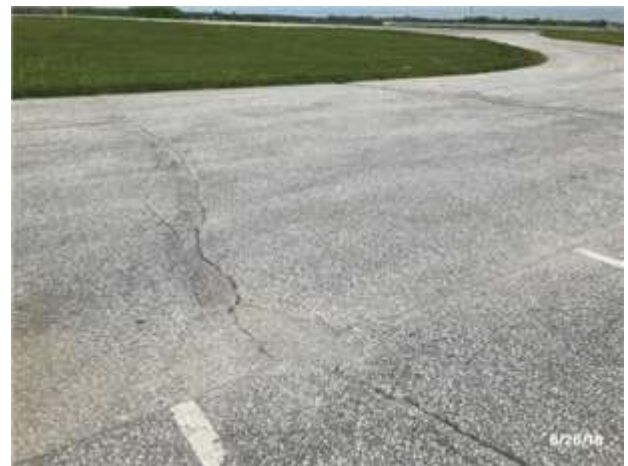
Cracking observed across the entire length of the drive.
