FACILITY CONDITION ASSESSMENT

FACILITY CONDITION ASSESSMENT
OF
WILLISTON NORTH INFORMATION CENTER
I-89 NORTHBOUND MILE MARKER 82
WILLISTON, VT 05495

106686.18R000-170.305

May 30, 2019

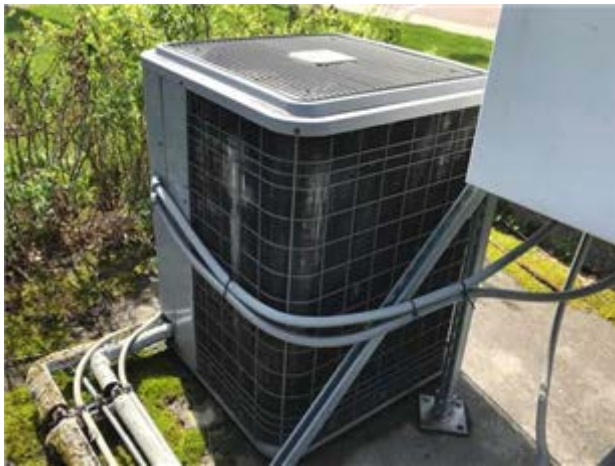
Unit is beyond expected useful life.

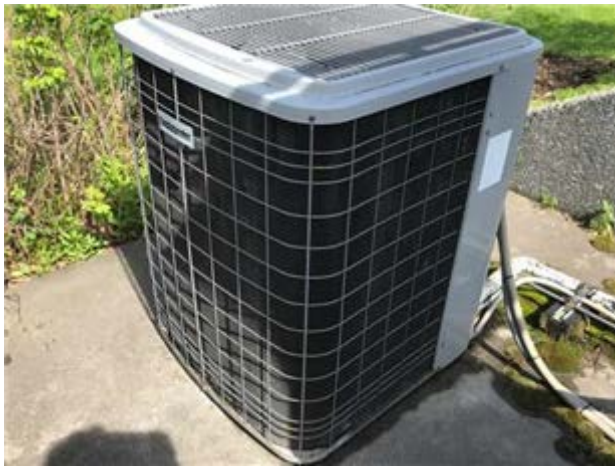
Unit is beyond expected useful life.

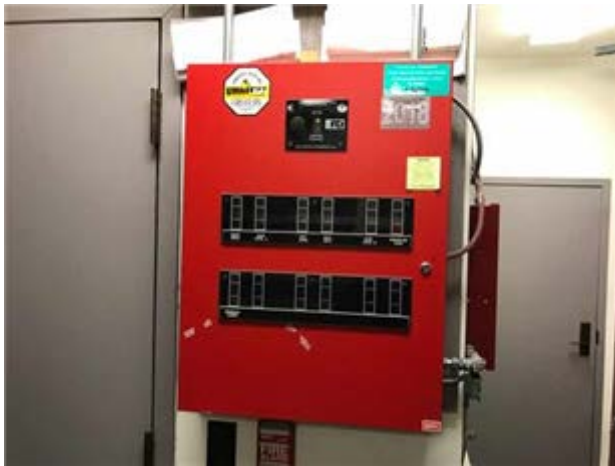
The panel is at the end of its service life.

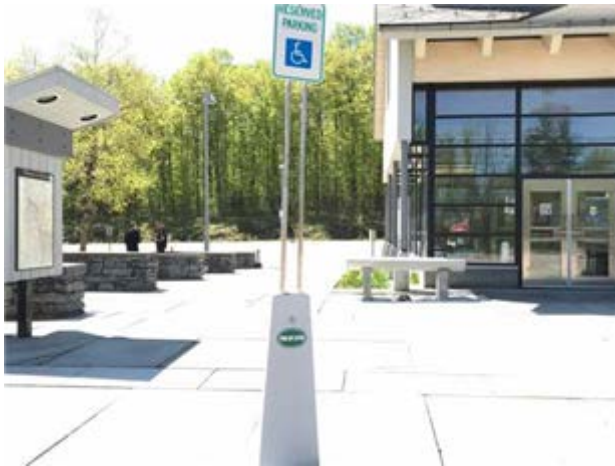
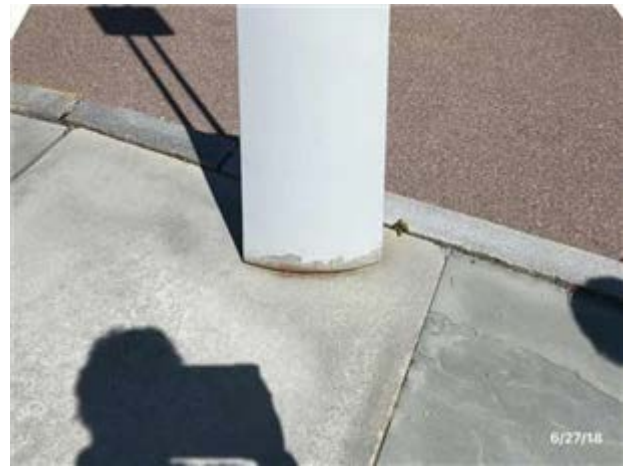
Sign bases are corroding.

Corroding Base

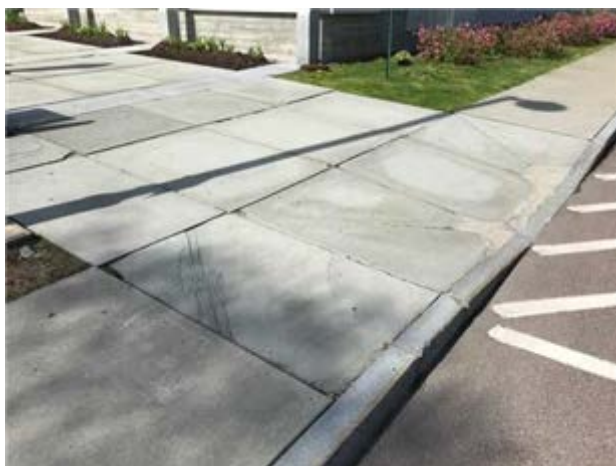
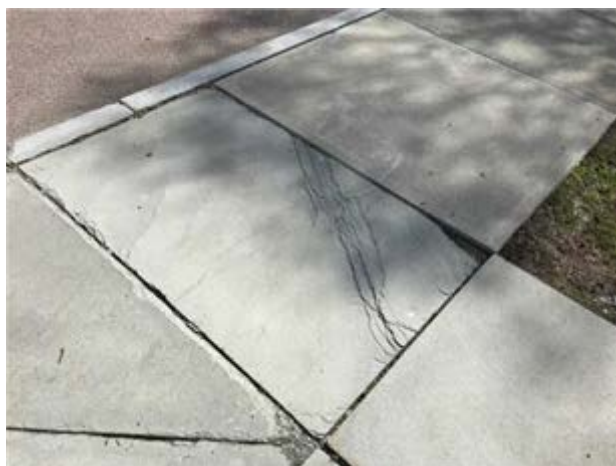
Some areas deteriorating.

Deteriorating paver

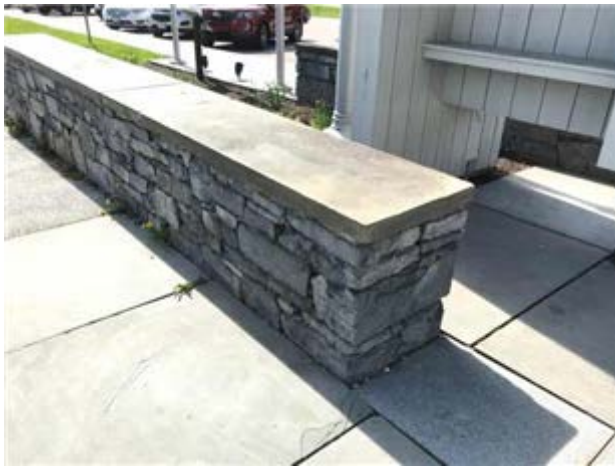
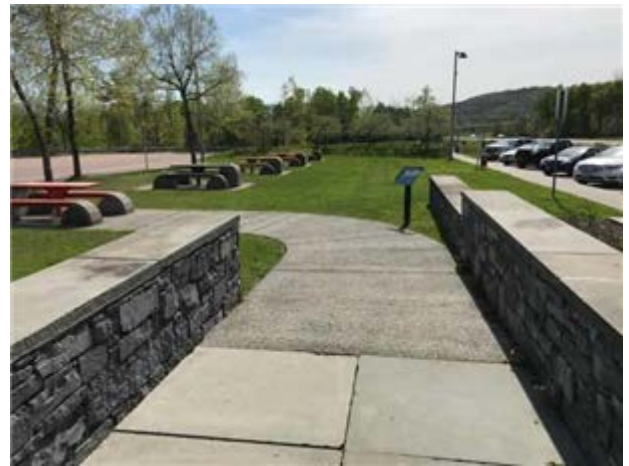
The joints along the tops of the landscape walls need sealer replacement.

Failed sealant
