### FACILITY CONDITION ASSESSMENT

### I-89 NORTH & SOUTH INFORMATION CENTERS

5200 Interstate 89 North and 5800 Interstate 89 South  
Georgia, Vermont 05478

**EMG Project #:** 106686.14R-018.305  
**Date of Report:** February 4, 2015  
**On site Date:** October 6, 2014

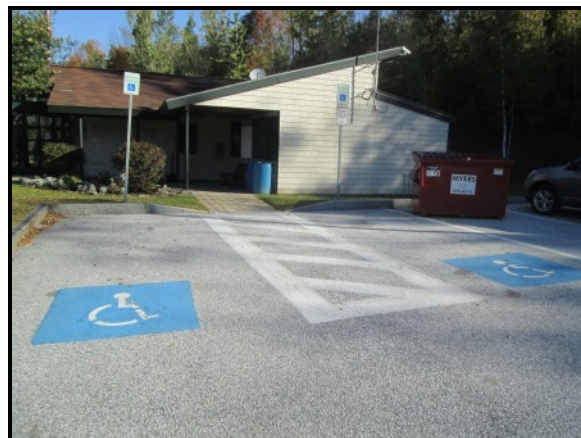
- The asphalt pavement is in fair to poor condition. There are significant signs of cracks or surface deterioration. In order to maximize the pavement life, pothole patching, crack sealing, seal coating, and re-striping of the asphalt paving will be required during the assessment period. The cost of this work is included in the deferred cost section of the Replacement Reserves Cost Estimate-Table.

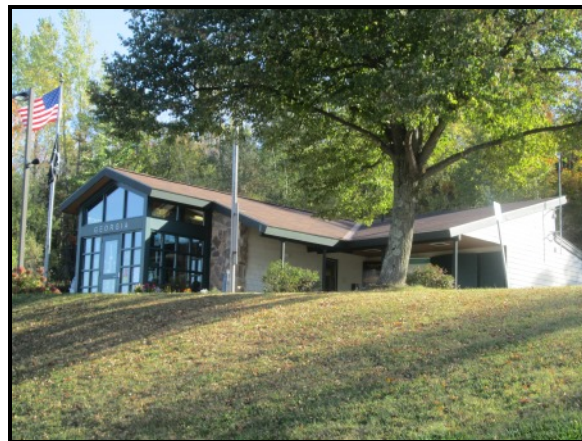
- The topography and adjacent uses do not appear to present conditions detrimental to the property.
- The landscape materials are in good condition and will require routine maintenance during the assessment period.

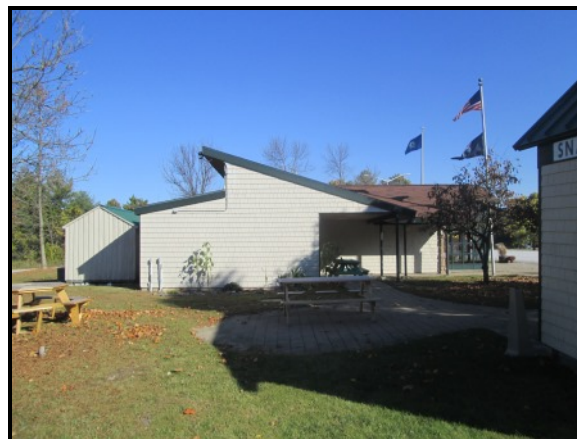
- The building signs are in good condition. Routine maintenance will be required during the assessment period.
- The exterior site and building light fixtures are in good condition. Routine maintenance will be required during the assessment period.
- The dumpsters are owned and maintained by the refuse contractor.

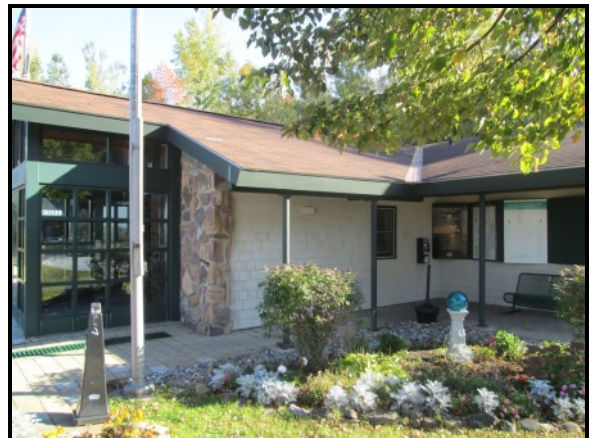
- Most of the superstructure is concealed. Walls and floors appear to be plumb, level, and stable. There are no significant signs of deflection or movement.

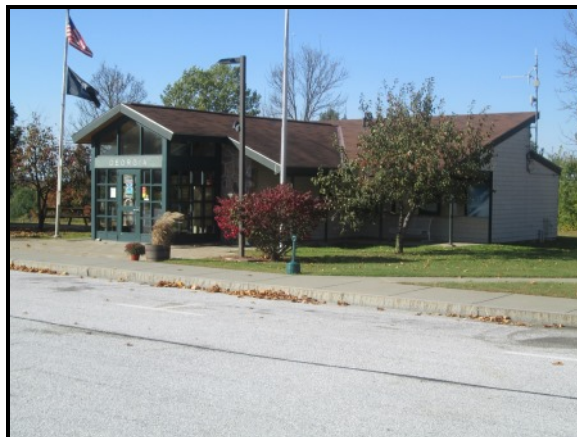
- The roof finishes are approximately 16 years old. Information regarding roof warranties or bonds were requested but are not available.
- The roof shingles are in fair to poor condition with numerous missing tabs noted and will require replacement during the assessment period. The cost of this work is included in the deferred cost section of the Replacement Reserves Cost Estimate Table.
- The roof flashings are in good condition and will require routine maintenance during the assessment period.
- Roof drainage appears to be adequate.
- The roof vents are in good condition and will require routine maintenance during the assessment period.
- There is no evidence of moisture or water intrusion in the roof systems.

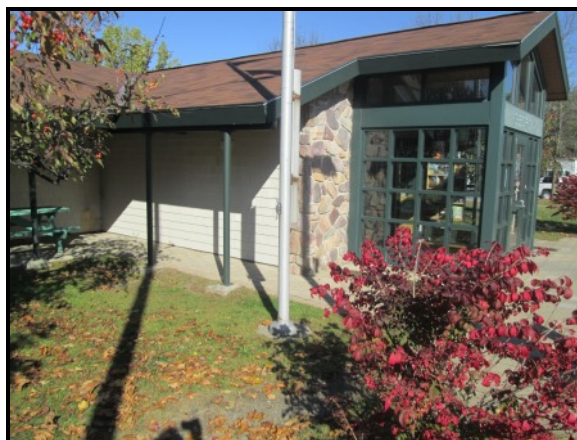
- The exterior finishes are in good condition. Painting and patching will be required during the assessment period. The cost of this work is included in the Replacement Reserves Cost Estimate Table.
- The sealant is flexible, smooth, and in good condition and will require routine maintenance during the assessment period.

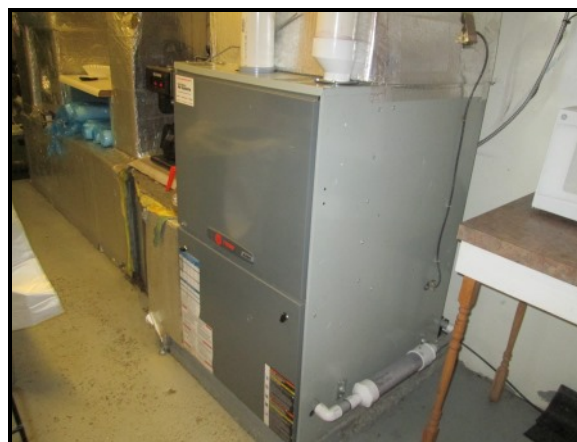
- Records of the installation, maintenance, upgrades, and replacement of the HVAC equipment have been maintained since the property was first occupied.
- The furnaces and wall air conditioners vary in age. HVAC equipment is reportedly replaced on an "as-needed" basis.
- The HVAC equipment appears to be in good condition. Based on its estimated Remaining Useful Life (RUL), the furnaces, wall air conditioners and exhaust fans will require replacement during the assessment period. The cost of this work is included in the Replacement Reserves Cost Estimate Table.

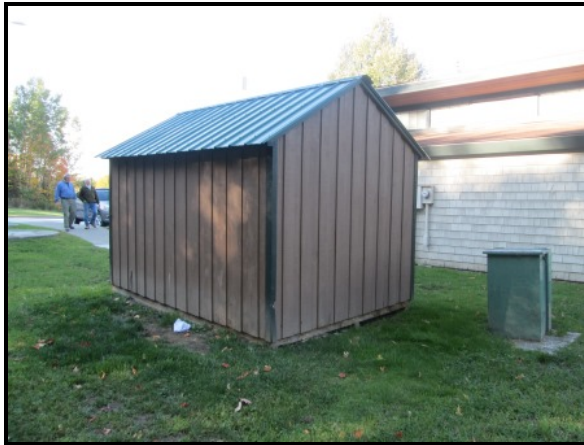
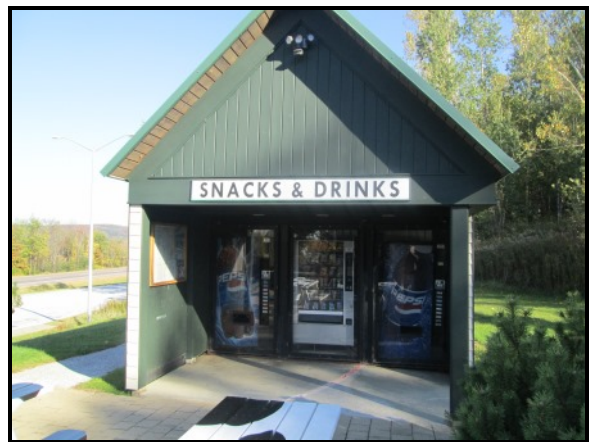
- The sheds and vending canopies are in good condition and will require routine maintenance during the assessment period. Refer to 6.1 for repairs needed to the vending canopy foundations.

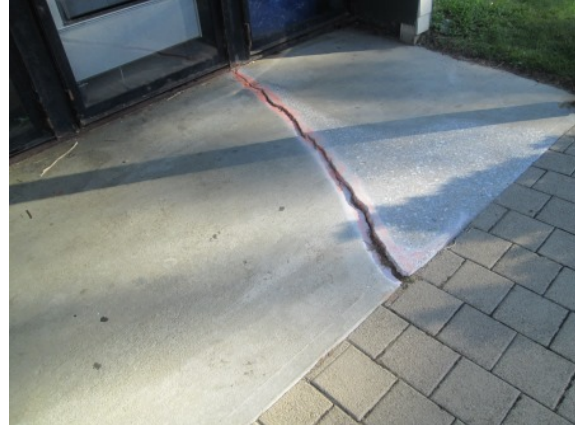
Photo #10: Northbound vending area foundation with crack and settlement

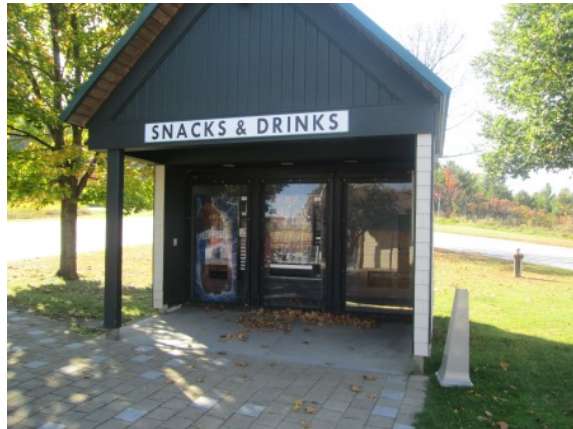
Photo #16: Southbound vending canopy (note settlement)
