FACILITY CONDITION ASSESSMENT

FACILITY CONDITION ASSESSMENT
OF
BENNINGTON WELCOME CENTER
100 VT RT. 279
BENNINGTON, VT 05201

106686.17R000-068.305

June 23, 2017

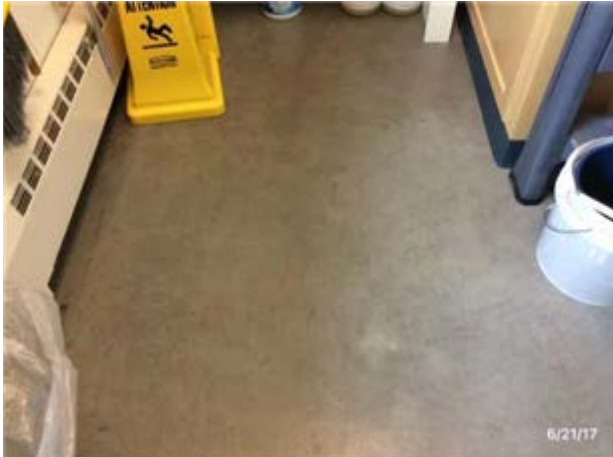
Coding / Field Name	Asset Description
A1031 Standard Slab on Grade	Concrete Slab-On-Grade
Condition	Good
Qty / UOM	6000 / SF
Unit Cost	\$10.44
Basis of Costing	Concrete Slab-On-Grade
Year in Service	2013
Expected Useful Life (EUL)	40 Year(s), Based on Industry Averages
Remaining Useful Life (RUL)	36 Year(s), Estimated, Based on Date of Observation
Location	Structure
Basement Wall Construction	Concrete

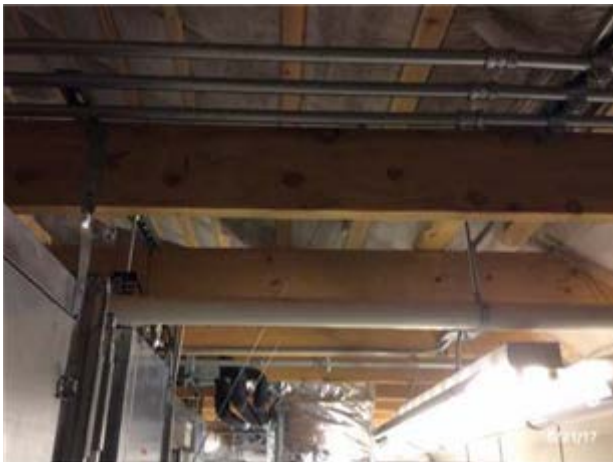
Coding / Field Name	Asset Description
B1012 Upper Floors Construction	Superstructure
Condition	Good
Qty / UOM	6000 / SF
Unit Cost	\$18.10
Basis of Costing	Superstructure, Structural Frame, Wood Conventional Stud
Year in Service	2000
Expected Useful Life (EUL)	50 Year(s), Based on Industry Averages
Remaining Useful Life (RUL)	33 Year(s), Estimated, Based on Date of Observation
Location	Structure
Basement Floor Construction	Concrete Cast-In-Place System
Joist Material	Wood
Basement Floor Decking	Concrete
Upper Floor Decking	Concrete
Concrete Type- All Floors	Cast In Place

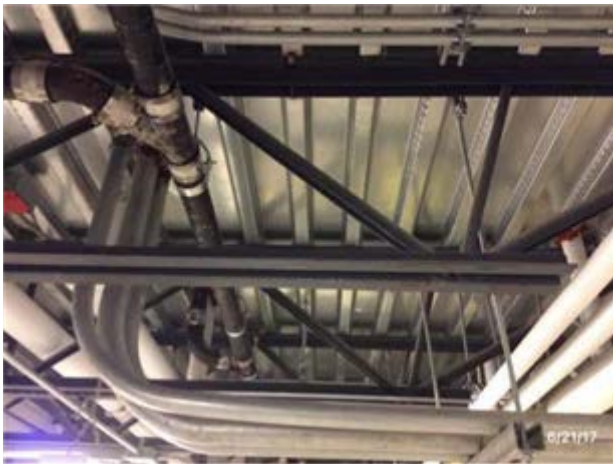
Coding / Field Name	Asset Description
B1012 Upper Floors Construction	Concrete Decking
Condition	Good
Qty / UOM	1000 / SF
Unit Cost	\$29.24
Basis of Costing	Concrete Decking
Year in Service	2000
Expected Useful Life (EUL)	50 Year(s), Based on Industry Averages
Remaining Useful Life (RUL)	33 Year(s), Estimated, Based on Date of Observation
Location	Structure
Basement Floor Construction	Concrete Cast-In-Place System
Joist Material	Steel
Basement Floor Decking	Concrete
Upper Floor Decking	Concrete
Concrete Type- All Floors	Cast In Place

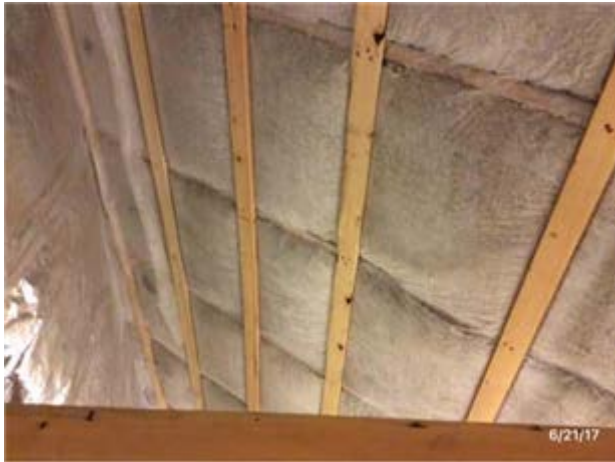
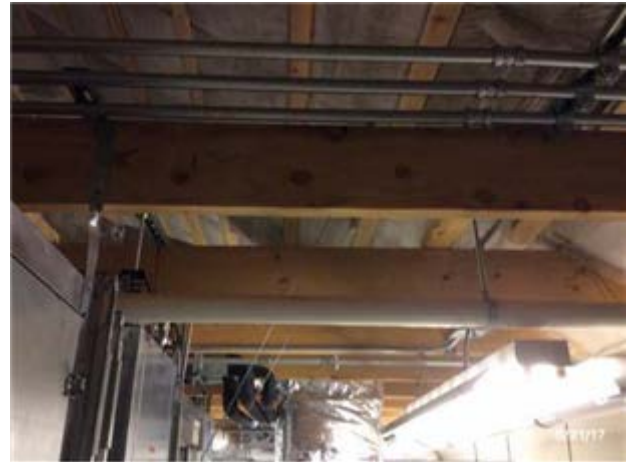
Coding / Field Name	Asset Description
B1022 Pitched Roof Construction	Roof Structure, Pitched, Wood Rafters
Condition	Good
Qty / UOM	6000 / SF
Unit Cost	\$19.72
Basis of Costing	Roof Structure, Pitched, Wood Rafters
Year in Service	2013
Expected Useful Life (EUL)	50 Year(s), Based on Industry Averages
Remaining Useful Life (RUL)	46 Year(s), Estimated, Based on Date of Observation
Location	Structure
Roofing Type	Gable
Parapet Wall Edge Flashing	Metal
Attic	Yes
Roof Access	None

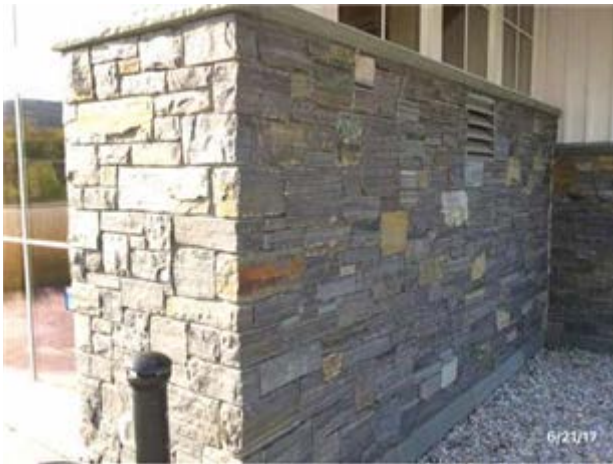
Coding / Field Name	Asset Description
B2011 Exterior Wall Construction	Stone Veneer Exterior Wall
Condition	Good
Qty / UOM	2000 / SF
Unit Cost	\$35.49
Basis of Costing	Stone Veneer Exterior Wall
Year in Service	2013
Expected Useful Life (EUL)	40 Year(s), Based on Industry Averages
Remaining Useful Life (RUL)	36 Year(s), Estimated, Based on Date of Observation
Location	Exterior Walls
Exterior Wall Construction	Stone Veneer
Parapets	No

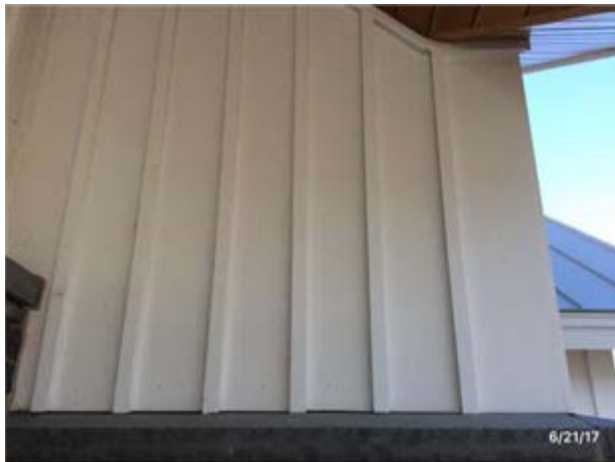
Coding / Field Name	Asset Description
B2011 Exterior Wall Construction	Wood, Exterior
Condition	Good
Qty / UOM	2000 / SF
Unit Cost	\$27.03
Basis of Costing	Wood Clapboard, Exterior, 1-2 Stories
Year in Service	2013
Expected Useful Life (EUL)	20 Year(s), Based on Industry Averages
Remaining Useful Life (RUL)	16 Year(s), Estimated, Based on Date of Observation
Location	Exterior Walls
Exterior Wall Construction	Solid Wood Lap Siding
Parapets	No

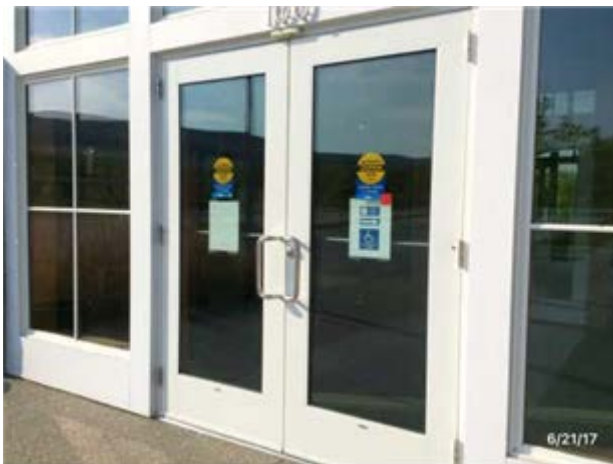
Coding / Field Name	Asset Description
B2031 Glazed Doors & Entrances	Exterior Door
Condition	Good
Qty / UOM	5 / EA
Unit Cost	\$1,368.37
Basis of Costing	Aluminum Frame, Fully Glazed, Exterior Door
Year in Service	2013
Expected Useful Life (EUL)	30 Year(s), Based on Industry Averages
Remaining Useful Life (RUL)	26 Year(s), Estimated, Based on Date of Observation
Location	Exterior Walls
Door Hardware	Lever
Door Operation	Both
Glass Type	Standard Glass
Door Frame	Metal Framed
Door Use	Entrance

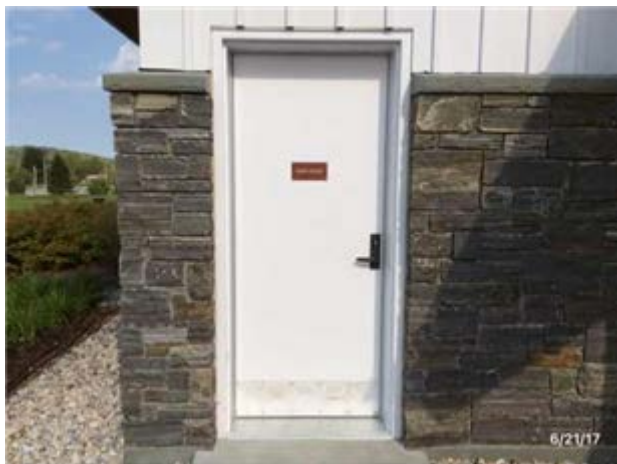
Coding / Field Name	Asset Description
B2032 Solid Exterior Doors	Steel, Insulated, Exterior Door
Condition	Good
Qty / UOM	3 / EA
Unit Cost	\$1,577.53
Basis of Costing	Steel, Insulated, Exterior Door
Year in Service	2013
Expected Useful Life (EUL)	25 Year(s), Based on Industry Averages
Remaining Useful Life (RUL)	21 Year(s), Estimated, Based on Date of Observation
Location	Exterior Walls
Door Hardware	Lever
Door Operation	Manual
Core Type	Hollow Core
Door Frame	Metal Framed

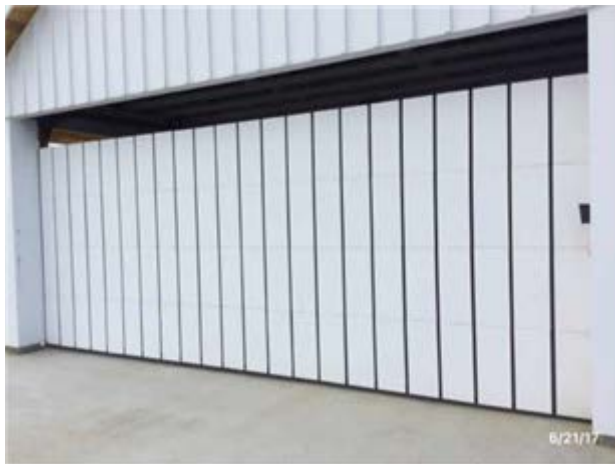
Coding / Field Name	Asset Description
B2034 Overhead Doors	Wood Roll-up Door
Condition	Good
Qty / UOM	1 / EA
Unit Cost	\$2,634.03
Basis of Costing	Wood Roll-up Door, 144 SF
Year in Service	2013
Expected Useful Life (EUL)	35 Year(s), Based on Industry Averages
Remaining Useful Life (RUL)	31 Year(s), Estimated, Based on Date of Observation
Location	Generator Shed

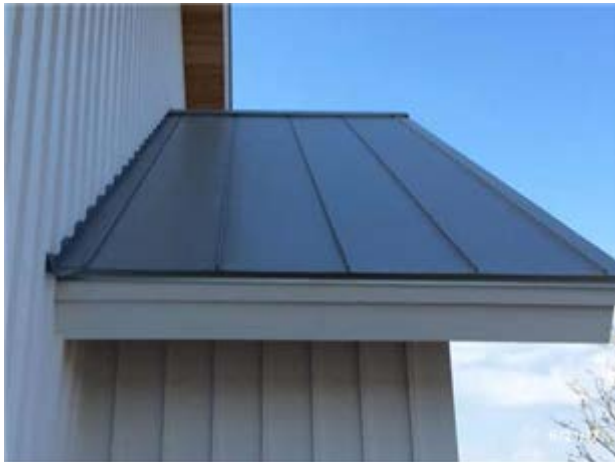
Coding / Field Name	Asset Description
B3011 Roof Finishes	Metal Roof
Condition	Good
Qty / UOM	8000 / SF
Cost Adjustment Factor/Reason	1.3 / Gable
Unit Cost (Adjusted)	\$42.13
Basis of Costing	Metal Roof (Includes Tear-Off of Old)
Year in Service	2013
Expected Useful Life (EUL)	40 Year(s), Based on Industry Averages
Remaining Useful Life (RUL)	36 Year(s), Estimated, Based on Date of Observation
Location	Roof
Insulation	Batt
Flashings and Trim	Metal
Roof Eaves and Soffits	Yes
Roof Drainage	Metal Gutter And Down Spouts
Roof Warranty	Unknown

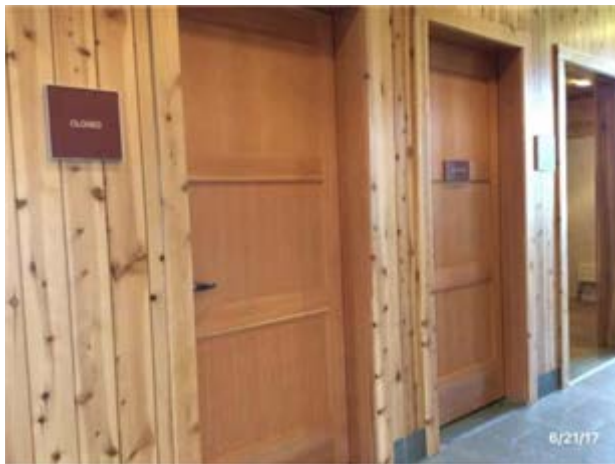
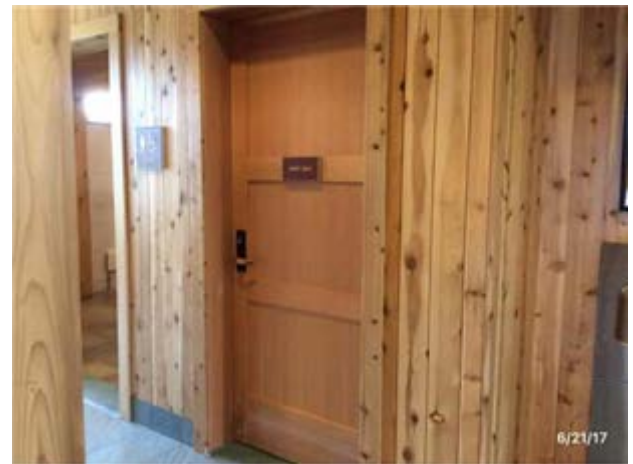
Coding / Field Name	Asset Description
C1021 Interior Doors	Wood, Solid Core, Painted/Stained, Interior Door
Condition	Good
Qty / UOM	18 / EA
Unit Cost	\$1,423.11
Basis of Costing	Wood, Solid Core, Painted/Stained, Interior Door
Year in Service	2013
Expected Useful Life (EUL)	20 Year(s), Based on Industry Averages
Remaining Useful Life (RUL)	16 Year(s), Estimated, Based on Date of Observation
Location	Building Interior (General)

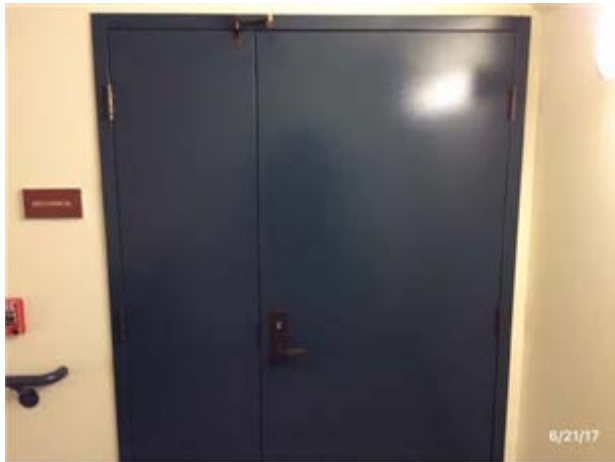
Coding / Field Name	Asset Description
C1021 Interior Doors	Fire Doors
Condition	Good
Qty / UOM	2 / EA
Unit Cost	\$1,649.06
Basis of Costing	Fire Doors
Year in Service	2013
Expected Useful Life (EUL)	20 Year(s), Based on Industry Averages
Remaining Useful Life (RUL)	16 Year(s), Estimated, Based on Date of Observation
Location	Building Interior (General)

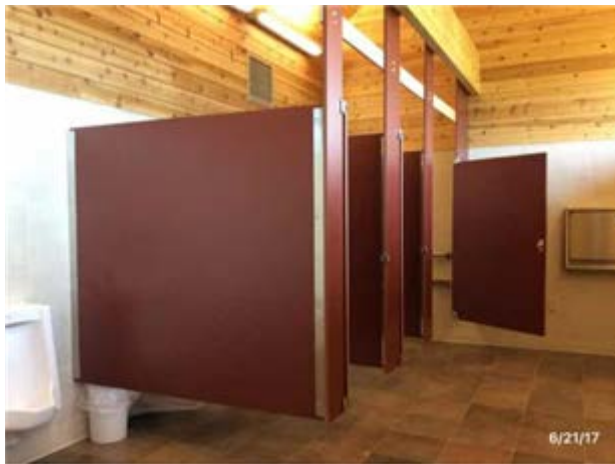
Coding / Field Name	Asset Description
C1031 Fabricated Toilet Partitions	Toilet Partitions
Condition	Good
Qty / UOM	6861 / EA
Unit Cost	\$850.00
Basis of Costing	Toilet Partitions, Metal, Overhead Braced
Year in Service	2013
Expected Useful Life (EUL)	20 Year(s), Based on Industry Averages
Remaining Useful Life (RUL)	16 Year(s), Estimated, Based on Date of Observation
Location	Restrooms

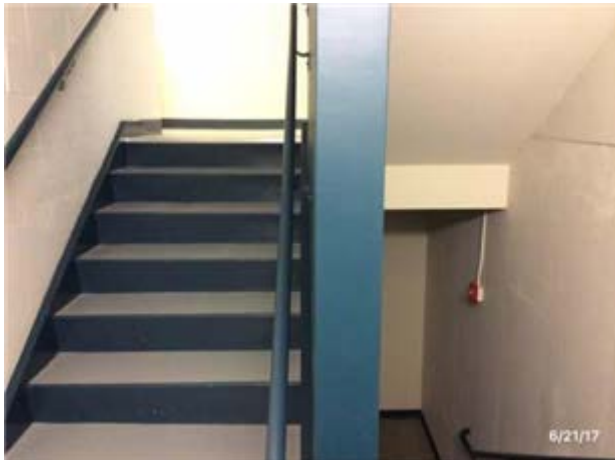
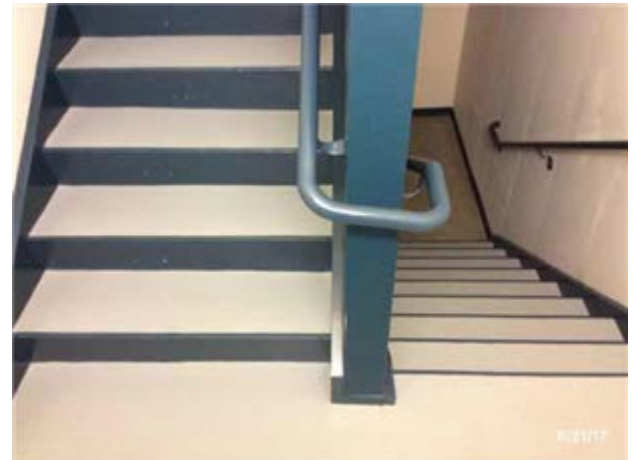
Coding / Field Name	Asset Description
C2011 Regular Stairs	Metal, Interior Stairs
Condition	Good
Qty / UOM	300 / SF
Unit Cost	\$44.53
Basis of Costing	Metal, Interior Stairs
Year in Service	2013
Expected Useful Life (EUL)	50 Year(s), Based on Industry Averages
Remaining Useful Life (RUL)	46 Year(s), Estimated, Based on Date of Observation
Location	Stair Tower
Stairs Frame	Steel
Stair Riser	Open
Stair Treads	Concrete-Filled/Metal Pan
Stair Railings	Metal
Stair Soffit Finishes	Drywall
Stair Handrail Finishes	Painted

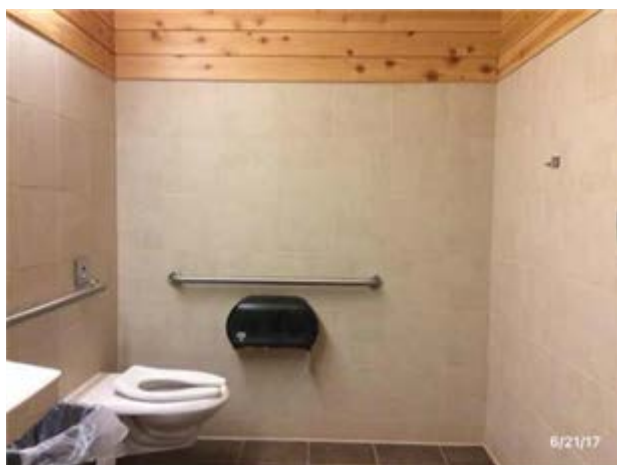
Coding / Field Name	Asset Description
C3012 Wall Finishes to Interior Walls	Ceramic Tile, Interior Wall Finish
Condition	Good
Qty / UOM	500 / SF
Unit Cost	\$16.55
Basis of Costing	Ceramic Tile, Interior Wall Finish
Year in Service	2013
Expected Useful Life (EUL)	25 Year(s), Based on Industry Averages
Remaining Useful Life (RUL)	21 Year(s), Estimated, Based on Date of Observation
Location	Building Interior (General)

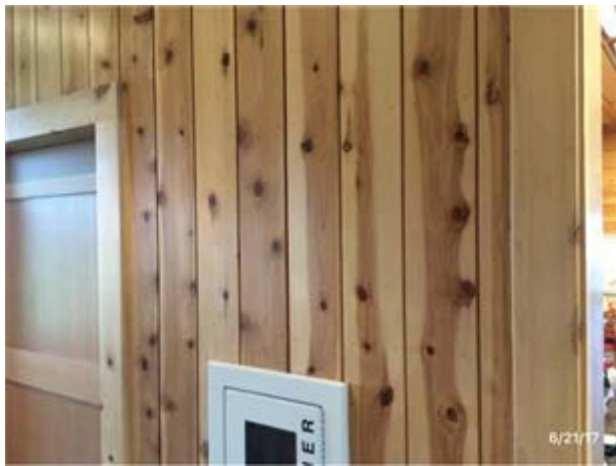
Coding / Field Name	Asset Description
C3012 Wall Finishes to Interior Walls	Interior Wall Finish, Wood, Stained
Condition	Good
Qty / UOM	5000 / SF
Unit Cost	\$23.73
Basis of Costing	Wood, Finished, Interior Paneling
Year in Service	2013
Expected Useful Life (EUL)	20 Year(s), Based on Industry Averages
Remaining Useful Life (RUL)	16 Year(s), Estimated, Based on Date of Observation
Location	Building Interior (General)

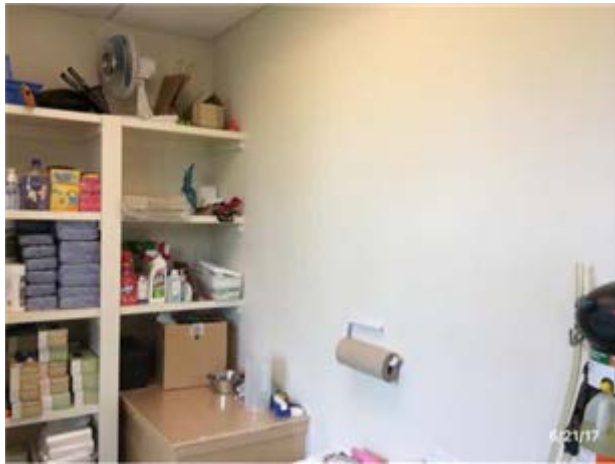
Coding / Field Name	Asset Description
C3012 Wall Finishes to Interior Walls	Gypsum Board, Wall
Condition	Good
Qty / UOM	4500 / SF
Unit Cost	\$3.38
Basis of Costing	Gypsum Board/Plaster, Interior Wall
Year in Service	2013
Expected Useful Life (EUL)	40 Year(s), Based on Industry Averages
Remaining Useful Life (RUL)	36 Year(s), Estimated, Based on Date of Observation
Location	Building Interior (General)

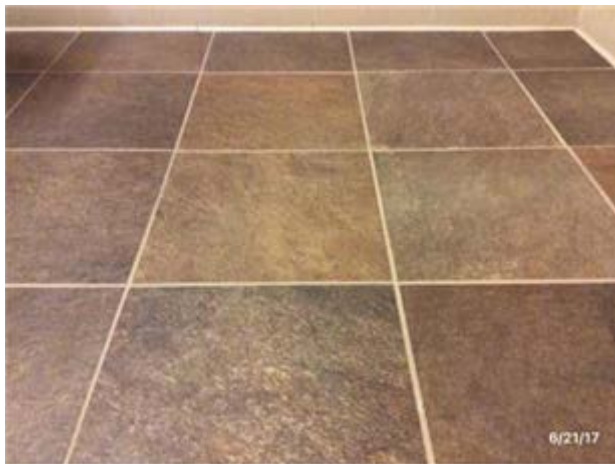
Coding / Field Name	Asset Description
C3024 Flooring	Ceramic Tile Flooring
Condition	Good
Qty / UOM	1000 / SF
Unit Cost	\$15.75
Basis of Costing	Ceramic Tile Flooring
Year in Service	2013
Expected Useful Life (EUL)	50 Year(s), Based on Industry Averages
Remaining Useful Life (RUL)	46 Year(s), Estimated, Based on Date of Observation
Location	Restrooms

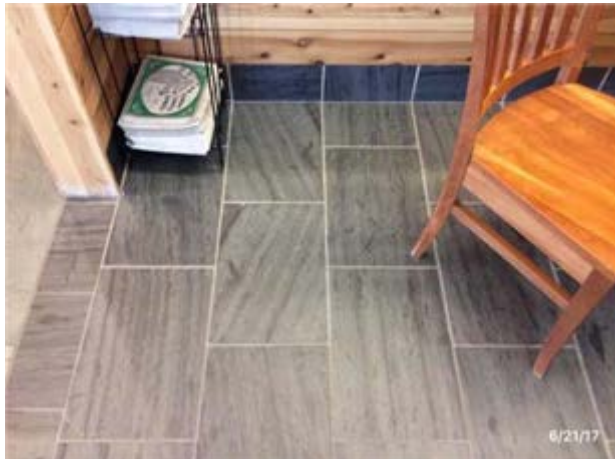
Coding / Field Name	Asset Description
C3024 Flooring	Slate Tile Flooring
Condition	Good
Qty / UOM	3000 / SF
Cost Adjustment Factor/Reason	0.5 / Slate tile
Unit Cost (Adjusted)	\$34.79
Basis of Costing	Marble Flooring
Year in Service	2013
Expected Useful Life (EUL)	50 Year(s), Based on Industry Averages
Remaining Useful Life (RUL)	46 Year(s), Estimated, Based on Date of Observation
Location	Building Interior (General)

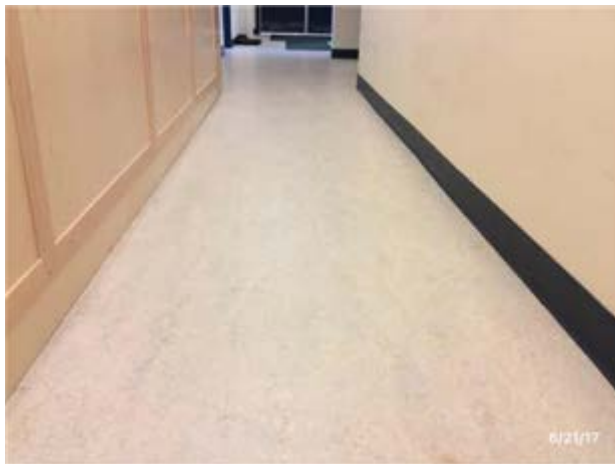
Coding / Field Name	Asset Description
C3024 Flooring	Vinyl Sheet Flooring
Condition	Good
Qty / UOM	1500 / SF
Unit Cost	\$7.01
Basis of Costing	Vinyl Sheet Flooring
Year in Service	2013
Expected Useful Life (EUL)	15 Year(s), Based on Industry Averages
Remaining Useful Life (RUL)	11 Year(s), Estimated, Based on Date of Observation
Location	Building Interior (General)

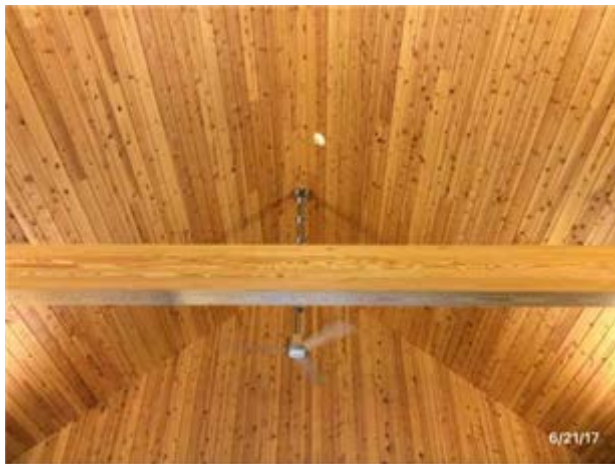
Coding / Field Name	Asset Description
C3031 Ceiling Finishes	Wood Ceiling
Condition	Good
Qty / UOM	5000 / SF
Unit Cost	\$9.22
Basis of Costing	Wood Ceiling
Year in Service	2013
Expected Useful Life (EUL)	30 Year(s), Based on Industry Averages
Remaining Useful Life (RUL)	26 Year(s), Estimated, Based on Date of Observation
Location	Building Interior (General)

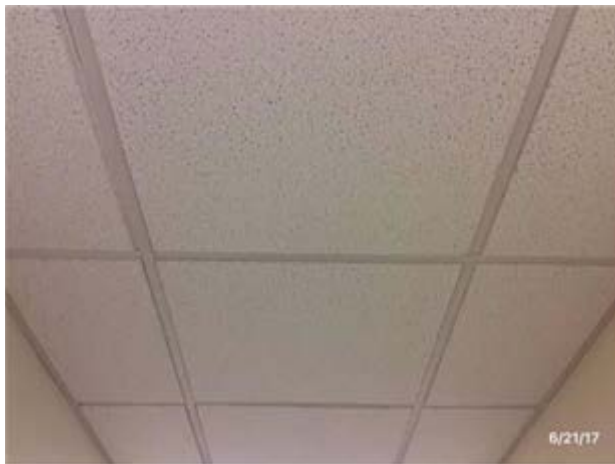
Coding / Field Name	Asset Description
C3032 Suspended Ceilings	Acoustical Tile Ceiling
Condition	Good
Qty / UOM	2000 / SF
Unit Cost	\$5.60
Basis of Costing	Acoustical Tile Ceiling
Year in Service	2013
Expected Useful Life (EUL)	20 Year(s), Based on Industry Averages
Remaining Useful Life (RUL)	16 Year(s), Estimated, Based on Date of Observation
Location	Building Interior (General)

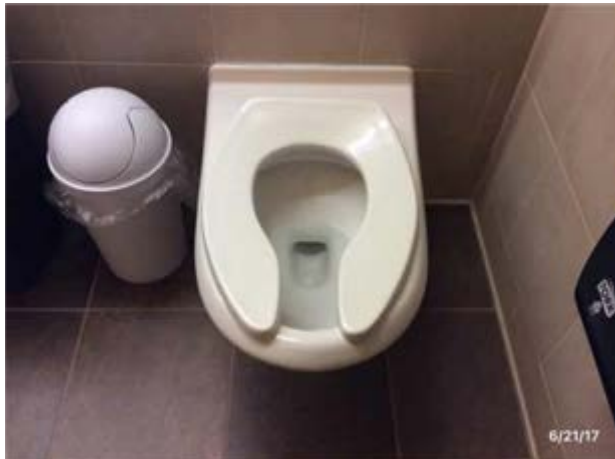
Coding / Field Name	Asset Description
D2011 Water Closets	Tankless Water Closet
Condition	Good
Qty / UOM	16 / EA
Unit Cost	\$842.97
Basis of Costing	Tankless Water Closet
Year in Service	2013
Expected Useful Life (EUL)	20 Year(s), Based on Industry Averages
Remaining Useful Life (RUL)	16 Year(s), Estimated, Based on Date of Observation
Location	Restrooms
System Grade	Commercial Grade

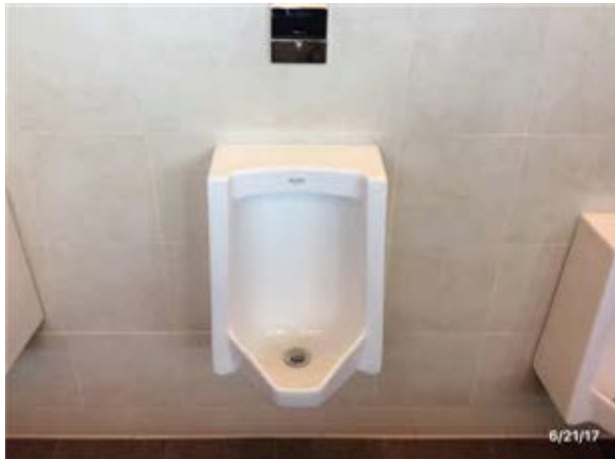
Coding / Field Name	Asset Description
D2012 Urinals	Urinal, Vitreous China
Condition	Good
Qty / UOM	3 / EA
Unit Cost	\$1,193.44
Basis of Costing	Urinal, Vitreous China
Year in Service	2013
Expected Useful Life (EUL)	20 Year(s), Based on Industry Averages
Remaining Useful Life (RUL)	16 Year(s), Estimated, Based on Date of Observation
Location	Restrooms
System Grade	Commercial Grade

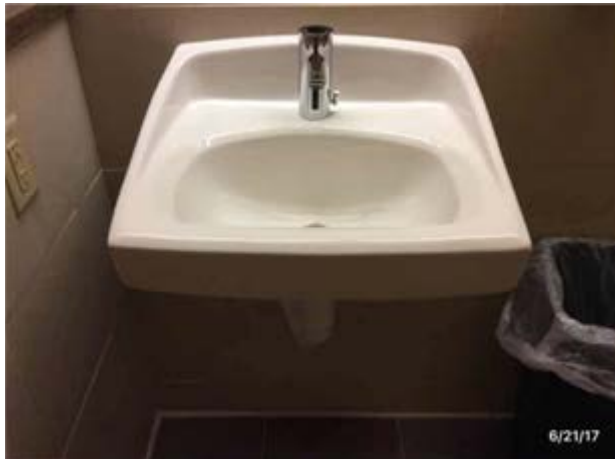
Coding / Field Name	Asset Description
D2013 Lavatories	Lavatory, Enameled Steel
Condition	Good
Qty / UOM	14 / EA
Unit Cost	\$353.05
Basis of Costing	Lavatory, Enameled Steel
Year in Service	2013
Expected Useful Life (EUL)	20 Year(s), Based on Industry Averages
Remaining Useful Life (RUL)	16 Year(s), Estimated, Based on Date of Observation
Location	Restrooms
System Grade	Commercial Grade

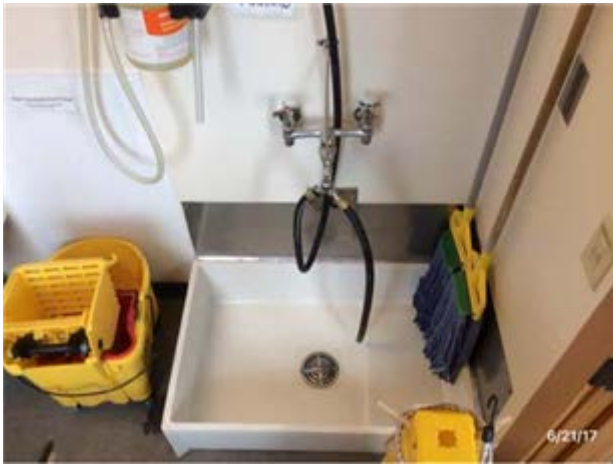
Coding / Field Name	Asset Description
D2014 Sinks	Service Sink, Floor
Condition	Good
Qty / UOM	1 / EA
Unit Cost	\$1,599.51
Basis of Costing	Service Sink, Floor
Year in Service	2013
Expected Useful Life (EUL)	35 Year(s), Based on Industry Averages
Remaining Useful Life (RUL)	31 Year(s), Estimated, Based on Date of Observation
Location	MEP Closet

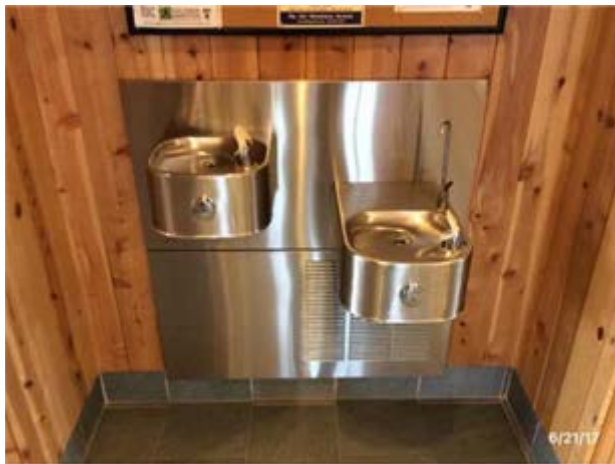
Coding / Field Name	Asset Description
D2018 Drinking Fountains and Coolers	Drinking Fountain, Refrigerated
Condition	Good
Qty / UOM	2 / EA
Unit Cost	\$1,257.51
Basis of Costing	Drinking Fountain, Refrigerated
Year in Service	2013
Expected Useful Life (EUL)	10 Year(s), Based on Industry Averages
Remaining Useful Life (RUL)	6 Year(s), Estimated, Based on Date of Observation
Location	Building Interior (General)

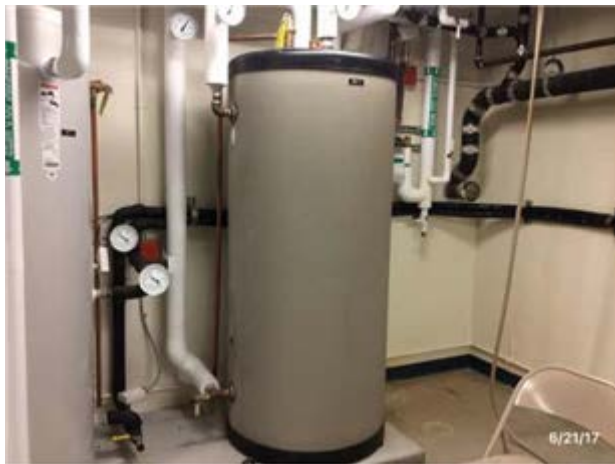
Coding / Field Name	Asset Description
D2023 Domestic Water Supply Equipment	Water Heater, Indirect, 80 to 120 GAL
Condition	Good
Qty / UOM	1 / EA
Unit Cost	\$4,371.07
Basis of Costing	Water Heater, Indirect, 80 to 120 GAL
Year in Service	2013
Expected Useful Life (EUL)	15 Year(s), Based on Industry Averages
Remaining Useful Life (RUL)	11 Year(s), Estimated, Based on Date of Observation
Location	Mechanical Room (Primary)

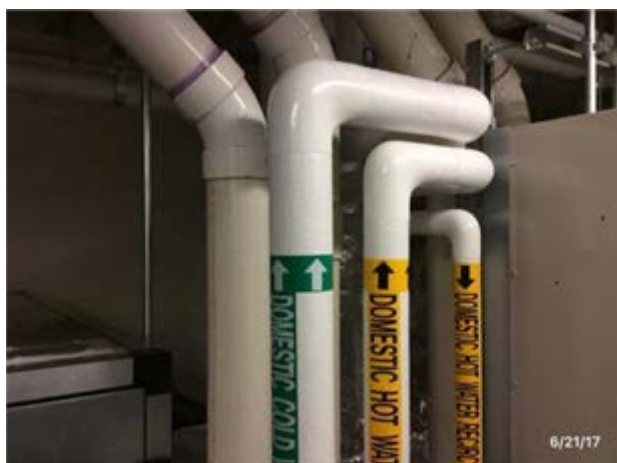
Coding / Field Name	Asset Description
D2029 Plumbing Systems	Plumbing System, Domestic Supply
Condition	Good
Qty / UOM	6861 / SF
Unit Cost	\$7.59
Basis of Costing	Plumbing System, Domestic Supply
Year in Service	2000
Expected Useful Life (EUL)	40 Year(s), Based on Industry Averages
Remaining Useful Life (RUL)	23 Year(s), Estimated, Based on Date of Observation
Location	Building Interior (General)

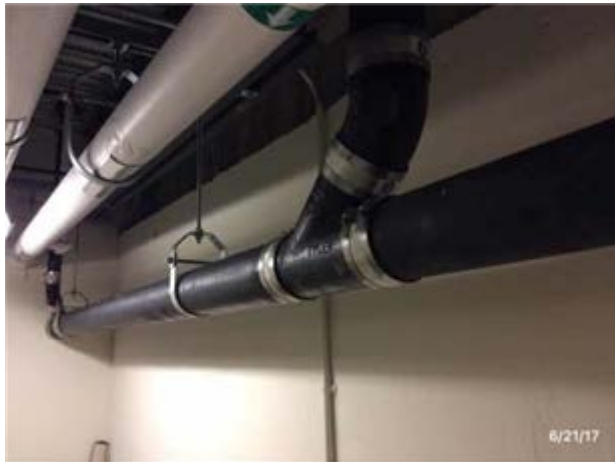
Coding / Field Name	Asset Description
D2034 Sanitary Waste Equipment	Plumbing System, Sanitary Waste
Condition	Good
Qty / UOM	6861 / SF
Unit Cost	\$5.06
Basis of Costing	Plumbing System, Sanitary Waste
Year in Service	2013
Expected Useful Life (EUL)	40 Year(s), Based on Industry Averages
Remaining Useful Life (RUL)	36 Year(s), Estimated, Based on Date of Observation
Location	Building Interior (General)

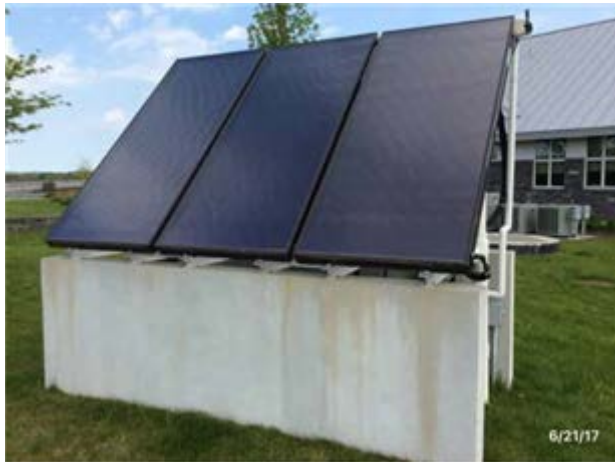
Coding / Field Name	Asset Description
D3016 Solar Energy System	Solar Panel, Hydronic, 24 SF
Condition	Good
Qty / UOM	3 / EA
Unit Cost	\$1,634.07
Basis of Costing	Solar Panel, 24 SF
Year in Service	2013
Expected Useful Life (EUL)	15 Year(s), Based on Industry Averages
Remaining Useful Life (RUL)	11 Year(s), Estimated, Based on Date of Observation
Location	Site

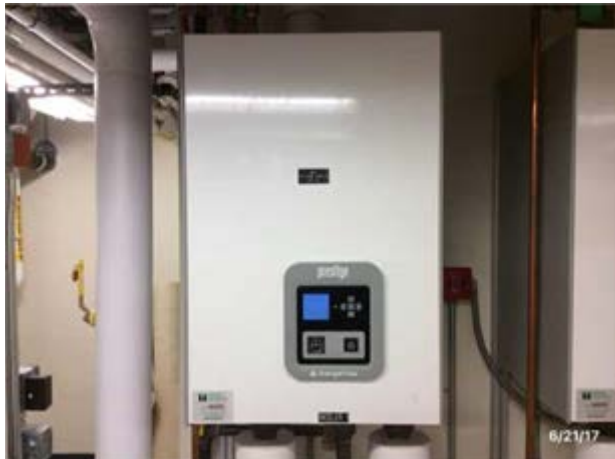
Coding / Field Name	Asset Description
D3021 Boilers	Boiler, Propane, B-1
Condition	Good
Qty / UOM	1 / EA
Unit Cost	\$23,840.88
Basis of Costing	Boiler, Gas, 301 to 750 MBH
Year in Service	2013
Expected Useful Life (EUL)	25 Year(s), Based on Industry Averages
Remaining Useful Life (RUL)	21 Year(s), Estimated, Based on Date of Observation
Location	Mechanical Room (Primary)
Boiler Draft Type	Forced Draft

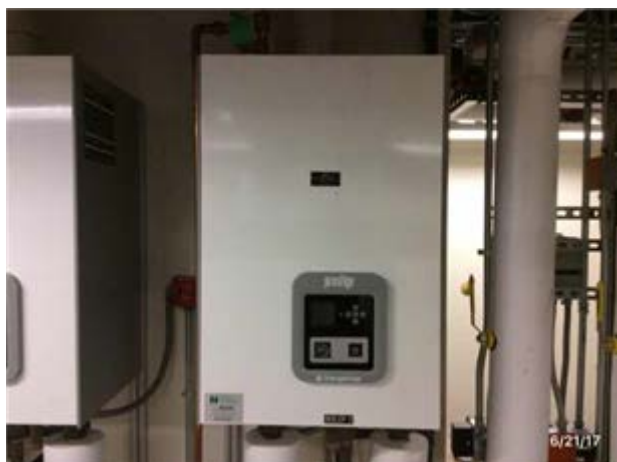
Coding / Field Name	Asset Description
D3021 Boilers	Boiler, Propane, B-2
Condition	Good
Qty / UOM	1 / EA
Unit Cost	\$23,840.88
Basis of Costing	Boiler, Gas, 301 to 750 MBH
Year in Service	2013
Expected Useful Life (EUL)	25 Year(s), Based on Industry Averages
Remaining Useful Life (RUL)	21 Year(s), Estimated, Based on Date of Observation
Location	Mechanical Room (Primary)
Boiler Draft Type	Forced Draft
