FACILITY CONDITION ASSESSMENT

FACILITY CONDITION ASSESSMENT
OF
09916 DERBY WELCOME CENTER
1076 RT. I-91 SOUTHBOUND
DERBY, VT 05855

June 19, 2017

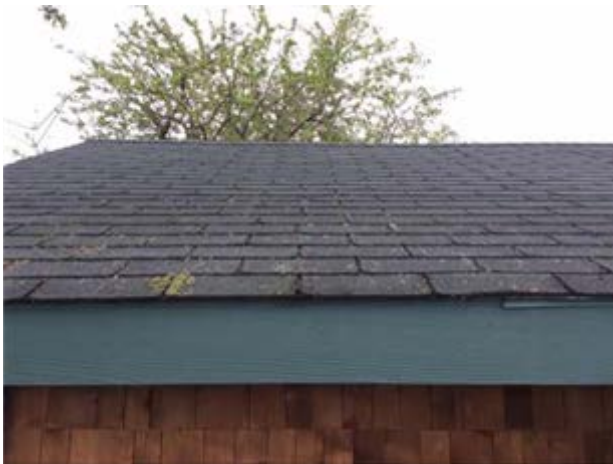
History of leaks reported.

Recommendations

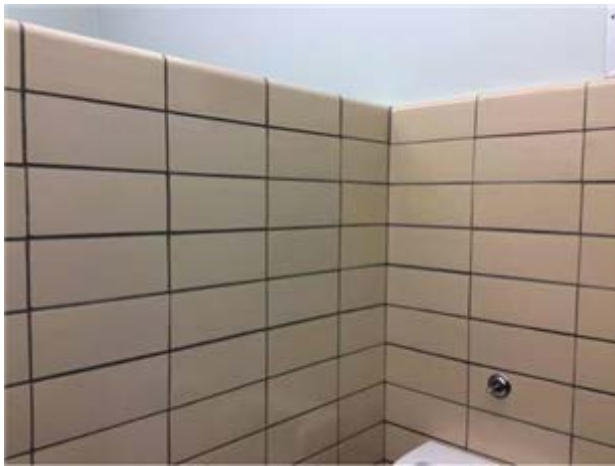
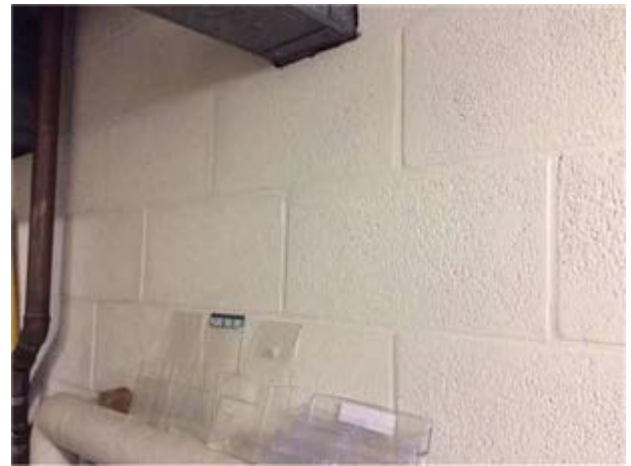
Includes glazed and paintd block

Recommendations

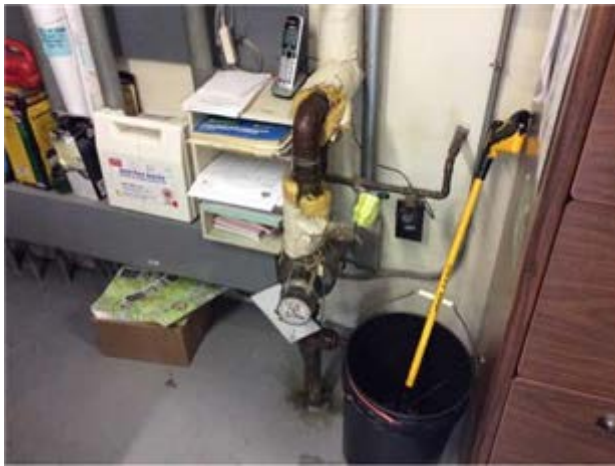
Backflow preventer not observed.

Recommendations

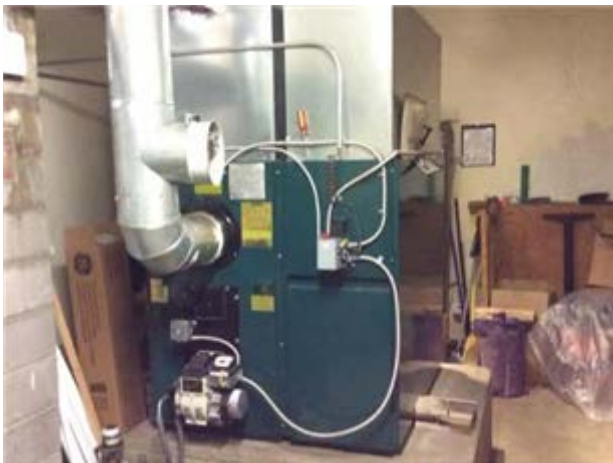
Includes separate, dedicated wood-burning and oil-burning sections.

Recommendations

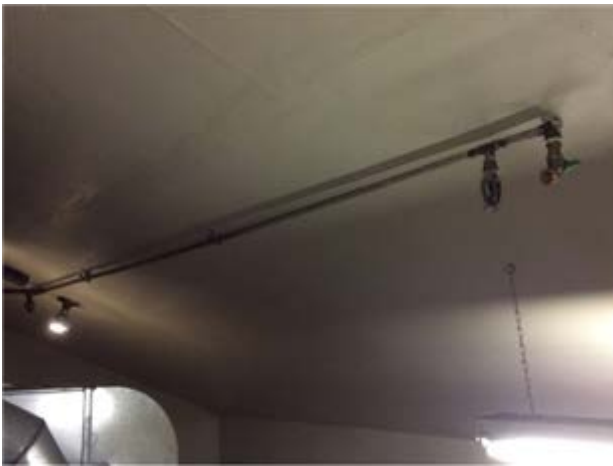
Located in room with furnace only.

Recommendations

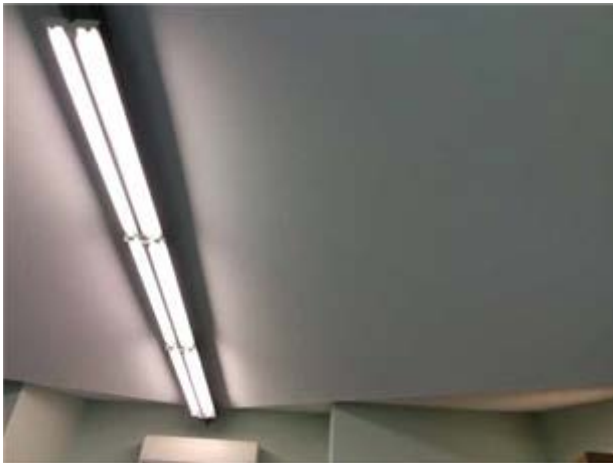
No automatic wet sprinkler fire suppression system was observed. Though likely grandfathered, installation is recommended for life safety and asset protection reasons.

Recommendations

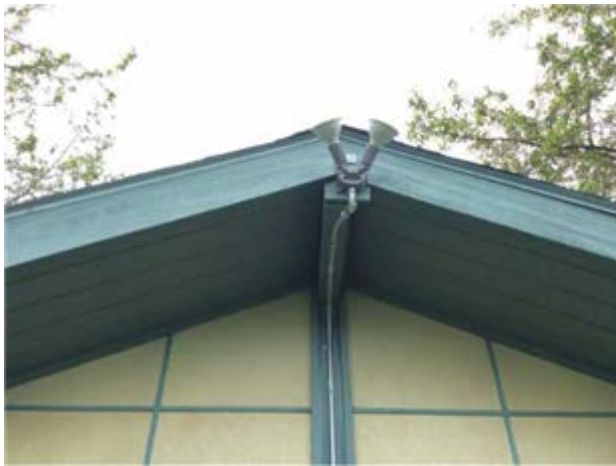
Incandescent fixtures with LED bulbs

Recommendations

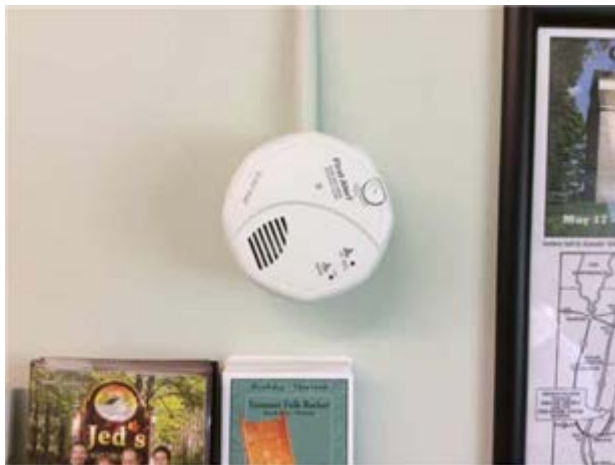
Existing system appear limited to a wall smoke/CO detector. No centralized fire alarm system exists. The likely grandfathered, installation of a centralized system with remote notification is recommended for life safety and asset protection reasons.

Recommendations

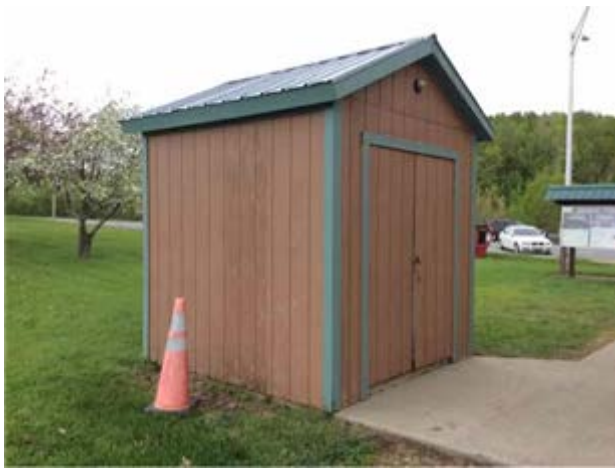
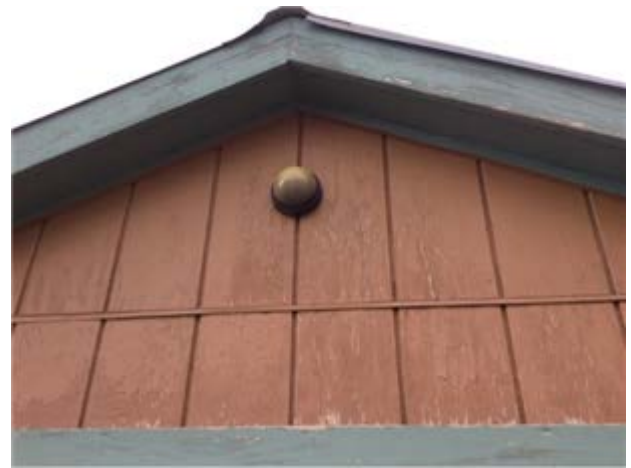
Paint is beginning to peel

Recommendations

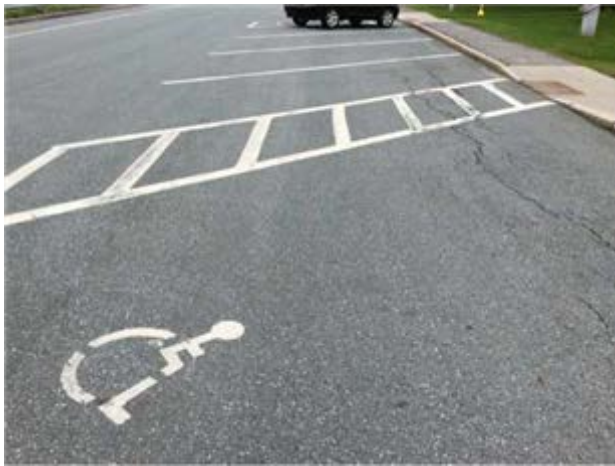
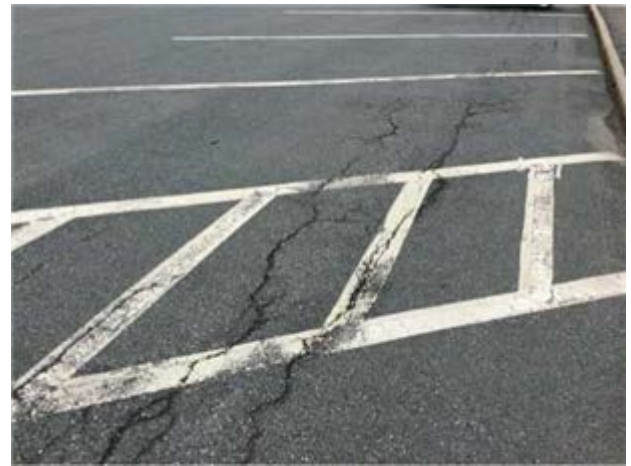
Isolated cracks. Sealant is worn.

Recommendations
