FACILITY CONDITION ASSESSMENT

106686.17R000-086.305

June 19, 2017

FACILITY CONDITION ASSESSMENT
OF
GUILFORD WELCOME CENTER
91 NORTH
GUILFORD, VT 05602

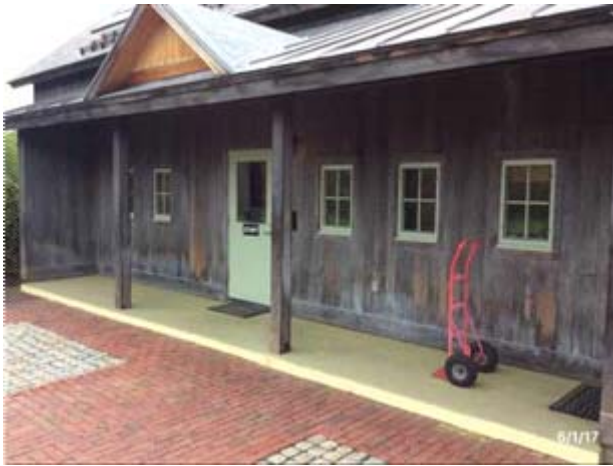
Coding / Field Name	Asset Description
B2021 Windows	Vinyl Window, Double Glazed
Condition	Fair
Qty / UOM	13 / EA
Unit Cost	\$1,000.05
Basis of Costing	Vinyl Window, Double Glazed, 1-2 Stories, 12 SF
Year in Service	1999
Expected Useful Life (EUL)	30 Year(s), Based on Industry Averages
Remaining Useful Life (RUL)	12 Year(s), Estimated, Based on Date of Observation
Location	Exterior Walls
Window Type	Casement
Windows Material	Vinyl
Windows Glazing	Double Glazed
Window Operation	Manual

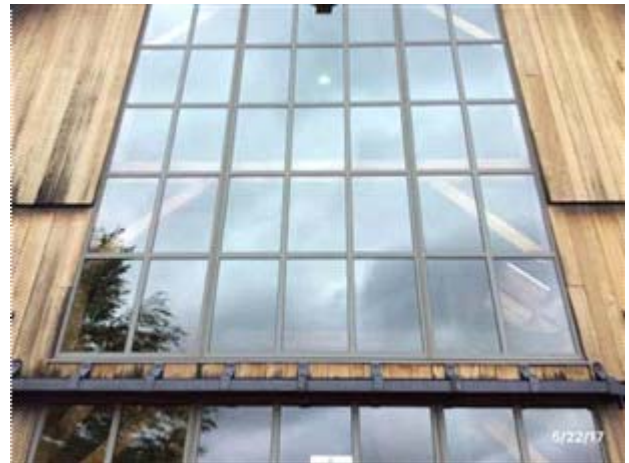
Coding / Field Name	Asset Description
B2023 Storefronts	Storefront Glazing & Framing
Condition	Fair
Qty / UOM	1985 / SF
Unit Cost	\$48.00
Year in Service	1999
Expected Useful Life (EUL)	30 Year(s), Based on Industry Averages
Remaining Useful Life (RUL)	12 Year(s), Estimated, Based on Date of Observation
Location	Exterior Walls
Window Type	Fixed
Windows Material	Aluminum
Windows Glazing	Double Glazed
Window Operation	Fixed

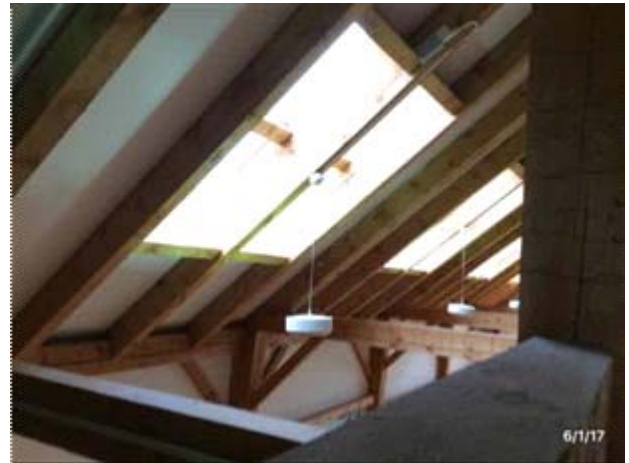
Coding / Field Name	Asset Description
B3021 Glazed Roof Openings	Single Unit Glass Skylight
Condition	Fair
Qty / UOM	130 / SF
Cost Adjustment Factor/Reason	2 / Segmented units
Unit Cost (Adjusted)	\$167.64
Basis of Costing	Single Unit Glass Skylight
Year in Service	1999
Expected Useful Life (EUL)	30 Year(s), Based on Industry Averages
Remaining Useful Life (RUL)	12 Year(s), Estimated, Based on Date of Observation
Location	Roof

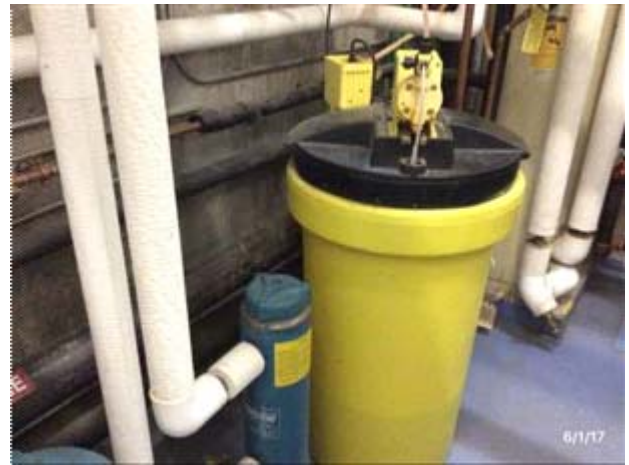
Coding / Field Name	Asset Description
D3047 Glycol Distribution Systems	Glycol Snowmelt System
Condition	Fair
Qty / UOM	1 / EA
Unit Cost	\$8,000.00
Year in Service	1999
Expected Useful Life (EUL)	30 Year(s), Based on Industry Averages
Remaining Useful Life (RUL)	12 Year(s), Estimated, Based on Date of Observation
Location	Site

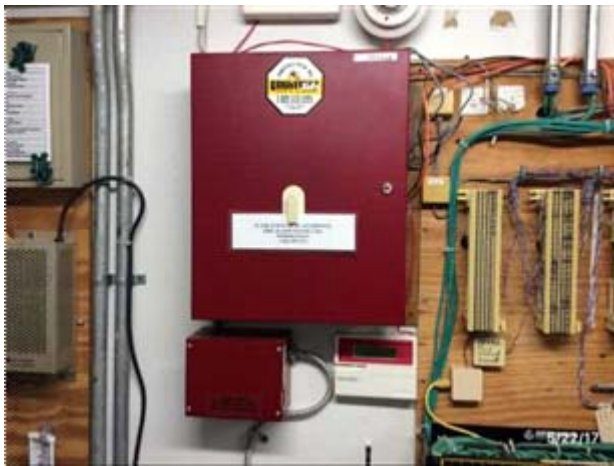
Coding / Field Name	Asset Description
D5037 Fire Alarm Systems	Fire Alarm Control Panel, Addressable
Condition	Poor
Qty / UOM	1 / EA
Unit Cost	\$20,297.59
Basis of Costing	Fire Alarm Control Panel, Addressable
Year in Service	1999
Expected Useful Life (EUL)	15 Year(s), Based on Industry Averages
Remaining Useful Life (RUL)	2 Year(s), Estimated, Based on Date of Observation
Location	Mechanical Room

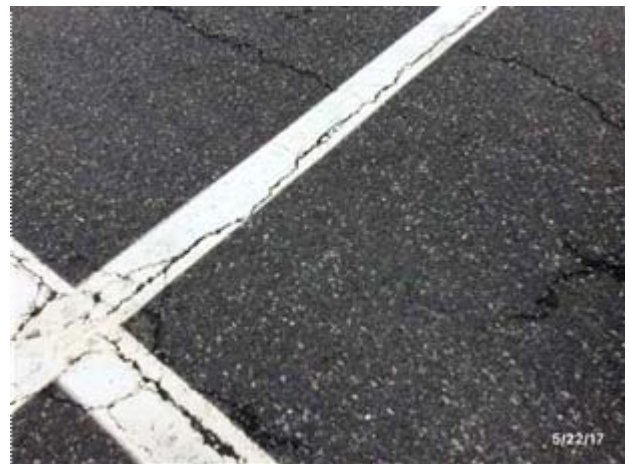
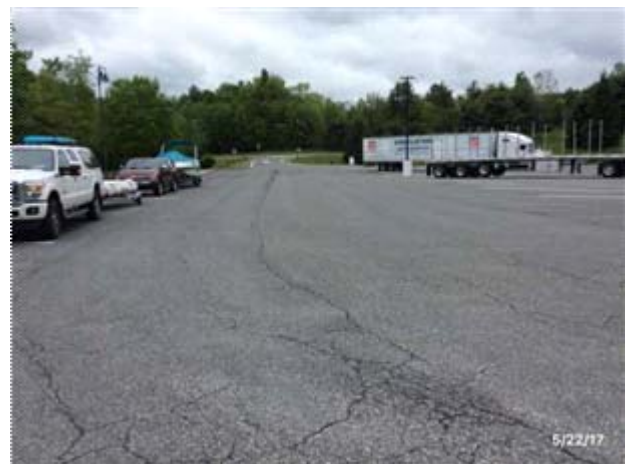
Isolated patching needed. Crack sealing and seal coat needed. Striping is recent.

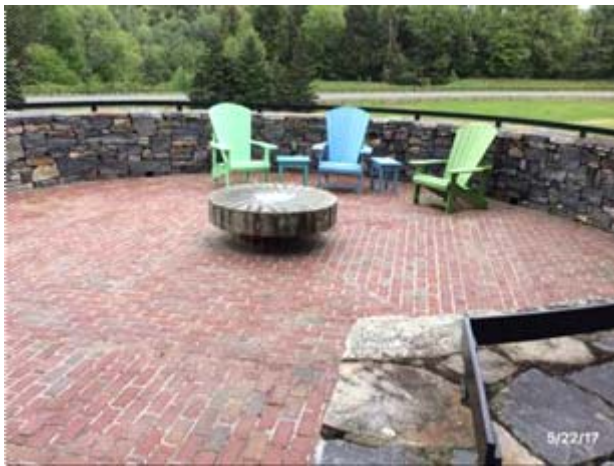
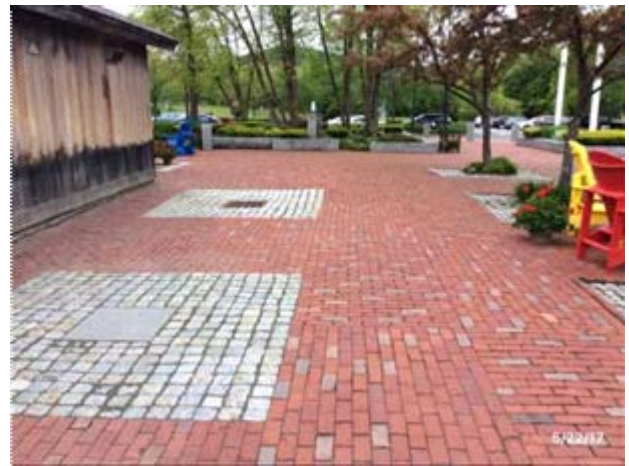
Coding / Field Name	Asset Description
G2031 Paving & Surfacing	Clay Brick/Masonry Paver Sidewalk, Exterior
Condition	Fair
Qty / UOM	24650 / SF
Unit Cost	\$34.11
Basis of Costing	Clay Brick/Masonry Paver Sidewalk, Exterior
Year in Service	1999
Expected Useful Life (EUL)	30 Year(s), Based on Industry Averages
Remaining Useful Life (RUL)	12 Year(s), Estimated, Based on Date of Observation
Location	Site

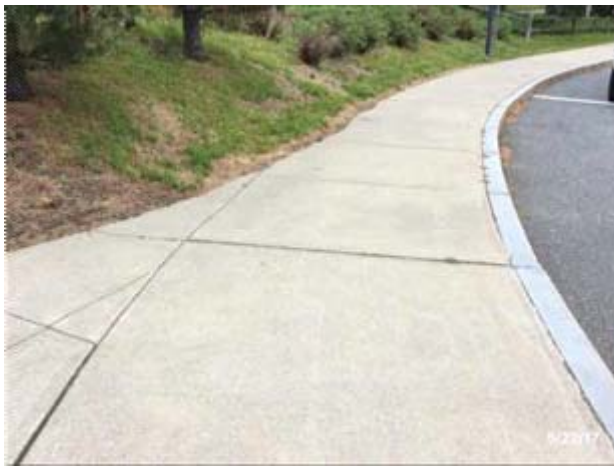
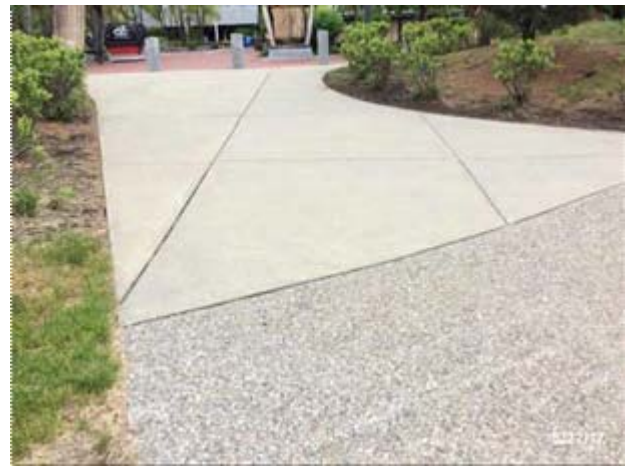
Coding / Field Name	Asset Description
G2031 Paving & Surfacing	Concrete Sidewalk and Picnic Pads
Condition	Fair
Qty / UOM	3400 / SF
Unit Cost	\$19.82
Basis of Costing	Concrete Sidewalk
Year in Service	1999
Expected Useful Life (EUL)	30 Year(s), Based on Industry Averages
Remaining Useful Life (RUL)	20 Year(s), Estimated, Based on Date of Observation
Location	Site

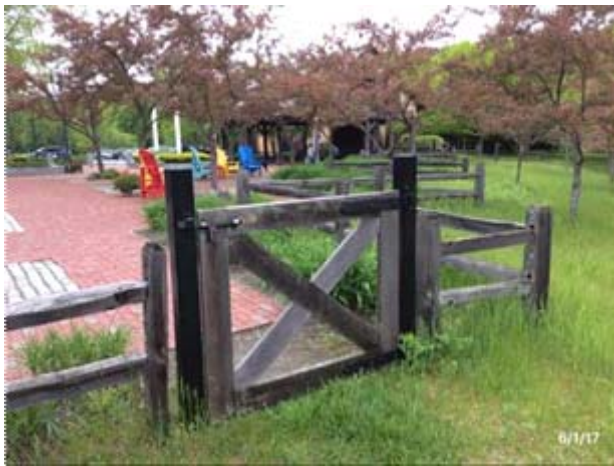
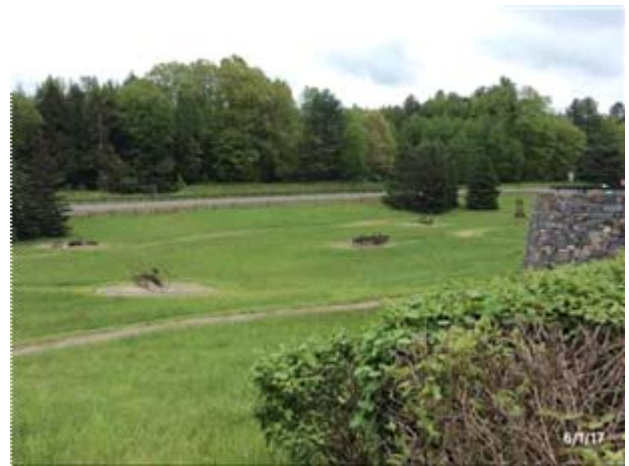
Coding / Field Name	Asset Description
G2041 Fences & Gates	Wood Board Fence
Condition	Fair
Qty / UOM	3550 / LF
Unit Cost	\$41.59
Basis of Costing	Wood Board Fence, Cedar, 6' High (per LF)
Year in Service	1999
Expected Useful Life (EUL)	30 Year(s), Based on Industry Averages
Remaining Useful Life (RUL)	12 Year(s), Estimated, Based on Date of Observation
Location	Site

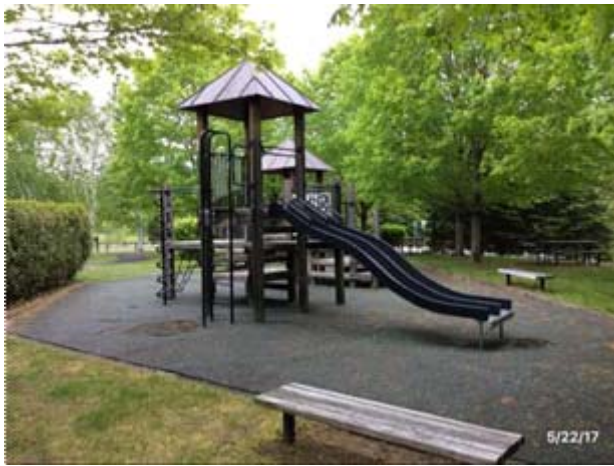
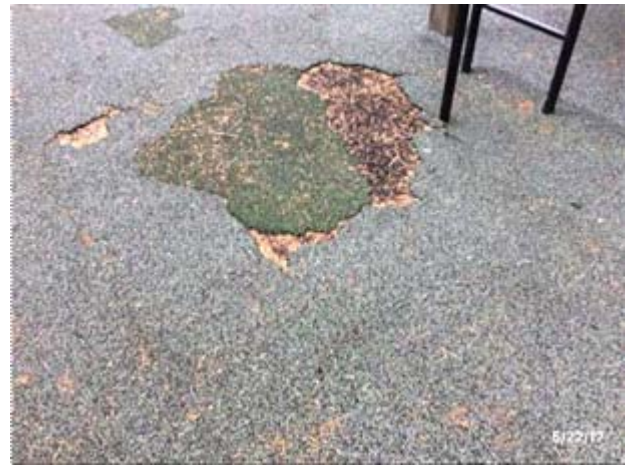
The play area surface is deteriorating and has worn areas.

Deteriorated play surface
