FACILITY CONDITION ASSESSMENT

FACILITY CONDITION ASSESSMENT OF

09713 LYNDON INFORMATION CENTER
I-91 SOUTHBOUND, MILE MARKER 141
LYNDON, VT 05850

June 19, 2017

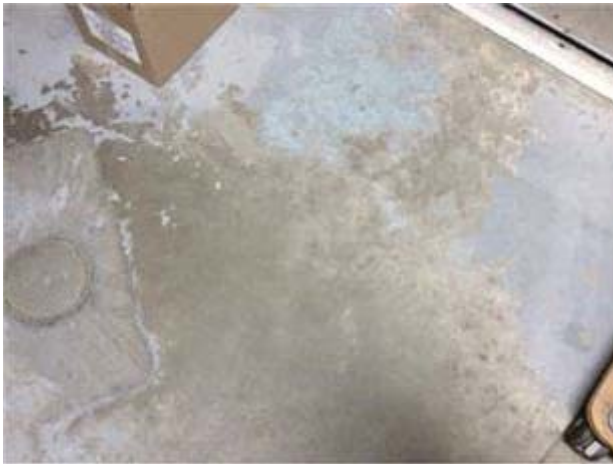
Coding / Field Name	Asset Description
A1031 Standard Slab on Grade	Slab on Grade
Condition	Fair
Qty / UOM	1328 / SF
Unit Cost	\$10.00
Basis of Costing	Concrete Slab-On-Grade
Year in Service	1973
Expected Useful Life (EUL)	50 Year(s), Based on Industry Averages
Remaining Useful Life (RUL)	35 Year(s), Estimated, Based on Date of Observation
Location	Structure

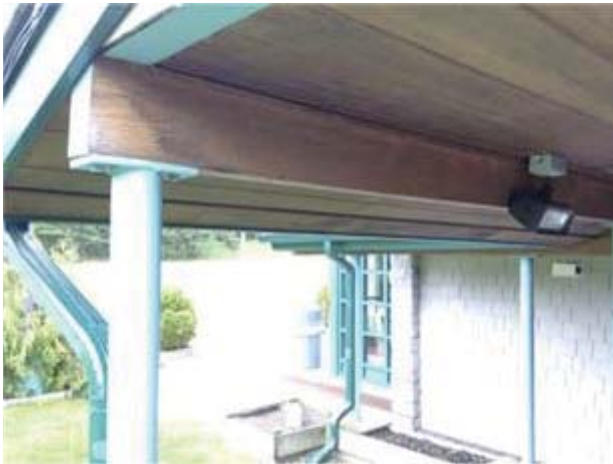
Coding / Field Name	Asset Description
B1012 Upper Floors Construction	Superstructure, Structural Frame, Wood Conventional Stud
Condition	Fair
Qty / UOM	1328 / SF
Unit Cost	\$18.10
Basis of Costing	Superstructure, Structural Frame, Wood Conventional Stud
Year in Service	1973
Expected Useful Life (EUL)	50 Year(s), Based on Industry Averages
Remaining Useful Life (RUL)	35 Year(s), Estimated, Based on Date of Observation
Location	Structure

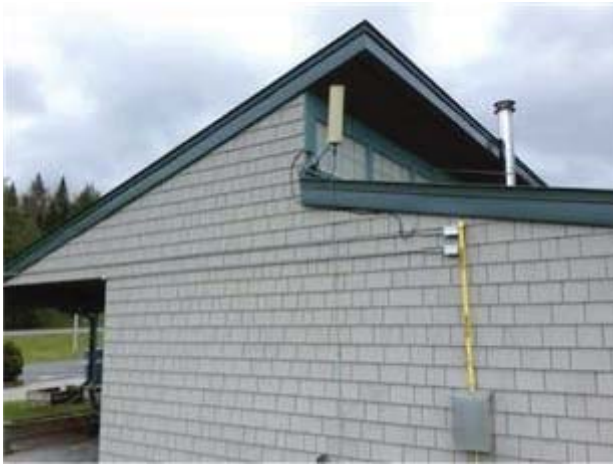
Coding / Field Name	Asset Description
B1022 Pitched Roof Construction	Roof Construction, Wood, Rafters
Condition	Fair
Qty / UOM	2000 / SF
Unit Cost	\$19.72
Basis of Costing	Roof Structure, Pitched, Wood Rafters
Year in Service	1973
Expected Useful Life (EUL)	50 Year(s), Based on Industry Averages
Remaining Useful Life (RUL)	35 Year(s), Estimated, Based on Date of Observation
Location	Structure
Roofing Type	Pitched
Parapet Wall Edge Flashing	Metal
Attic	No
Roof Access	None

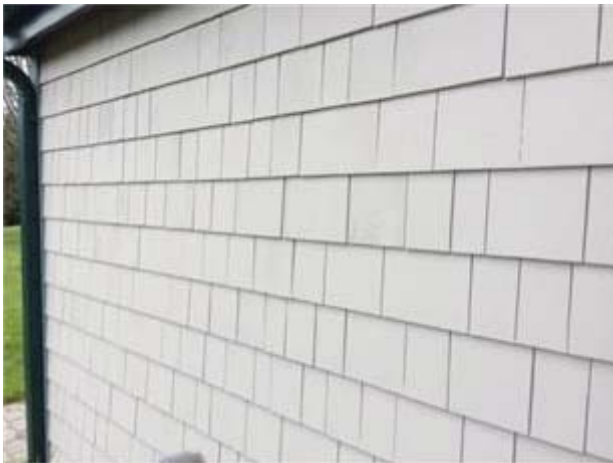
Coding / Field Name	Asset Description
B2011 Exterior Wall Construction	Wood Shingles, 1-2 Stories
Condition	Good
Qty / UOM	2000 / SF
Unit Cost	\$6.69
Basis of Costing	Wood Shingles, 1-2 Stories
Year in Service	2010
Expected Useful Life (EUL)	20 Year(s), Based on Industry Averages
Remaining Useful Life (RUL)	15 Year(s), Estimated, Based on Date of Observation
Location	Exterior Walls
Exterior Wall Construction	Wood Shake Siding
Parapets	No
Exterior Soffits	Exposed

Uniformat	Action Description	Quantity	Unit Cost	Plan Type	Priority	Year	Expenditure
B2011	Prep & Paint Exterior Walls, up to 4-Story Building	2,000 SF	\$1.41	BYL	Priority 2	2022	\$2,820
B2011	Prep & Paint Exterior Walls, up to 4-Story Building	2,000 SF	\$1.41	BYL	Priority 2	2032	\$2,820
B2011	Replace Wood Shingles, 1-2 Stories	2,000 SF	\$6.69	BYL	Priority 3	2032	\$13,378

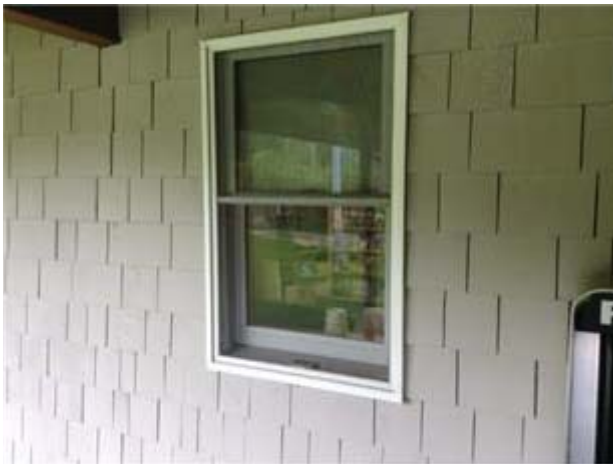
Coding / Field Name	Asset Description
B2021 Windows	Aluminum Window, Double Glazed
Condition	Fair
Qty / UOM	1 / EA
Unit Cost	\$1,051.57
Basis of Costing	Aluminum Window, Double Glazed, 1-2 Stories, 12 SF
Year in Service	1996
Expected Useful Life (EUL)	30 Year(s), Based on Industry Averages
Remaining Useful Life (RUL)	9 Year(s), Estimated, Based on Date of Observation
Location	Exterior Walls
Window Type	Double Hung
Windows Material	Wood
Windows Glazing	Single Glazed
Window Operation	Manual

Uniformat	Action Description	Quantity	Unit Cost	Plan Type	Priority	Year	Expenditure
B2021	Replace Aluminum Window, Double Glazed	1 EA	\$1,051.57	BYL	Priority 3	2026	\$1,052

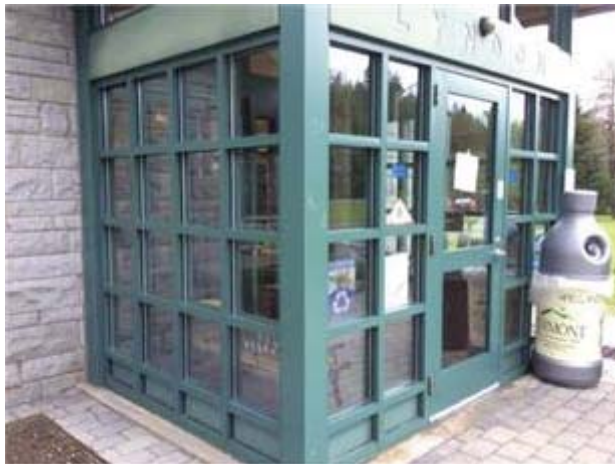
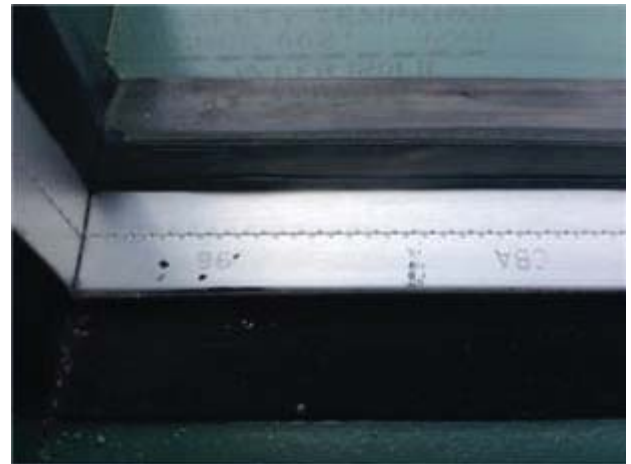
Coding / Field Name	Asset Description
B2022 Curtain Walls	Storefront Glazing & Framing
Condition	Fair
Qty / UOM	400 / SF
Unit Cost	\$48.45
Basis of Costing	Glass Curtain Wall
Year in Service	1996
Expected Useful Life (EUL)	30 Year(s), Based on Industry Averages
Remaining Useful Life (RUL)	9 Year(s), Estimated, Based on Date of Observation
Location	Exterior Walls
Window Type	Fixed
Windows Material	Aluminum
Windows Glazing	Double Glazed
Window Operation	Fixed

Uniformat	Action Description	Quantity	Unit Cost	Plan Type	Priority	Year	Expenditure
B2022	Replace Storefront Glazing & Framing	400 SF	\$48.45	BYL	Priority 3	2026	\$19,380

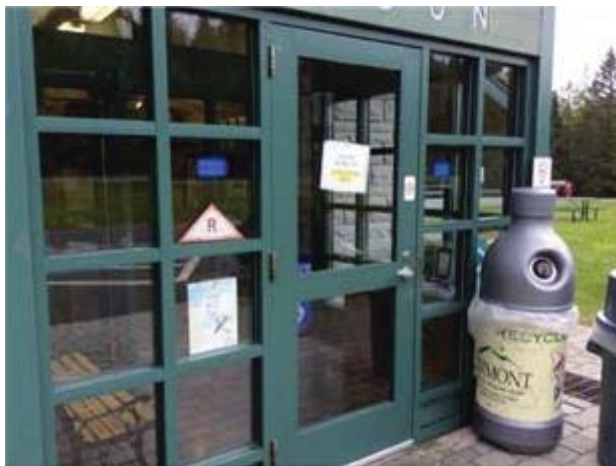
Coding / Field Name	Asset Description
B2031 Glazed Doors & Entrances	Aluminum Frame, Fully Glazed, Exterior Door
Condition	Fair
Qty / UOM	2 / EA
Unit Cost	\$1,368.37
Basis of Costing	Aluminum Frame, Fully Glazed, Exterior Door
Year in Service	1996
Expected Useful Life (EUL)	30 Year(s), Based on Industry Averages
Remaining Useful Life (RUL)	9 Year(s), Estimated, Based on Date of Observation
Location	Exterior Walls
Door Hardware	Lever
Door Operation	Manual
Glass Type	Tempered Glass
Door Frame	Metal Framed
Door Use	Entrance

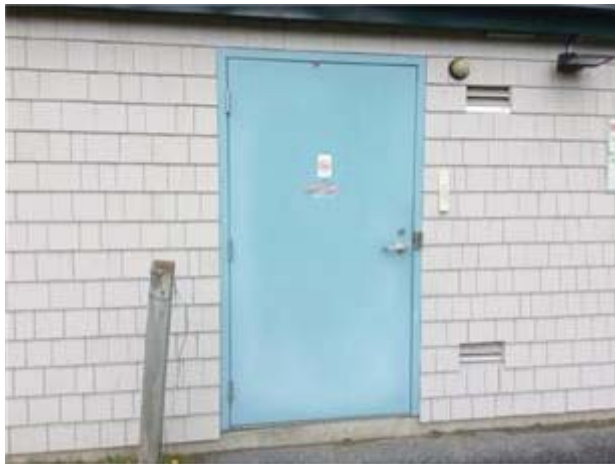
Coding / Field Name	Asset Description
B2032 Solid Exterior Doors	Steel, Insulated, Exterior Door
Condition	Fair
Qty / UOM	2 / EA
Unit Cost	\$1,577.53
Basis of Costing	Steel, Insulated, Exterior Door
Year in Service	1996
Expected Useful Life (EUL)	25 Year(s), Based on Industry Averages
Remaining Useful Life (RUL)	12 Year(s), Estimated, Based on Date of Observation
Location	Exterior Walls
Door Hardware	Lever
Door Operation	Manual
Core Type	Hollow Core
Door Frame	Metal Framed

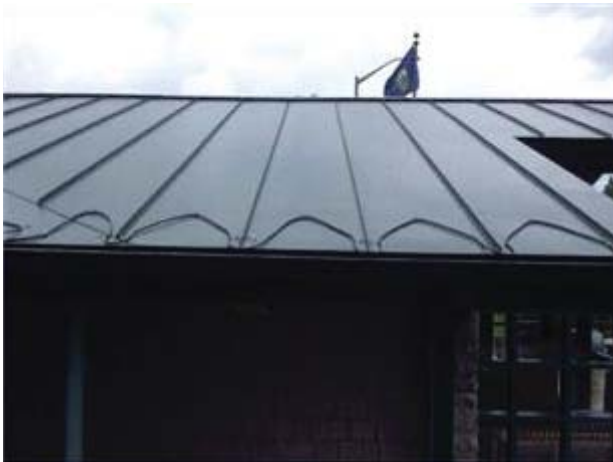
Coding / Field Name	Asset Description
B3011 Roof Finishes	Metal Roof (Includes Tear-Off of Old)
Condition	Fair
Qty / UOM	2500 / SF
Cost Adjustment Factor/Reason	1.3 / Gable
Unit Cost (Adjusted)	\$42.13
Basis of Costing	Metal Roof (Includes Tear-Off of Old)
Year in Service	1996
Expected Useful Life (EUL)	40 Year(s), Based on Industry Averages
Remaining Useful Life (RUL)	19 Year(s), Estimated, Based on Date of Observation
Location	Roof
Insulation	Batt
Flashings and Trim	Metal
Roof Eaves and Soffits	Yes
Roof Drainage	Metal Gutter And Down Spouts
Roof Warranty	Unknown

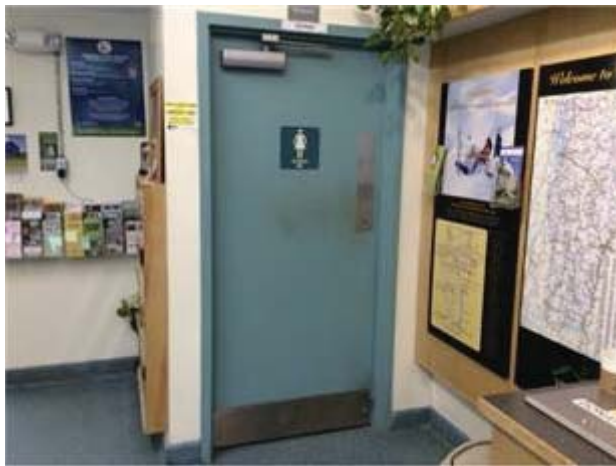
Coding / Field Name	Asset Description
C1021 Interior Doors	Steel, Interior Door
Condition	Fair
Qty / UOM	8 / EA
Unit Cost	\$950.12
Basis of Costing	Steel, Interior Door
Year in Service	1996
Expected Useful Life (EUL)	25 Year(s), Based on Industry Averages
Remaining Useful Life (RUL)	11 Year(s), Estimated, Based on Date of Observation
Location	Building Interior (General)

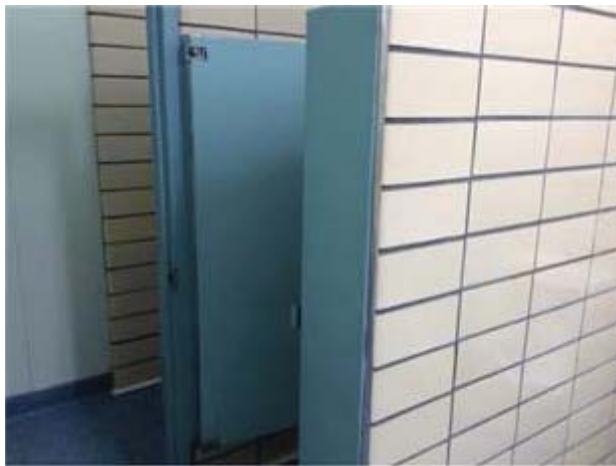
Coding / Field Name	Asset Description
C1031 Fabricated Toilet Partitions	Toilet Partitions, Metal, Overhead Braced
Condition	Fair
Qty / UOM	3 / EA
Unit Cost	\$850.00
Basis of Costing	Toilet Partitions, Metal, Overhead Braced
Year in Service	1996
Expected Useful Life (EUL)	20 Year(s), Based on Industry Averages
Remaining Useful Life (RUL)	5 Year(s), Estimated, Based on Date of Observation
Location	Restrooms

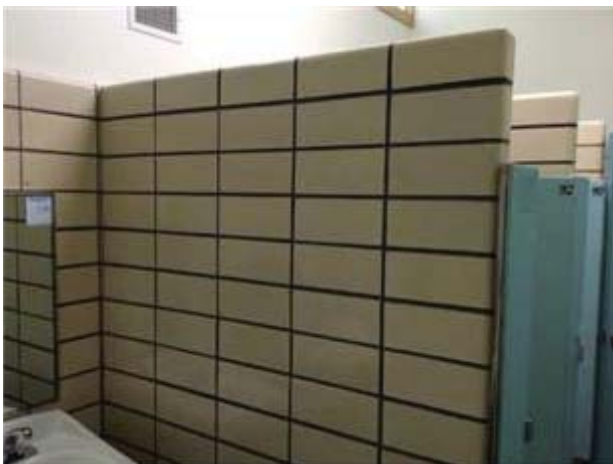
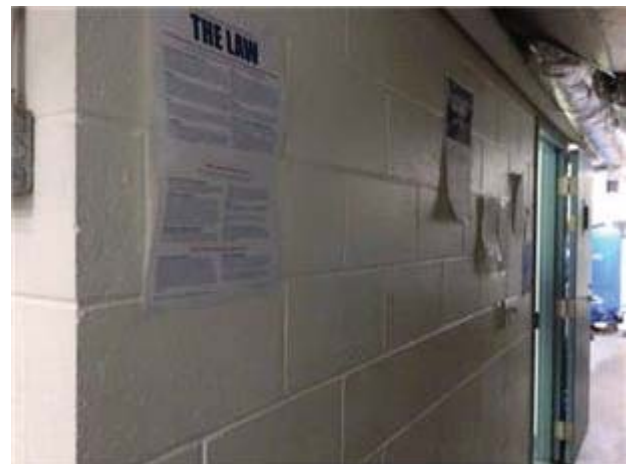
Includes glazed and paintd block

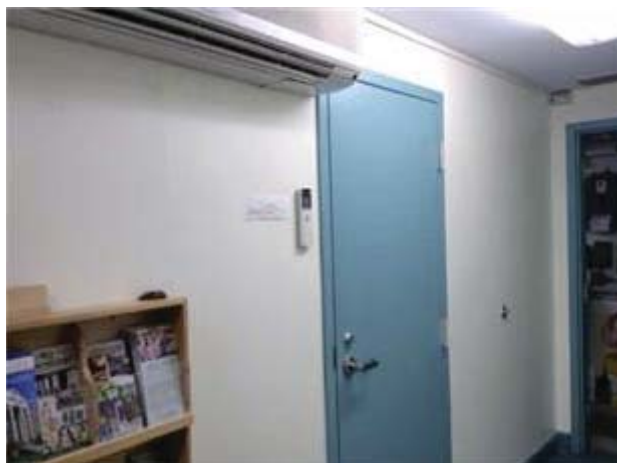
Coding / Field Name	Asset Description
C3012 Wall Finishes to Interior Walls	Gypsum Board/Plaster, Interior Wall
Condition	Fair
Qty / UOM	1000 / SF
Unit Cost	\$3.38
Basis of Costing	Gypsum Board/Plaster, Interior Wall
Year in Service	1973
Expected Useful Life (EUL)	40 Year(s), Based on Industry Averages
Remaining Useful Life (RUL)	25 Year(s), Estimated, Based on Date of Observation
Location	Building Interior (General)

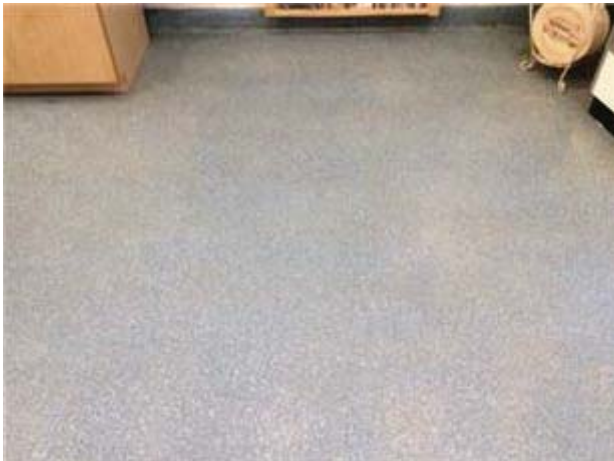
Coding / Field Name	Asset Description
C3021 Floor Toppings	Epoxy Floor Finish
Condition	Fair
Qty / UOM	500 / SF
Unit Cost	\$8.74
Basis of Costing	Epoxy Floor Finish
Year in Service	1996
Expected Useful Life (EUL)	10 Year(s), Based on Industry Averages
Remaining Useful Life (RUL)	3 Year(s), Estimated, Based on Date of Observation
Location	Building Interior (General)
Floor Toppings	Poured Epoxy Sealant

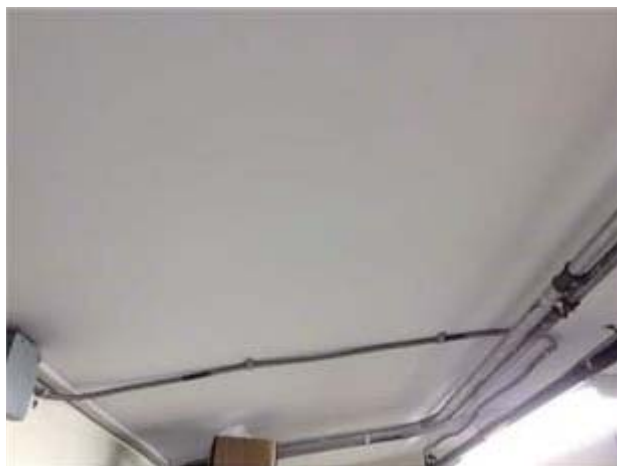
Coding / Field Name	Asset Description
C3031 Ceiling Finishes	Gypsum Board/Plaster, Ceiling
Condition	Fair
Qty / UOM	1400 / SF
Unit Cost	\$7.13
Basis of Costing	Gypsum Board/Plaster, Ceiling
Year in Service	1973
Expected Useful Life (EUL)	50 Year(s), Based on Industry Averages
Remaining Useful Life (RUL)	25 Year(s), Estimated, Based on Date of Observation
Location	Building Interior (General)

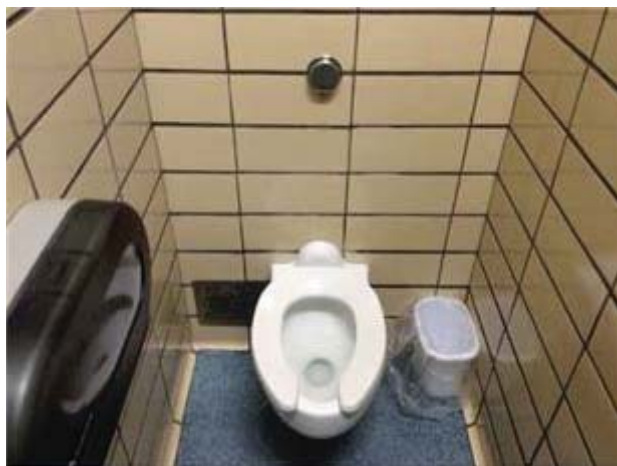
Coding / Field Name	Asset Description
D2011 Water Closets	Tankless Water Closet
Condition	Fair
Qty / UOM	6 / EA
Unit Cost	\$842.97
Basis of Costing	Tankless Water Closet
Year in Service	1996
Expected Useful Life (EUL)	20 Year(s), Based on Industry Averages
Remaining Useful Life (RUL)	5 Year(s), Estimated, Based on Date of Observation
Location	Restrooms

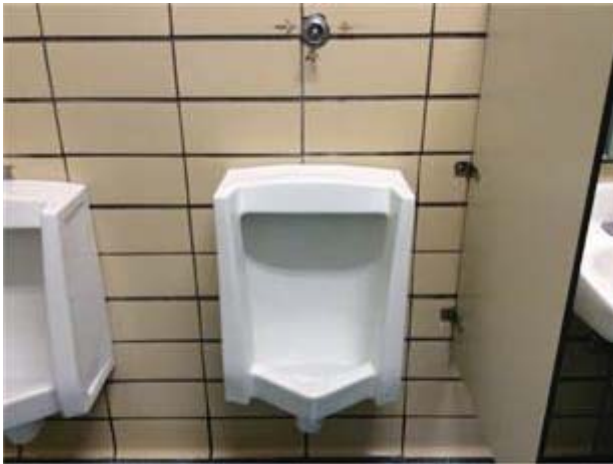
Coding / Field Name	Asset Description
D2012 Urinals	Urinal, Vitreous China
Condition	Fair
Qty / UOM	2 / EA
Unit Cost	\$1,193.44
Basis of Costing	Urinal, Vitreous China
Year in Service	1996
Expected Useful Life (EUL)	20 Year(s), Based on Industry Averages
Remaining Useful Life (RUL)	7 Year(s), Estimated, Based on Date of Observation
Location	Restrooms

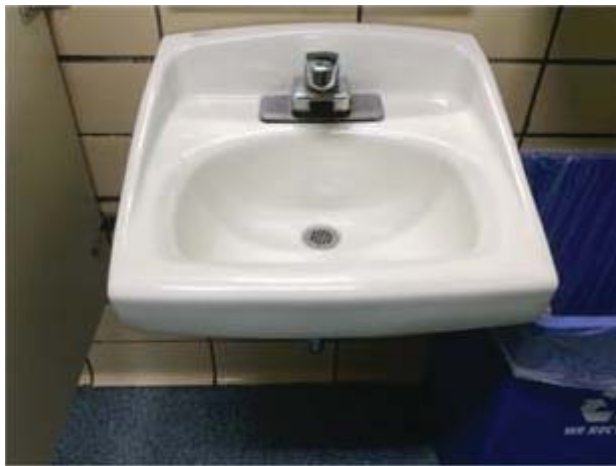
Coding / Field Name	Asset Description
D2013 Lavatories	Lavatory, Enameled Steel
Condition	Fair
Qty / UOM	5 / EA
Unit Cost	\$353.05
Basis of Costing	Lavatory, Enameled Steel
Year in Service	1996
Expected Useful Life (EUL)	20 Year(s), Based on Industry Averages
Remaining Useful Life (RUL)	6 Year(s), Estimated, Based on Date of Observation
Location	Restrooms

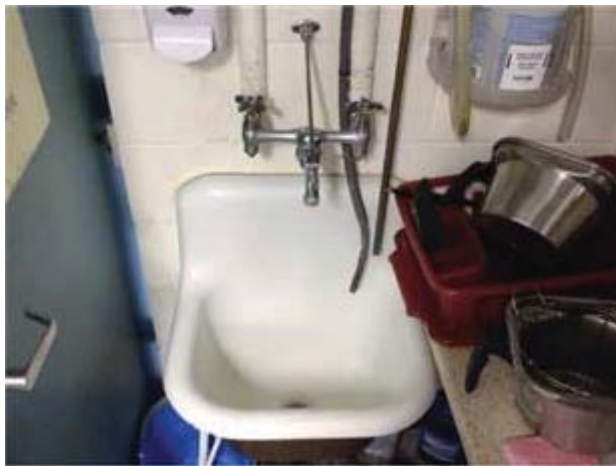
Coding / Field Name	Asset Description
D2014 Sinks	Service Sink, Porcelain Enamel, Cast Iron
Condition	Fair
Qty / UOM	1 / EA
Unit Cost	\$1,360.33
Basis of Costing	Service Sink, Porcelain Enamel, Cast Iron
Year in Service	1973
Expected Useful Life (EUL)	20 Year(s), Based on Industry Averages
Remaining Useful Life (RUL)	7 Year(s), Estimated, Based on Date of Observation
Location	Utility Area

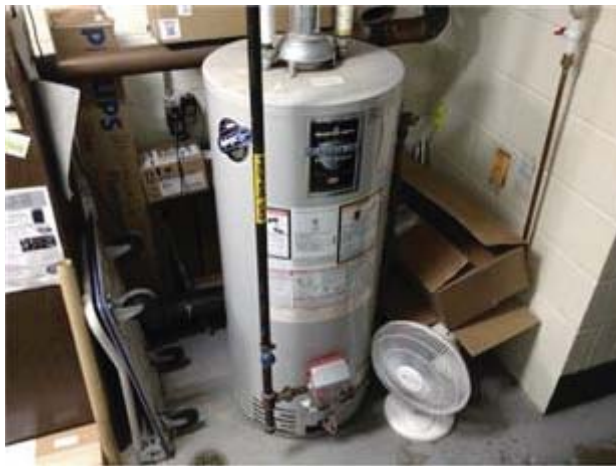
Coding / Field Name	Asset Description
D2023 Domestic Water Supply Equipment	Water Heater, Gas, Residential, 40 GAL
Condition	Fair
Qty / UOM	1 / EA
Unit Cost	\$2,349.48
Basis of Costing	Water Heater, Gas, Residential, 30 to 50 GAL
Year in Service	2011
Expected Useful Life (EUL)	10 Year(s), Based on Industry Averages
Remaining Useful Life (RUL)	6 Year(s), Estimated, Based on Date of Observation
Location	Utility Area

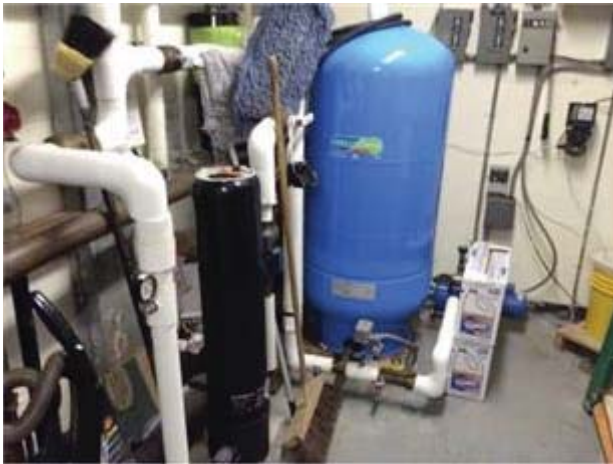
Coding / Field Name	Asset Description
D2023 Domestic Water Supply Equipment	Water Filter
Condition	Good
Qty / UOM	1 / EA
Unit Cost	\$8,975.51
Basis of Costing	Water Filter
Year in Service	2012
Expected Useful Life (EUL)	15 Year(s), Based on Industry Averages
Remaining Useful Life (RUL)	10 Year(s), Estimated, Based on Date of Observation
Location	Utility Area

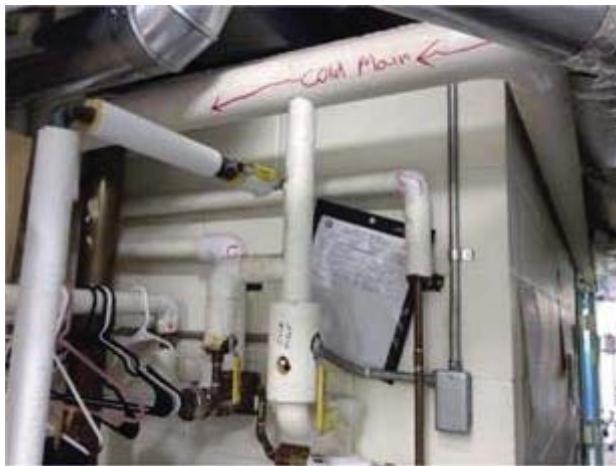
Coding / Field Name	Asset Description
D2029 Plumbing Systems	Plumbing System, Domestic Supply
Condition	Fair
Qty / UOM	1328 / SF
Unit Cost	\$7.59
Basis of Costing	Plumbing System, Domestic Supply
Year in Service	1973
Expected Useful Life (EUL)	40 Year(s), Based on Industry Averages
Remaining Useful Life (RUL)	5 Year(s), Estimated, Based on Date of Observation
Location	Building Interior (General)

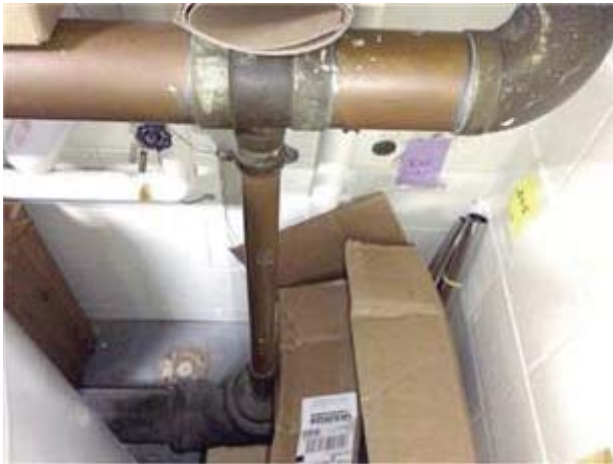
Coding / Field Name	Asset Description
D2034 Sanitary Waste Equipment	Plumbing System, Sanitary Waste
Condition	Fair
Qty / UOM	1328 / SF
Unit Cost	\$5.06
Basis of Costing	Plumbing System, Sanitary Waste
Year in Service	1973
Expected Useful Life (EUL)	40 Year(s), Based on Industry Averages
Remaining Useful Life (RUL)	20 Year(s), Estimated, Based on Date of Observation
Location	Building Interior (General)

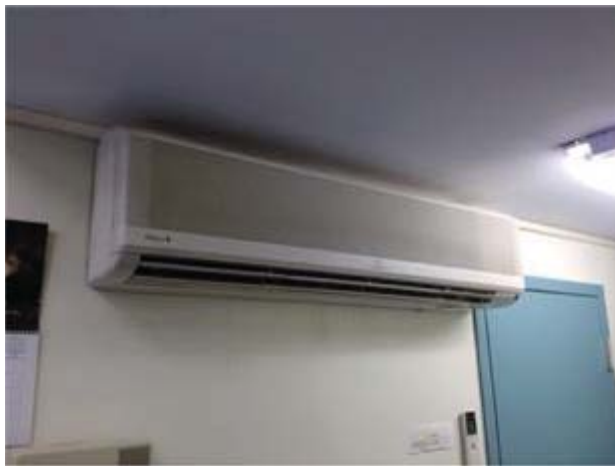
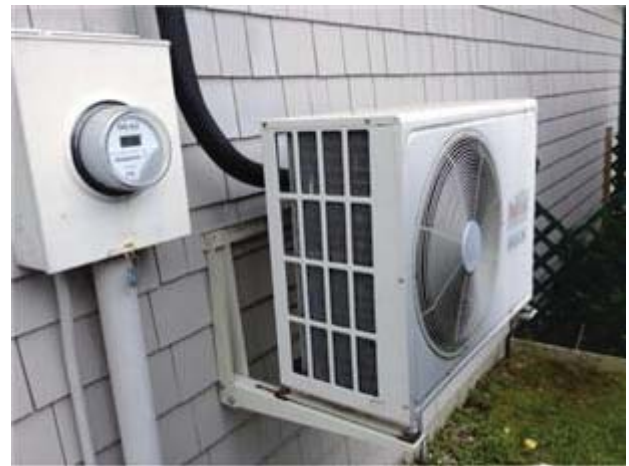
Coding / Field Name	Asset Description
D3032 Direct Expansion Systems	Ductless Split System, Single Zone, 2 Ton
Condition	Fair
Qty / UOM	1 / EA
Unit Cost	\$4,473.11
Basis of Costing	Ductless Split System, Single Zone, 1.5 to 2 Ton
Year in Service	2005
Expected Useful Life (EUL)	15 Year(s), Based on Industry Averages
Remaining Useful Life (RUL)	3 Year(s), Estimated, Based on Date of Observation
Location	Building Interior (General)

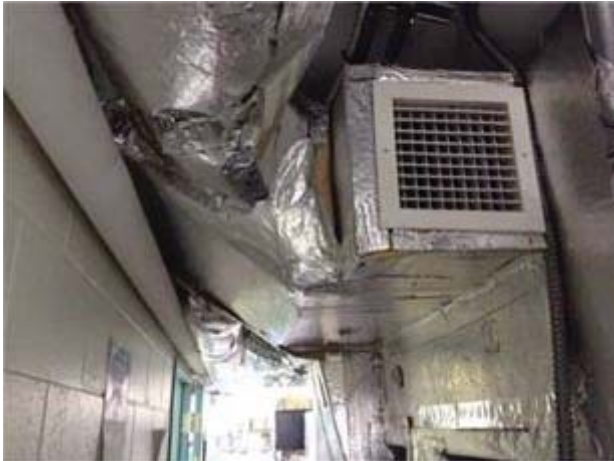
Coding / Field Name	Asset Description
D3041 Air Distribution Systems	HVAC System Ductwork, Sheetmetal
Condition	Fair
Qty / UOM	1328 / SF
Cost Adjustment Factor/Reason	0.7 / Simple System
Unit Cost (Adjusted)	\$13.65
Basis of Costing	HVAC System Ductwork, Sheet Metal
Year in Service	1996
Expected Useful Life (EUL)	30 Year(s), Based on Industry Averages
Remaining Useful Life (RUL)	15 Year(s), Estimated, Based on Date of Observation
Location	Building Interior (General)

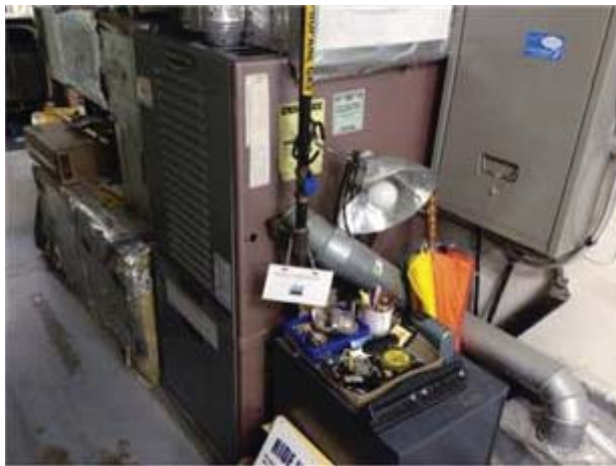
Coding / Field Name	Asset Description
D3051 Terminal Self-Contained Units	Furnace, Propane, 125 MBH
Condition	Fair
Qty / UOM	1 / EA
Unit Cost	\$5,644.27
Basis of Costing	Furnace, Gas, 101 to 150 MBH
Year in Service	1996
Expected Useful Life (EUL)	20 Year(s), Based on Industry Averages
Remaining Useful Life (RUL)	4 Year(s), Estimated, Based on Date of Observation
Location	Mechanical Room (Primary)

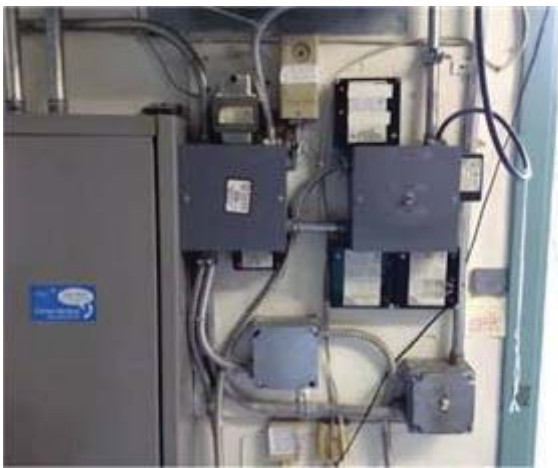
Basic electric controls only.

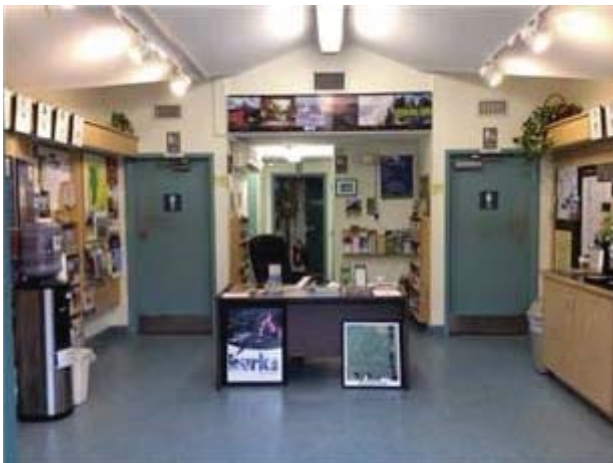
An automatic wet sprinkler fire suppression system was not observed. Though likely grandfathered, installation is recommended for life safety and asset protection reasons.

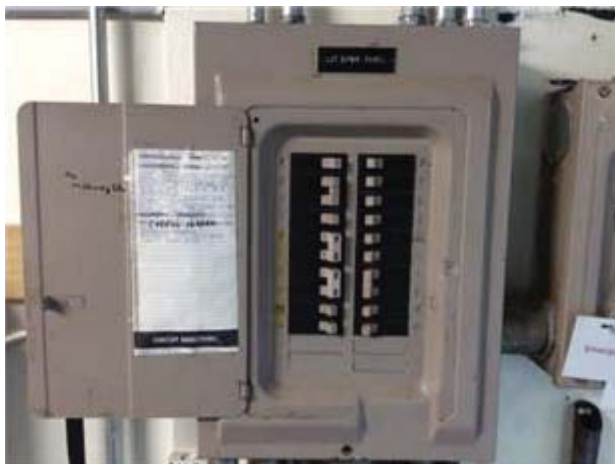
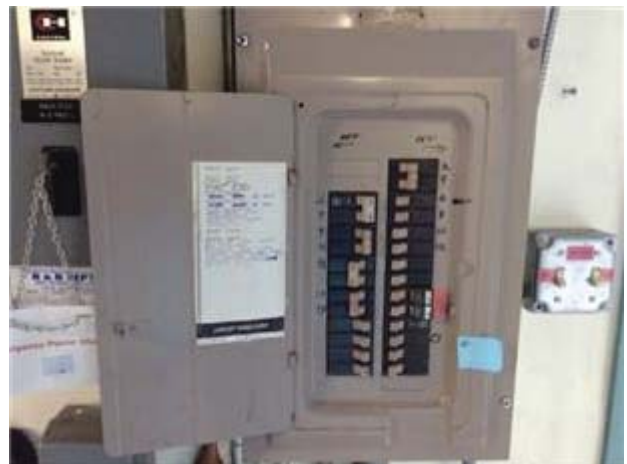
Panels are dated, and parts will be difficult to obtain,

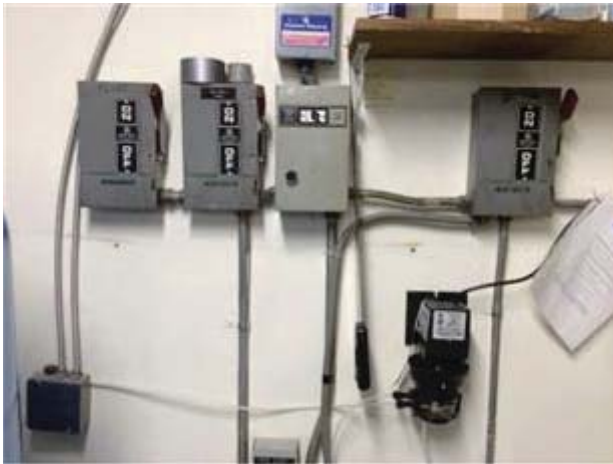
Coding / Field Name	Asset Description
D5019 Electrical Systems	Electrical System, Distribution
Condition	Fair
Qty / UOM	1328 / SF
Unit Cost	\$27.25
Basis of Costing	Electrical System, Full Upgrade, Office (per SF)
Year in Service	1973
Expected Useful Life (EUL)	40 Year(s), Based on Industry Averages
Remaining Useful Life (RUL)	12 Year(s), Estimated, Based on Date of Observation
Location	Building Interior (General)

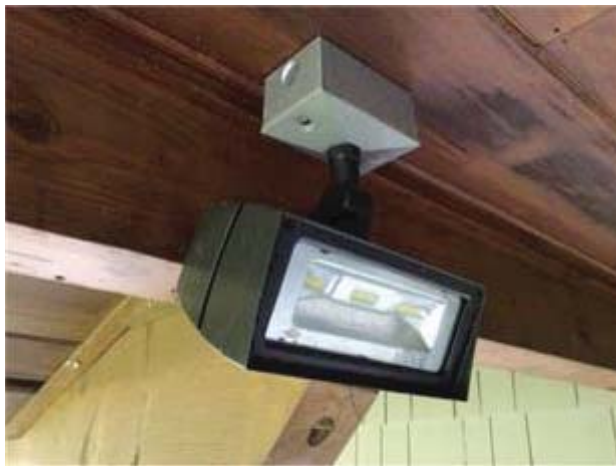
Coding / Field Name	Asset Description
D5022 Lighting Equipment	Light Fixture, Exterior, LED
Condition	Good
Qty / UOM	10 / EA
Unit Cost	\$180.19
Basis of Costing	LED Lighting Fixture, Basic, 20 W
Year in Service	2014
Expected Useful Life (EUL)	20 Year(s), Based on Industry Averages
Remaining Useful Life (RUL)	17 Year(s), Estimated, Based on Date of Observation
Location	Exterior Walls

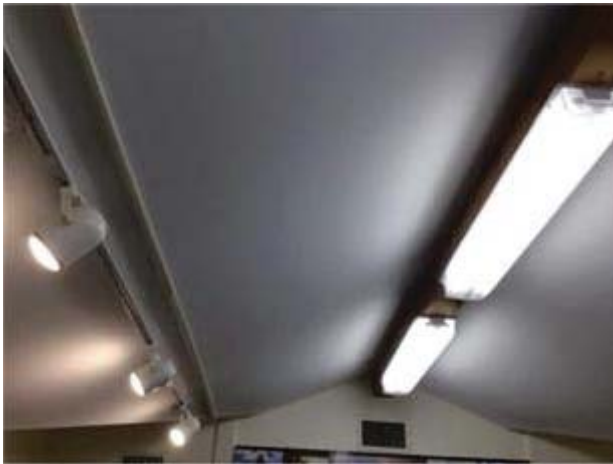
Coding / Field Name	Asset Description
D5029 Lighting Systems	Lighting System, Interior
Condition	Fair
Qty / UOM	1328 / SF
Unit Cost	\$9.24
Basis of Costing	Lighting System, Full Upgrade, Office (per SF)
Year in Service	2008
Expected Useful Life (EUL)	25 Year(s), Based on Industry Averages
Remaining Useful Life (RUL)	16 Year(s), Estimated, Based on Date of Observation
Location	Building Interior (General)

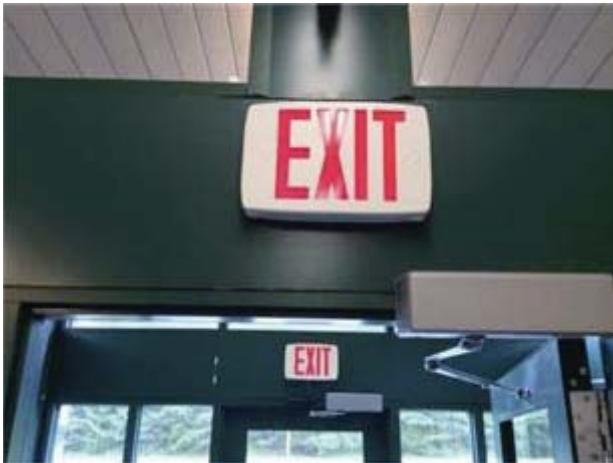
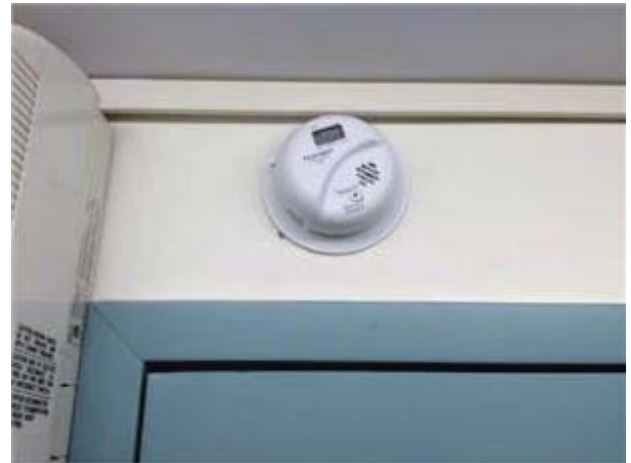
No centralized fire alarm system/smoke detectors/remote notification. Though likely grandfathered, installation is recommended for life safety and asset protection reasons.

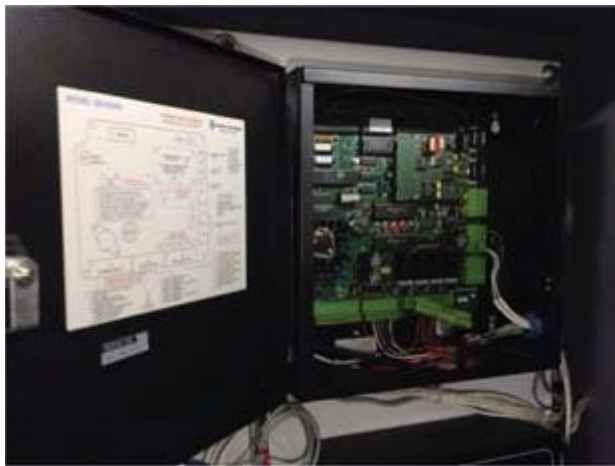
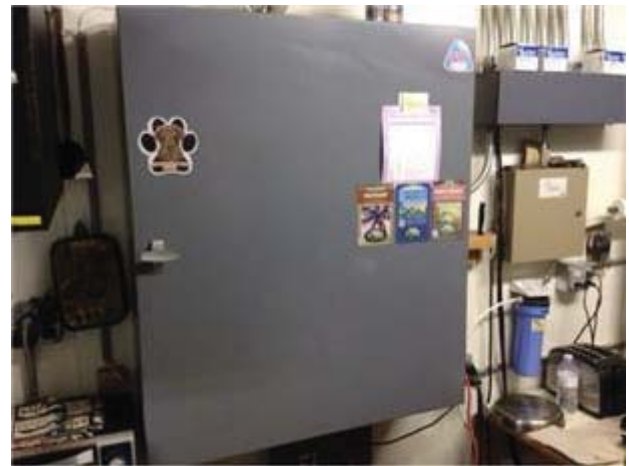
Coding / Field Name	Asset Description
D5039 Local Area Networks	Security System, Full Upgrade/Install, Cameras and CCTV (per SF)
Condition	Fair
Qty / UOM	1328 / SF
Unit Cost	\$4.35
Basis of Costing	Security System, Full Upgrade/Install, Cameras and CCTV (per SF)
Year in Service	1996
Expected Useful Life (EUL)	10 Year(s), Based on Industry Averages
Remaining Useful Life (RUL)	3 Year(s), Estimated, Based on Date of Observation
Location	Building Interior (General)

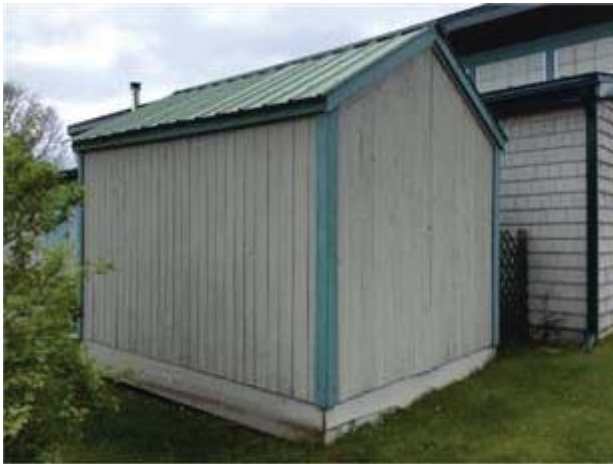
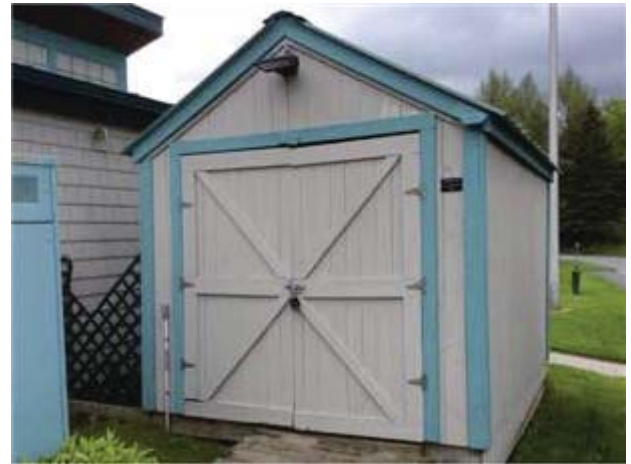
Coding / Field Name	Asset Description
F1013 Other Special Structures	Ancillary Structure, Shed, All Components
Condition	Fair
Qty / UOM	100 / SF
Unit Cost	\$125.19
Basis of Costing	Prefabricated Temporary Building, All Components
Year in Service	1997
Expected Useful Life (EUL)	30 Year(s), Based on Industry Averages
Remaining Useful Life (RUL)	15 Year(s), Estimated, Based on Date of Observation
Location	Site

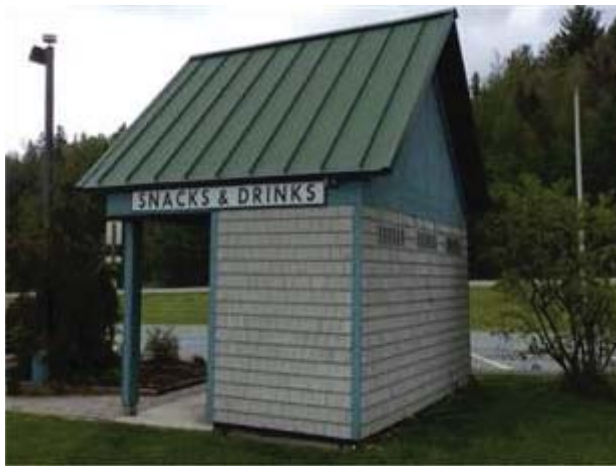
Coding / Field Name	Asset Description
F1013 Other Special Structures	Ancillary Structure, Vending Stand, All Components
Condition	Fair
Qty / UOM	100 / SF
Unit Cost	\$125.19
Basis of Costing	Prefabricated Temporary Building, All Components
Year in Service	1996
Expected Useful Life (EUL)	30 Year(s), Based on Industry Averages
Remaining Useful Life (RUL)	15 Year(s), Estimated, Based on Date of Observation
Location	Site

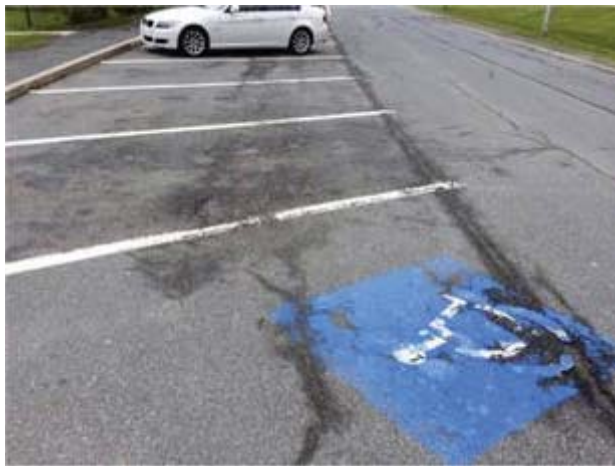
Coding / Field Name	Asset Description
G2022 Paving & Surfacing	Asphalt Pavement, Parking Lot
Condition	Fair
Qty / UOM	5000 / SF
Unit Cost	\$5.90
Basis of Costing	Asphalt Pavement, Parking Lot
Year in Service	1996
Expected Useful Life (EUL)	25 Year(s), Based on Industry Averages
Remaining Useful Life (RUL)	8 Year(s), Estimated, Based on Date of Observation
Location	Site

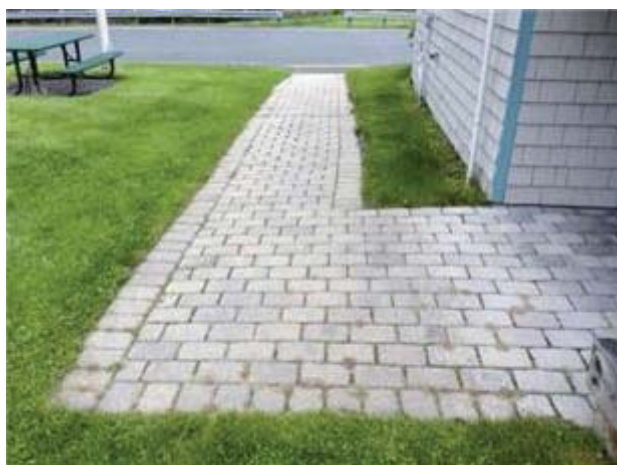
Coding / Field Name	Asset Description
G2031 Paving & Surfacing	Clay Brick/Masonry Paver Sidewalk, Exterior
Condition	Fair
Qty / UOM	1500 / SF
Unit Cost	\$34.11
Basis of Costing	Clay Brick/Masonry Paver Sidewalk, Exterior
Year in Service	1996
Expected Useful Life (EUL)	30 Year(s), Based on Industry Averages
Remaining Useful Life (RUL)	9 Year(s), Estimated, Based on Date of Observation
Location	Site

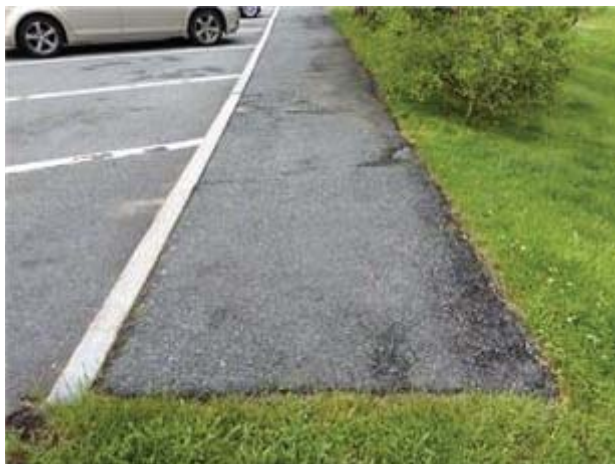
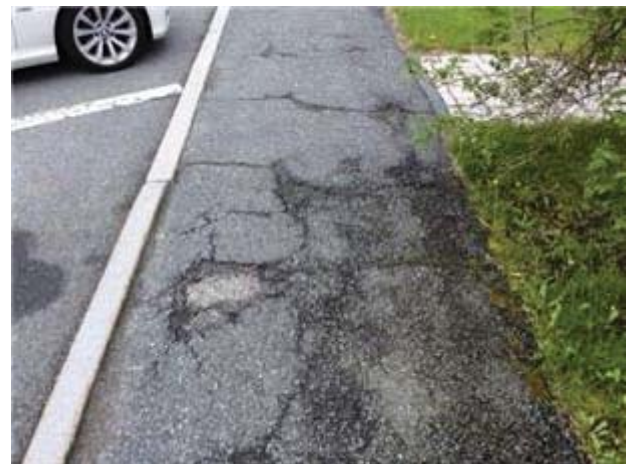
Repair 100 SF

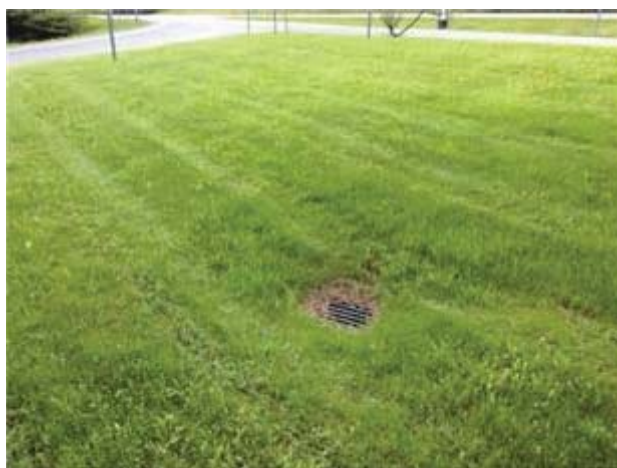
Coding / Field Name	Asset Description
G3030 Storm Sewer	Site Drainage
Condition	Fair
Qty / UOM	37000 /
Unit Cost	\$1.00
Year in Service	1973
Expected Useful Life (EUL)	50 Year(s), Based on Industry Averages
Remaining Useful Life (RUL)	25 Year(s), Estimated, Based on Date of Observation
Location	Site
