FACILITY CONDITION ASSESSMENT

FACILITY CONDITION ASSESSMENT
OF
09731 WATERFORD WELCOME CENTER
1270 I-93 NORTHBOUND
WATERFORD, VT 05819

106686.17R000-152.305

June 21, 2017

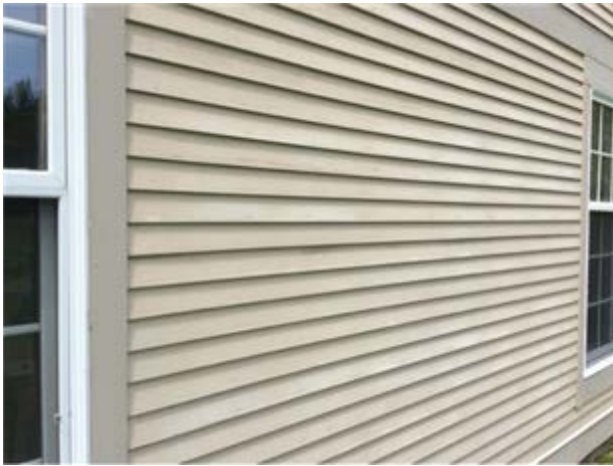
Coding / Field Name	Asset Description
B2011 Exterior Wall Construction	Wood Clapboard, Exterior, 1-2 Stories
Condition	Fair
Qty / UOM	2500 / SF
Unit Cost	\$27.03
Basis of Costing	Wood Clapboard, Exterior, 1-2 Stories
Year in Service	2002
Expected Useful Life (EUL)	20 Year(s), Based on Industry Averages
Remaining Useful Life (RUL)	12 Year(s), Estimated, Based on Date of Observation
Location	Exterior Walls

Uniformat	Action Description	Quantity	Unit Cost	Plan Type	Priority	Year	Expenditure
B2011	Prep & Paint Exterior Walls, up to 4-Story Building	2,500 SF	\$1.41	BYL	Priority 3	2023	\$3,525
B2011	Replace Wood Clapboard, Exterior, 1-2 Stories	2,500 SF	\$27.03	BYL	Priority 3	2029	\$67,565
B2011	Prep & Paint Exterior Walls, up to 4-Story Building	2,500 SF	\$1.41	BYL	Priority 3	2033	\$3,525

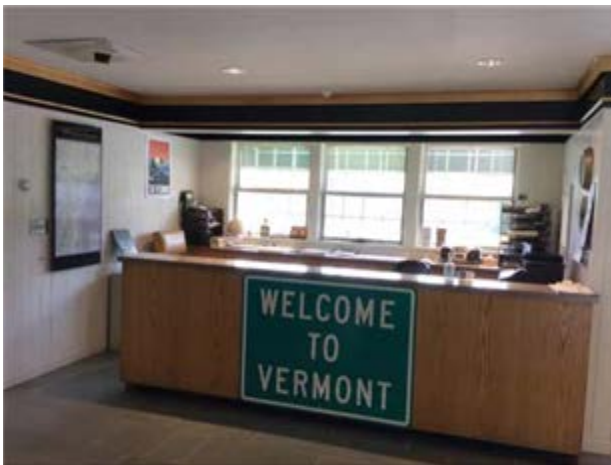
An automatic wet sprinkler fire protection system was not observed. Though likely grandfathered, installation is recommended for life safety and asset protection reasons.

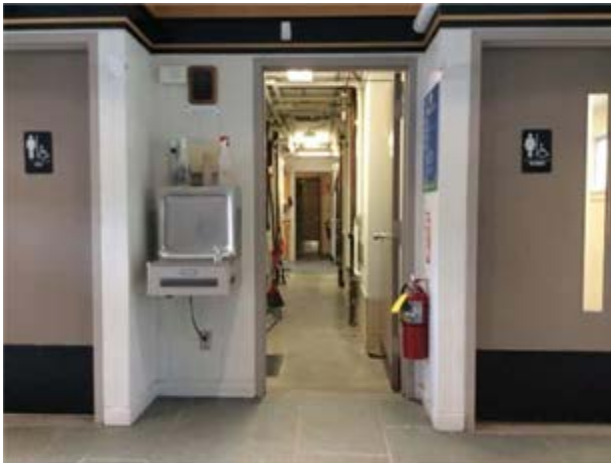
A fire alarm system was not observed. Though likely grandfathered, installation is recommended for life safety and asset protection reasons.

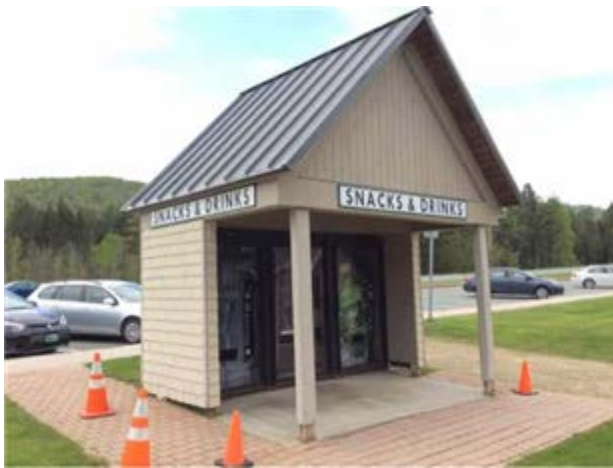
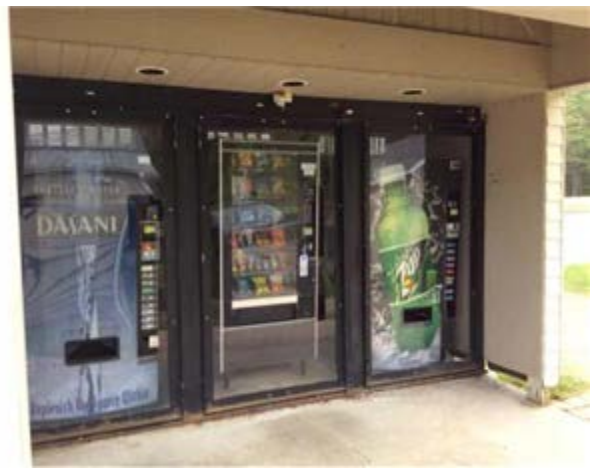
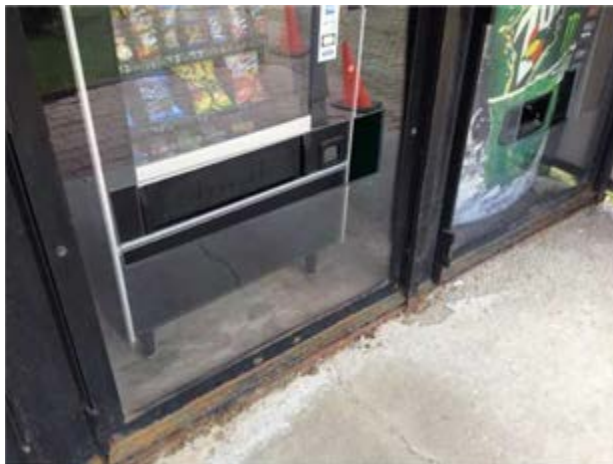
Glazed doors and frames are rusting

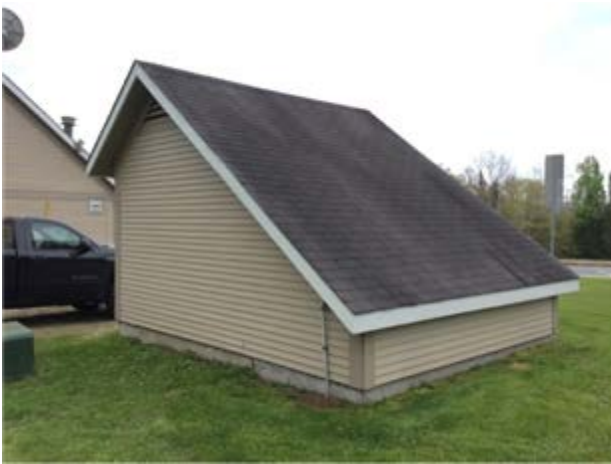
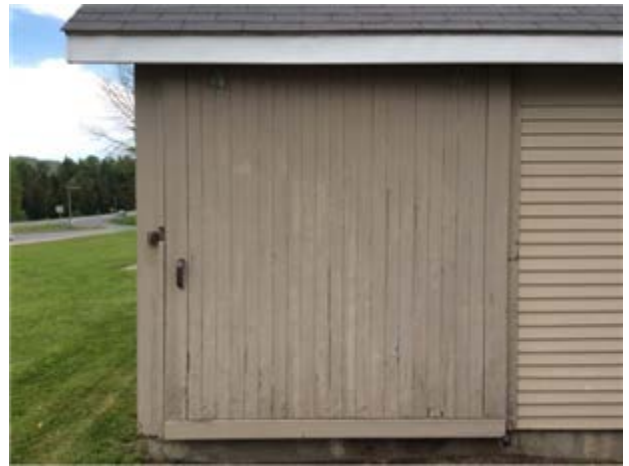
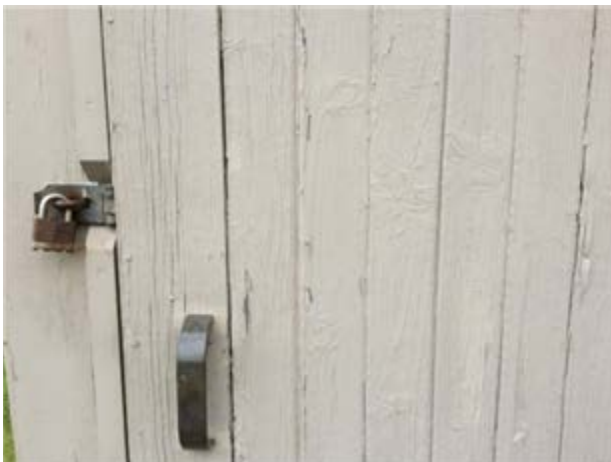
Paint is peeling and cracking

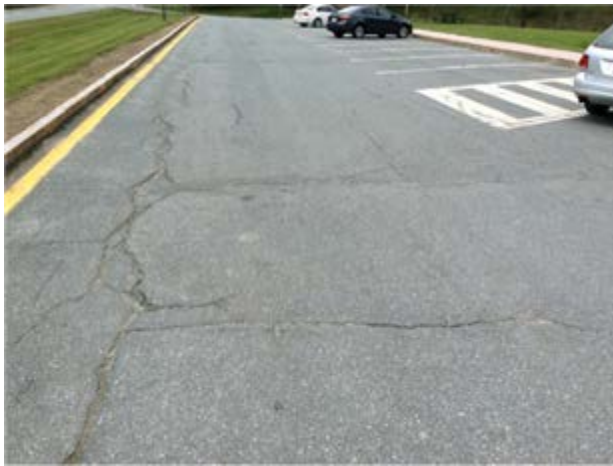
Sealant is worn and cracks were observed.

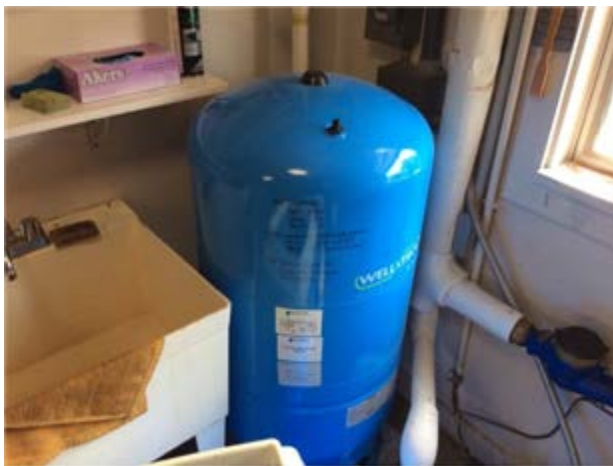
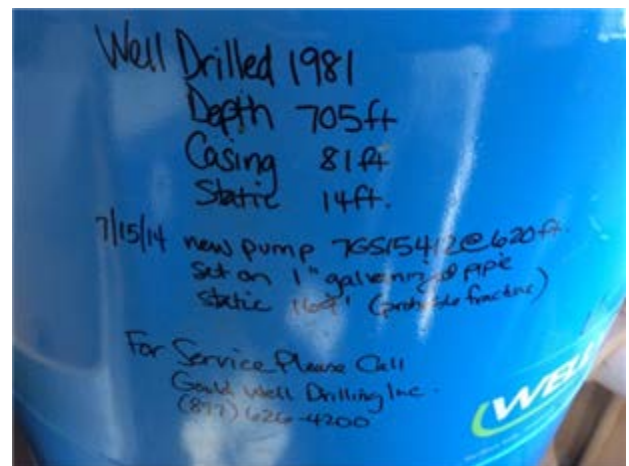
Pump not directly observable. Information based on hand written data on indoor tank regarding pump.
