FACILITY CONDITION ASSESSMENT

FACILITY CONDITION ASSESSMENT
OF
SHARON NORTH INFORMATION CENTER
I-89 NORTHBOUND MILE MARKER 10
SHARON, VT 05065

December 17, 2018

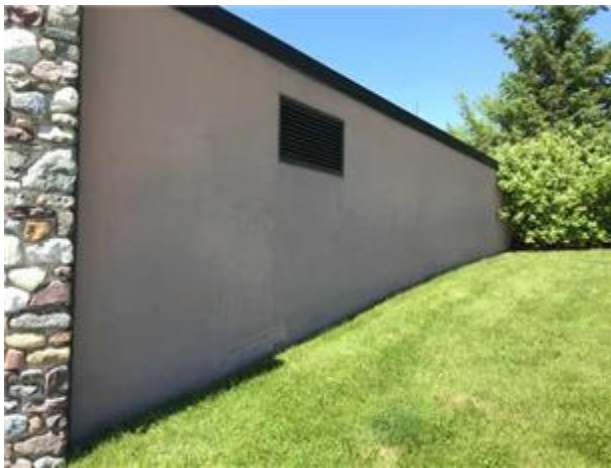
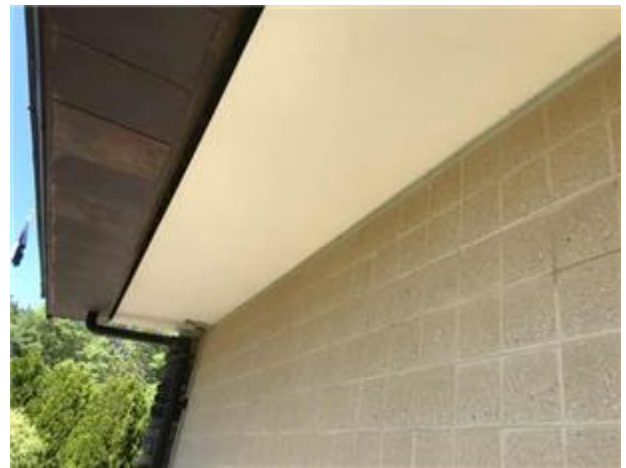
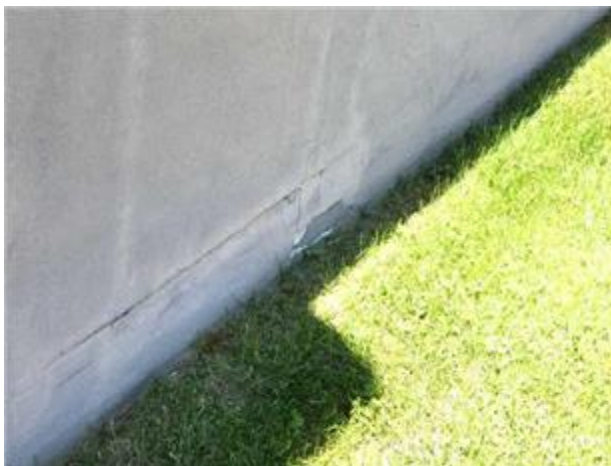
Damaged Finish

Isolated section of damaged finish.

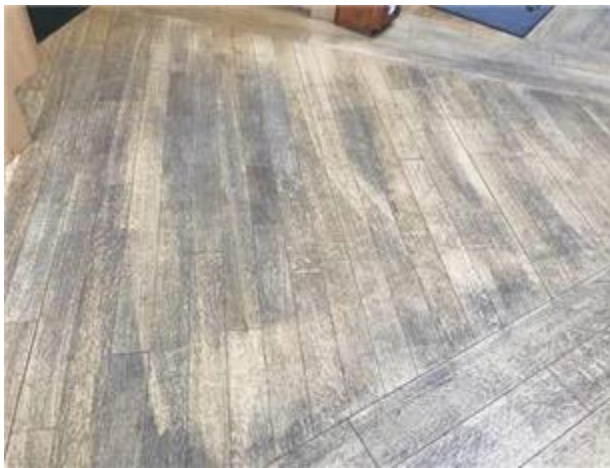
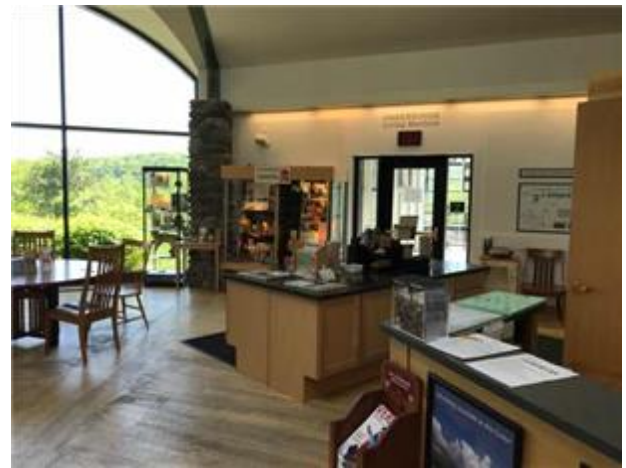
Very worn needs refinishing.

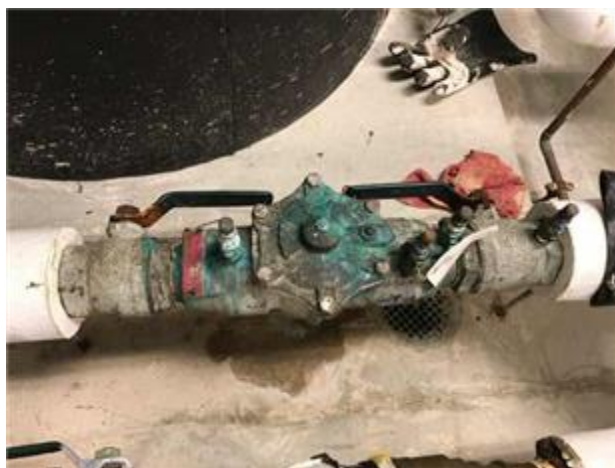
Unit is near the end of its EUL.

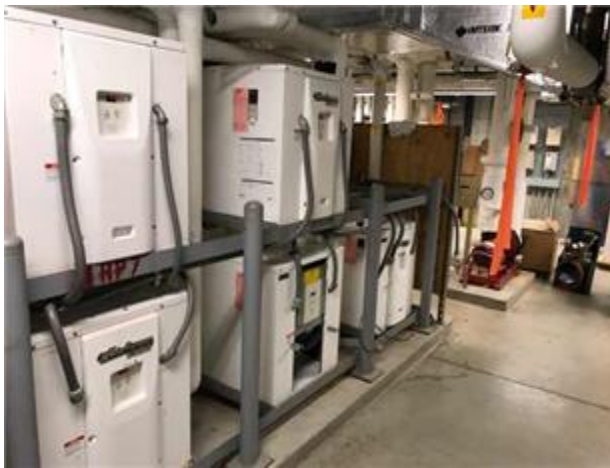
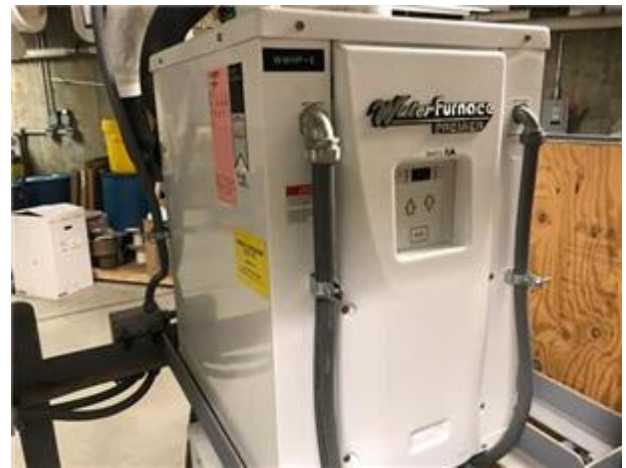
Units near end of life and have reportedly require frequent maintenance and restarting under high loads. One unit not operating.

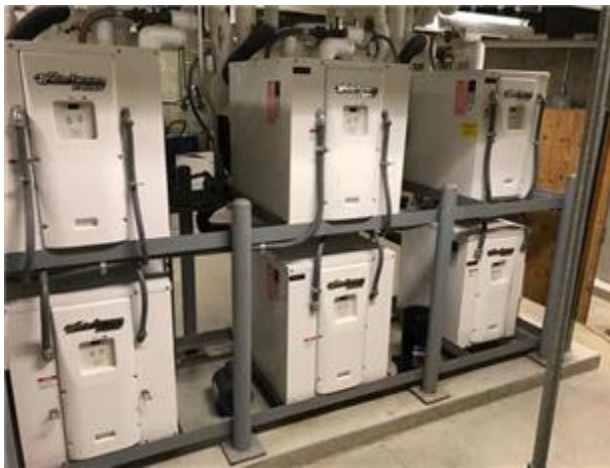
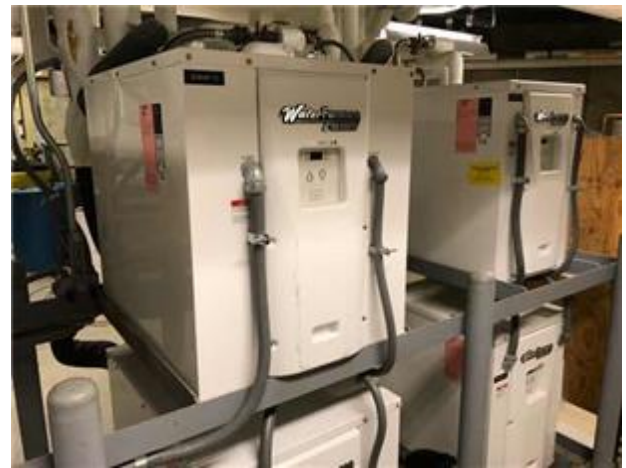
Units near end of life and have reportedly require frequent maintenance and restarting under high loads.

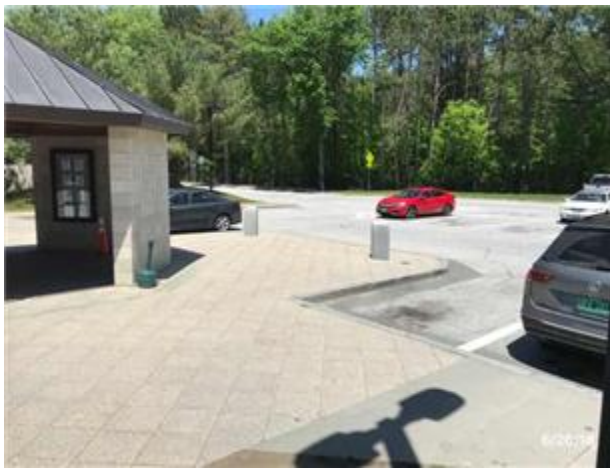
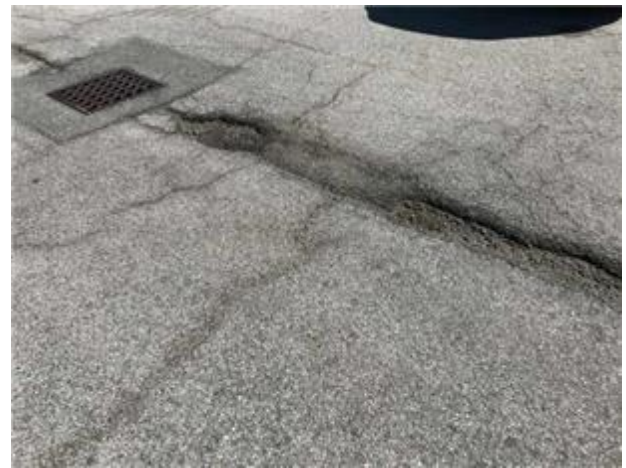
Asphalt wear

Patching is needed in the main car parking lot.

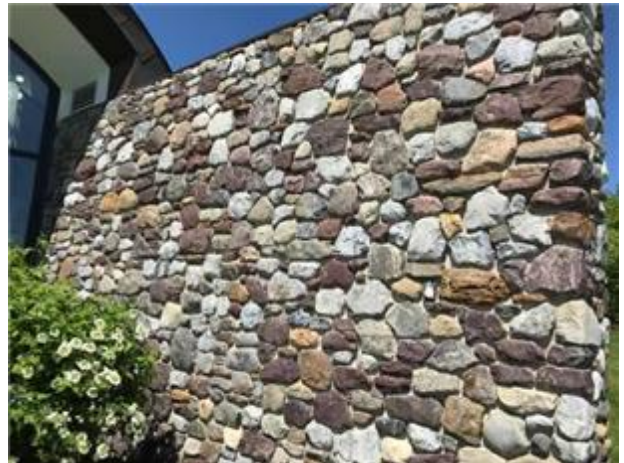
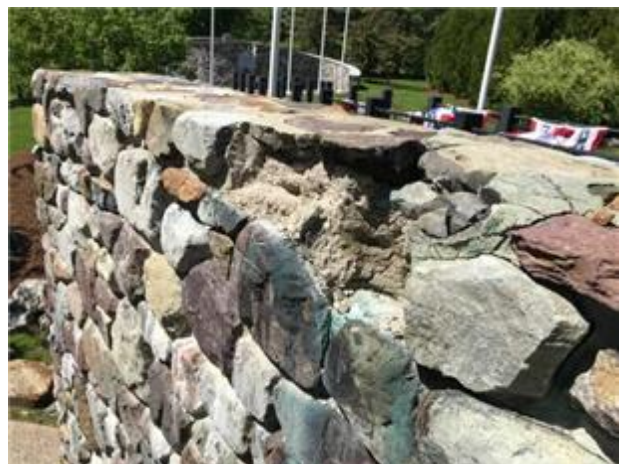
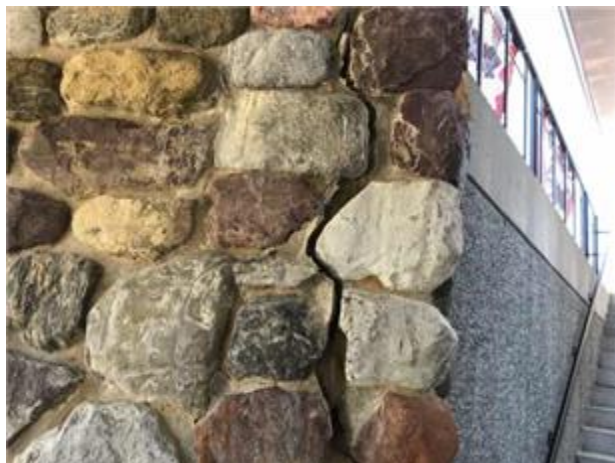
Portions of the stone veneer have failed and several areas are cracked. Immediate repairs are needed. Most of the mortar joints need repointing around the building. The memorial walls were capped and patched within the last 5 years.
