# FACILITY CONDITION ASSESSMENT

FACILITY CONDITION ASSESSMENT  
OF  
WILLISTON SOUTH INFORMATION CENTER  
I-89 SOUTHBOUND MILE MARKER 83  
WILLISTON, VT 05495

December 17, 2018

May 16, 2018

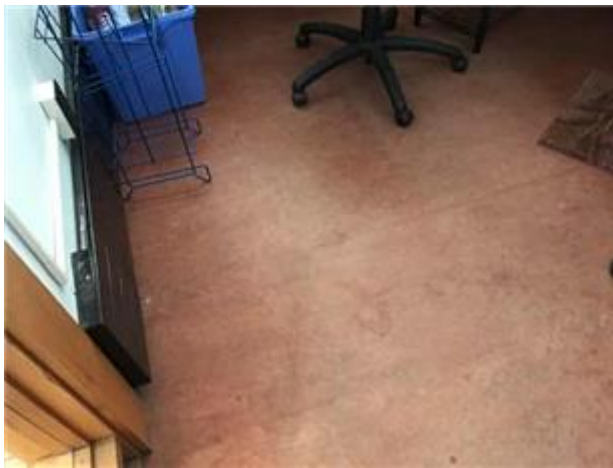
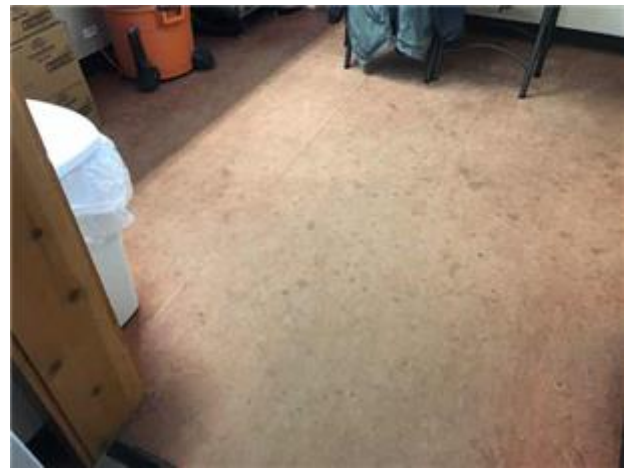
The sheet flooring is faded and worn.

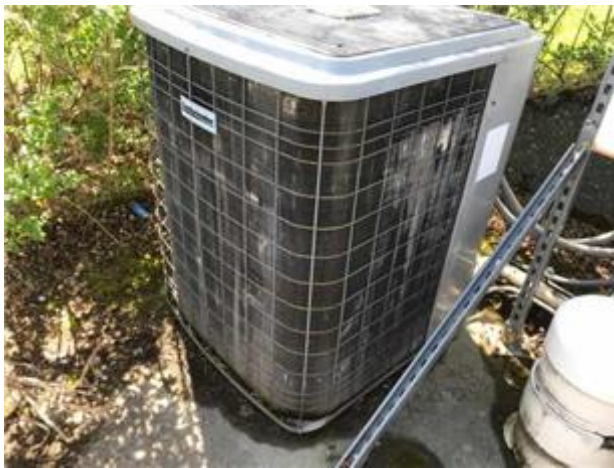
Unit is beyond expected useful life.

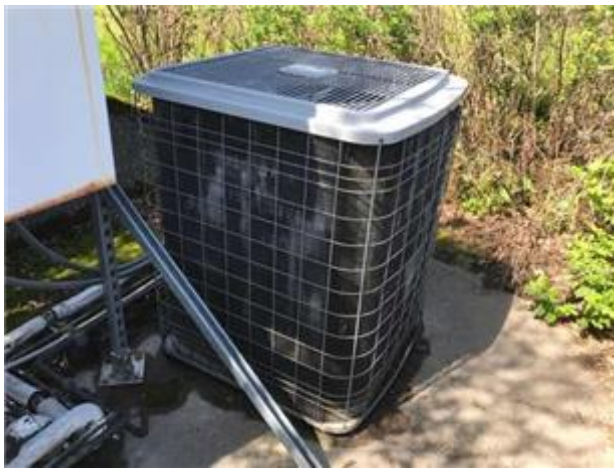
Unit is beyond expected useful life.

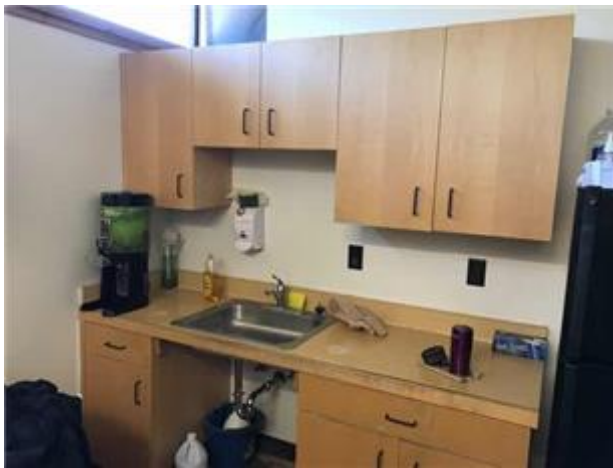
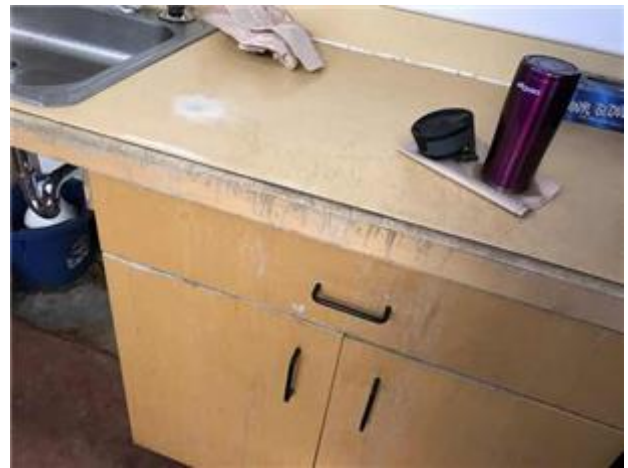
The break room counter and cabinets are very worn.

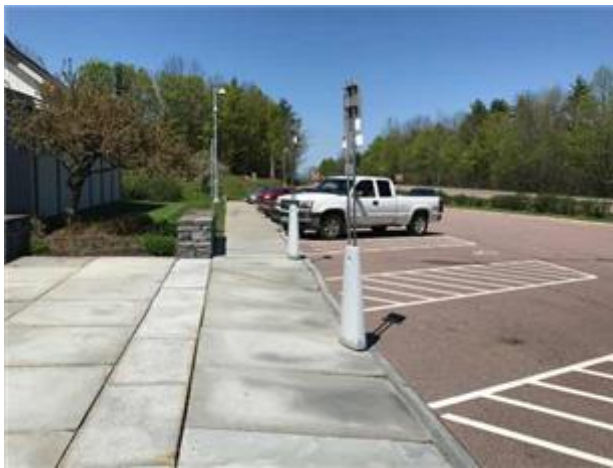
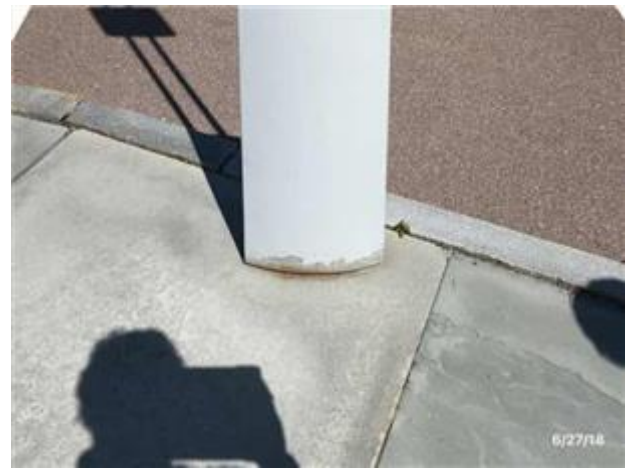
Sign bases are corroding.

Corroding Base

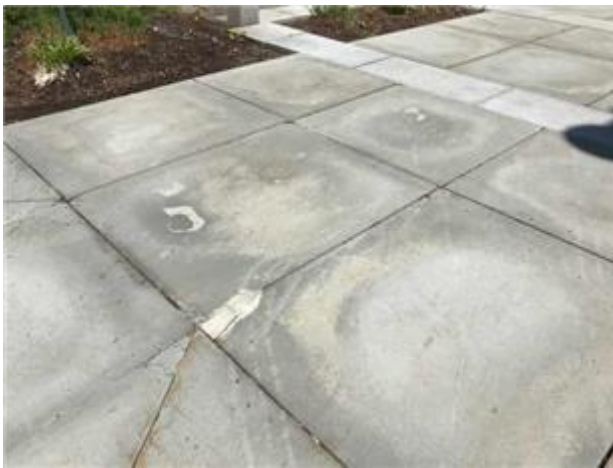
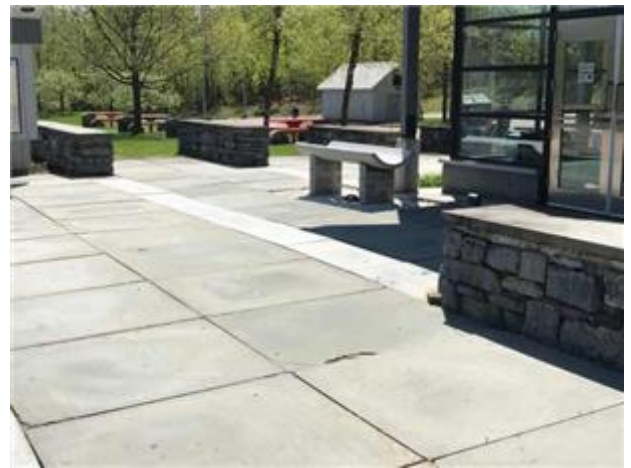
Some areas deteriorating.

Deteriorated pavers

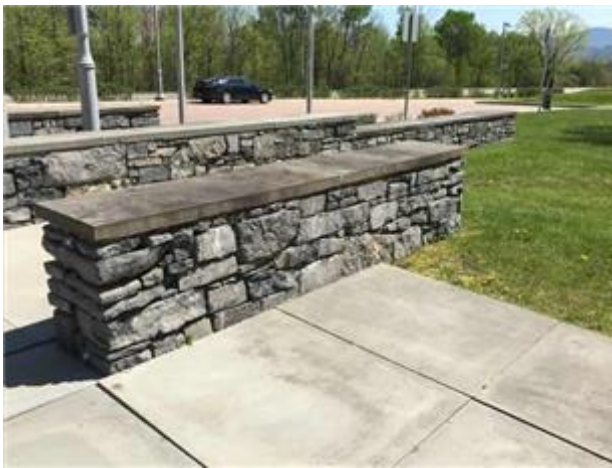
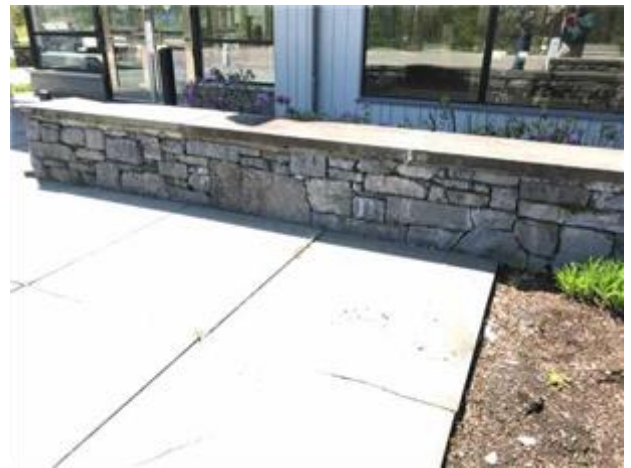
The joints along the tops of the landscape walls need sealer replacement.

Failed sealant
