# FACILITY CONDITION ASSESSMENT

June 18, 2017

FACILITY CONDITION ASSESSMENT  
OF

09250  
47098 PROSPECT ST (RT. 4)  
FAIR HAVEN, VT 05743

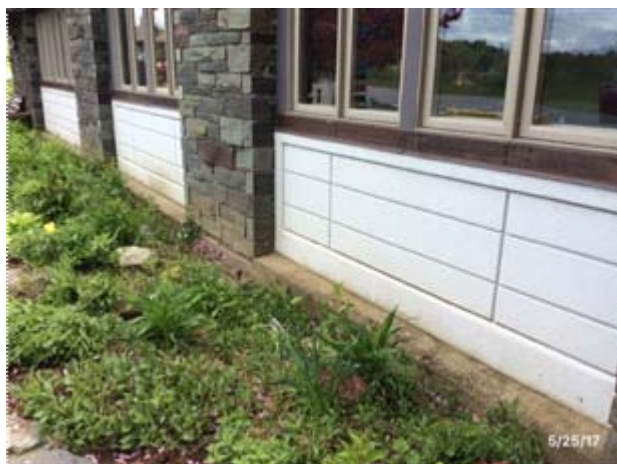
Used in accent locations.

Uniformat	Action Description	Quantity	Unit Cost	Plan Type	Priority	Year	Expenditure
<b>B2011</b>	Allowance to paint EIFS	1 SF	\$500.00	APP	Priority 3	2022	\$500
<b>B2011</b>	Replace Exterior Insulated Finishing System (EIFS)	150 SF	\$45.60	BYL	Priority 3	2031	\$6,841
<b>B2011</b>	Allowance to paint EIFS	1 SF	\$500.00	APP	Priority 3	2032	\$500

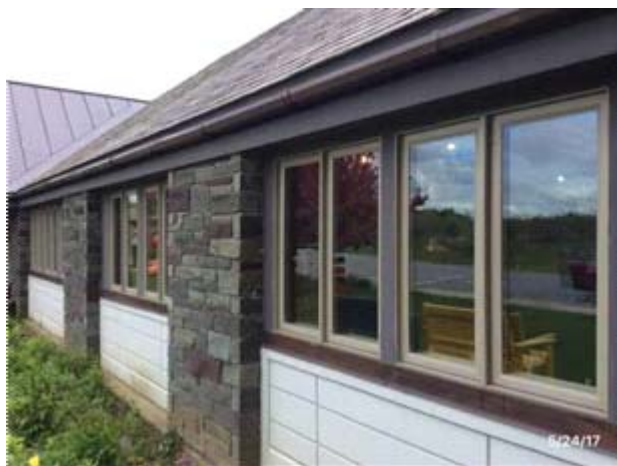
Coding / Field Name	Asset Description
<b>B2021 Windows</b>	Aluminum Window, Double Glazed
<b>Condition</b>	Fair
<b>Qty / UOM</b>	24 / EA
<b>Unit Cost</b>	\$1,051.57
<b>Basis of Costing</b>	Aluminum Window, Double Glazed, 1-2 Stories, 12 SF
<b>Year in Service</b>	2004
<b>Expected Useful Life (EUL)</b>	30 Year(s), Based on Industry Averages
<b>Remaining Useful Life (RUL)</b>	17 Year(s), Estimated, Based on Date of Observation
<b>Location</b>	Exterior Walls
<b>Window Type</b>	Casement
<b>Windows Material</b>	Aluminum
<b>Windows Glazing</b>	Double Glazed
<b>Window Operation</b>	Manual

Uniformat	Action Description	Quantity	Unit Cost	Plan Type	Priority	Year	Expenditure
<b>B2021</b>	Replace Aluminum Window, Double Glazed	24 EA	\$1,051.57	BYL	Priority 3	2034	\$25,238

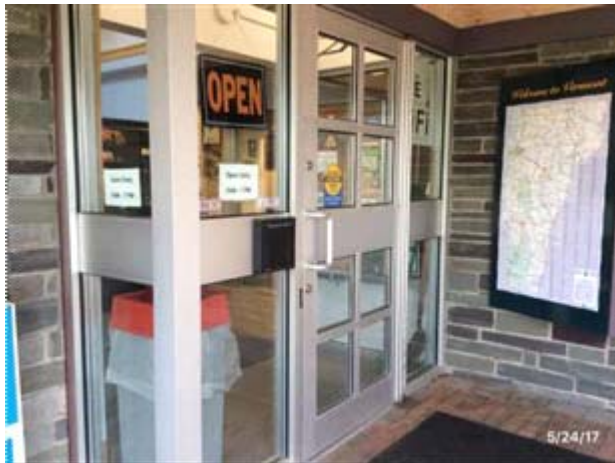
Coding / Field Name	Asset Description
<b>B2023 Storefronts</b>	Storefront Glazing & Framing
<b>Condition</b>	Fair
<b>Qty / UOM</b>	150 / SF
<b>Unit Cost</b>	\$48.00
<b>Year in Service</b>	1997
<b>Expected Useful Life (EUL)</b>	30 Year(s), Based on Industry Averages
<b>Remaining Useful Life (RUL)</b>	10 Year(s), Estimated, Based on Date of Observation
<b>Location</b>	Exterior Walls
<b>Window Type</b>	Fixed
<b>Windows Material</b>	Aluminum
<b>Windows Glazing</b>	Double Glazed
<b>Window Operation</b>	Fixed

Uniformat	Action Description	Quantity	Unit Cost	Plan Type	Priority	Year	Expenditure
<b>B2023</b>	Replace Storefront Glazing & Framing	150 SF	\$48.00	BYL	Priority 3	2027	\$7,200

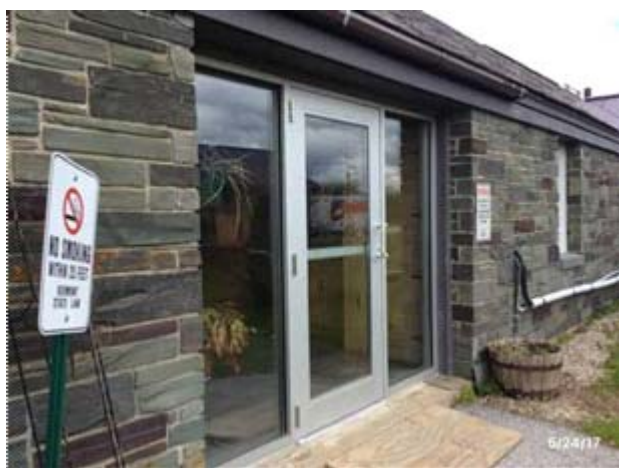
Coding / Field Name	Asset Description
<b>B2031 Glazed Doors &amp; Entrances</b>	Aluminum Frame, Fully Glazed, Exterior Door
<b>Condition</b>	Fair
<b>Qty / UOM</b>	2 / EA
<b>Unit Cost</b>	\$1,368.37
<b>Basis of Costing</b>	Aluminum Frame, Fully Glazed, Exterior Door
<b>Year in Service</b>	1997
<b>Expected Useful Life (EUL)</b>	30 Year(s), Based on Industry Averages
<b>Remaining Useful Life (RUL)</b>	10 Year(s), Estimated, Based on Date of Observation
<b>Location</b>	Exterior Walls
<b>Door Hardware</b>	Lever
<b>Door Operation</b>	Manual
<b>Glass Type</b>	Tempered Glass
<b>Door Frame</b>	Metal Framed
<b>Door Use</b>	Entrance

Uniformat	Action Description	Quantity	Unit Cost	Plan Type	Priority	Year	Expenditure
<b>B2031</b>	Replace Aluminum Frame, Fully Glazed, Exterior Door	2 EA	\$1,368.37	BYL	Priority 3	2027	\$2,737

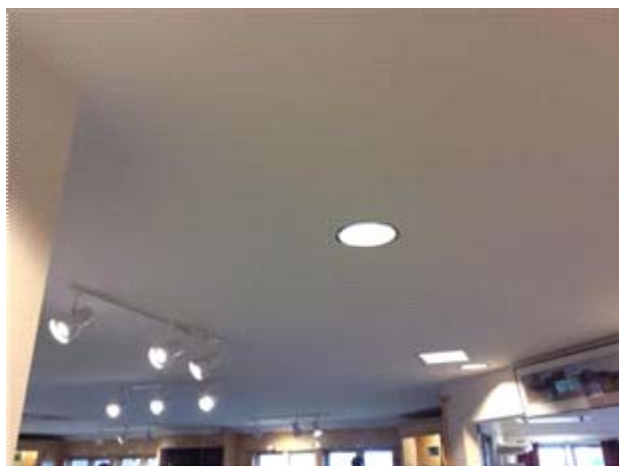
There is no wet sprinkler fire suppression system in the building. Though likely grandfathered, installation is recommended for life safety and asset protection reasons.

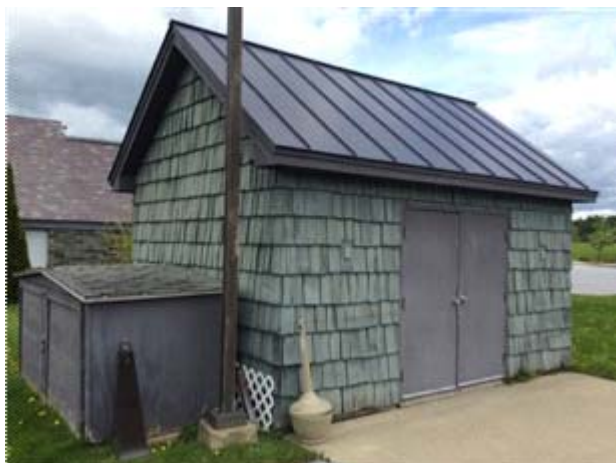
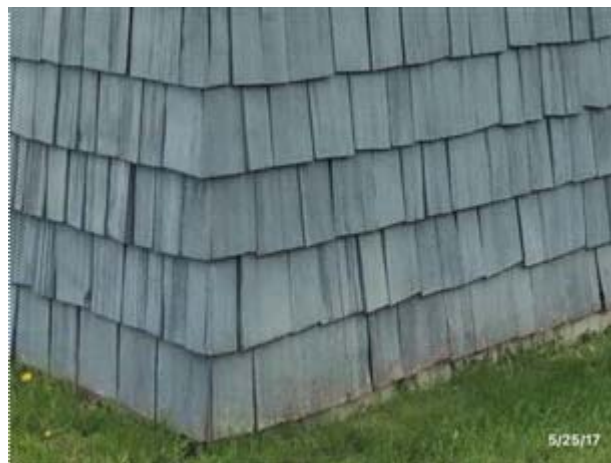
Used primarily for storage of printed materials. Paint is worn.

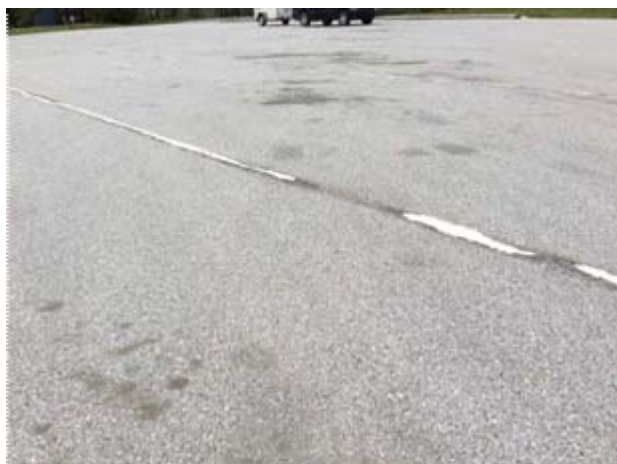
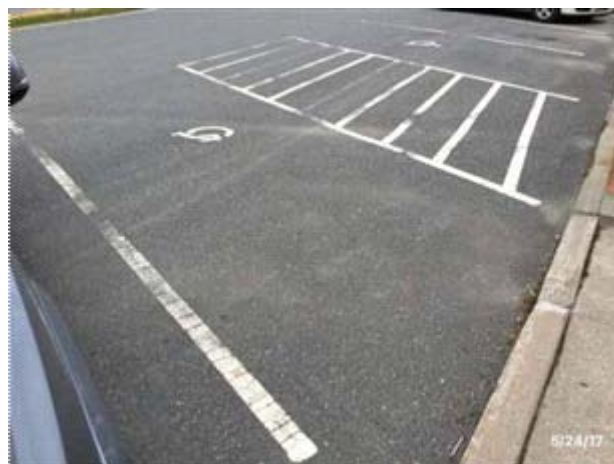
Sealant and striping are worn.
