# FACILITY CONDITION ASSESSMENT

**Vermont Agency of Education\_FCA Phase Two  
1 National Life Drive, Davis 5  
Montpelier, VT 05620-2501**

*July 12, 2023*

**VERGENNES UHS - Main Building (PS312)  
50 Monkton Road  
Vergennes , VT 05491**

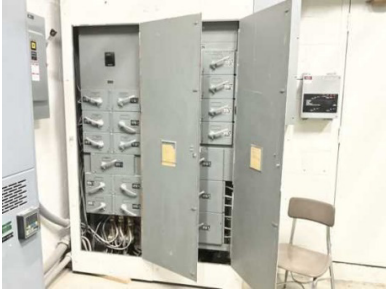
### Switchboard in Poor condition.

120/208 V, 800 AMP

Outdated - AssetCALC ID: 6697209

Recommendation: **Replace in 2022**

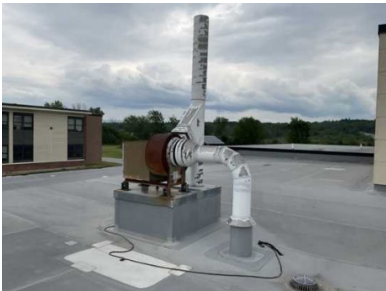
### Exhaust Fan in Poor condition.

Roof or Wall-Mounted, 12" Damper, 501 to 1000 CFM

Units are rusting and beyond RUL. - AssetCALC ID: 6697003

Recommendation: **Replace in 2022**

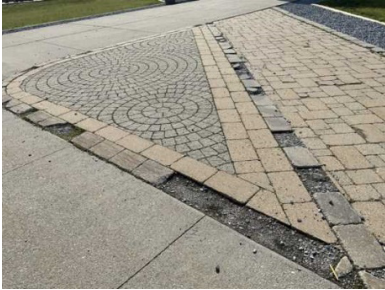
### Sidewalk in Poor condition.

Brick/Masonry Pavers

Some of the paving tiles are missing. - AssetCALC ID: 6697033

Recommendation: **Repair in 2022**

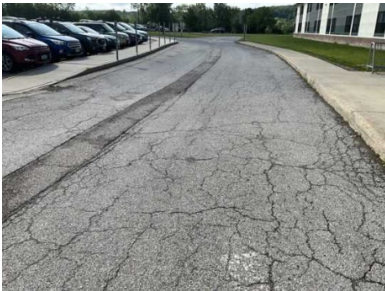
### Parking Lots in Poor condition.

Pavement, Asphalt

Asphalt paving is dried out and has severe alligator cracking. - AssetCALC ID: 6697154

Recommendation: **Seal & Stripe in 2022**

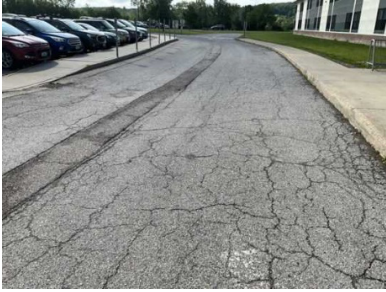
### Parking Lots in Poor condition.

Pavement, Asphalt

Asphalt paving is dried out and has severe alligator cracking. - AssetCALC ID: 6754690

Recommendation: **Mill & Overlay in 2022**

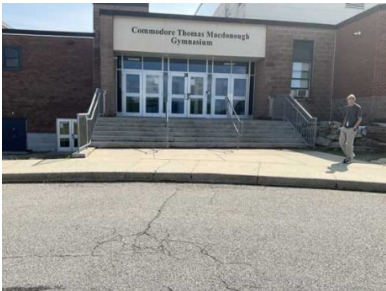
### Stairs in Poor condition.

Concrete, Exterior

Concrete stairs are severely cracked. - AssetCALC ID: 6696920

Recommendation: **Replace in 2022**

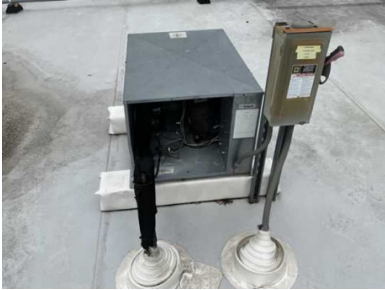
## Foodservice Equipment in Poor condition.

Walk-In, Condenser for Refrigerator/Freezer

Unit is aged beyond RUL - AssetCALC ID: 6696955

Recommendation: **Replace in 2022**
