FACILITY CONDITION ASSESSMENT

May 20, 2023

**CHAMPLAIN ELEMENTARY SCHOOL - Main Building (PS065-U021)
800 Pine Street
Burlington, VT 05401**

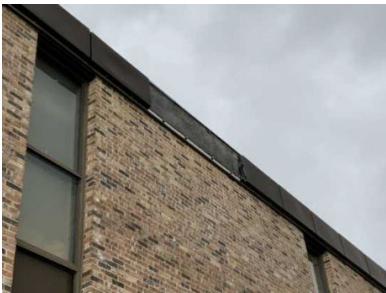
Exterior Walls in Failed condition.

Metal/Insulated Sandwich Panels
 CHAMPLAIN ELEMENTARY SCHOOL - Main Building Exterior

The exterior wall is missing the metal panels. - AssetCALC ID: 6045228

Uniformat Code: B2010
 Recommendation: **Replace in 2023**
 Priority Score: **89.9**
 Plan Type: Performance/Integrity
 Cost Estimate: \$4,400

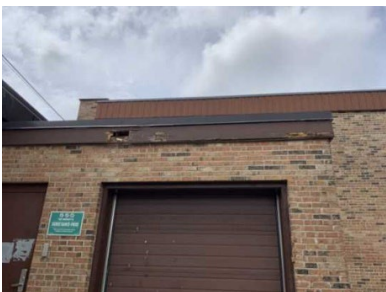
Roof Sheathing in Poor condition.

Plywood
 CHAMPLAIN ELEMENTARY SCHOOL - Main Building Exterior

The roof trimming is damaged and needs to be replaced. - AssetCALC ID: 6045285

Uniformat Code: B1020
 Recommendation: **Replace in 2023**
 Priority Score: **89.9**
 Plan Type: Performance/Integrity
 Cost Estimate: \$1,600

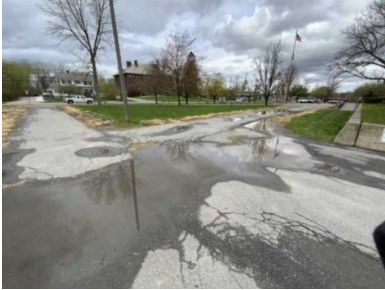
Roadways in Poor condition.

Pavement, Asphalt
CHAMPLAIN ELEMENTARY SCHOOL - Main Building Site

The asphalt roadway has major cracks and potholes throughout. - AssetCALC ID: 6045238

Uniformat Code: G2010
Recommendation: **Mill & Overlay in 2023**
Priority Score: **84.9**
Plan Type: Performance/Integrity
Cost Estimate: \$70,000

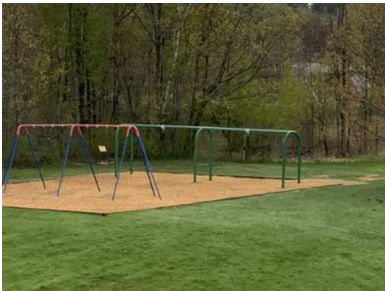
Play Structure in Poor condition.

Swing Set, 4 Seats
CHAMPLAIN ELEMENTARY SCHOOL - Main Building Site

The swing structure is missing the swinging components. - AssetCALC ID: 6045200

Uniformat Code: G2050
Recommendation: **Replace in 2023**
Priority Score: **82.9**
Plan Type: Performance/Integrity
Cost Estimate: \$5,000

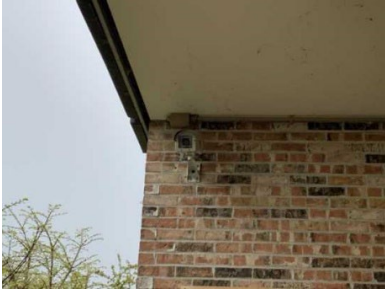
Security/Surveillance System in Poor condition.

Full System Upgrade, Average Density
 CHAMPLAIN ELEMENTARY SCHOOL - Main Building Throughout building

This school does not camera surveillance throughout the school, only camera surveillance at the main entrance. - AssetCALC ID: 6045225

Uniformat Code: D7030
 Recommendation: **Replace in 2023**
 Priority Score: **81.9**
 Plan Type: Performance/Integrity
 Cost Estimate: \$104,600
\$\$\$\$

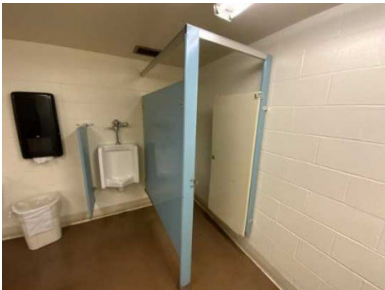
Toilet Partitions in Poor condition.

Metal
 CHAMPLAIN ELEMENTARY SCHOOL - Main Building Restrooms

The toilet partition panels are aged and rusted. It's recommended to be replaced. - AssetCALC ID: 6045249

Uniformat Code: C1090
 Recommendation: **Replace in 2023**
 Priority Score: **81.9**
 Plan Type: Performance/Integrity
 Cost Estimate: \$2,600
\$\$\$\$
