FACILITY CONDITION ASSESSMENT

158982.22R000-089.379

July 23, 2023

**COLCHESTER HIGH SCHOOL - Main Building (PS072-U401)
131 Laker Lane
Colchester VT, 05446**

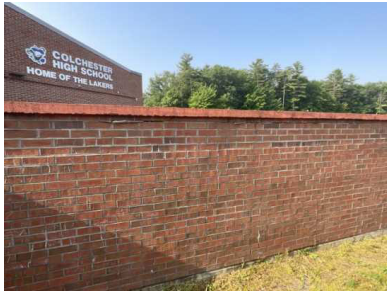
Exterior Walls in Poor condition.

Brick
COLCHESTER HIGH SCHOOL - Main Building Building Exterior

Some areas of brick walls need repointing - AssetCALC ID: 6752873

Uniformat Code: B2010
Recommendation: **Repair/Repoint in 2023**
Priority Score: **89.9**
Plan Type: Performance/Integrity
Cost Estimate: \$33,000

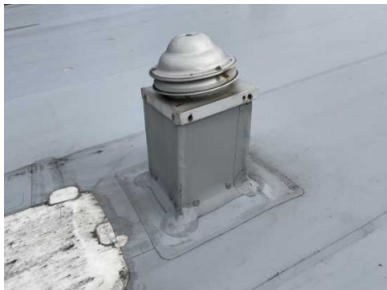
Exhaust Fan in Poor condition.

Roof or Wall-Mounted, 12" Damper
COLCHESTER HIGH SCHOOL - Main Building Roof

Fan loose, flange damaged. - AssetCALC ID: 6753071

Uniformat Code: D3060
Recommendation: **Replace in 2023**
Priority Score: **85.9**
Plan Type: Performance/Integrity
Cost Estimate: \$1,400

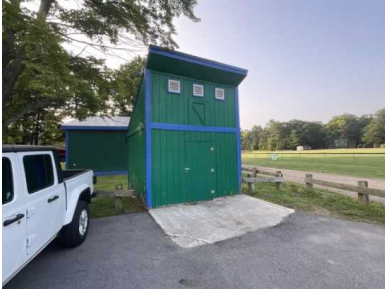
Shed/Gazebo/Shade Structure in Poor condition.

Wood or Metal-Framed, Standard
COLCHESTER HIGH SCHOOL - Main Building Site

Some wood rot and roof in poor condition - AssetCALC ID: 6752845

Recommendation: **Replace in 2023**

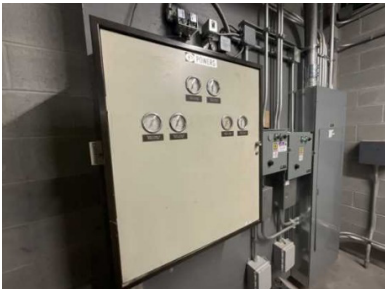
BAS/HVAC Controls in Poor condition.

Basic System or Legacy Upgrades
COLCHESTER HIGH SCHOOL - Main Building Throughout

System has received partial periodic upgrades but some original components still in service - AssetCALC ID: 6752990

Recommendation: **Install in 2023**
