FACILITY CONDITION ASSESSMENT

158982.22R000-284.379

June 8, 2023

**ROXBURY VILLAGE SCHOOL - Main Building (PS250-SU025)
1559 Roxbury Road
Roxbury, VT 05669**

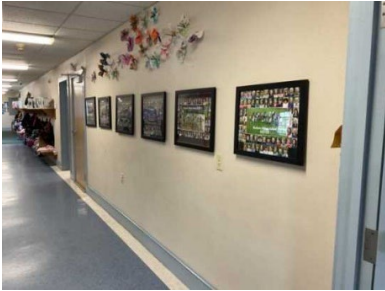
Wall Finishes in Poor condition.

Wallpaper

Wallpaper is peeling and should be replaced. - AssetCALC ID: 6181803

Recommendation: **Replace in 2023**

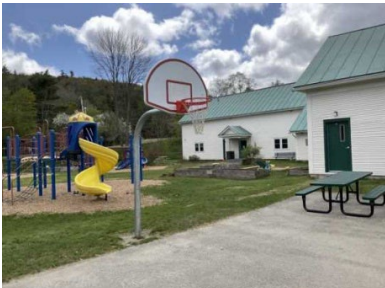
Athletic Surfaces & Courts in Failed condition.

Basketball/General, Asphalt Pavement

Striping is missing and should be redone - AssetCALC ID: 6262143

Recommendation: **Seal & Stripe in 2023**

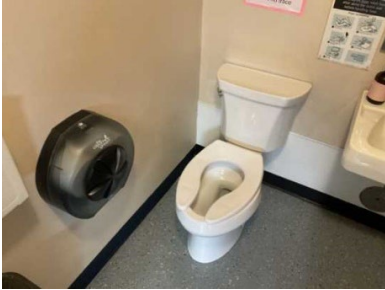
ADA Miscellaneous

Bathrooms do not have grab bars, and the parking lot does not have accessible striping. The building and additions were likely made before accessibility was a requirement, but any future improvements should consider accessibility. - AssetCALC ID: 6264705

Recommendation: **Evaluate/Report in 2023**
