FACILITY CONDITION ASSESSMENT

May 18, 2023

**UNION ELEMENTARY SCHOOL - Main Building (PS308-SU009)
1 PARK AVENUE
MONTPELIER , VT 05602**

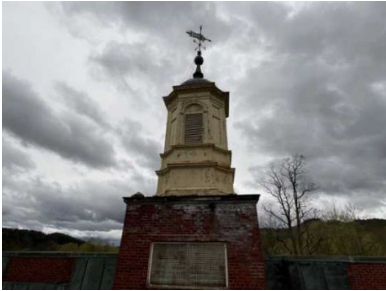
Exterior Windows, steeple, and Trim in Poor condition.

any painted surface
UNION ELEMENTARY SCHOOL - Main Building Building exterior

Window trim and steeple are intricate areas requiring a lot of prep work and lifts. - AssetCALC ID: 6082526

Uniformat Code: B2010
Recommendation: **Prep & Paint in 2024**
Priority Score: **89.7**
Plan Type: Performance/Integrity
Cost Estimate: \$48,000

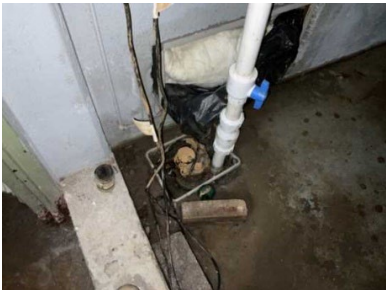
Pump in Failed condition.

Sump
UNION ELEMENTARY SCHOOL - Main Building Basement

Unit doesn't work - AssetCALC ID: 6081109

Uniformat Code: D2030
Recommendation: **Replace in 2023**
Priority Score: **85.9**
Plan Type: Performance/Integrity
Cost Estimate: \$4,300

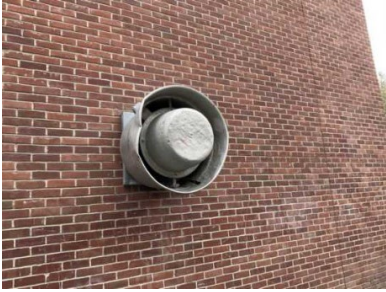
Exhaust Fan in Poor condition.

Roof or Wall-Mounted, 24" Damper
UNION ELEMENTARY SCHOOL - Main Building Building Exterior

Unit is damaged but functional - AssetCALC ID: 6081086

Recommendation: **Replace in 2024**

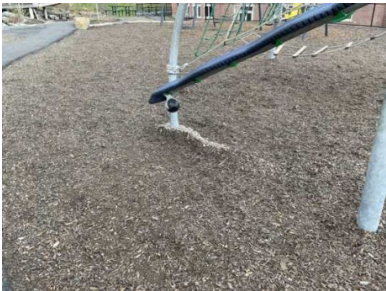
Playfield Surfaces in Poor condition.

Chips Wood, 6" Depth
UNION ELEMENTARY SCHOOL - Main Building Site

Wood chips appear worn and and should be refreshed. - AssetCALC ID: 6081182

Recommendation: **Replace in 2023**

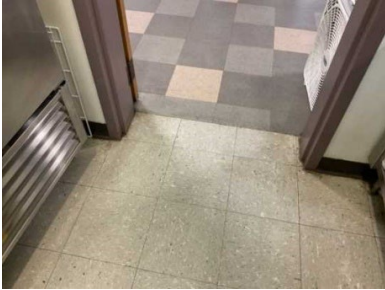
Flooring in Poor condition.

Vinyl Tile (VCT)

areas of VCT are cracked and should be replaced - AssetCALC ID: 6081104

Recommendation: **Replace in 2023**

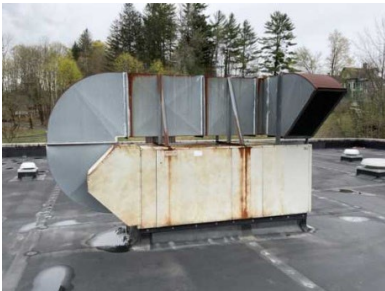
Make-Up Air Unit in Poor condition.

MUA or MAU

Make up air unit or heat exchanger unit is rusting and sounds to not be in optimal condition. Replacement is recommended. - AssetCALC ID: 6081140

Recommendation: **Replace in 2023**

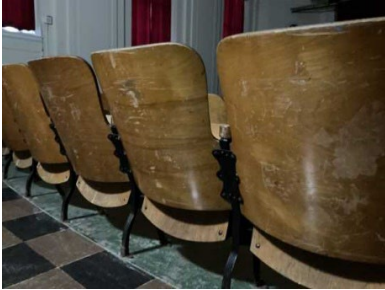
Flooring in Poor condition.

Vinyl Tile (VCT), w/ Asbestos Abatement
UNION ELEMENTARY SCHOOL - Main Building Theater

Asbestos mastic in the theater is scratched and should be replaced before it becomes friable. - AssetCALC ID: 6081074

Recommendation: **Replace in 2024**

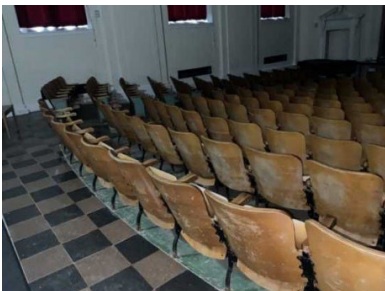
Fixed Seating in Poor condition.

Auditorium/Theater, Metal Cushioned Standard
UNION ELEMENTARY SCHOOL - Main Building Theater

Seating is original to the building, and, badly worn. It should be replaced the near future. - AssetCALC ID: 6081171

Recommendation: **Replace in 2024**

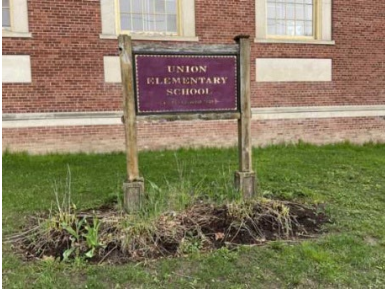
Signage in Poor condition.

Property, Monument
UNION ELEMENTARY SCHOOL - Main Building Site

sign is aging and should be replaced - AssetCALC ID: 6081064

Uniformat Code: G2060
Recommendation: **Replace/Install in 2024**
Priority Score: **81.8**
Plan Type: Performance/Integrity
Cost Estimate: \$3,000

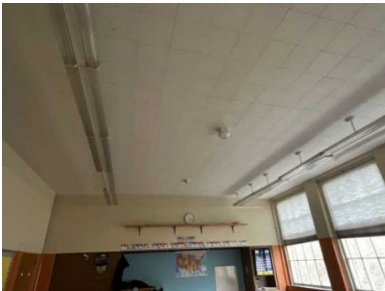
Wall Finishes in Poor condition.

any surface
UNION ELEMENTARY SCHOOL - Main Building Throughout Building

Paint in some the auditorium and some classrooms is peeling and should be redone - AssetCALC ID: 6082529

Uniformat Code: C2010
Recommendation: **Prep & Paint in 2024**
Priority Score: **81.7**
Plan Type: Performance/Integrity
Cost Estimate: \$45,000

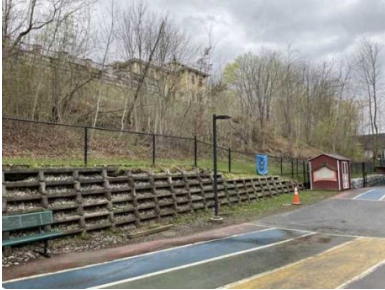
The hill south of the school appears to be slumping and could be a landslide risk. Trees on the hill are rotating, and there are what appear to be horizontal tears in the hill that suggest movement. A professional engineer or geoscientist must be retained to analyze the existing condition, provide recommendations and, if necessary, estimate the scope and cost of any required stabilization. The cost of this study and continued monitoring is included in the cost tables. Due to the ambiguity of the required stabilization at the time of this assessment, the cost for any possible subsequent work is not included

Recommended Follow-up Study: Geoengineering, Hill STability

Geoengineering, Hill STability
 UNION ELEMENTARY SCHOOL - Main Building Hill behind school

The hill behind the school appears to be slumping. Tilted trees, and what appear to be small horizontal cracks or linear inconsistencies on the hill could be observed from the building roof. The hill appears to be sloped at or steeper than the natural angle of repose, and with the added weight of a parking lot and building above may have the potential for failure. The hill should be monitored for movement to prevent loss of life from a catastrophic failure. Study will likely need to be ongoing. - AssetCALC ID: 6085550

Uniformat Code: P2030
 Recommendation: **Study and monitor in 2023**
 Priority Score: **72.9**
 Plan Type: Environmental
 Cost Estimate: \$40,000

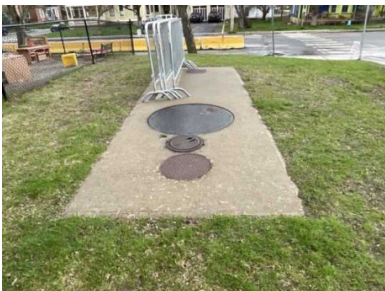
Recommended Follow-up Study: Environmental, ESA Phase II

Environmental, ESA Phase II
 UNION ELEMENTARY SCHOOL - Main Building Site

A Phase II ESA should be conducted concurrent to the removal of the UST - AssetCALC ID: 6085551

Uniformat Code: P2030
 Recommendation: **Evaluate/Report in 2029**
 Priority Score: **72.4**
 Plan Type: Environmental
 Cost Estimate: \$12,500

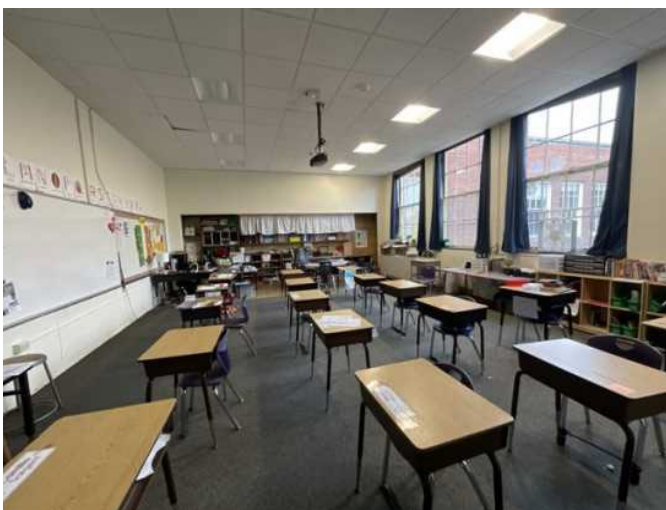
17 - CLASSROOM WITH OLD CARPET
