# FACILITY CONDITION ASSESSMENT

**Vermont Agency of Education\_FCA Phase Two  
1 National Life Drive, Davis 5  
Montpelier, VT 05620-2501**

*158982.22R000-382, 383.379*

Woodstock Middle Campus  
4961 Woodstock Road  
Woodstock, VT 05091

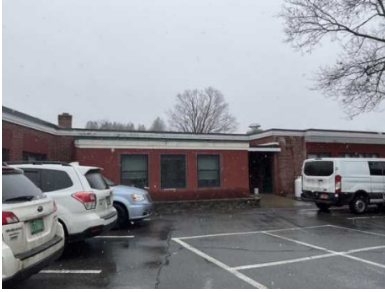
## Exterior Walls in Poor condition.

The painted fascia along the building exterior is in poor condition. The paint is peeling and worn. - AssetCALC ID: 4822903

Recommendation: **Prep & Paint in 2023**

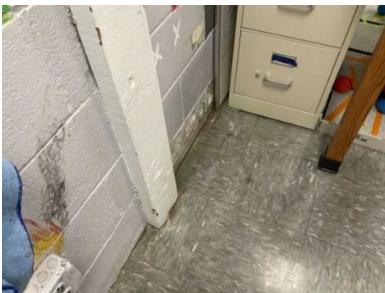
## Exterior Walls in Poor condition.

There are areas of the foundation and slab that have extreme moisture issues. The top of columns at the gym ceiling joists have significant step cracking. A cost estimate to repair damaged areas is included here. -

Recommendation: **Repair/Repoint in 2023**

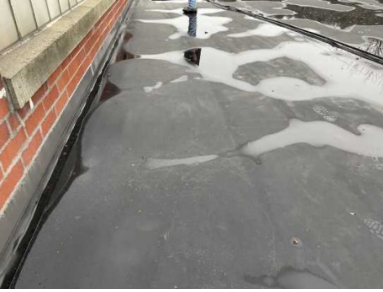
### Roofing in Poor condition.

The roof membrane is not fully adhered. There are numerous leaks throughout the building. The membrane is at the end of its life and should be replaced. - AssetCALC ID: 4822767

Recommendation: **Replace in 2023**

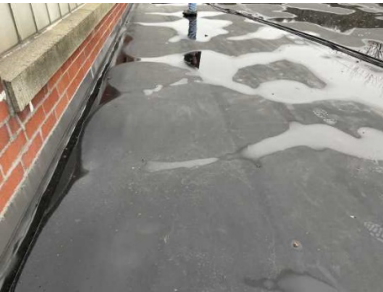
### Roofing in Poor condition.

The roof is in poor condition. The material is not fully adhered and is lifting. There are numerous areas of damaged ceiling tiles and wall finishes due to extensive leaks. - AssetCALC ID: 4863082

Recommendation: **Replace in 2023**

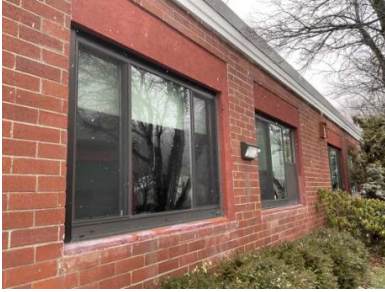
### Window in Poor condition.

The windows are antiquated and inefficient. They barely operate. The frames are not insulated, and the thermal seals have failed throughout the building. Replacement is recommended. - AssetCALC ID: 4822874

Uniformat Code: B2020  
Recommendation: **Replace in 2023**  
Priority Score: **87.9**  
Plan Type: Performance/Integrity  
Cost Estimate: \$150,000

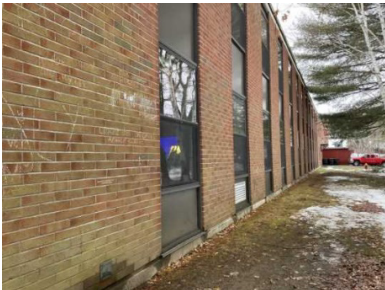
### Window in Poor condition.

The windows are antiquated, the frames are not insulated and many of the seals have failed. Replacement is recommended. - AssetCALC ID: 4822755

Uniformat Code: B2020  
Recommendation: **Replace in 2023**  
Priority Score: **87.9**  
Plan Type: Performance/Integrity  
Cost Estimate: \$100,000

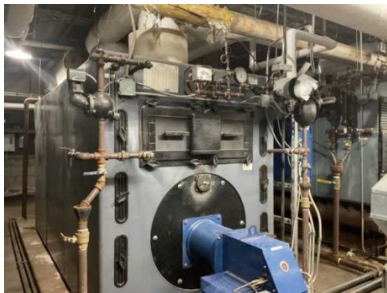
## Boiler in Poor condition.

The boilers are antiquated and inefficient. They have reached the end of their useful life and maintenance is difficult as replacement parts are no longer available. - AssetCALC ID: 4822891

Recommendation: **Replace in 2024**

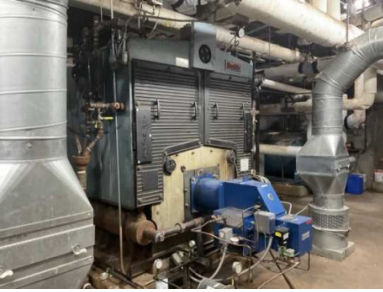
### Boiler in Poor condition.

The boilers are antiquated and inefficient. They have reached the end of their useful life and maintenance is difficult as replacement parts are no longer available. - AssetCALC ID: 4822907

Recommendation: **Replace in 2024**

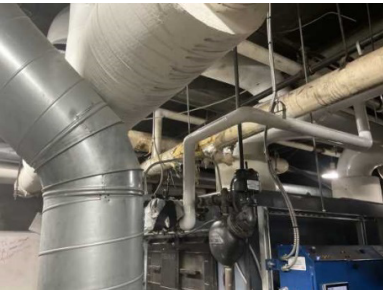
### Piping & Valves in Poor condition.

Damaged pipe insulation should be repaired or replaced. - AssetCALC ID: 4822916

Recommendation: **Replace in 2023**

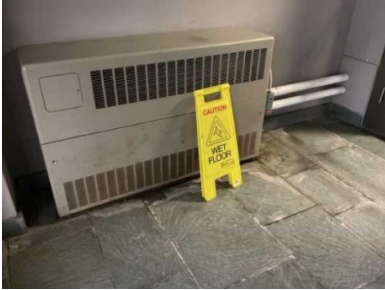
## HVAC System in Poor condition.

Steam system piping throughout the buildings is old and deteriorating. Replacement is recommended as part of an overall modernization plan. - AssetCALC ID: 4855185

Recommendation: **Replace in 2023**

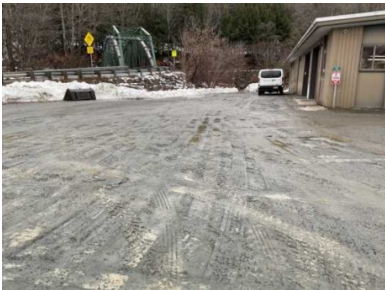
## Parking Lots in Poor condition.

The unpaved parking and roadway to the maintenance garage is difficult to maintain. - AssetCALC ID: 4822794

Recommendation: **Install in 2023**

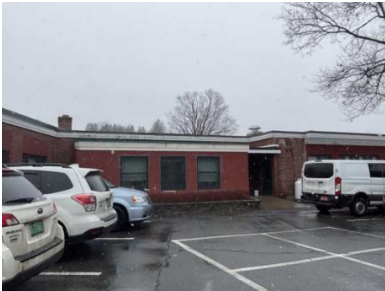
### Exterior Walls in Poor condition.

The painted fascia along the building exterior is in poor condition. The paint is peeling and worn. - AssetCALC ID: 4822903

Recommendation: **Prep & Paint in 2023**

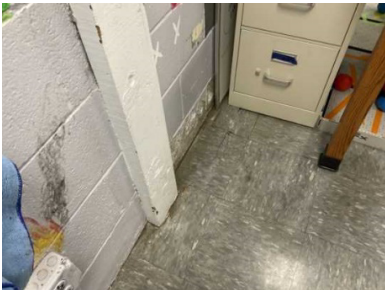
### Exterior Walls in Poor condition.

There are areas of the foundation and slab that have extreme moisture issues. The top of columns at the gym ceiling joists has significant step cracking. A cost estimate to repair damaged areas is included here. -

Recommendation: **Repair/Repoint in 2023**

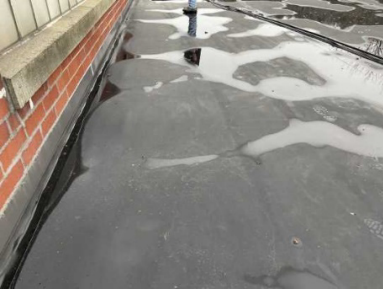
### Roofing in Poor condition.

The roof membrane is not fully adhered. There are numerous leaks throughout the building. The membrane is at the end of its life and should be replaced. - AssetCALC ID: 4822767

Recommendation: **Replace in 2023**

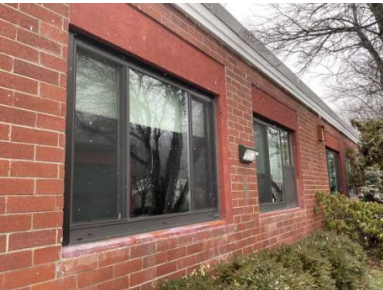
### Window in Poor condition.

The windows are antiquated and inefficient. They barely operate. The frames are not insulated, and the thermal seals have failed throughout the building. Replacement is recommended. - AssetCALC ID: 4822874

Recommendation: **Replace in 2023**

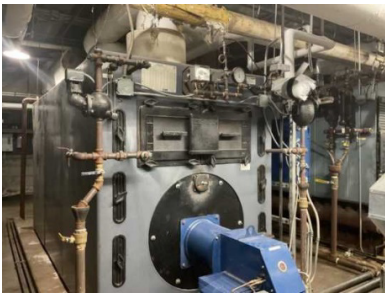
## Boiler in Poor condition.

The boilers are antiquated and inefficient. They have reached the end of their useful life and maintenance is difficult as replacement parts are no longer available. - AssetCALC ID: 4822891

Recommendation: **Replace in 2024**

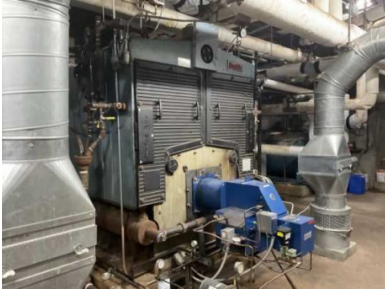
### Boiler in Poor condition.

The boilers are antiquated and inefficient. They have reached the end of their useful life and maintenance is difficult as replacement parts are no longer available. - AssetCALC ID: 4822907

Recommendation: **Replace in 2024**

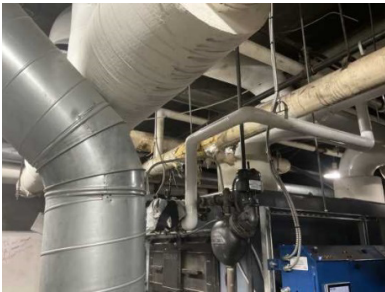
### Piping & Valves in Poor condition.

Damaged pipe insulation should be repaired or replaced. - AssetCALC ID: 4822916

Recommendation: **Replace in 2023**

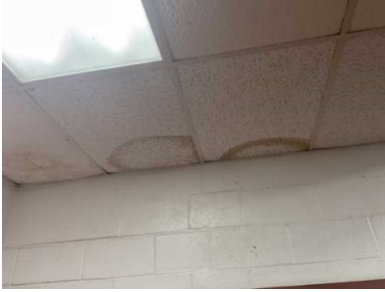
## Suspended Ceilings in Poor condition.

Damaged ceiling tiles from water leaks throughout the building should be replaced. - AssetCALC ID: 4822930

Recommendation: **Replace in 2023**

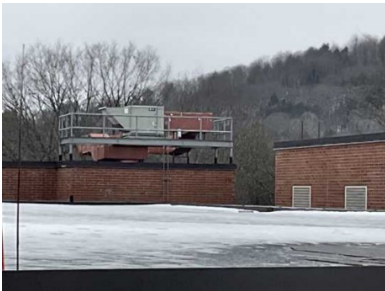
## Make-Up Air Unit in Poor condition.

The mechanical equipment throughout the building is inefficient and antiquated. Replacement with new and modern systems is recommended. - AssetCALC ID: 4822746

Recommendation: **Replace in 2023**

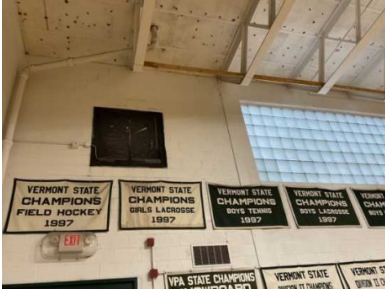
## Recommended Follow-up Study: Structural, General Design

There are areas of the foundation and slab that have extreme moisture issues. The top of columns at the gym ceiling joists has significant step cracking. An engineering study of the structure is recommended. -

Recommendation: **Design in 2023**

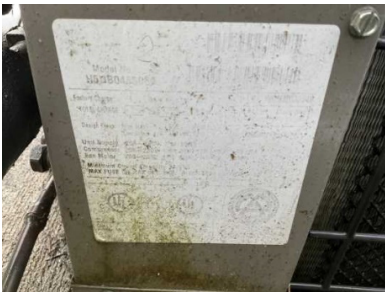
## Split System in Poor condition.

Uses phased-out R-22 refrigerant. - AssetCALC ID: 4822928

Recommendation: **Replace in 2023**

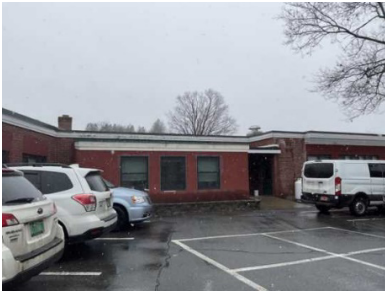
### Exterior Walls in Poor condition.

The painted fascia along the building exterior is in poor condition. The paint is peeling and worn. - AssetCALC ID: 4822903

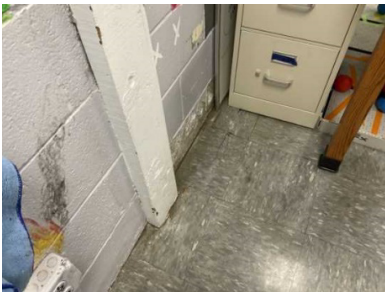
### Exterior Walls in Poor condition.

There are areas of the foundation and slab that have extreme moisture issues. The top of columns at the gym ceiling joists have significant step cracking. A cost estimate to repair damaged areas is included here. - AssetCALC ID: 4822909

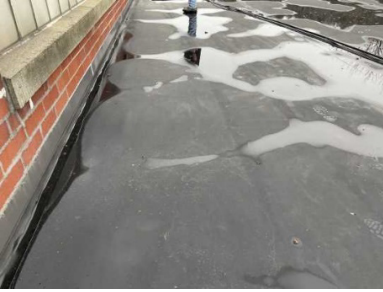
### Roofing in Poor condition.

The roof membrane is not fully adhered. There are numerous leaks throughout the building. The membrane is at the end of its life and should be replaced. - AssetCALC ID: 4822767

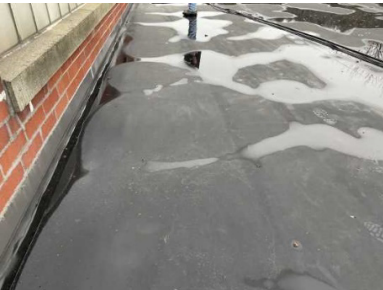
### Roofing in Poor condition.

The roof is in poor condition. The material is not fully adhered and is lifting. There are numerous areas of damaged ceiling tiles and wall finishes due to extensive leaks. - AssetCALC ID: 4863082

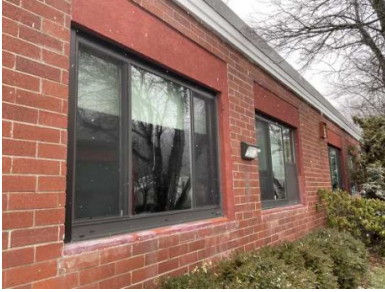
### Window in Poor condition.

The windows are antiquated and inefficient. They barely operate. The frames are not insulated, and the thermal seals have failed throughout the building. Replacement is recommended. - AssetCALC ID: 4822874

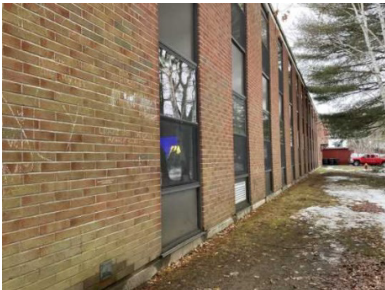
### Window in Poor condition.

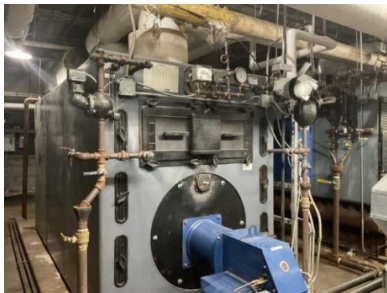
## Boiler in Poor condition.

The boilers are antiquated and inefficient. They have reached the end of their useful life and maintenance is difficult as replacement parts are no longer available. - AssetCALC ID: 4822891

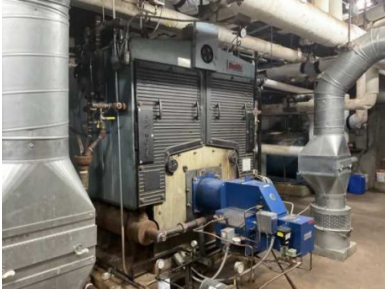
### Boiler in Poor condition.

The boilers are antiquated and inefficient. They have reached the end of their useful life and maintenance is difficult as replacement parts are no longer available. - AssetCALC ID: 4822907

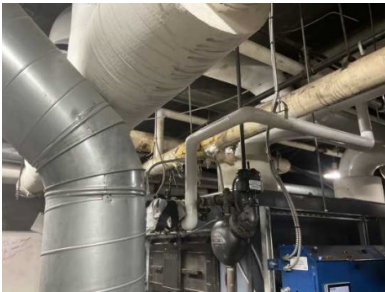
### Piping & Valves in Poor condition.

Damaged pipe insulation should be repaired or replaced. - AssetCALC ID: 4822916

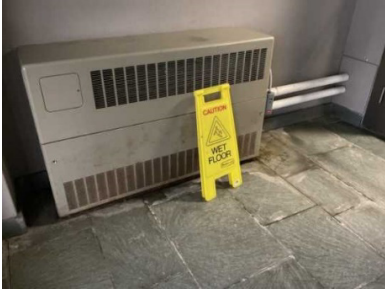
## HVAC System in Poor condition.

Steam system piping throughout the buildings is old and deteriorating. Replacement is recommended as part of an overall modernization plan. - AssetCALC ID: 4855185

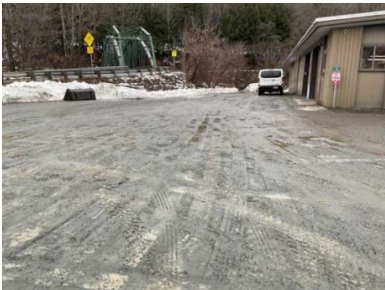
## Parking Lots in Poor condition.
