FACILITY CONDITION ASSESSMENT

**Vermont Agency of Education_FCA Phase Two
1 National Life Drive, Davis 5
Montpelier, VT 05620-2501**

June 20, 2023

LAKE REGION UHS #24 - Main Building (PS157-)
317 Lake Region Road
Orleans, VT 05860

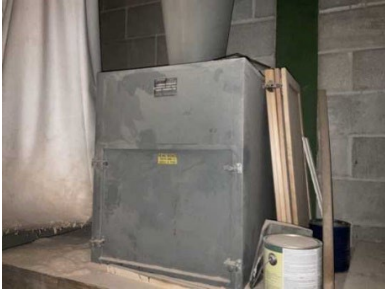
Exhaust Fan in Poor condition.

Industrial Dust Collection, 1 to 1.5 HP Motor
LAKE REGION UHS #24 - Main Building Welding shop

Abandoned in place - AssetCALC ID: 6123668

Recommendation: **Replace in 2023**

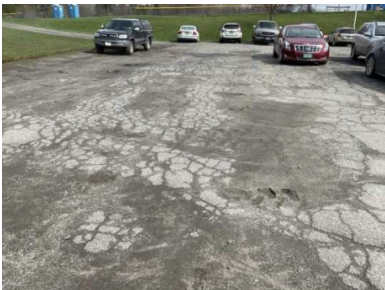
Parking Lots in Failed condition.

Pavement, Asphalt

Very damaged. Severe cracking and large potholes throughout - AssetCALC ID: 6123697

Recommendation: **Mill & Overlay in 2023**

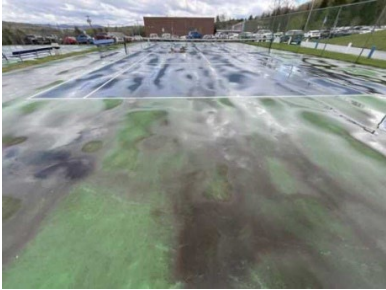
Athletic Surfaces & Courts in Poor condition.

Tennis/Volleyball, 2-Color Surface
LAKE REGION UHS #24 - Main Building Site

Wavy surface. Sunk into ground - AssetCALC ID: 6123694

Uniformat Code: G2050
Recommendation: **Seal & Stripe in 2023**
Priority Score: **82.9**
Plan Type: Performance/Integrity
Cost Estimate: \$31,200
