FACILITY CONDITION ASSESSMENT

**Vermont Agency of Education_FCA Phase Two
1 National Life Drive, Davis 5
Montpelier, VT 05620-2501**

June 22, 2023

**CRAFTSBURY ELEMENTARY SCHOOL (PS078-SU001)
1422 North Craftsbury Road
Craftsbury Community, VT 05827**

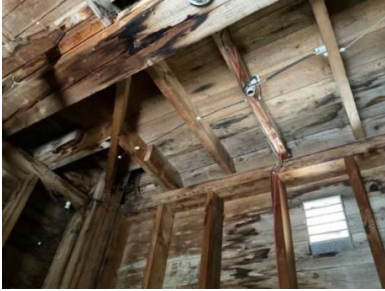
Electrical System in Poor condition.

Wiring & Switches, High Density/Complexity
CRAFTSBURY SCHOOLS - Elementary Throughout building

Evidence of knob and tube wiring. Verify it has been disconnected - AssetCALC ID: 5489890

Recommendation: **Replace in 2022**

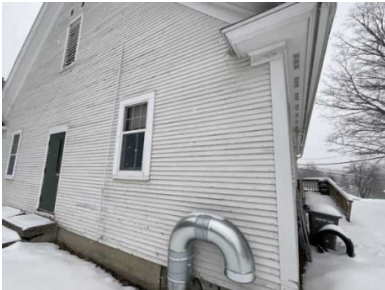
Exterior Walls in Poor condition.

Wood Siding
CRAFTSBURY SCHOOLS - Elementary Building Exterior

Wood Exterior siding rotting and becoming deteriorated. - AssetCALC ID: 5489885

Recommendation: **Replace in 2022**

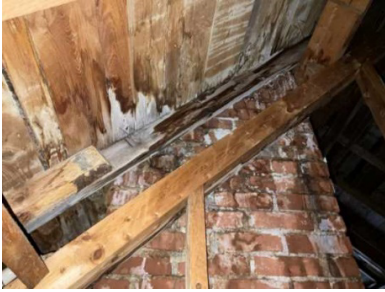
Roofing in Poor condition.

any type, Repairs per Man-Day
CRAFTSBURY SCHOOLS - Elementary Roof

Marking on interior side of roof could be evidence of roof leaks or compromised components. - AssetCALC ID: 5489869

Recommendation: **Repair in 2022**

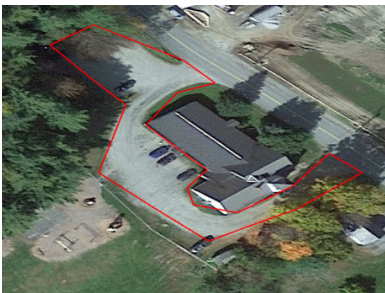
Parking Lots in Poor condition.

Pavement, Asphalt
CRAFTSBURY SCHOOLS - Elementary Site

May need stripe - AssetCALC ID: 5594212

Recommendation: **Seal & Stripe in 2022**

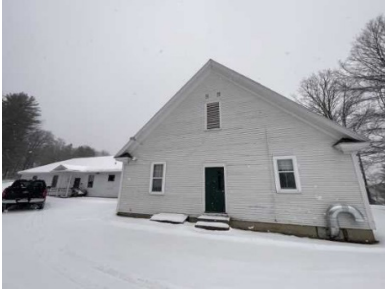
Roadways in Poor condition.

Pavement, Asphalt
CRAFTSBURY SCHOOLS - Elementary Site

Parking Lot may need sealing, was covered with snow at on site. - AssetCALC ID: 5972810

Uniformat Code: G2010
Recommendation: **Mill & Overlay in 2022**
Priority Score: **84.9**
Plan Type: Performance/Integrity
Cost Estimate: \$52,500

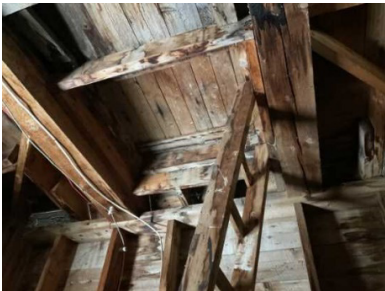
Recommended Follow-up Study: Structural, Superstructure

Structural, Superstructure
CRAFTSBURY SCHOOLS - Elementary Attic

Study recommended for the wood framing assembly construction integrity. - AssetCALC ID: 5489878

Uniformat Code: P2030
Recommendation: **Evaluate/Report in 2022**
Priority Score: **81.9**
Plan Type: Performance/Integrity
Cost Estimate: \$10,000

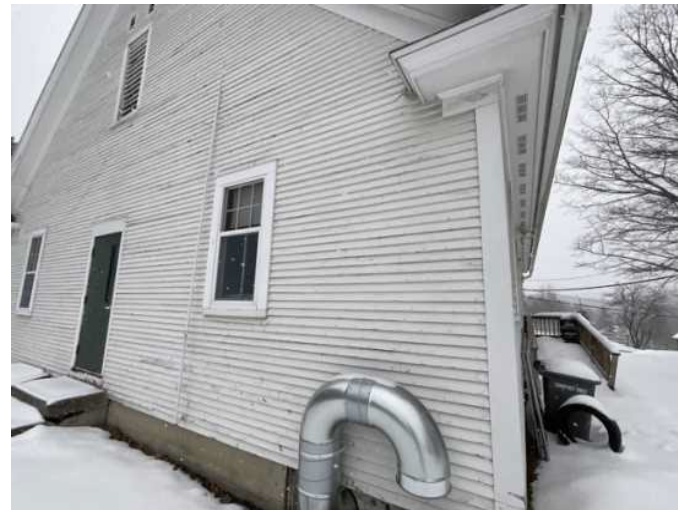
The exterior wood siding of the building was found to be in poor condition. Large areas of the wall siding have become rotted and are deteriorating. Exposure to the elements as well as other issues, poor water shed, and ice damming have also been contributing factors to the degradation of the exterior wall system. The framing assembly in the attic space should be studied to ensure structural integrity. The areas mentioned are showing signs of exterior weather penetration either from roof leaks or moisture related issues.

10 - EXTERIOR WALLS WOOD SIDING
