FACILITY CONDITION ASSESSMENT

158982.22R000-287.379

July 7, 2023

**RUTLAND HIGH SCHOOL - Main Building (PS253-SU034)
22 Stratton Road
Rutland, VT 05701**

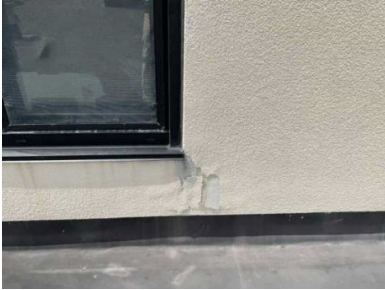
Exterior Walls in Poor condition.

Stucco

isolated areas of exterior wall stucco are damaged and losing integrity. The affected areas should be repaired to reduce the likelihood of damage spreading further throughout the wall system. - AssetCALC ID: 6434616

Recommendation: **Repair in 2023**

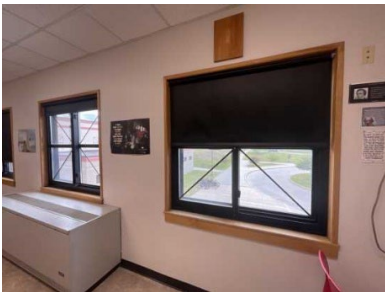
Window in Poor condition.

Aluminum Double-Glazed, 16-25 SF

The windows are becoming aged and antiquated. Seals are becoming compromised, additionally the frames are not insulated. - AssetCALC ID: 6434795

Recommendation: **Replace in 2023**

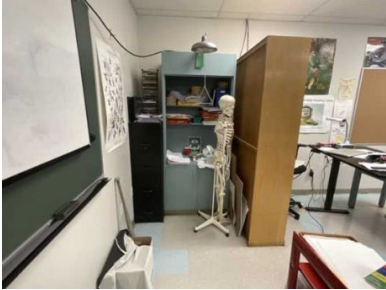
Piping & Valves in Failed condition.

Piping Cast Iron, Sanitary Drainage, 3 IN
RUTLAND HIGH SCHOOL - Main Building Science Rooms

Emergency shower stations have no floor drain or basin. Installation of a drain system is necessary to for proper use of the emergency shower. - AssetCALC ID: 6434710

Recommendation: **Install in 2023**

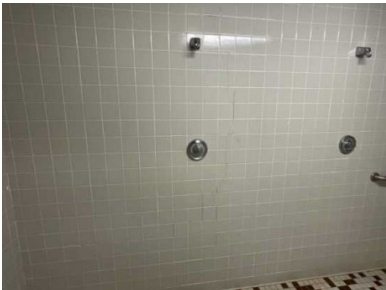
Wall Finishes in Poor condition.

Ceramic Tile

Areas of isolated cracking exist in the tile wall system of shower in locker room. Space seems to be not in use at the moment. - AssetCALC ID: 6434792

Recommendation: **Repair in 2023**

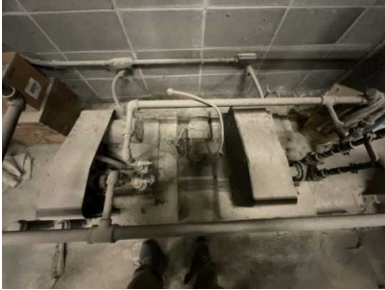
Pump in Poor condition.

Fuel Oil
RUTLAND HIGH SCHOOL - Main Building Mechanical room

Pump system set up very dirty and dusty. Looks to be operating but poorly serviced - AssetCALC ID: 6434820

Uniformat Code: D3010
Recommendation: **Replace in 2023**
Priority Score: **86.9**
Plan Type: Performance/Integrity
Cost Estimate: \$2,600
\$\$\$\$

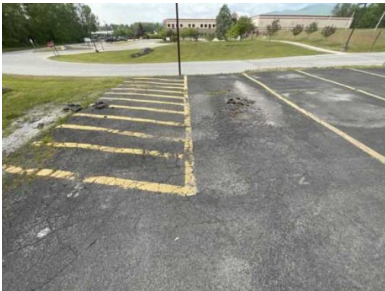
Parking Lots in Poor condition.

Pavement, Asphalt
RUTLAND HIGH SCHOOL - Main Building Site

The asphalt pavement exhibits isolated areas of failure and deterioration, such as alligator cracking, transverse cracking, extensive raveling, and localized depressions. The damaged areas of paving overlaid with new asphalt paving in order to maintain the integrity of the overall pavement system. Milling is recommended as part of the overall repair work. - AssetCALC ID: 6434704

Uniformat Code: G2020
Recommendation: **Repair in 2023**
Priority Score: **84.9**
Plan Type: Performance/Integrity
Cost Estimate: \$38,500
\$\$\$\$

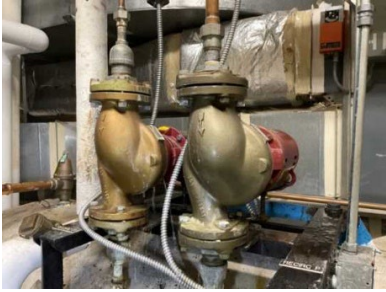
Pump in Failed condition.

Circulation, Domestic Water, 1 HP
RUTLAND HIGH SCHOOL - Main Building Mechanical room

Currently pumps are leaking. Management was unaware - AssetCALC ID: 6434659

Recommendation: **Replace in 2023**

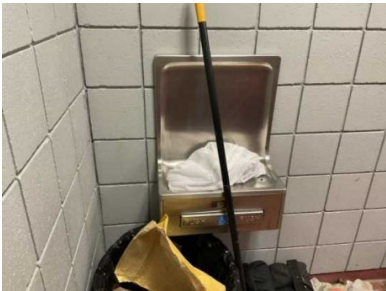
Drinking Fountain in Failed condition.

Wall-Mounted, Single-Level
RUTLAND HIGH SCHOOL - Main Building Locker room

Water fountains non functioning - AssetCALC ID: 6434671

Recommendation: **Replace in 2023**

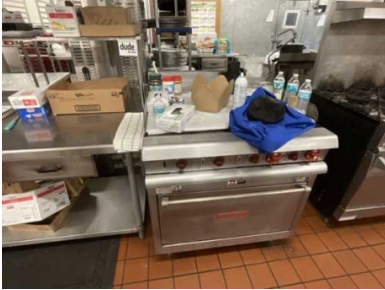
Foodservice Equipment in Failed condition.

Range/Oven, 6-Burner
RUTLAND HIGH SCHOOL - Main Building Kitchen

Appears that this range appliance is not in use - AssetCALC ID: 6434651

Uniformat Code: E1030
Recommendation: **Replace in 2023**
Priority Score: **81.9**
Plan Type: Performance/Integrity
Cost Estimate: \$6,000

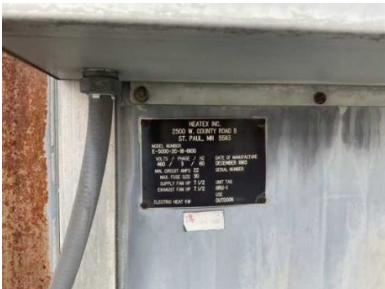
Air Ventilator in Poor condition.

Energy Recovery Unit, up to 6500 CFM
RUTLAND HIGH SCHOOL - Main Building Roof

Rusted - AssetCALC ID: 6434601

Uniformat Code: D3020
Recommendation: **Replace in 2023**
Priority Score: **81.9**
Plan Type: Performance/Integrity
Cost Estimate: \$13,000

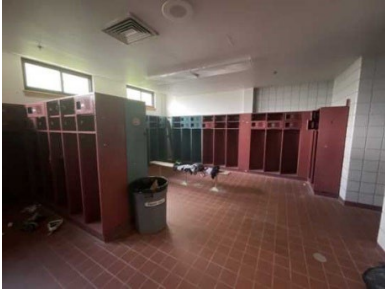
Lockers in Poor condition.

Steel-Baked Enamel, 12" W x 15" D x 72" H
RUTLAND HIGH SCHOOL - Main Building Locker room

Lockers in this specific room were broken and missing doors. A total renovation is needed to use this space as originally intended. - AssetCALC ID: 6434653

Recommendation: **Replace in 2023**
