# FACILITY CONDITION ASSESSMENT

**Vermont Agency of Education\_FCA Phase Two  
1 National Life Drive, Davis 5  
Montpelier, VT 05620-2501**

*September 21, 2023*

**SOUTH BURLINGTON HIGH SCHOOL - Main Building  
(PS272)  
550 Dorset Street  
S Burlington, VT 05403Z**

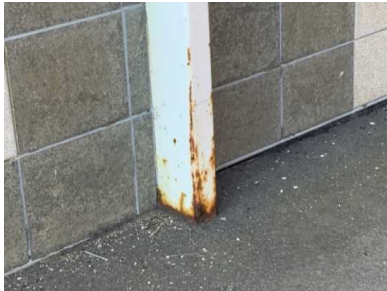
### Balcony Structure in Poor condition.

Vertical Column Steel  
SO BURLINGTON HIGH SCHOOL - Main Building Roof

Columns have split open - AssetCALC ID: 6959014

Uniformat Code: B1010  
Recommendation: **Replace in 2025**  
Priority Score: **88.7**  
Plan Type: Performance/Integrity  
Cost Estimate: \$1,100

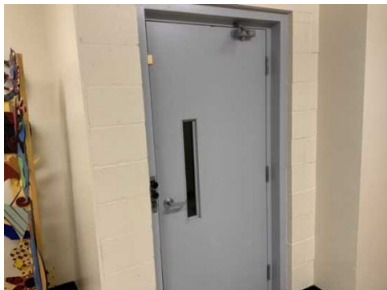
### Vertical Lift in Failed condition.

Wheelchair, 5' Rise  
SO BURLINGTON HIGH SCHOOL - Main Building Locker Room

Out of service. No plans to replace - AssetCALC ID: 6959256

Uniformat Code: D1010  
Recommendation: **Renovate in 2023**  
Priority Score: **85.9**  
Plan Type: Performance/Integrity  
Cost Estimate: \$17,000

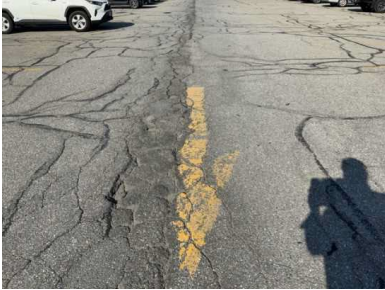
**Parking Lots in Poor condition.**

Pavement, Asphalt  
SO BURLINGTON HIGH SCHOOL - Main Building Site

Only half of lot - AssetCALC ID: 6966339

Uniformat Code: G2020  
Recommendation: **Seal & Stripe in 2023**  
Priority Score: **84.9**  
Plan Type: Performance/Integrity  
Cost Estimate: \$22,800  
**\$\$\$\$**

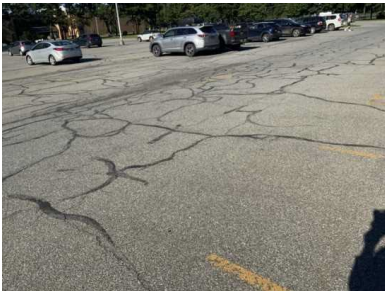
**Parking Lots in Poor condition.**

Pavement, Asphalt  
SO BURLINGTON HIGH SCHOOL - Main Building Site

Only half of lot - AssetCALC ID: 6959136

Uniformat Code: G2020  
Recommendation: **Mill & Overlay in 2024**  
Priority Score: **84.8**  
Plan Type: Performance/Integrity  
Cost Estimate: \$177,500  
**\$\$\$\$**

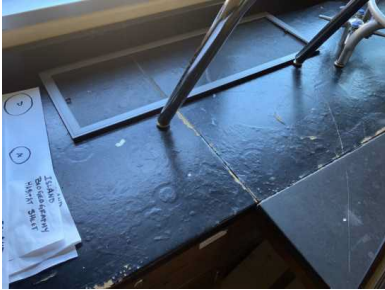
## Casework in Poor condition.

Countertop, Plastic Laminate  
SO BURLINGTON HIGH SCHOOL - Main Building Classrooms

Some areas infilled with non-epoxy tops and damaged - AssetCALC ID: 6959289

Recommendation: **Replace in 2024**

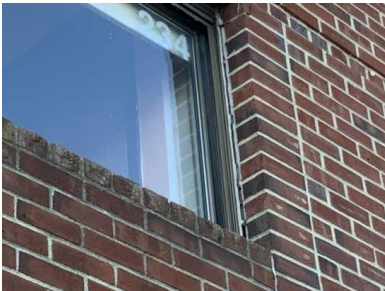
## Caulking in Poor condition.

Cold Joints, 0" to 1/2"

Pulled away from brick, gaps - AssetCALC ID: 6959208

Recommendation: **Replace in 2023**

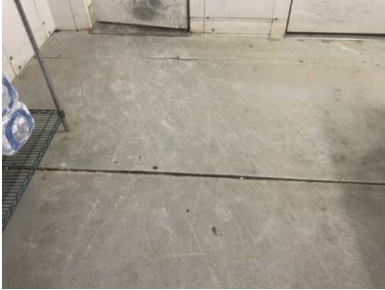
## Foodservice Equipment in Poor condition.

Walk-In, Refrigerator  
SO BURLINGTON HIGH SCHOOL - Main Building Kitchen

Floor bad near door - AssetCALC ID: 6958973

Uniformat Code: E1030  
Recommendation: **Replace in 2023**  
Priority Score: **81.9**  
Plan Type: Performance/Integrity  
Cost Estimate: \$15,000

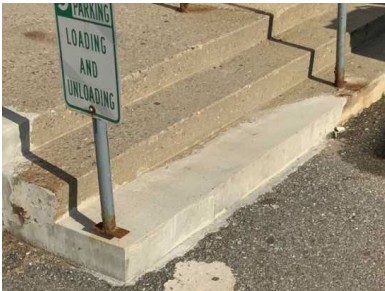
## Stair/Ramp Rails in Poor condition.

Metal  
SO BURLINGTON HIGH SCHOOL - Main Building Site

When repaired was not anchored to steps - AssetCALC ID: 6959262

Uniformat Code: B1080  
Recommendation: **Repair/Install in 2023**  
Priority Score: **81.9**  
Plan Type: Performance/Integrity  
Cost Estimate: \$600

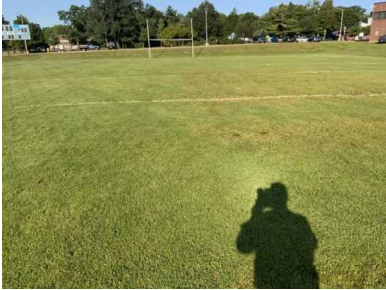
### Landscaping in Poor condition.

Turf/Sod  
SO BURLINGTON HIGH SCHOOL - Main Building Site

Areas are wet, crown is gone - AssetCALC ID: 6960809

Uniformat Code: G2080  
Recommendation: **Replace/Install in 2025**  
Priority Score: **81.7**  
Plan Type: Performance/Integrity  
Cost Estimate: \$60,000  
**\$\$\$\$**

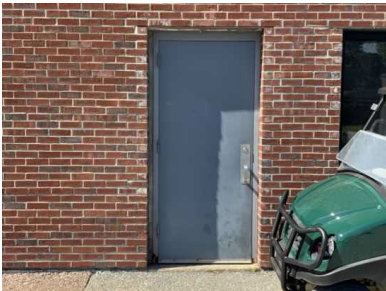
### Exterior Door in Poor condition.

Steel, Standard  
SO BURLINGTON HIGH SCHOOL - Main Building - Building Exterior

Many are rusted at bottom and in frames - AssetCALC ID: 6958991

Uniformat Code: B2050  
Recommendation: **Replace in 2025**  
Priority Score: **81.7**  
Plan Type: Performance/Integrity  
Cost Estimate: \$17,400  
**\$\$\$\$**

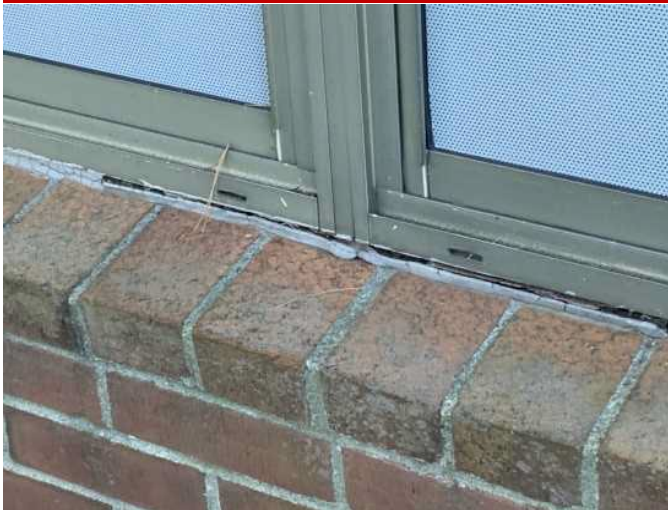
7 - WINDOW CAULKING PULL AWAY

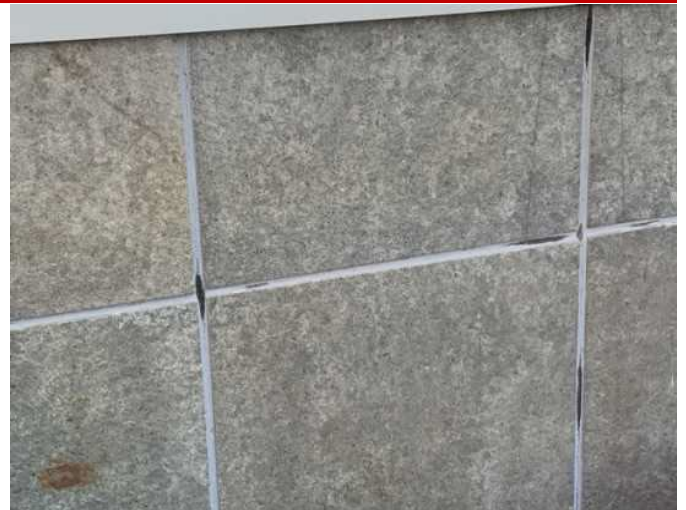
8 - EXTERIOR WALL CAULKING FAILURES

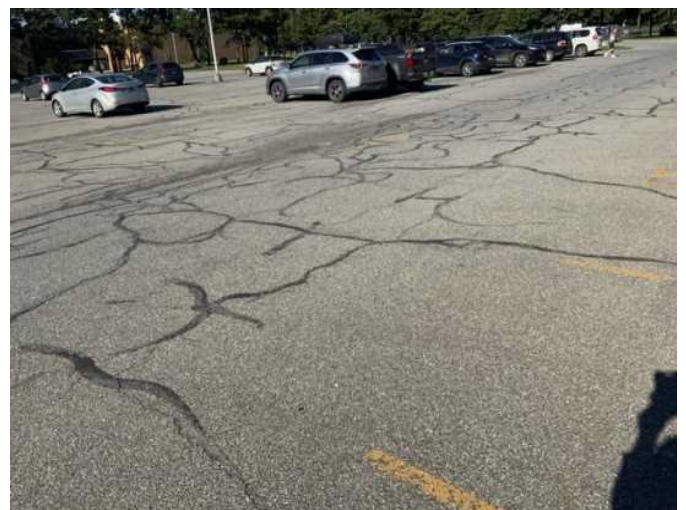
The north parking lot that is shared with the middle school is failing and needs a mill and overlay. The school district is working on a storm water compliance plan that may locate tanks under this parking lot. The road around the building has failed. The south and east parking lots require crack fill, sealcoating, and striping. The Practice field lost the crown and did not drain, the baseball diamonds need to have the infield rejuvenated. The stadium lights need to be upgraded to LED. The exterior lights on the buildings should have the LED replacement completed. The only field that has partial irrigation is the area North of the stadium bleachers towards the baseball diamond east of the middle school. The stadium, ticket booth and restroom buildings are all new since 2011 and in good condition.

30 - PARKING LOT BETWEEN SCHOOLS
