FACILITY CONDITION ASSESSMENT

**Vermont Agency of Education_FCA Phase Two
1 National Life Drive, Davis 5
Montpelier, VT 05620-2501**

May 21, 2023

**ARLINGTON MEMORIAL HIGH SCHOOL - Main Building (PS011)
529 East Arlington Road
Arlington, VT 05250**

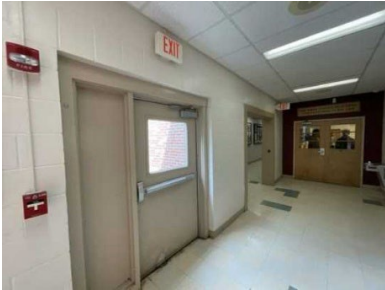
Fire Alarm System in Poor condition.

Fire Alarm Panel and System beyond recommended EUL - AssetCALC ID: 6070373

Recommendation: **Install in 2023**

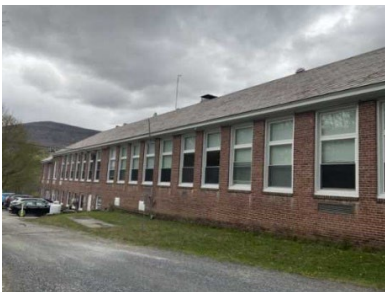
Roofing in Poor condition.

The field of the roofs have isolated areas of topping degradation, physical damage, cracking and missing slate tiles - AssetCALC ID: 6070368

Recommendation: **Replace in 2023**

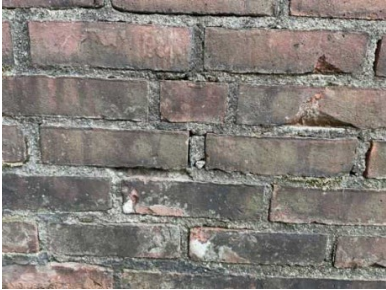
Exterior Walls in Poor condition.

Significant deterioration of exterior brick walls. Localized areas of missing mortar between brick and at sills. This needs to be repaired to maintain overall integrity of the exterior wall system. - AssetCALC ID: 6070329

Uniformat Code: B2010
Recommendation: **Repair/Repoint in 2023**
Priority Score: **89.9**
Plan Type: Performance/Integrity
Cost Estimate: \$165,000

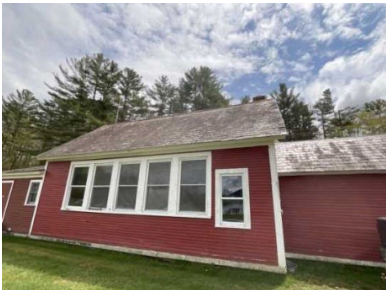
Exterior Walls in Poor condition.

The wood siding has significant areas of dry-rotted, weathered, deteriorated wood siding, wood trim and painted finishes throughout the entire exterior wall system. The damaged materials must be replaced. This structure was an original building on site and was moved to the location it exists at for custodial offices. - AssetCALC ID: 6070415

Uniformat Code: B2010
Recommendation: **Replace in 2023**
Priority Score: **89.9**
Plan Type: Performance/Integrity
Cost Estimate: \$20,000

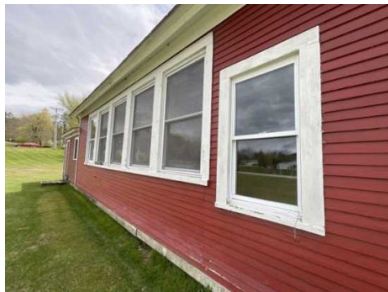
Window in Poor condition.

The windows display significant evidence of deteriorated and weathered window frames. - AssetCALC ID: 6070386

Uniformat Code: B2020
Recommendation: **Replace in 2023**
Priority Score: **87.9**
Plan Type: Performance/Integrity
Cost Estimate: \$11,200

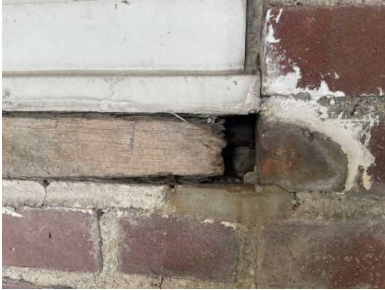
Window in Poor condition.

Extensive gaps exist between window frame and wall components. Sealants and mortar material should be used to properly close gaps for air leakage and water infiltration protection. - AssetCALC ID: 6073713

Uniformat Code: B2020
Recommendation: **Replace in 2023**
Priority Score: **87.9**
Plan Type: Performance/Integrity
Cost Estimate: \$92,800

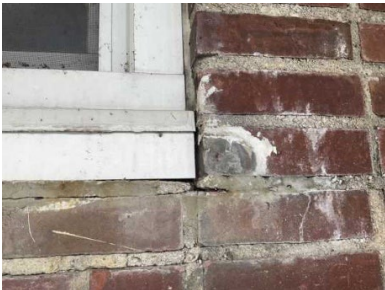
Window in Poor condition.

Extensive gaps exist between window frame and wall components. Sealants and mortar material should be used to properly close gaps for air leakage and water infiltration protection. - AssetCALC ID: 6070361

Uniformat Code: B2020
Recommendation: **Replace in 2023**
Priority Score: **87.9**
Plan Type: Performance/Integrity
Cost Estimate: \$18,000

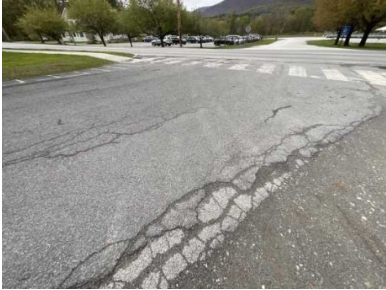
Roadways in Poor condition.

Parking and roadways have isolated areas of localized depressions, alligator cracking and transvers cracking.
 - AssetCALC ID: 6073516

Uniformat Code: G2010
 Recommendation: **Mill & Overlay in 2023**
 Priority Score: **84.9**
 Plan Type: Performance/Integrity
 Cost Estimate: \$58,200

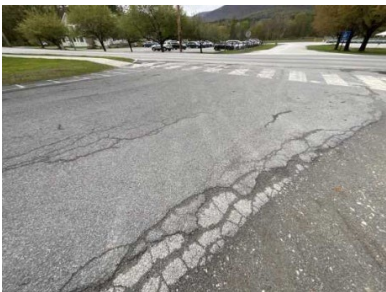
Parking Lots in Poor condition.

Parking and roadways have isolated areas of localized depressions, alligator cracking and transvers cracking.
 - AssetCALC ID: 6073517

Uniformat Code: G2020
 Recommendation: **Seal & Stripe in 2023**
 Priority Score: **84.9**
 Plan Type: Performance/Integrity
 Cost Estimate: \$42,800

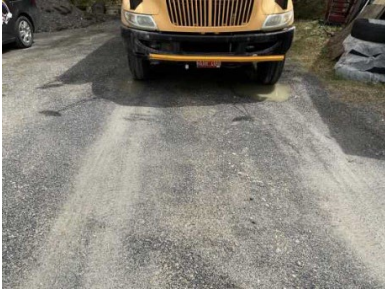
Parking Lots in Poor condition.

Uniformat Code: G2020
 Recommendation: **Replenish in 2023**
 Priority Score: **84.9**
 Plan Type: Performance/Integrity
 Cost Estimate: \$7,000
