FACILITY CONDITION ASSESSMENT

**Vermont Agency of Education_FCA Phase Two
1 National Life Drive, Davis 5
Montpelier, VT 05620-2501**

May 19, 2023

**SO ROYALTON ELEMENTARY - Main Building (PS274-SU067)
223 SOUTH WINDSOR ST
SOUTH ROYALTON , VT 05068**

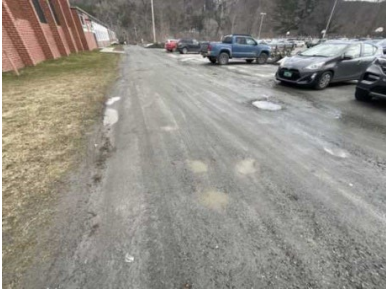
Parking Lots in Poor condition.

Aggregate/Stone, Surface Gravel
SO ROYALTON ELEMENTARY - Main Building Site

Damage and potholes - AssetCALC ID: 5921350

Uniformat Code: G2020
Recommendation: **Replenish in 2023**
Priority Score: **84.9**
Plan Type: Performance/Integrity
Cost Estimate: \$21,700

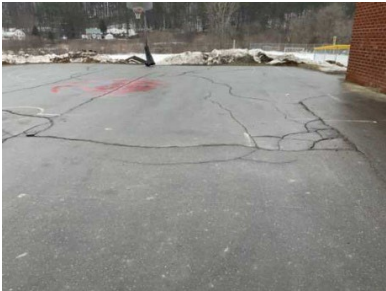
Athletic Surfaces & Courts in Poor condition.

Basketball/General, Asphalt Pavement
SO ROYALTON ELEMENTARY - Main Building Site

Severe cracking - AssetCALC ID: 5921376

Uniformat Code: G2050
Recommendation: **Replace in 2023**
Priority Score: **82.9**
Plan Type: Performance/Integrity
Cost Estimate: \$34,100
