FACILITY CONDITION ASSESSMENT

**Vermont Agency of Education_FCA Phase Two
1 National Life Drive, Davis 5
Montpelier, VT 05620-2501**

May 22, 2023

**DOVER ELEMENTARY SCHOOL - Main Building
9 SCHOOLHOUSE ROAD
EAST DOVER , VT 05351**

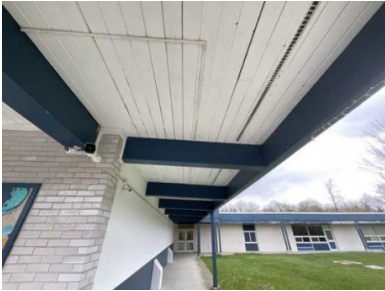
Exterior Walls in Poor condition.

any painted surface

Paint, soffit front of building down right side overhang - AssetCALC ID: 6125459

Recommendation: **Prep & Paint in 2023**

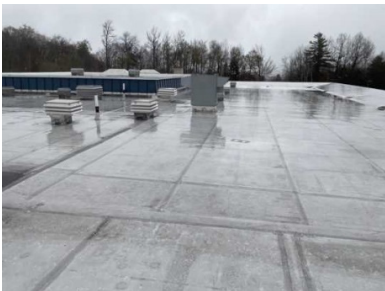
Roofing in Poor condition.

Single-Ply Membrane, TPO/PVC

The roof has passed its estimated useful life - AssetCALC ID: 6125507

Recommendation: **Replace in 2023**

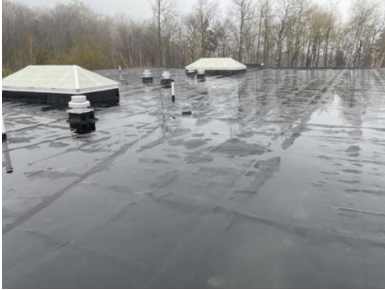
Roofing in Poor condition.

Single-Ply Membrane, EPDM
DOVER ELEMENTARY SCHOOL - Main Building Roof

The roof is past it's estimated useful life, maintenance reports, numerous leaks - AssetCALC ID: 6125535

Uniformat Code: B3010
Recommendation: **Replace in 2023**
Priority Score: **88.9**
Plan Type: Performance/Integrity
Cost Estimate: \$137,500

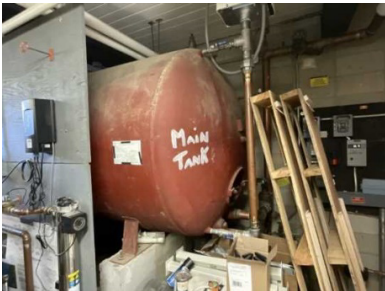
Storage Tank in Poor condition.

Domestic Water
DOVER ELEMENTARY SCHOOL - Main Building Maintenance room 24

Tank has exceeded recommended useful life - AssetCALC ID: 6125551

Uniformat Code: D2010
Recommendation: **Replace in 2023**
Priority Score: **84.9**
Plan Type: Performance/Integrity
Cost Estimate: \$11,000

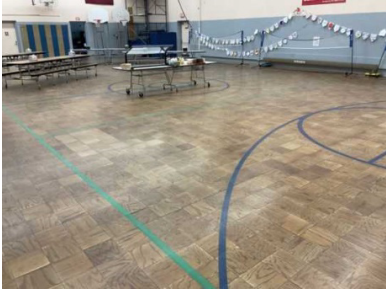
The Gymnasium floor is in poor condition. Asbestos containing building materials were reportedly found under the parquet floor of the gymnasium and around piping elbows in the commercial kitchen. A professional engineer must be retained to analyze the existing condition, provide recommendations and, if necessary, estimate the scope and cost of any required repairs. The cost of this study is included in the cost tables. A budgetary cost allowance to replace the floor is also included.

Flooring in Poor condition.

Parquet floor, w/ Asbestos Abatement
DOVER ELEMENTARY SCHOOL - Main Building Gymnasium

ACBM was reportedly found under Gymnasium floor and around piping elbows in Kitchen. Materials look non-friable. - AssetCALC ID: 6172817

Recommendation: **Replace in 2023**

Recommended Follow-up Study: Environmental, Sample for ACMs

Recommendation: **Evaluate/Report in 2023**
