FACILITY CONDITION ASSESSMENT

**Vermont Agency of Education_FCA Phase Two
1 National Life Drive, Davis 5
Montpelier, VT 05620-2501**

July 6, 2023

**WARDSBORO CENTRAL SCHOOL - Main Building (PS319-U064)
70 School Road
Wardsboro, VT 05355**

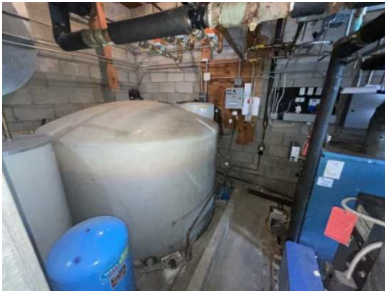
Plumbing System in Poor condition.

Supply & Sanitary, Low Density (excludes fixtures)
 WARDSBORO CENTRAL SCHOOL - Main Building Throughout building

Plumbing system has exceeded recommended useful life - AssetCALC ID: 6682435

Uniformat Code: D2010
 Recommendation: **Replace in 2024**
 Priority Score: **84.8**
 Plan Type: Performance/Integrity
 Cost Estimate: \$45,000

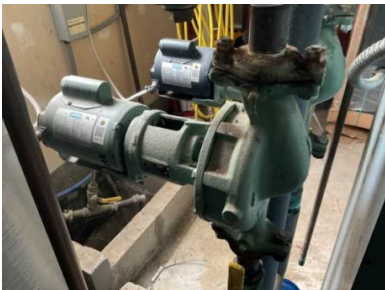
Pump in Poor condition.

Circulation, Domestic Water
 WARDSBORO CENTRAL SCHOOL - Main Building Boiler room

Pump has exceeded useful life - AssetCALC ID: 6682405

Uniformat Code: D2010
 Recommendation: **Replace in 2023**
 Priority Score: **83.9**
 Plan Type: Performance/Integrity
 Cost Estimate: \$5,200

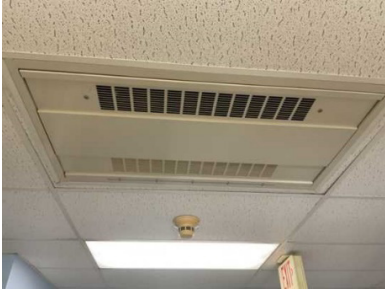
Fan Coil Unit in Poor condition.

Hydronic Terminal, 801 to 1200 CFM
WARDSBORO CENTRAL SCHOOL - Main Building Throughout building

Unit has exceeded recommended useful life - AssetCALC ID: 6682411

Uniformat Code: D3050
Recommendation: **Replace in 2023**
Priority Score: **81.9**
Plan Type: Performance/Integrity
Cost Estimate: \$5,100

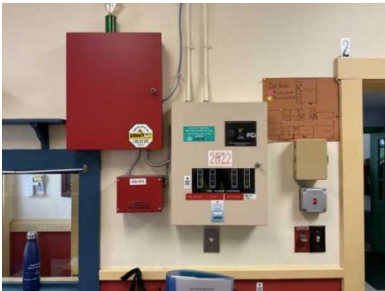
Fire Alarm System in Poor condition.

Full System Upgrade, Standard Addressable
WARDSBORO CENTRAL SCHOOL - Main Building Throughout building

Fire alarm system has passed recommended useful Wilfred - AssetCALC ID: 6682432

Uniformat Code: D7050
Recommendation: **Upgrade/Install in 2023**
Priority Score: **81.9**
Plan Type: Performance/Integrity
Cost Estimate: \$27,000

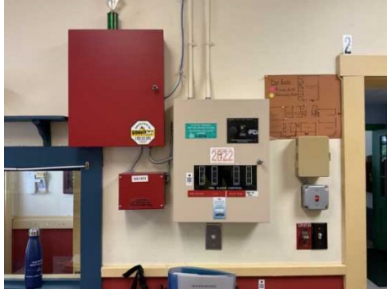
Fire Alarm Panel in Poor condition.

Fully Addressable
WARDSBORO CENTRAL SCHOOL - Main Building Office

Fire alarm system has passed recommended useful Wilfred - AssetCALC ID: 6717588

Uniformat Code: D7050
Recommendation: **Replace in 2023**
Priority Score: **81.9**
Plan Type: Performance/Integrity
Cost Estimate: \$15,000
\$\$\$\$

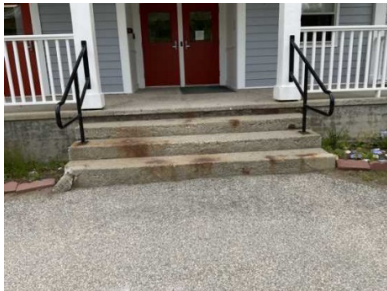
Stairs in Poor condition.

Concrete, Exterior
WARDSBORO CENTRAL SCHOOL - Main Building Site

Stairs are deteriorating with holes on the treads and corners with chips. - AssetCALC ID: 6682385

Uniformat Code: B1080
Recommendation: **Replace in 2023**
Priority Score: **81.9**
Plan Type: Performance/Integrity
Cost Estimate: \$1,700
\$\$\$\$
