TOWN OF SHAFTSBURY

Vermont Better Roads Grant Program Application

Project Name: Drainage Improvements Shaftsbury Hollow Road

Drainage Improvements and Capital Budget for Shaftsbury Hollow Road, Shaftsbury, Vermont

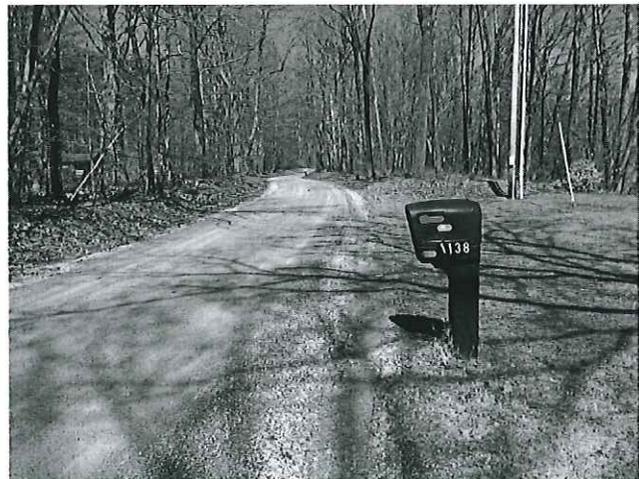
Site Inventory: Section 1

Drainage problems are associated with the erosion of the roadway surface and ditches resulting from little depth or lack of ditching. Adjacent mature trees and stone walls present problems for improving of drainage adjacent to roadway.

Erosion of the roadway occurs as result of no proper ditches along the majority of the road side. Small ditches are present in some places but have been filled in with debris and winter plowing of the road. Runoff entering the ditch/gutter is not directed away from the roadway due to absence of culverts.

Section without proper cross-section elements of crown and ditches.

Shallow to non-existent ditches

Flat crowns and high adjacent causing erosion parallel to alignment

Installation of ditches on west side with seed and mulch.

Construction of cross-culvert to serve ditch.

The construction of proper ditches to drain road base and increase roadway base and crown to increase surface runoff. The ditches are to be vegetated. Installation of a roadway cross-culvert from the west to the east. Outlet of a culvert is problematic due to the grade and surrounding terrain. It will involve work outside of right of way to daylight. A precise design location will need to be determined to reduce impact.

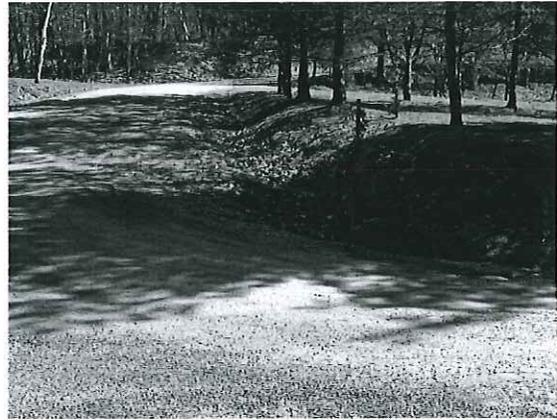
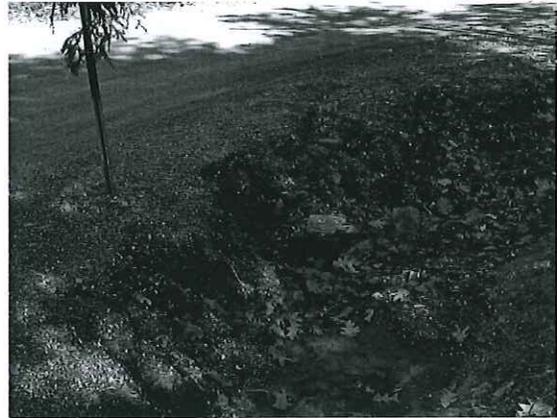
Site Inventory: Section 2 Ditch Erosion and Sedimentation of culvert in R.O.W.

Dwyers Camp Road is a private road that intersects the town road. It is initially steep. The drainage problem consists of ditch erosion/sedimentation that has blocked the cross culvert. The blocked culvert needs to be cleaned to avoid overtopping of the roadway in a storm event.

The instability of the roadway base is generated by the surrounding topography that sheds its surface and groundwater toward the road. The natural areas adjacent to the problem area is well vegetated with little slope.

The ditch erosion is typical for a steep section of roadway

Comments: **Dwyer Camp Road, good private road, with eroding ditches entering Town Road**

Environmental Comments: **Plugging of Town Culvert at intersection has limited its ability to function in periods of high flow.**

**Stabilize the ditches on Dwyer Camp Road with stone fill.
Clean sediment from culvert**

The construction of a stone lined ditch and vegetation of the backslope where eroded on both sides of Dwyer Camp Road from the intersection to the first drive top of the hill (approximately 100').

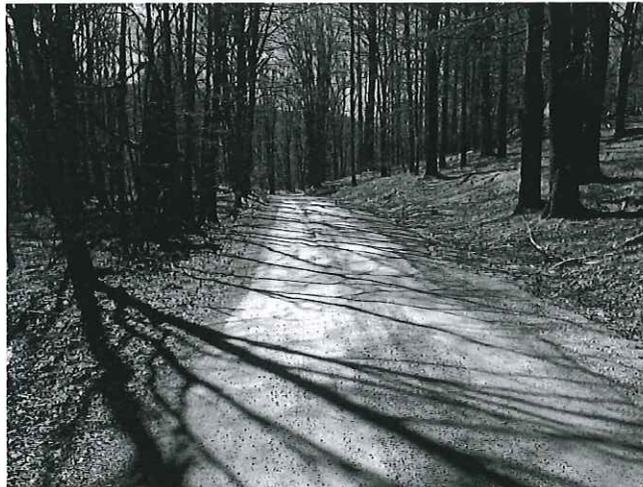
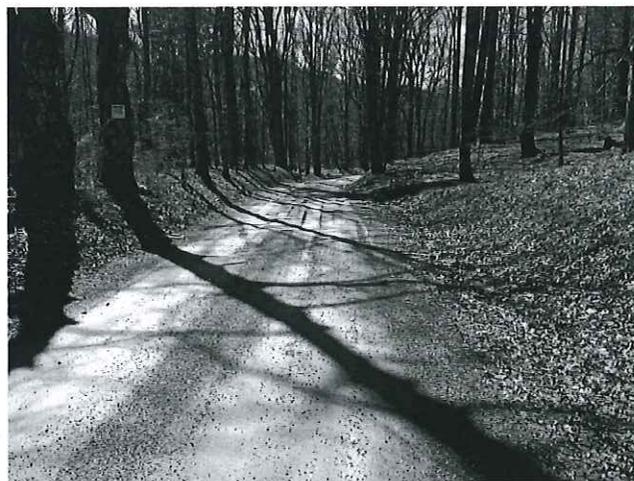
Site Inventory: 4 – Insufficient Ditching and Roadway Drainage

This is a continuation of Section 3 that varies by the increase in slope and some ditching with turn-outs with an existing culvert. There Drainage problems are associated with the erosion of the roadway surface parallel to roadway resulting from little depth or lack of ditching. There are fewer mature trees and no stone walls as with Section 3.

Erosion of the roadway occurs as result of no proper ditches along the majority of the road side. Small ditches are present in some places but have been filled in with debris and winter plowing of the road. Runoff entering the ditch/gutter is not directed away from the roadway due to absence of culverts where the roadway is flat. Grades are very flat. The west/uphill side of the road is a moderately steep hillside that drains directly to the roadway.

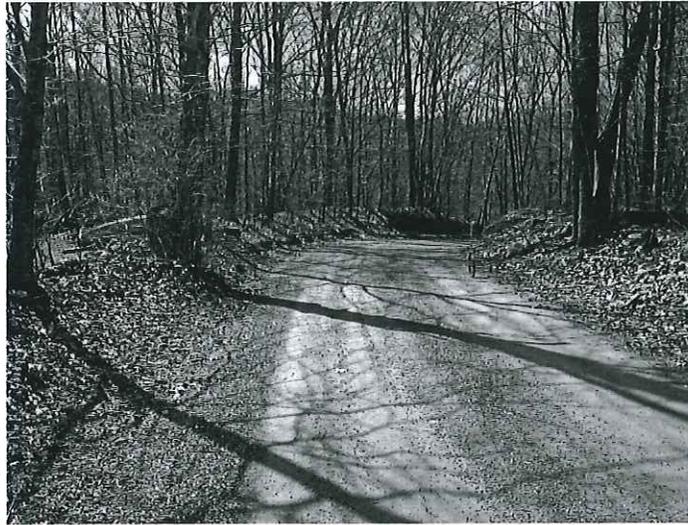
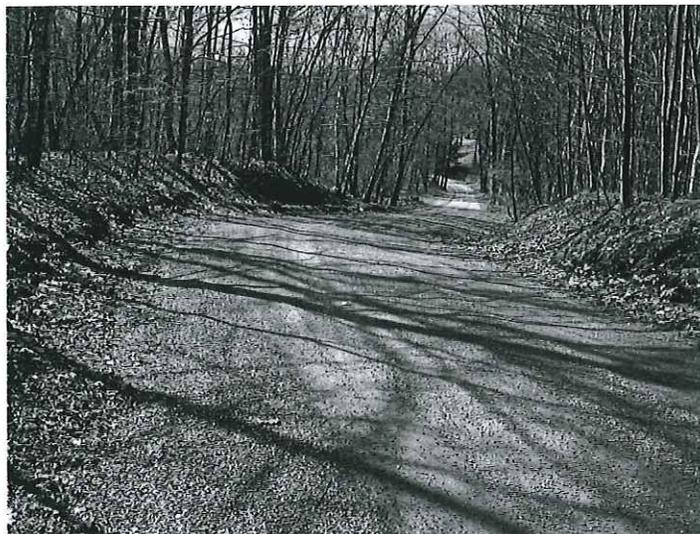
Site Inventory: Section 5 – Insufficient Road Drainage

Erosion of the roadway occurs as result of no proper ditches along the majority of the road side. Small ditches are present in some places but have been filled in with debris and winter plowing of the road. Runoff entering the ditch/gutter is not directed away from the roadway due to absence of culverts where the roadway is flat.

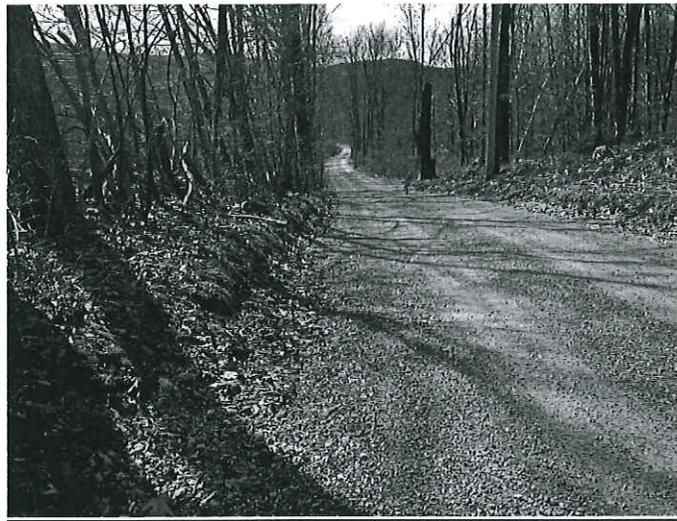
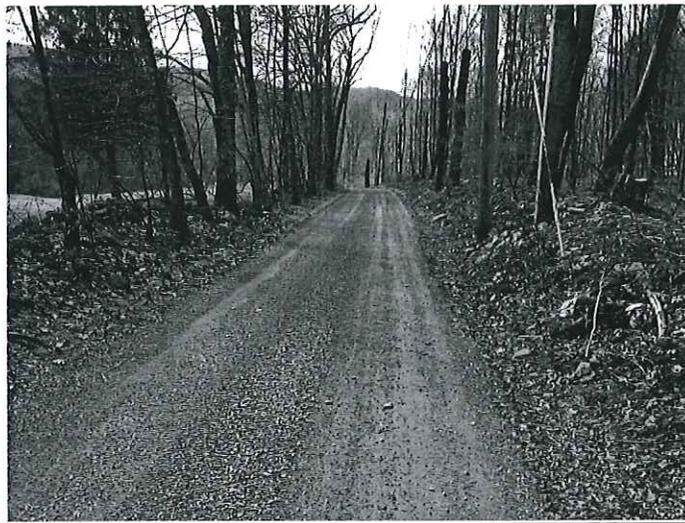
Site Inventory: Section 6 – Insufficient Roadway Drainage

Erosion of the roadway occurs as result of no proper ditches along the majority of the road. Small ditches are present in some places but have been filled in with debris and winter plowing of the road. Runoff entering the ditch/gutter is not directed away from the roadway due to absence of culverts where the roadway is flat. Grades are flat to 5%. This section terminates at the 60” metal culvert and Little White Creek.
