STATE OF VERMONT  
AGENCY OF TRANSPORTATION

Scoping Report

FOR  
Wardsboro BF 013-1(22)  
VT ROUTE 100, BRIDGE 73 OVER UNNAMED BROOK

July 30, 2013

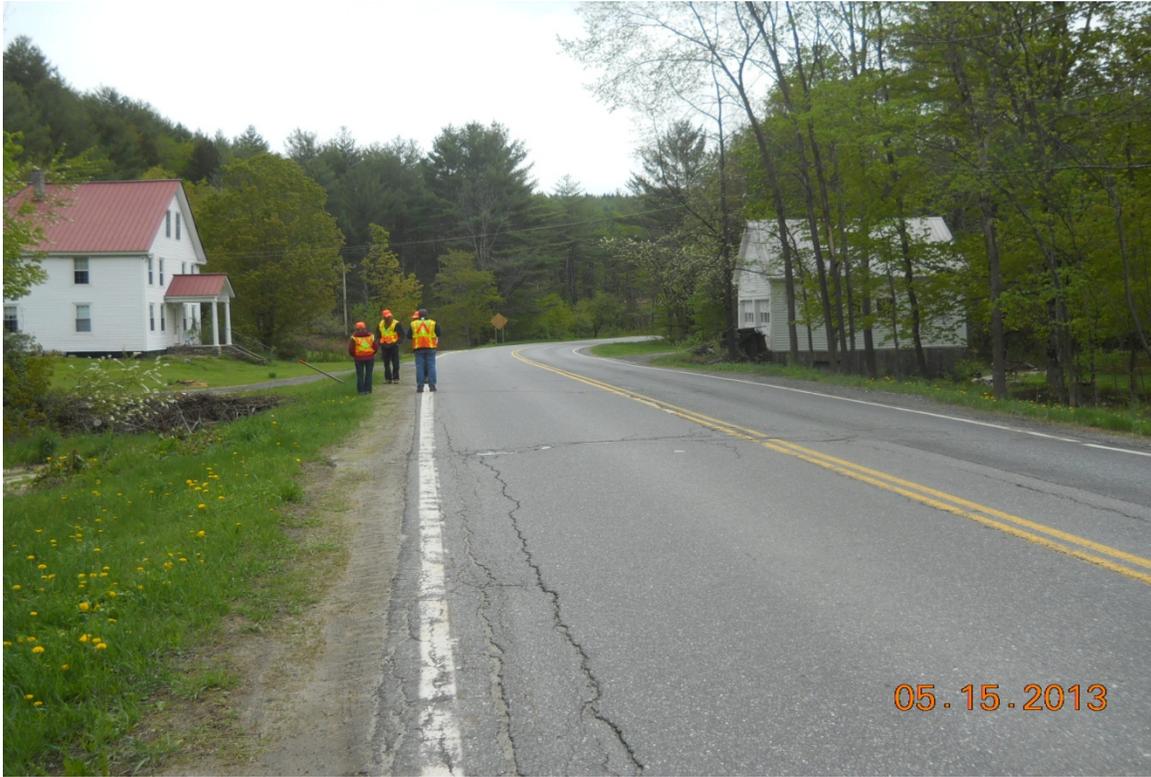
Looking East over the culvert

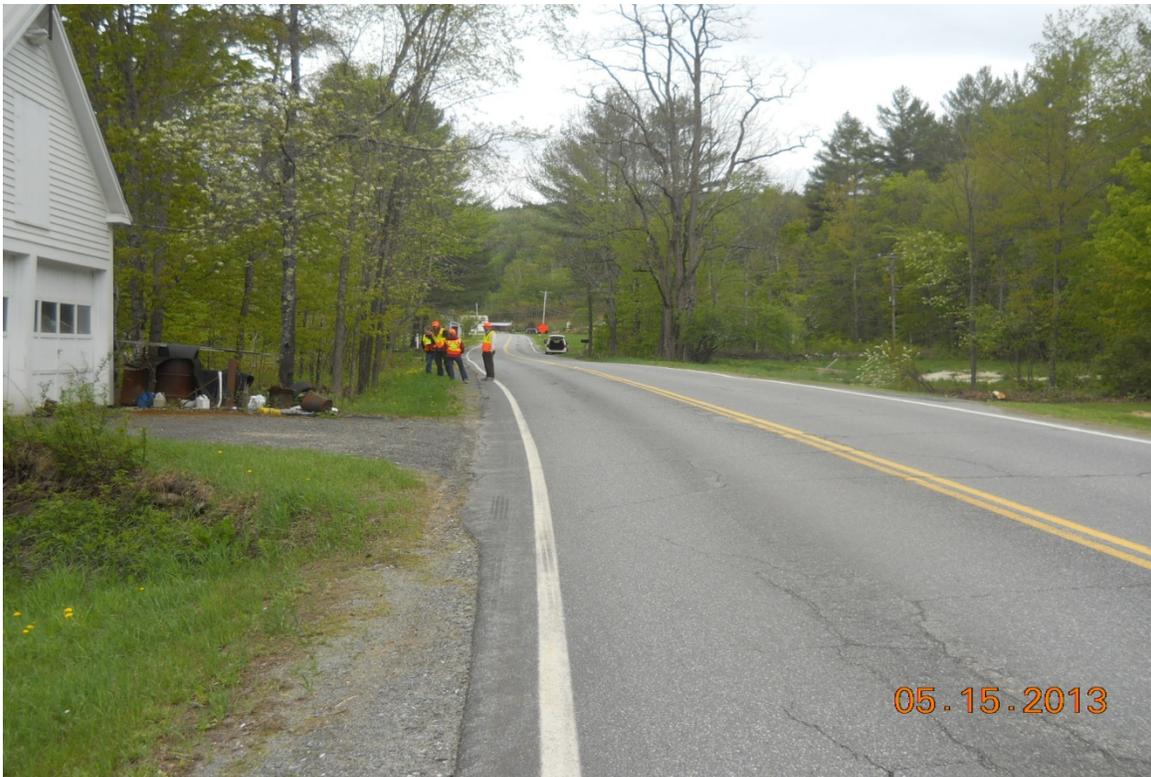
Looking West over the culvert

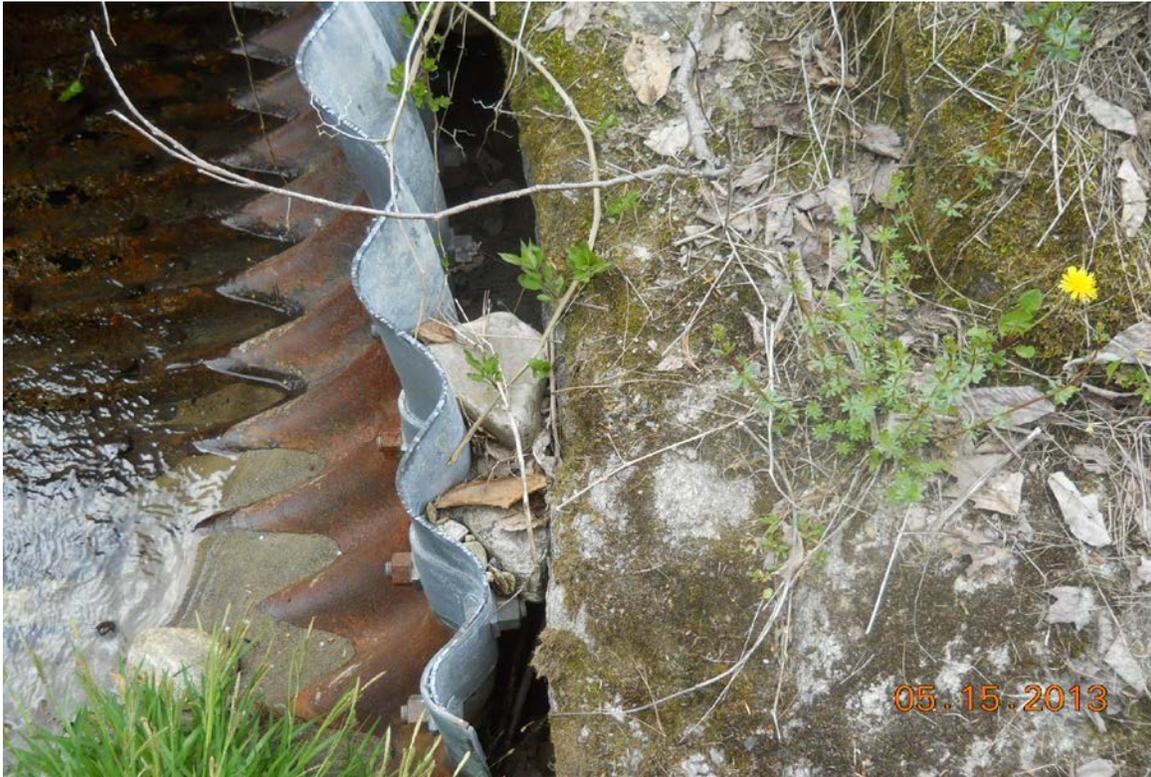
Culvert Inlet (Note that water is able to seep in around pipe due to lack of a cutoff wall)

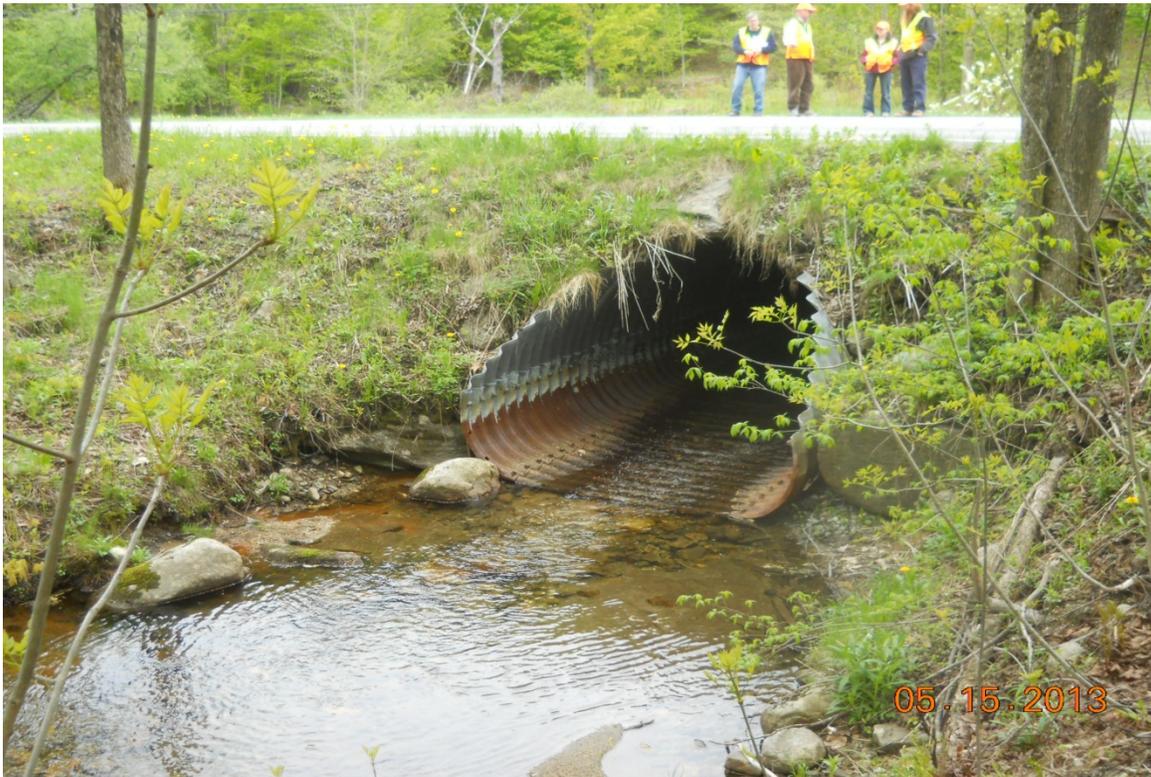
Culvert Outlet
