**STATE OF VERMONT  
AGENCY OF TRANSPORTATION**

**Scoping Report  
FOR  
Cavendish BO 1442(38)**

**TOWN HIGHWAY 1, BRIDGE 58 OVER THE BLACK RIVER**

March 31, 2015

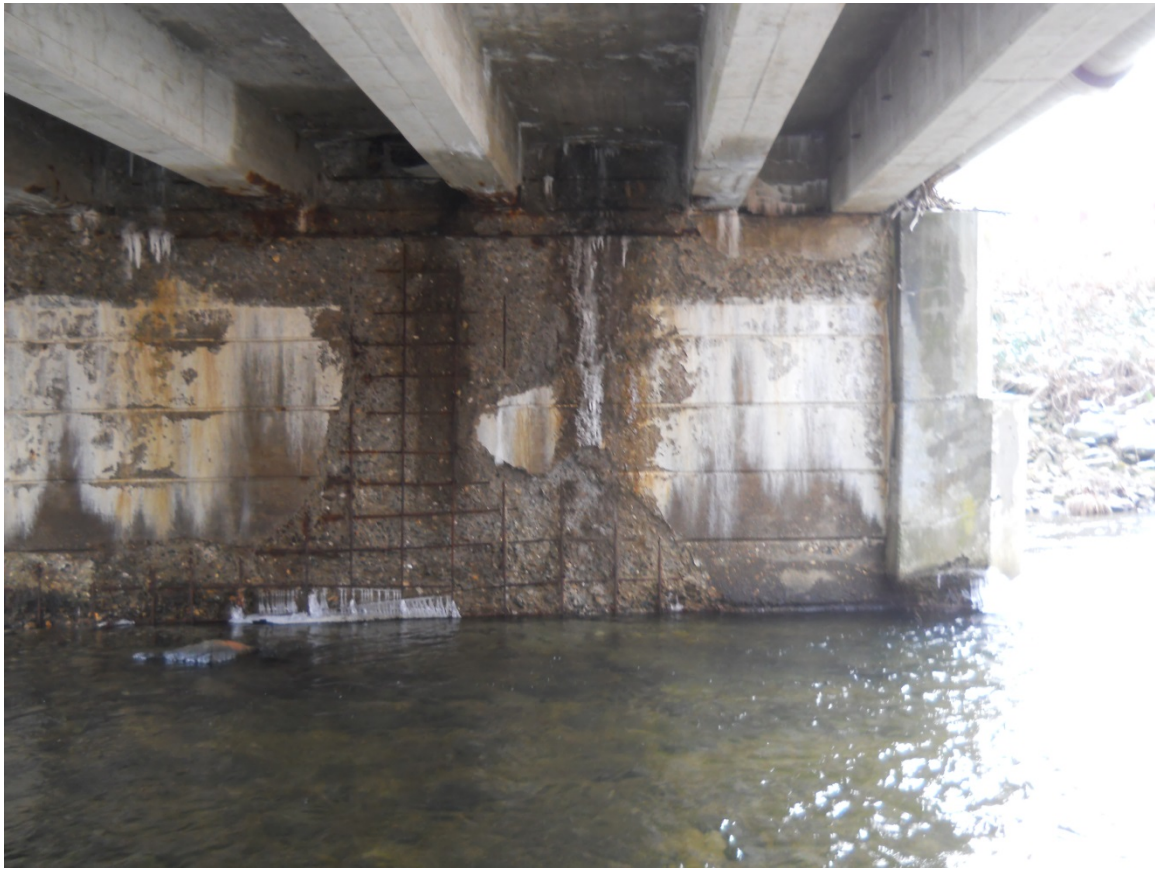
7/18/2011 – The deck was patched at abutment 2 and at the pier. The tee beams are in poor condition. The pier is in poor condition. The bridge should be replaced in the near future.  
~DCP/FRE

Substructure (Pier) deterioration

4/16/2012 – Beams should be cleaned and patched along with the bridge seat areas. Backwall on abutment #1 should be cleaned and patched. Debris on the upstream side of the pier and on the top should be clean out. ~FRE/DCP

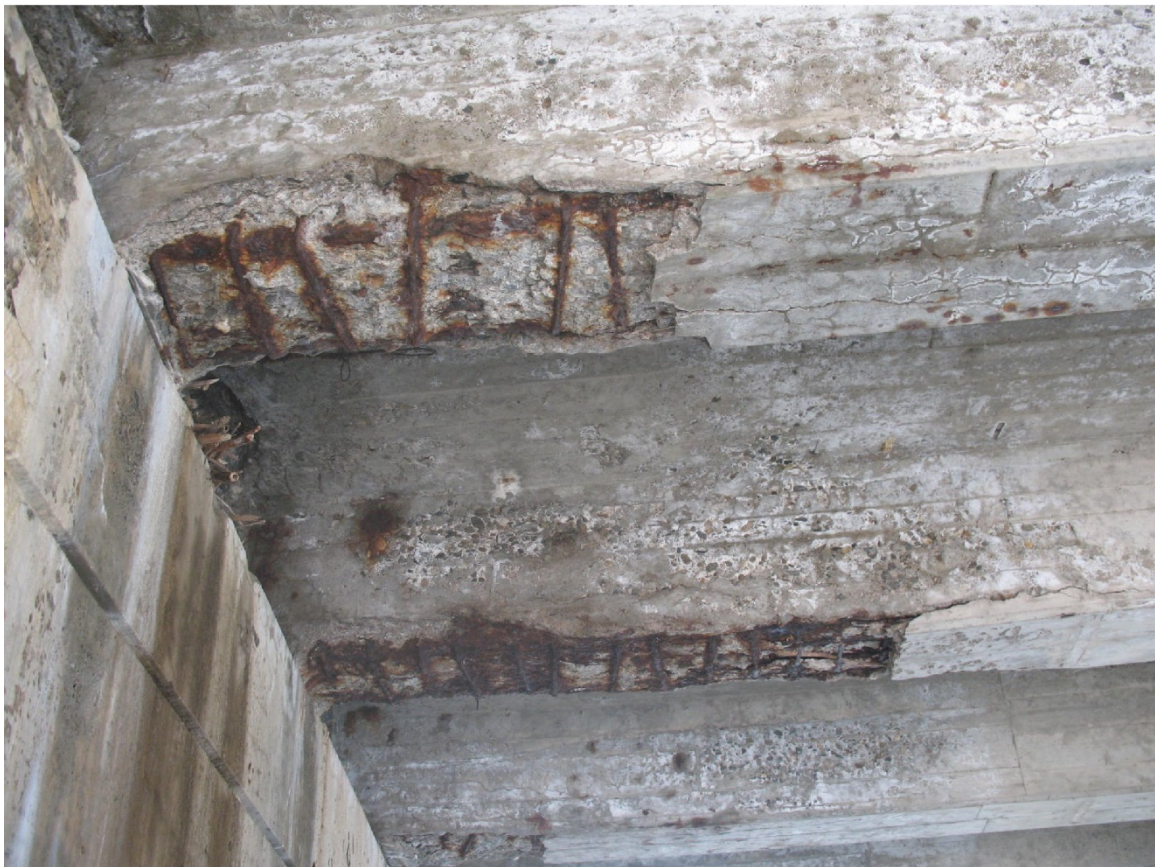
1. Bridge 58 is considered structurally deficient, with all bridge components rated as Poor. The existing T-beams, backwalls, and abutments have a significant amount of exposed rebar and are deteriorating at a rapid rate. Full depth holes have needed patching in the past, and full depth holes are possible in the future.
2. The bridge railing does not meet crash test standards.
3. There is a substandard sharp horizontal curve after the bridge.

T-Beam deterioration.

This alternative would address all of the existing deficiencies at the river crossing with a new structure designed to last another 80+ years. A rehabilitation option was not evaluated for this bridge because of the poor condition of all bridge components. The substructure has large areas of fully exposed reinforcing steel and spalling concrete, and it would not make economic sense to repair.

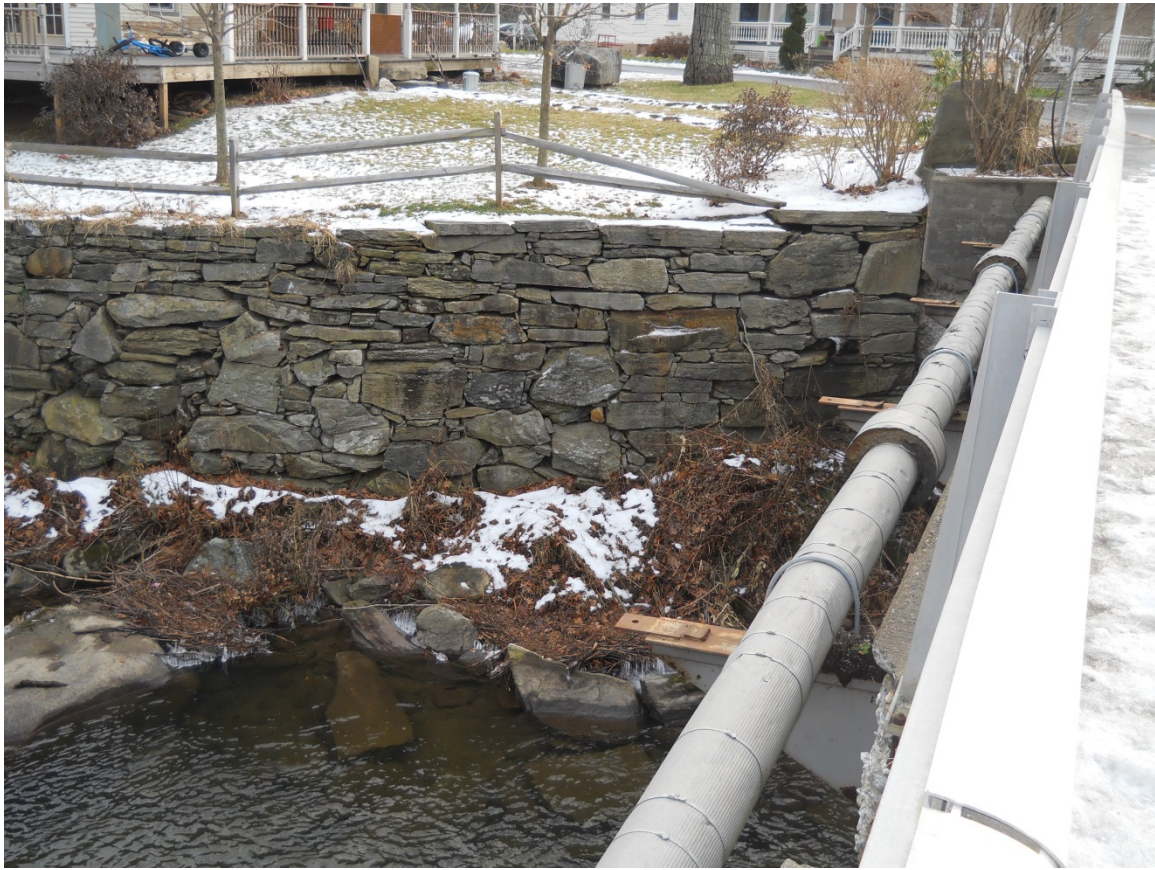
There are historic properties at the NE and NW quadrants of the bridge. The NE and SE wingwalls are part of long stone walls, which are contributing features to the historic district. Concerns for historic review will include takes from historic properties, proposed railing replacement, and elements of design such as bridge width.

Historic wall at wingwall 2

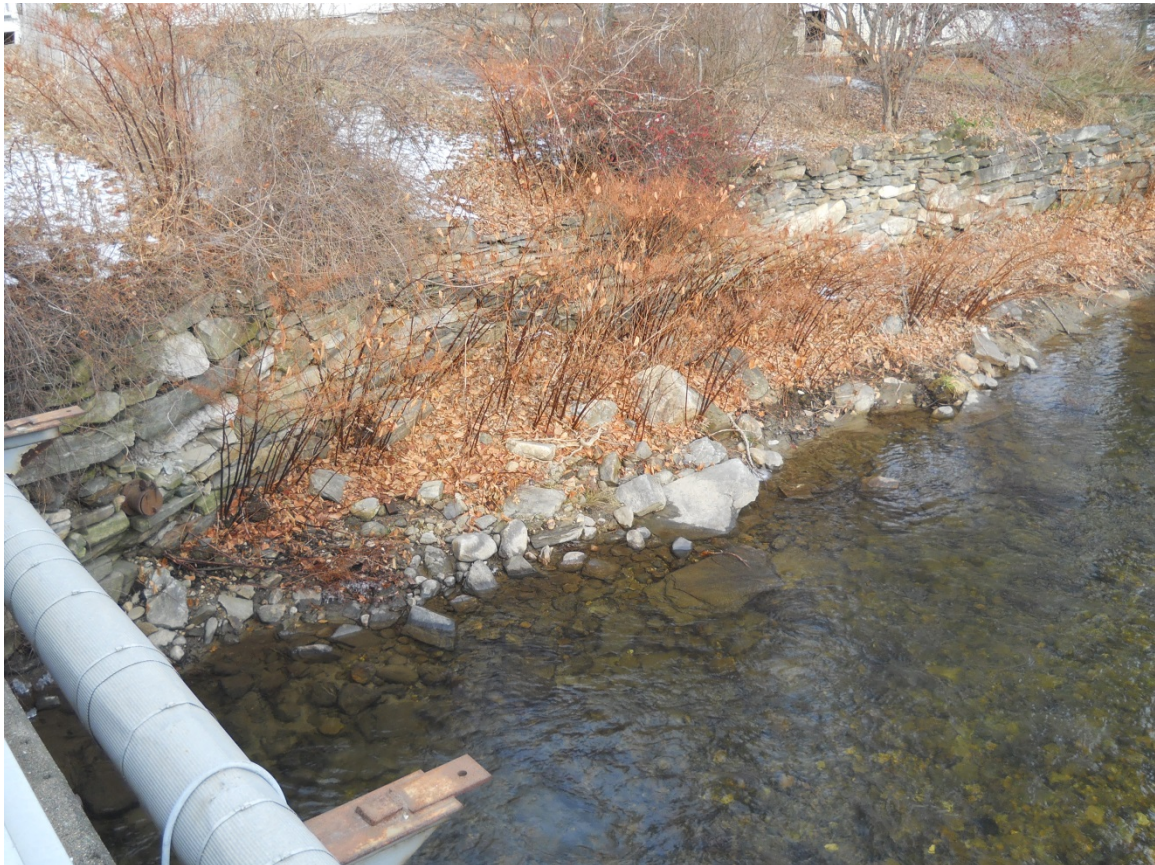
Historic wall at wingwall 4
