STATE OF VERMONT
AGENCY OF TRANSPORTATION

Scoping Report

Colchester IM 089-3(69)
I-89 Bridges 76 N&S over Bay Rd (TH 1) and
I-89 Bridges 77 N&S over Mallett's Creek

January 16, 2015

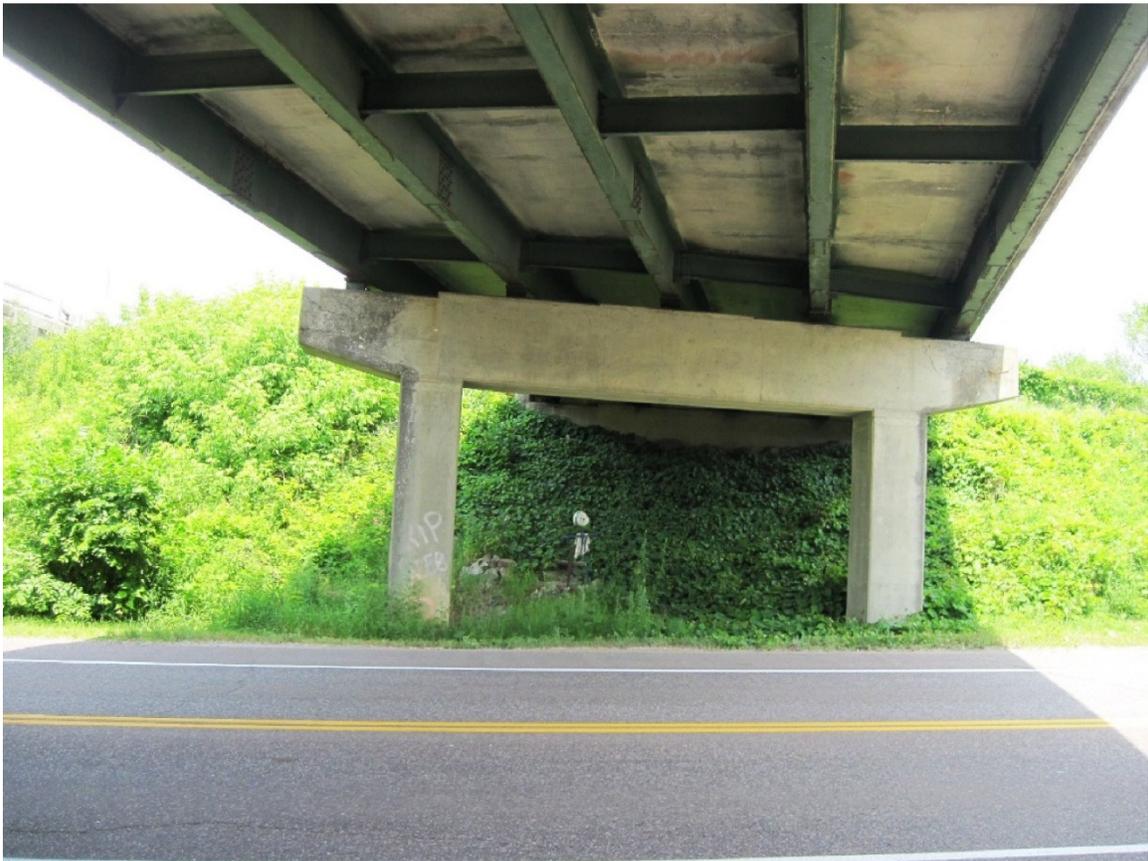
Bridge 76 N: 06/12/2014 - Bridge deck has advancing deterioration and needs to be programmed for replacement within the next 10 years. Sliding plate joint leaks heavily at the southern abutment and is causing deterioration along the steel superstructure and substructure. Plate joint is secure for now, but consider removing completely, as it may come loose again before the deck is replaced. South abutment bearing seat and the northern pier cap needs some concrete repair work. Standard heavy guard rail along the outside of the corner to protect the northern pier columns from impact is needed. ~ MJ/JS

Deck Deterioration Bridge 76N

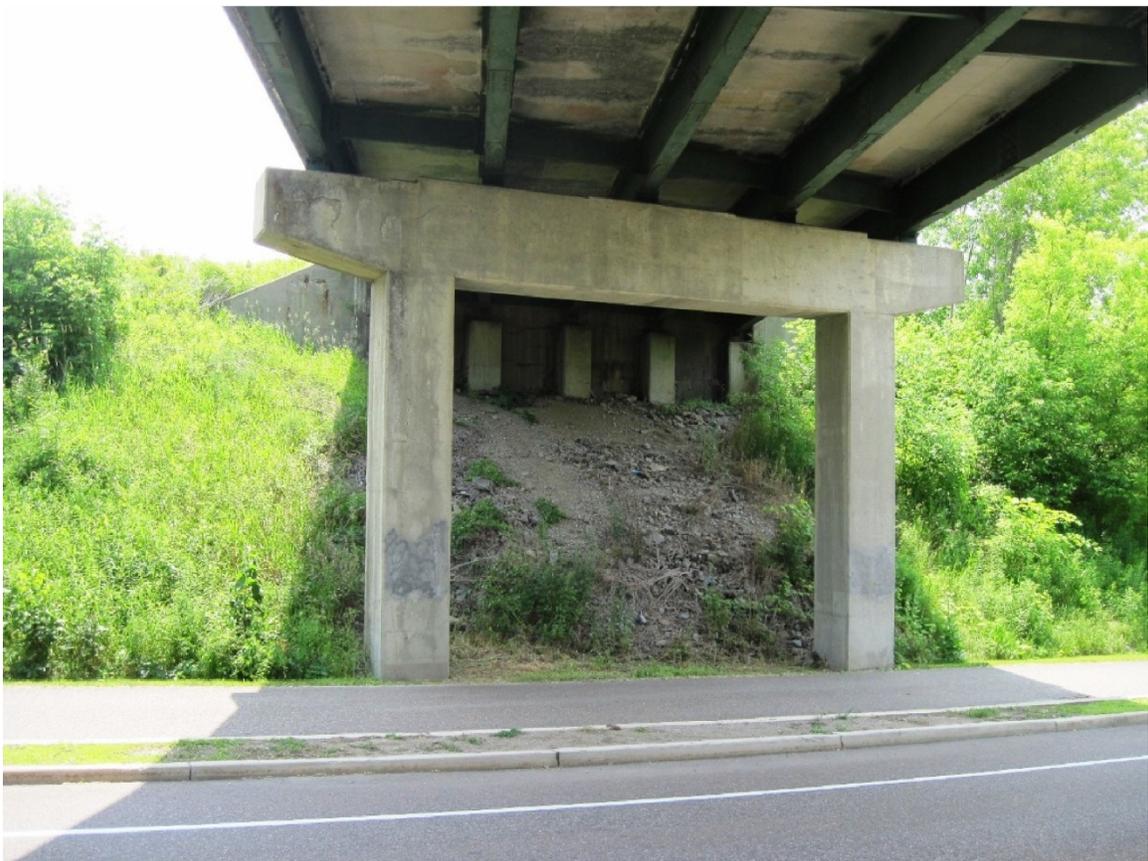
Bridge 76 S: 06/12/2014 - Bridge deck has advancing deterioration and needs to be programmed for replacement within the next 10 years. Sliding plate joint leaks heavily at the southern abutment and is causing deterioration along the steel superstructure and substructure. Standard heavy guard rail along the outside of the corner to protect the northern pier columns from impact is needed. ~ MJ/JS

Deck and Pier Deterioration Bridge 76S

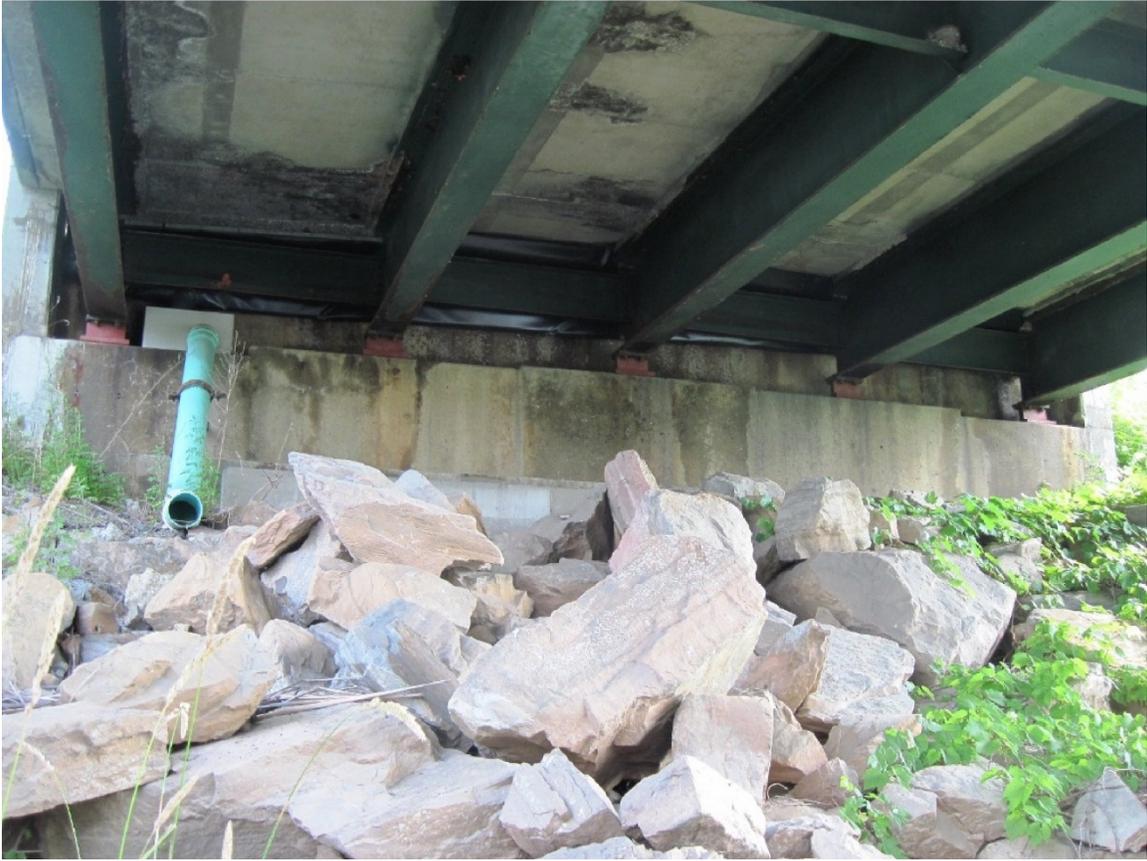
Deck Deterioration Bridge 77N

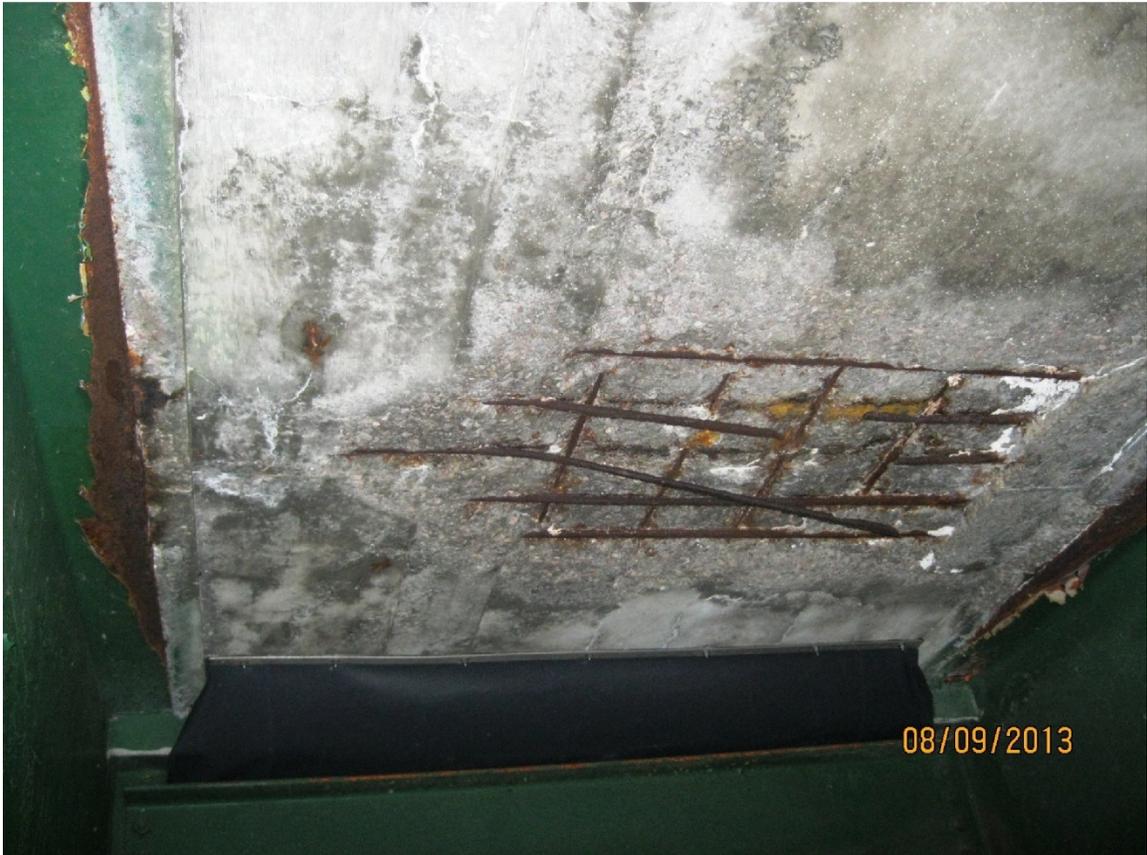
Deck Deterioration Bridge 77S

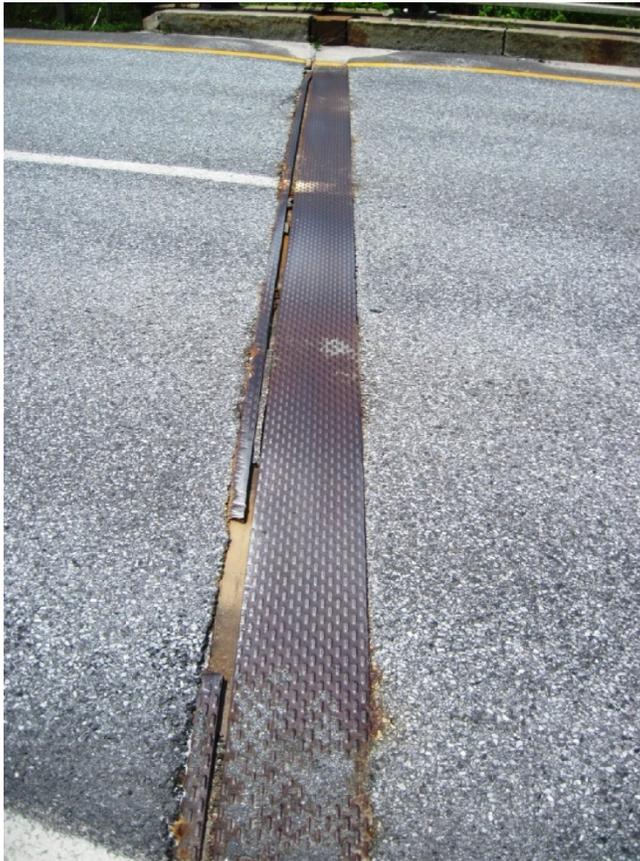
Broken Vermont Joint Bridge 76N

Any bridge seat repairs and substructure patching would be included on both bridges. All of the metallic bridge deck joints would be replaced with flexible joint material. Bearings would be evaluated and replaced as necessary.

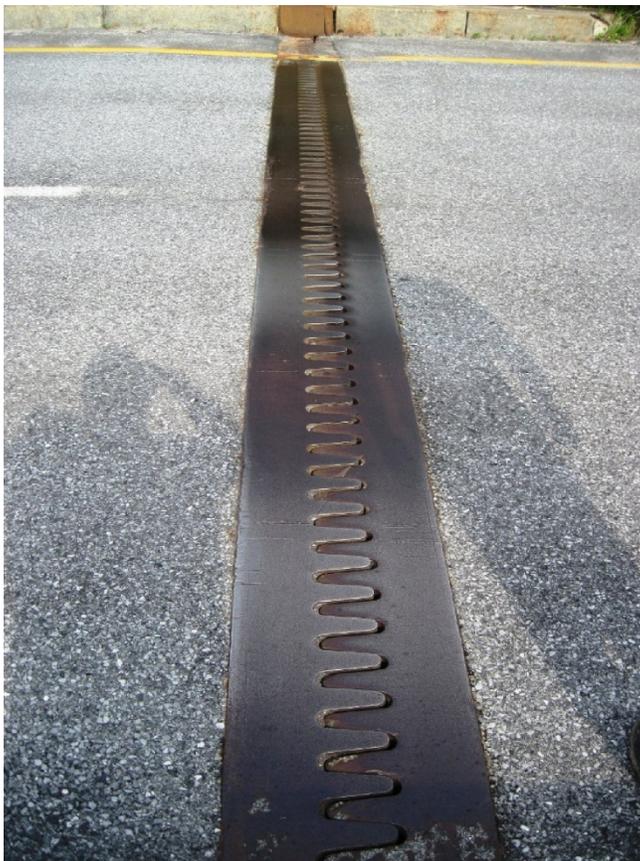
Pinched Finger Plate Joint Bridge 77N

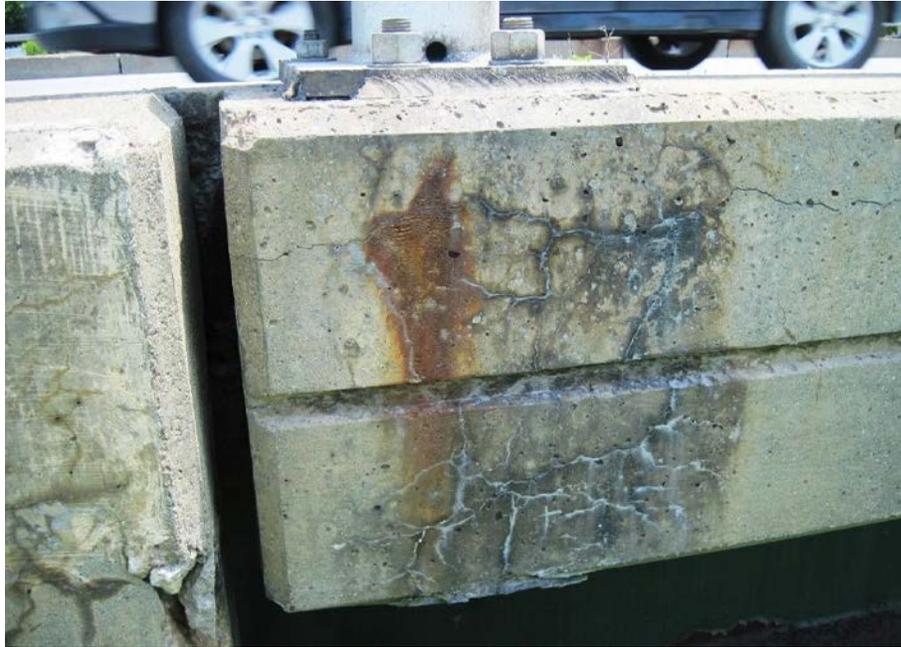
2.4.1 Bridge # 76N: Based on the latest bridge inspection photos for BR # 76N dated June 2012, portions of the concrete have cracked and spalled and the steel beams need cleaning and repainting as seen in Figures 3 and 4.

Figure 3. BR #76N Cracked and Spalled Concrete

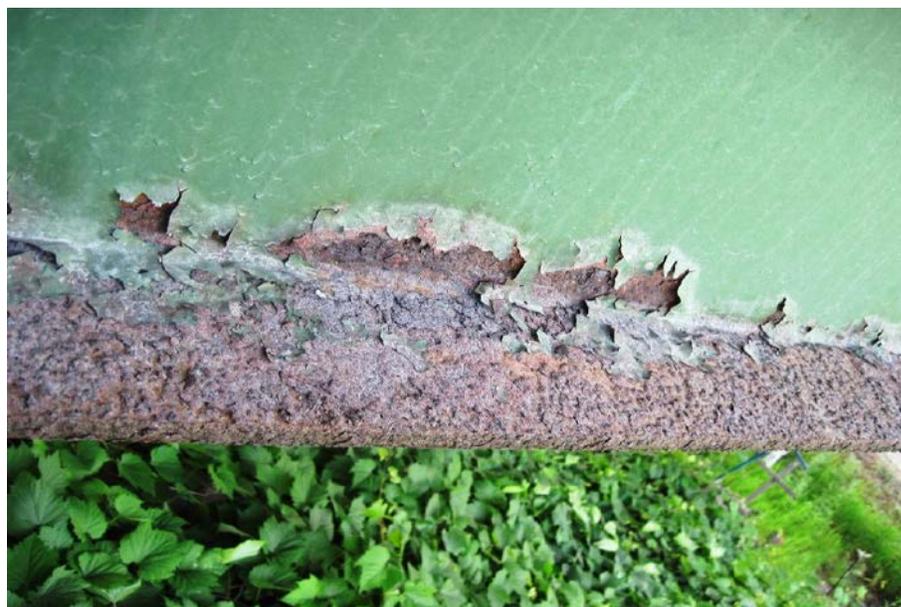
Figure 4. BR #76N Steel Beams Requiring Maintenance

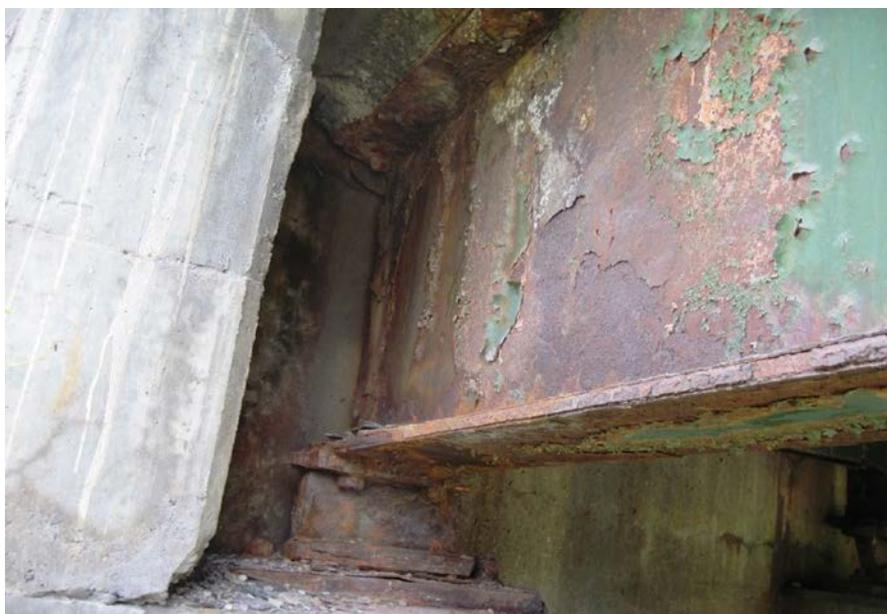
2.4.2 Bridge # 76S: Based on the latest bridge inspection photos for BR # 76S dated June 2012, large portions of the steel beams require similar maintenance as BR #76N, as seen in Figure 5. In addition to the beams, the bearings for both bridges have shifted and deteriorated. Figure 6 shows a deteriorated bearing from BR #76N as well as spalled concrete with exposed rebar.

Figure 5. BR #76S Steel Beams Requiring Maintenance

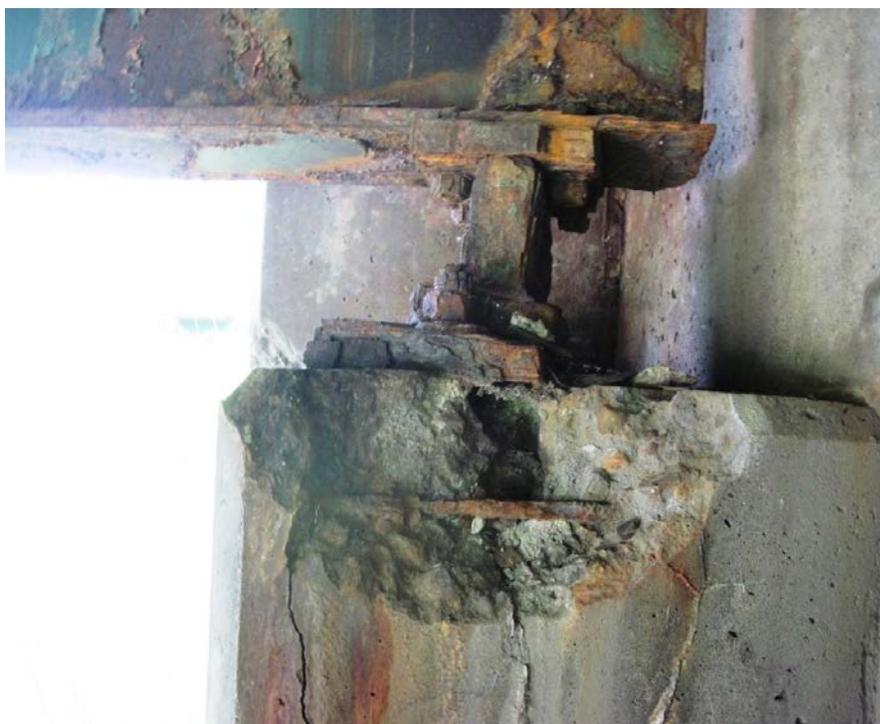
Figure 6. BR #76S Deteriorated and Shifted Bearing with Spalled Concrete

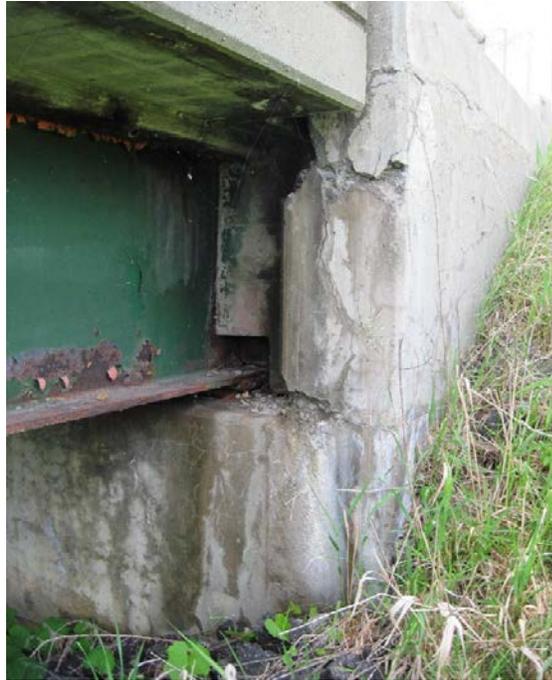
2.4.3 Bridge #77 N: Based on the latest bridge inspection photos for BR # 77N dated June 2012, similar concrete spalling and beam corrosion was evident as seen in Figure 7.

Figure 7. Concrete Spalling and Beam Corrosion

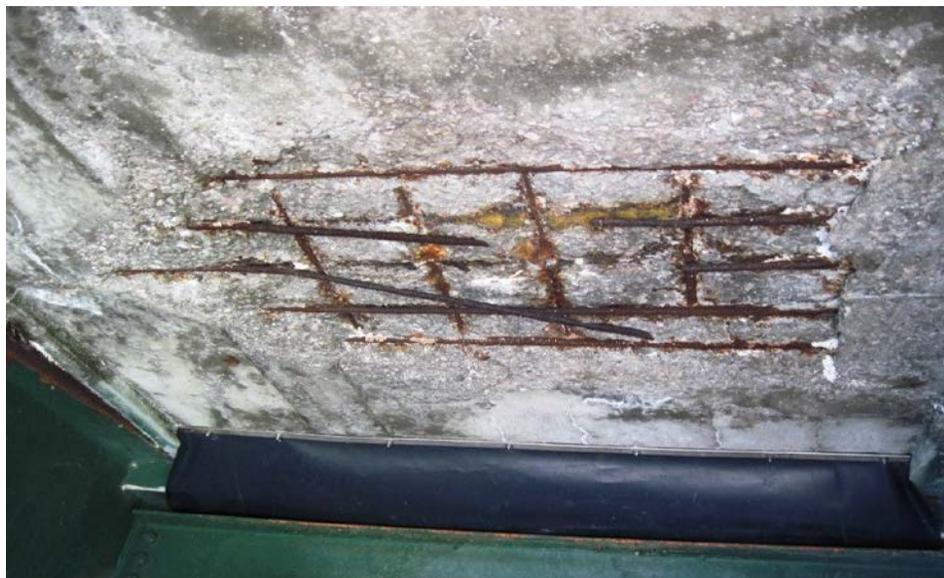
2.4.4 Bridge #77 S: Based on the latest bridge inspection photos for BR #77S, dated June 2012, portions of the concrete deck have deteriorated as can be seen in Figure 8.

Figure 8. BR #77S Concrete Deck Deterioration
